Kia Motors America Field Product Quality Report

Subject/Title: Panoramic Sunroof Shattered

Model Desc: OPTIMA EX

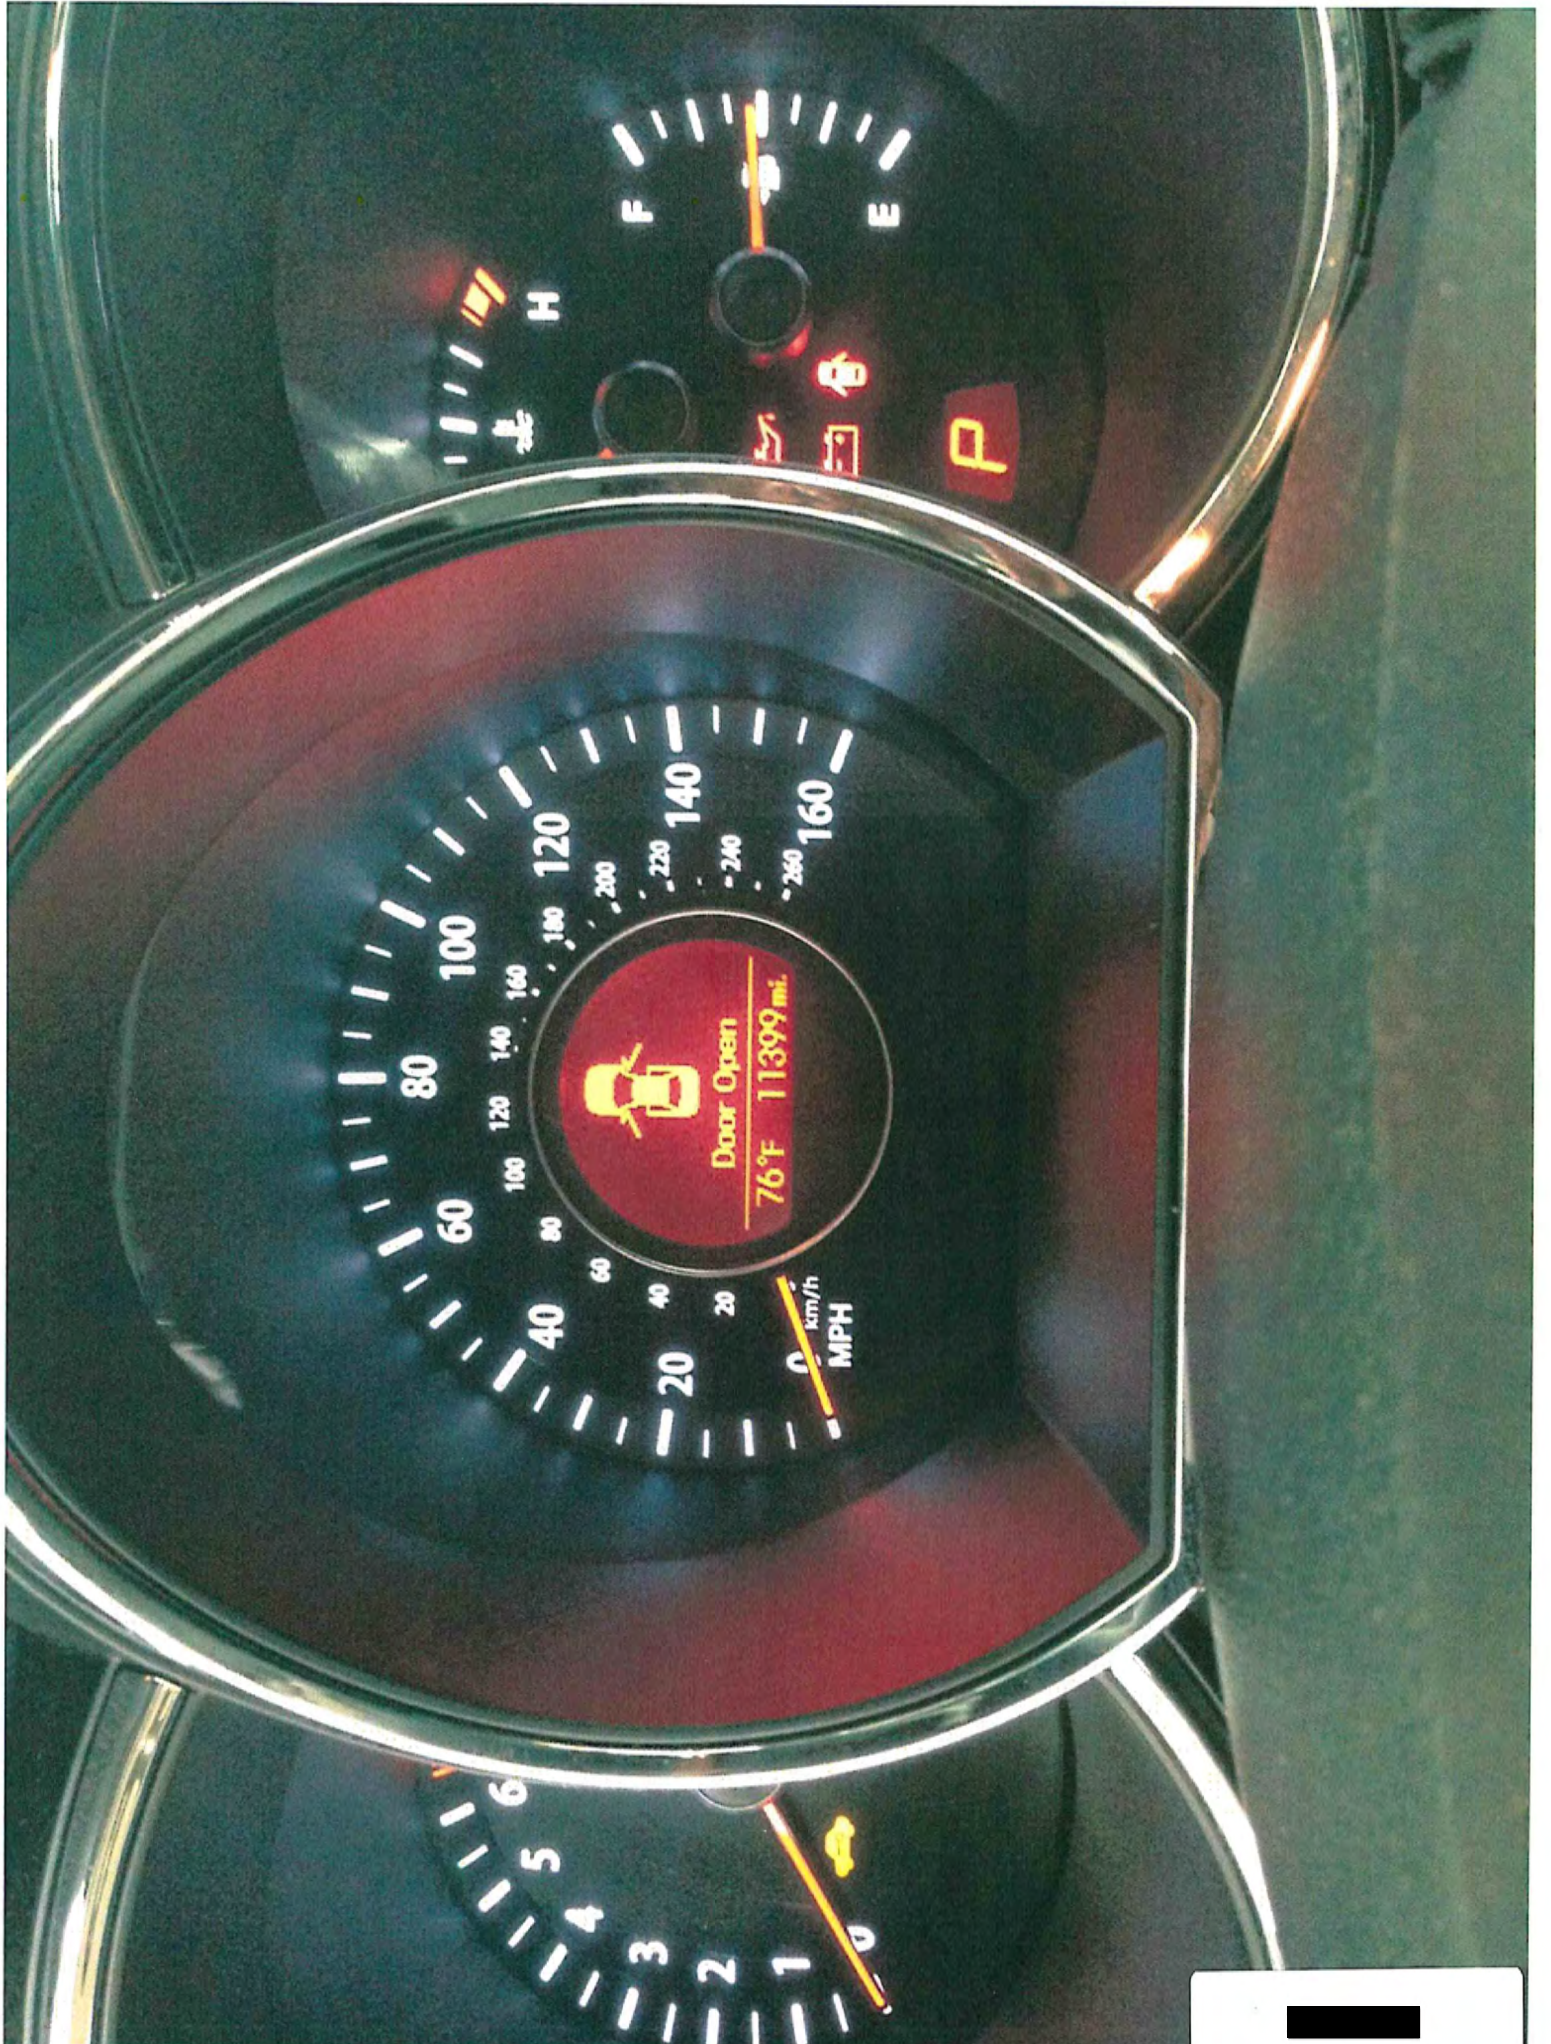
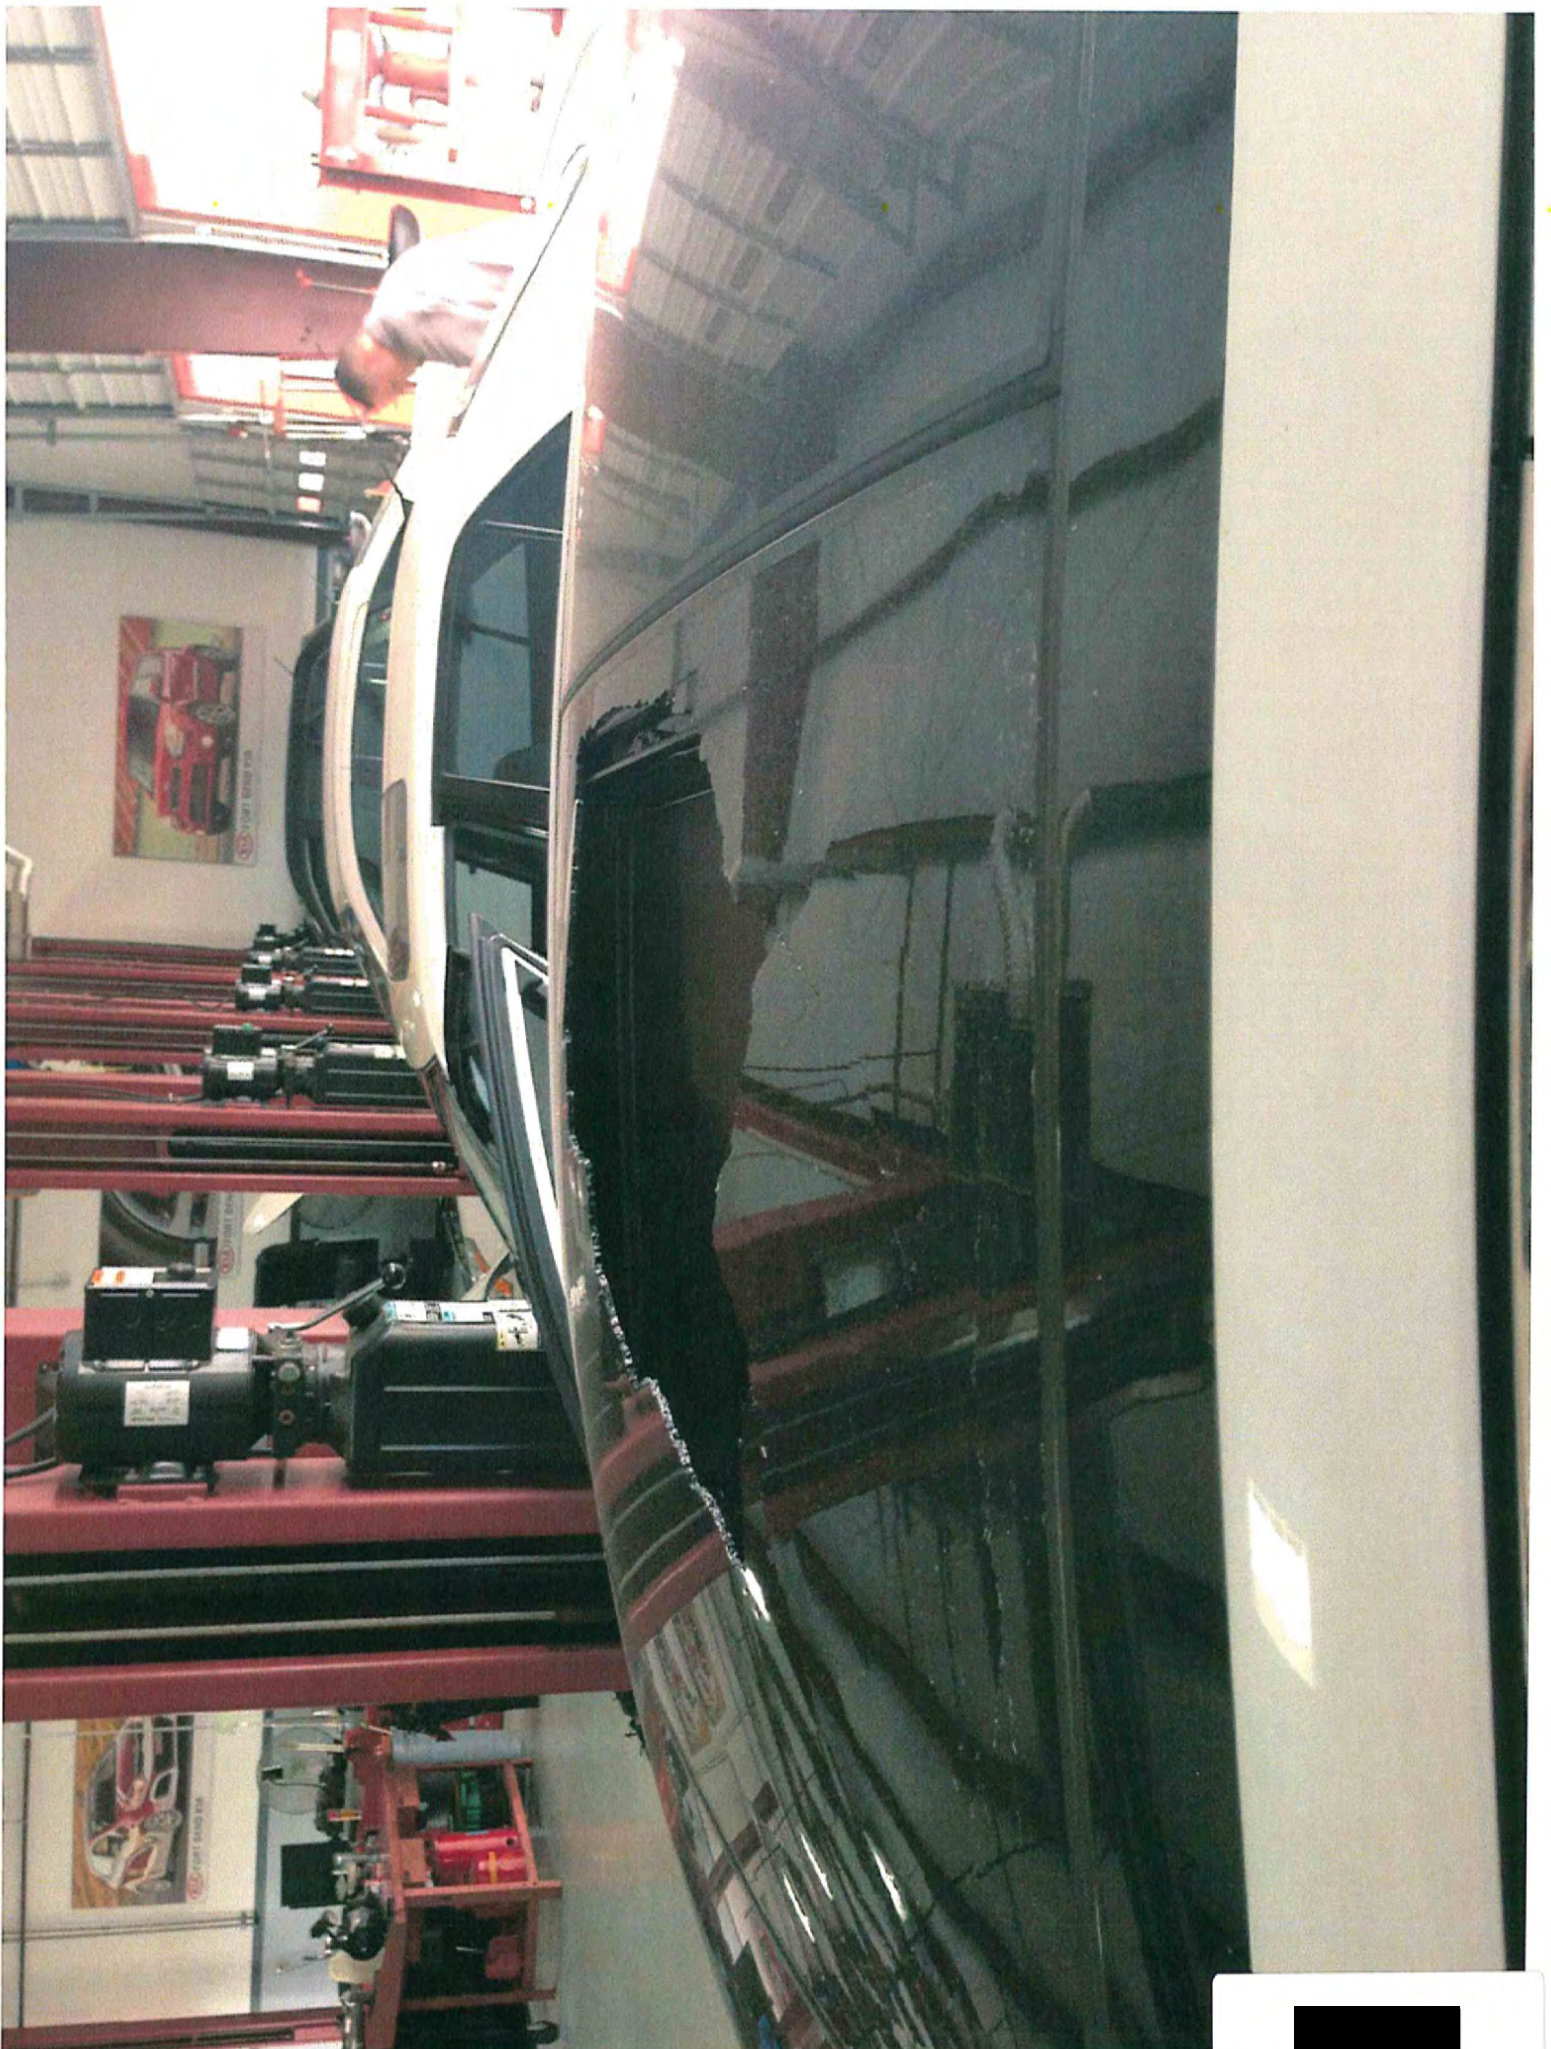
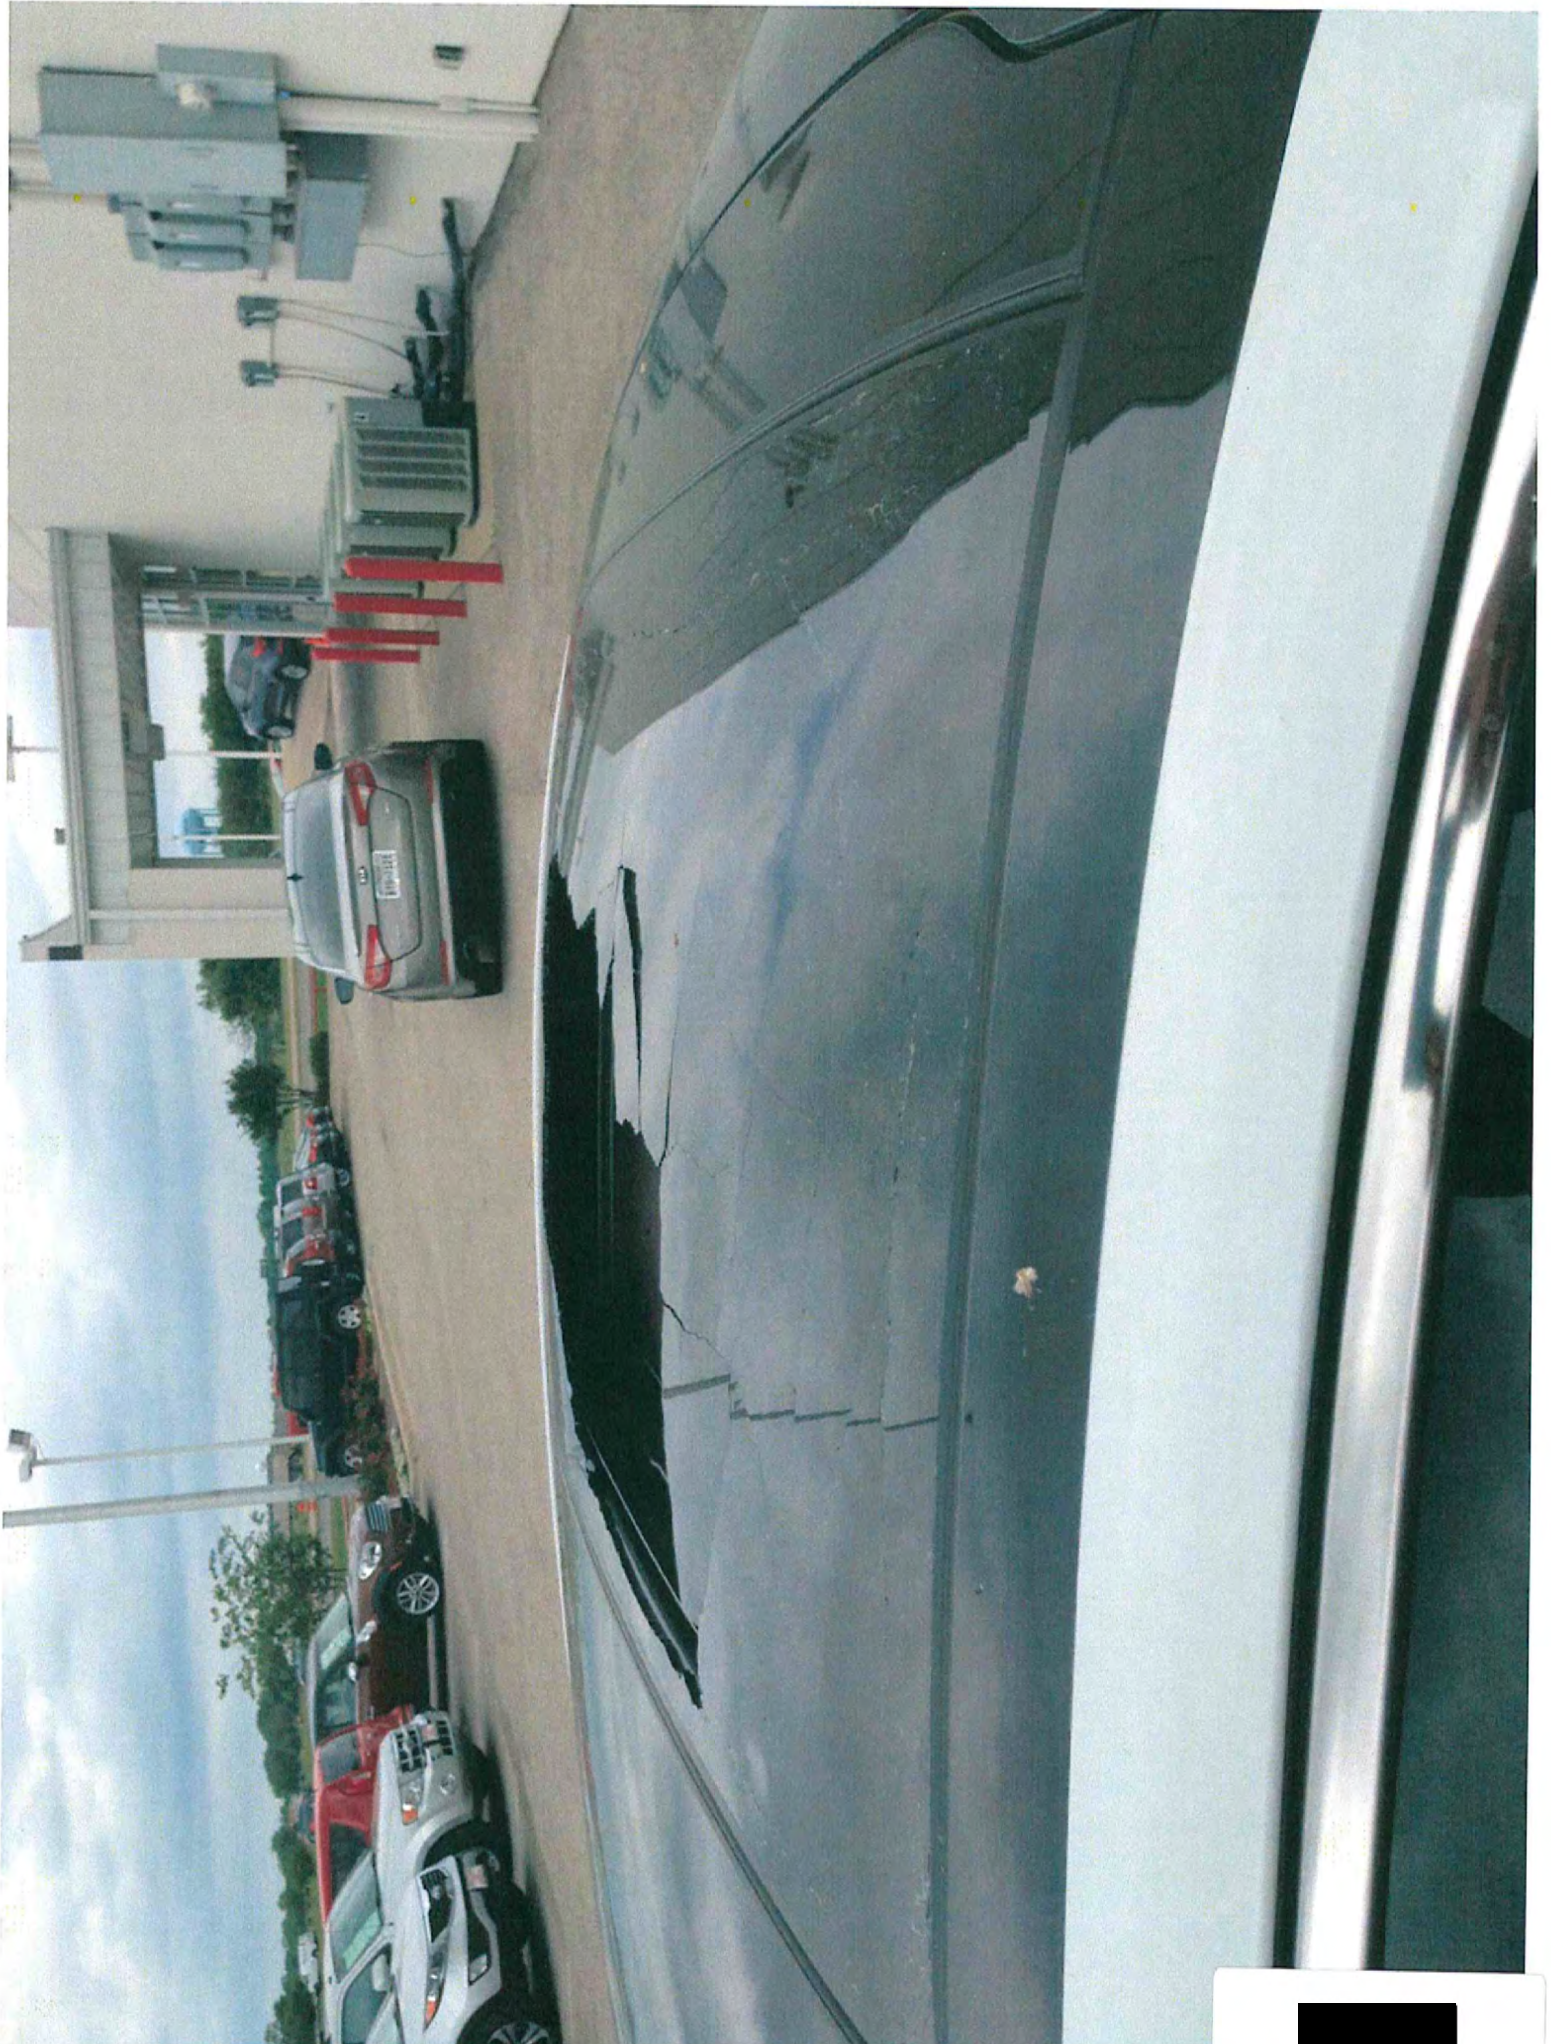
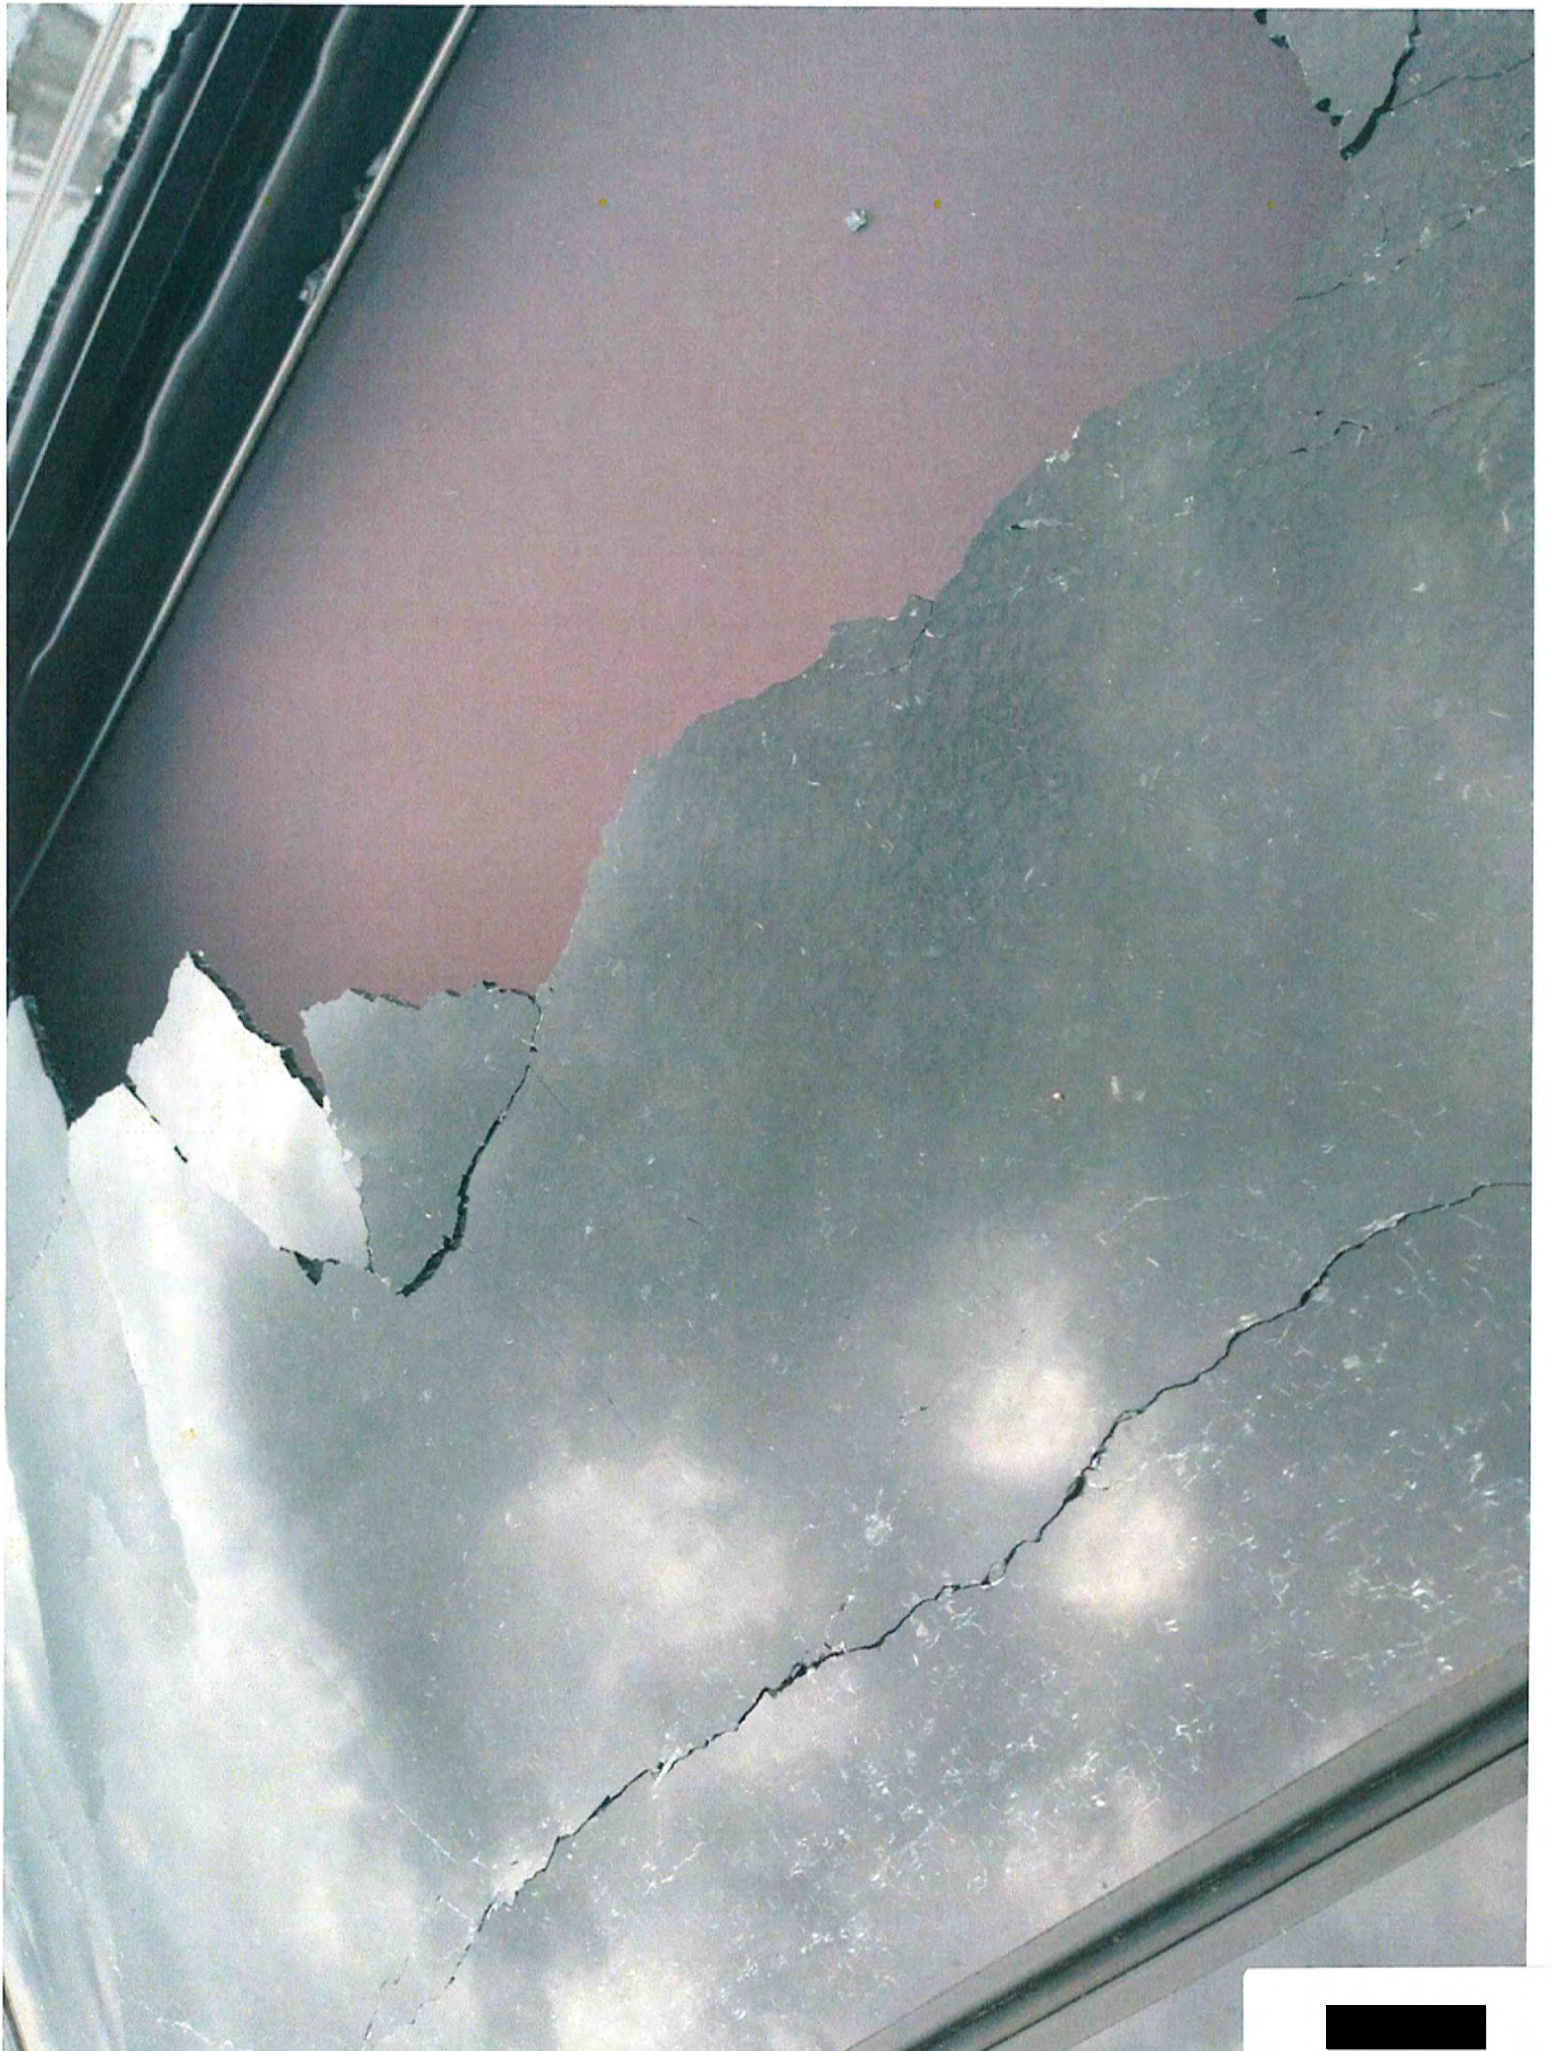
Found no reason why the roof shattered.

Replace the sunroof

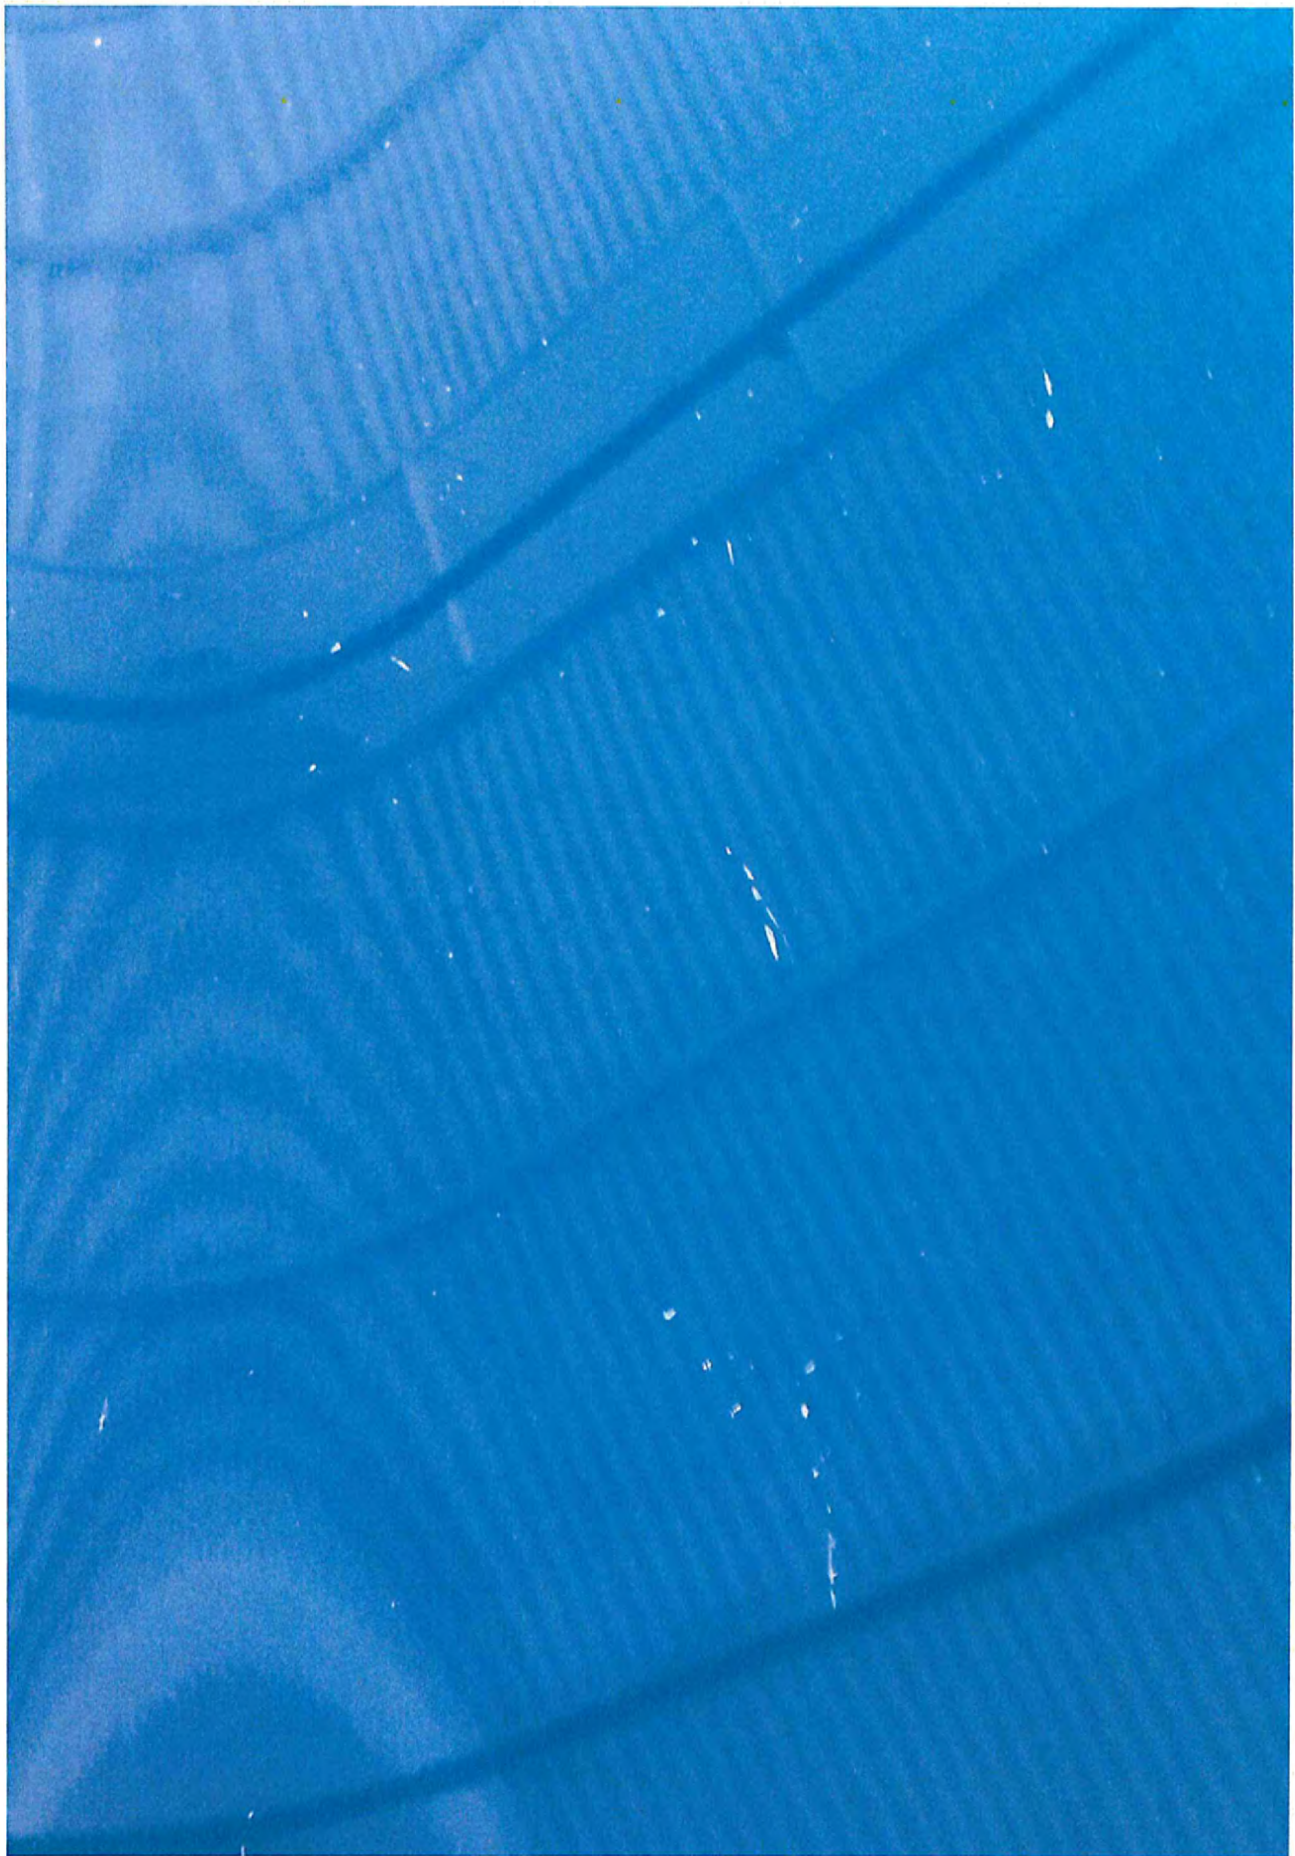
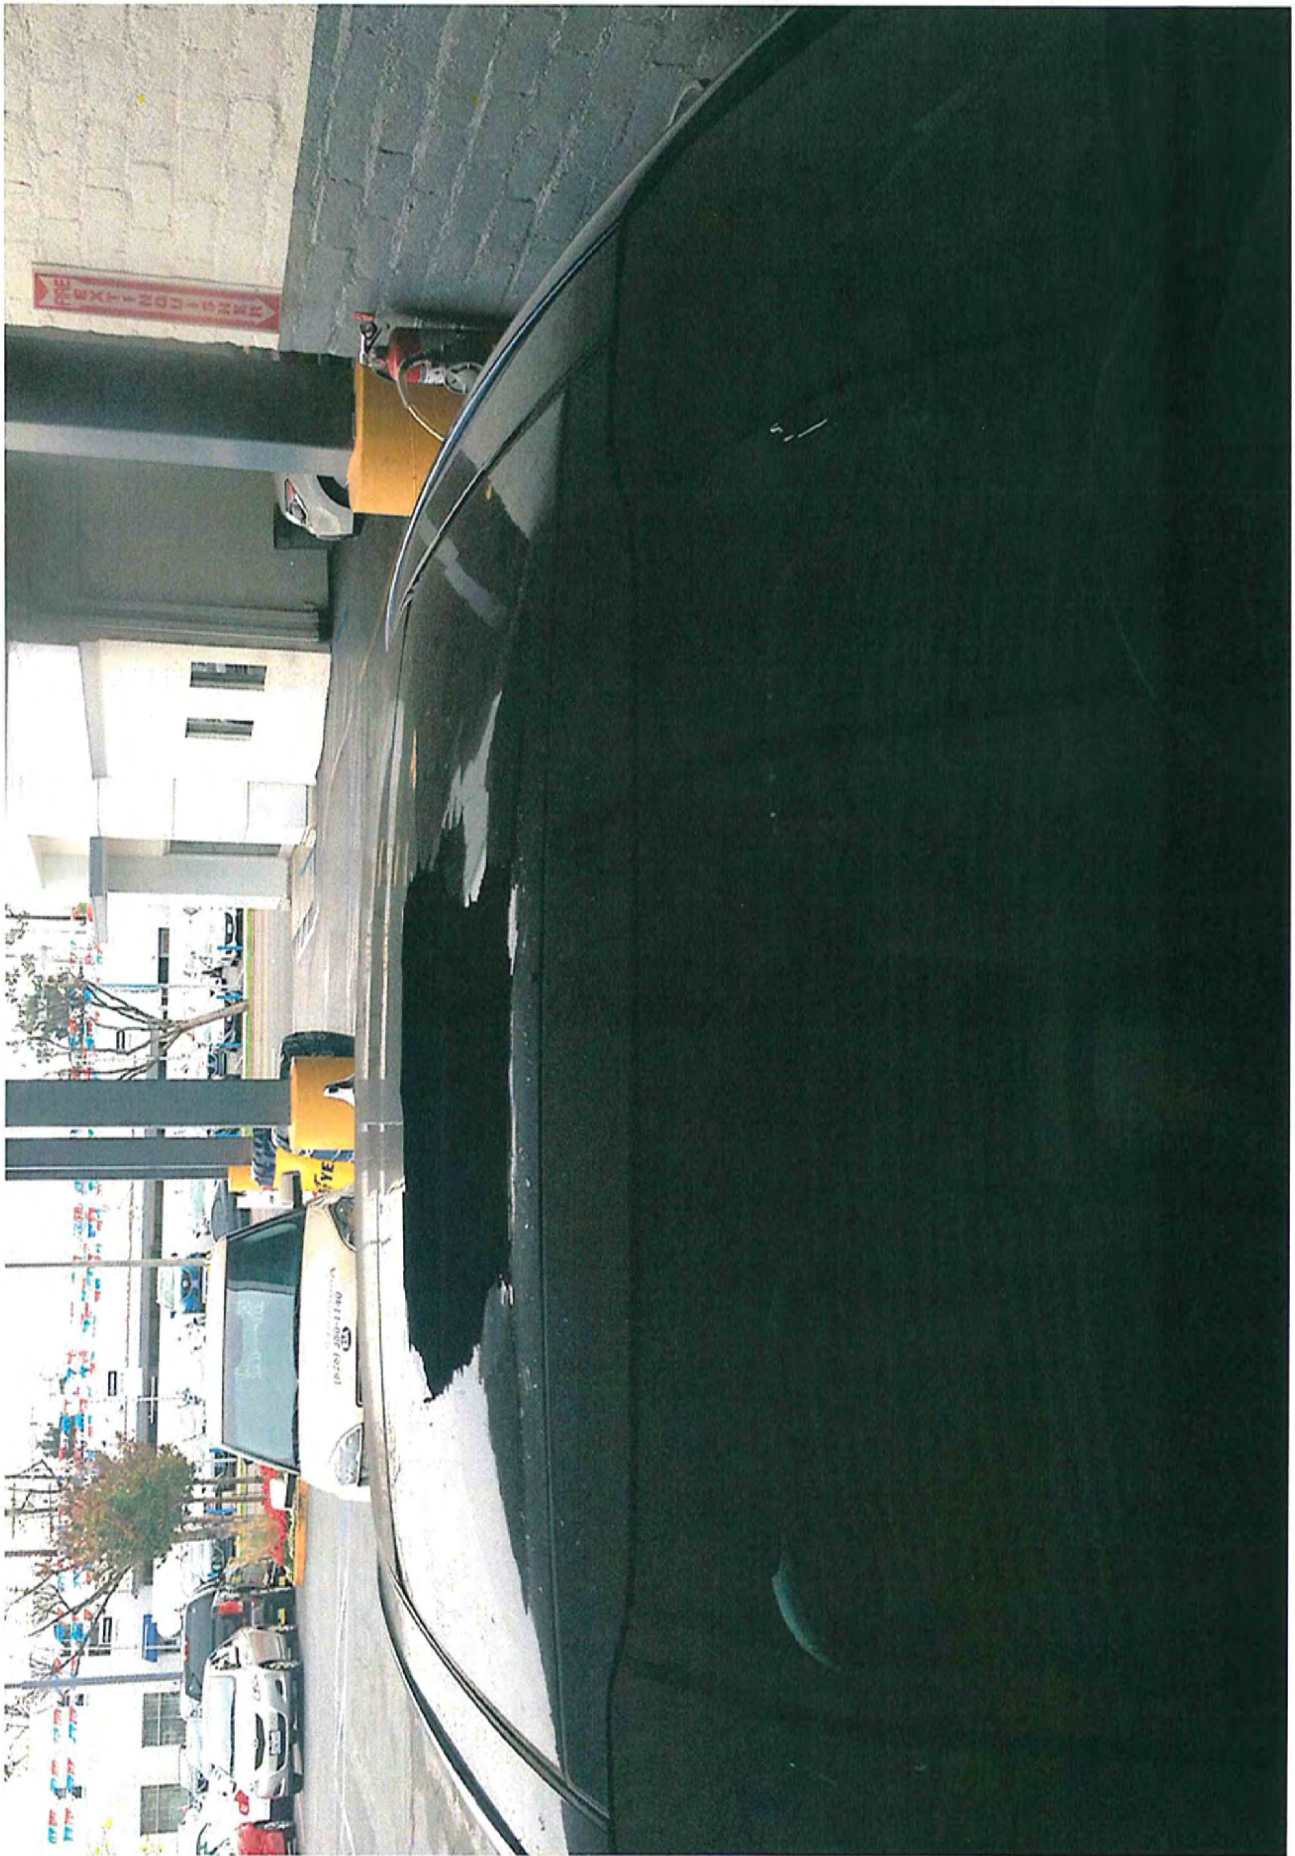
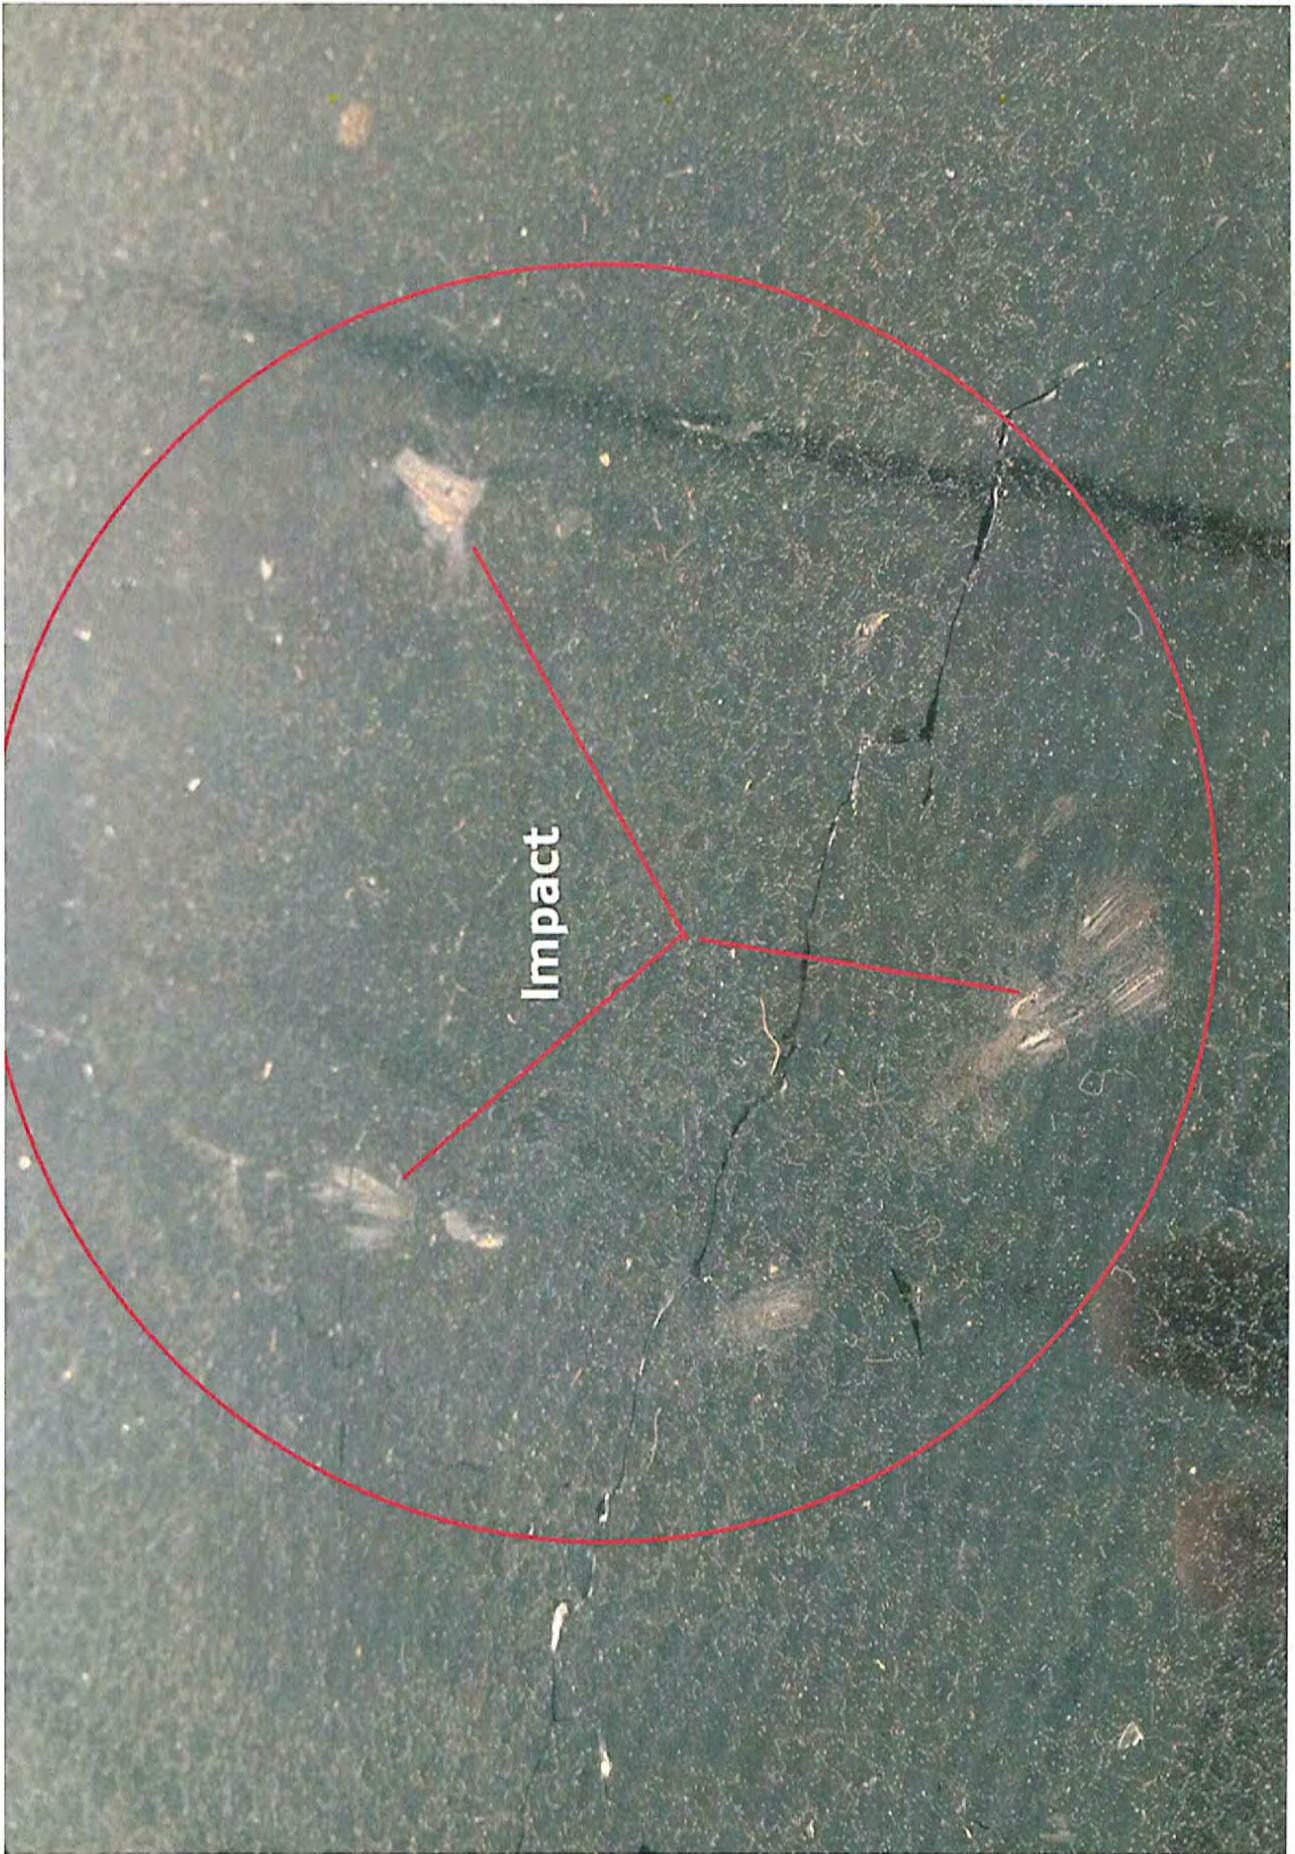
A hole was found at the center of the closed glass sunroof panel. (see photo) An outward crack was at the front of the glass that remained in place and cracks were throughout the rest of the panel. A paint chip was found on the rear of truck led. Multiple chip was also found at rear deck lid lip. (see photos attached).

Evidence of sunroof glass failure due to impact from outside source resulting in weakening of glass integrity. Signs of impact on sunroof glass and rear deck lid lip.

No action taken at this time. Results of inspection reported to Platform Engineer and NCA.
