Kia Motors America Field Product Quality Report

Subject/Title: Panoramic Sunroof Shattered

Model Desc: OPTIMA EX

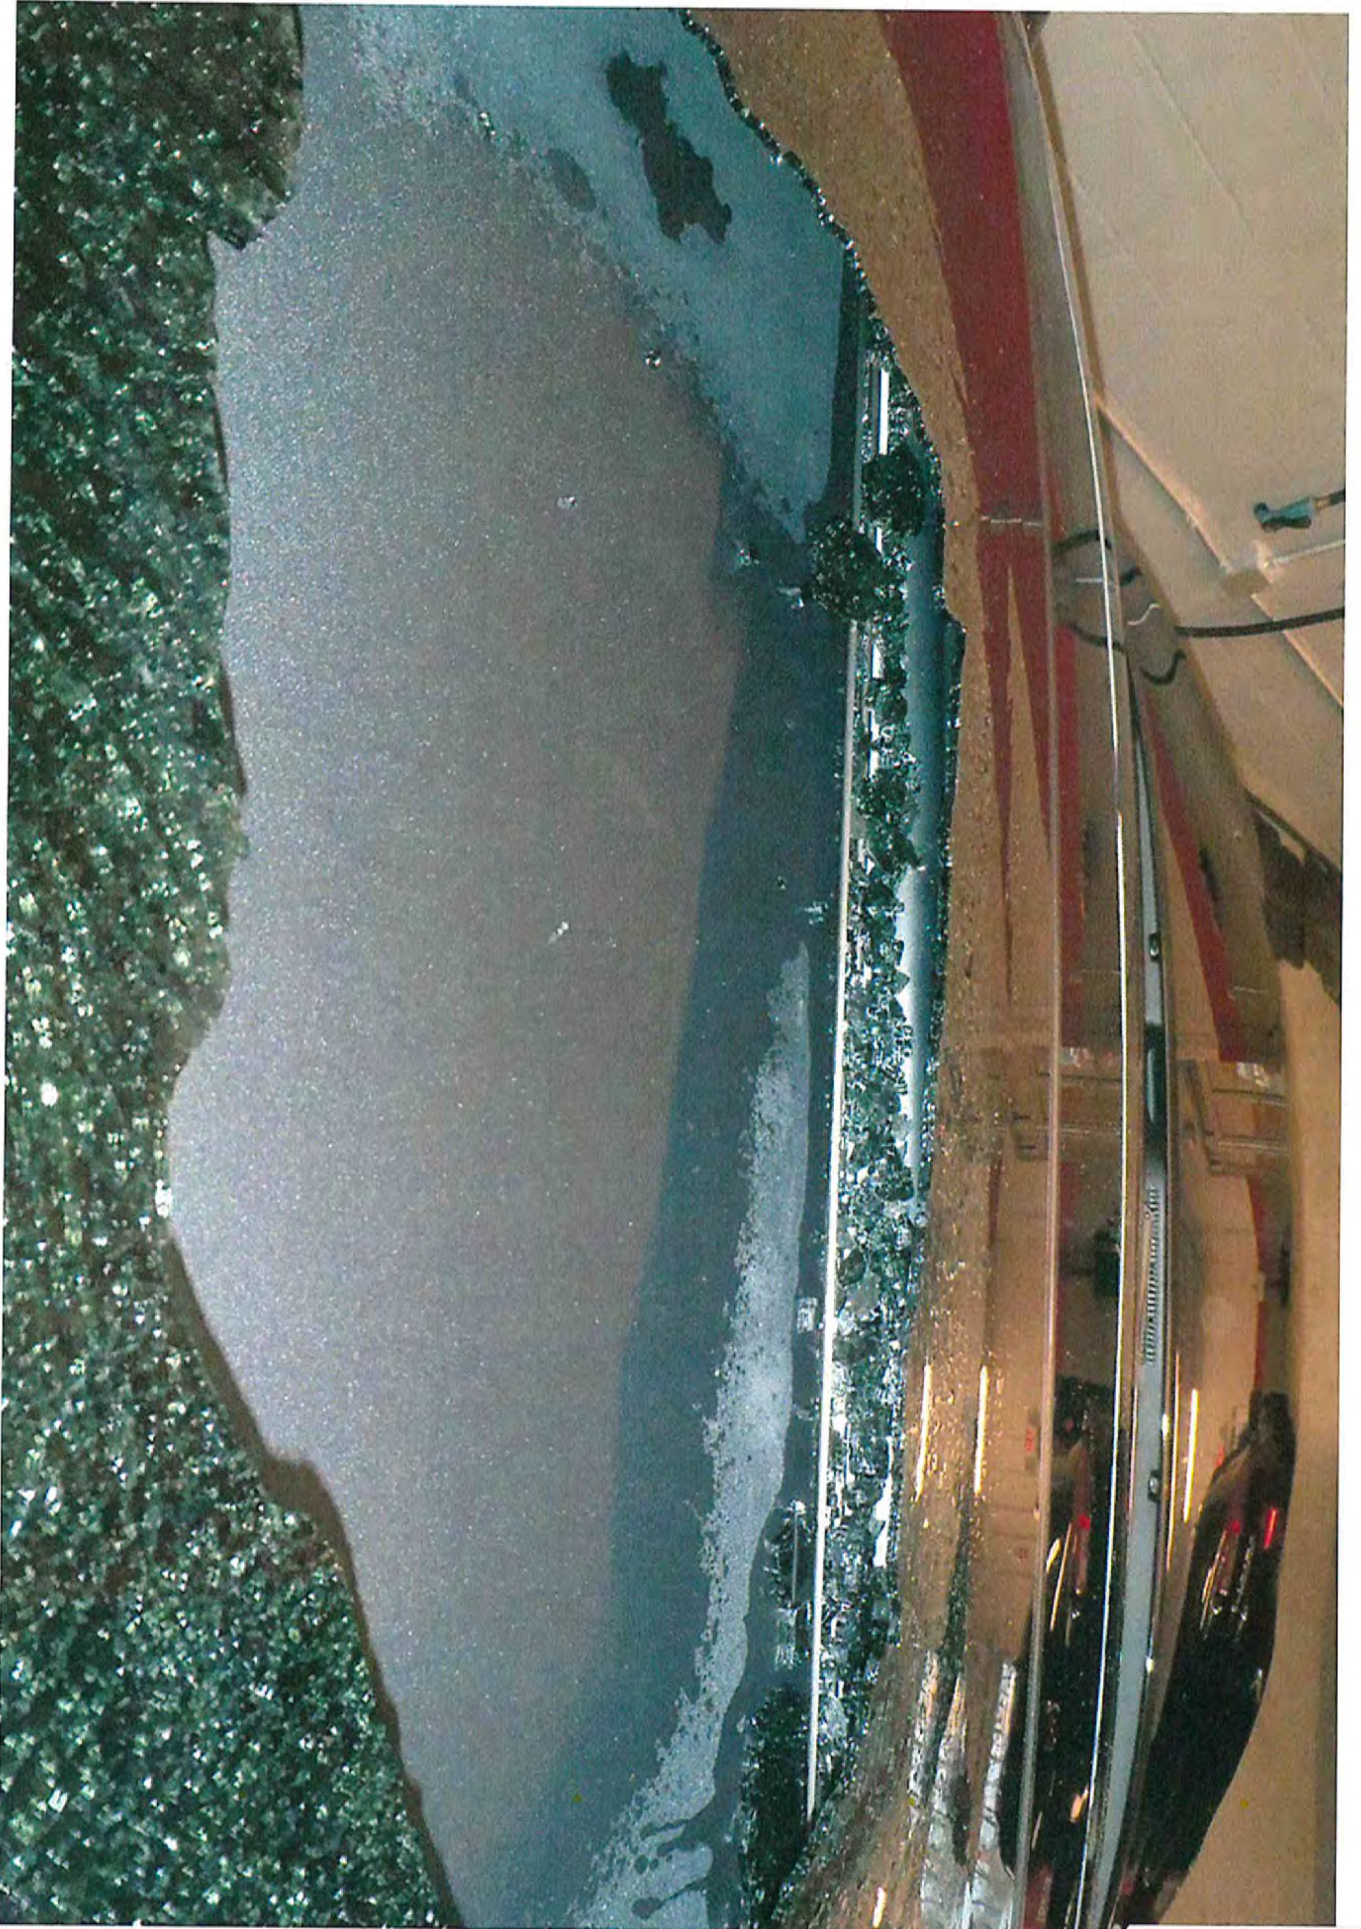
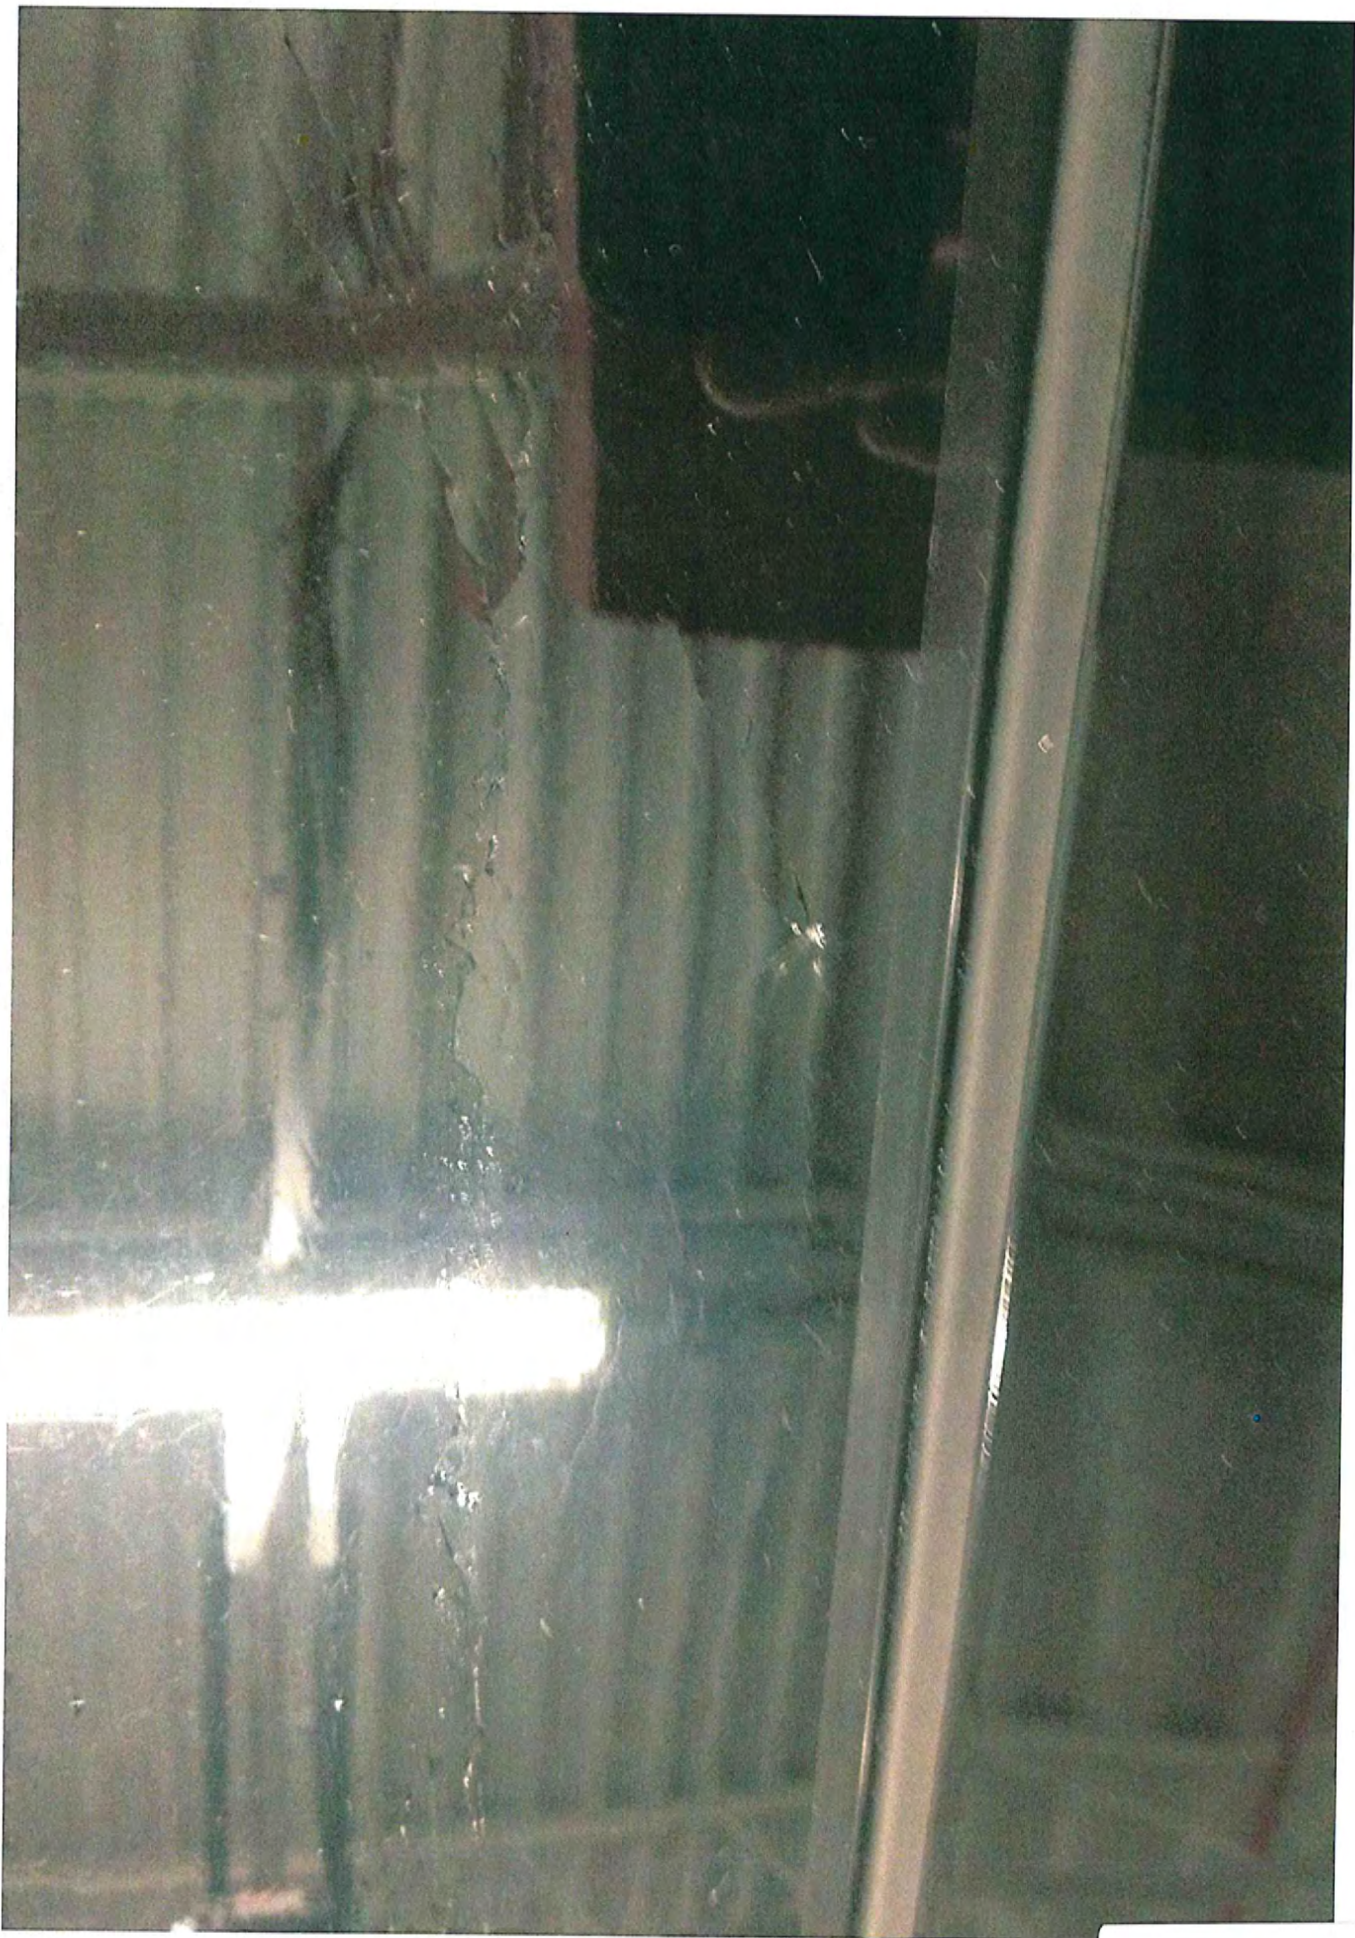
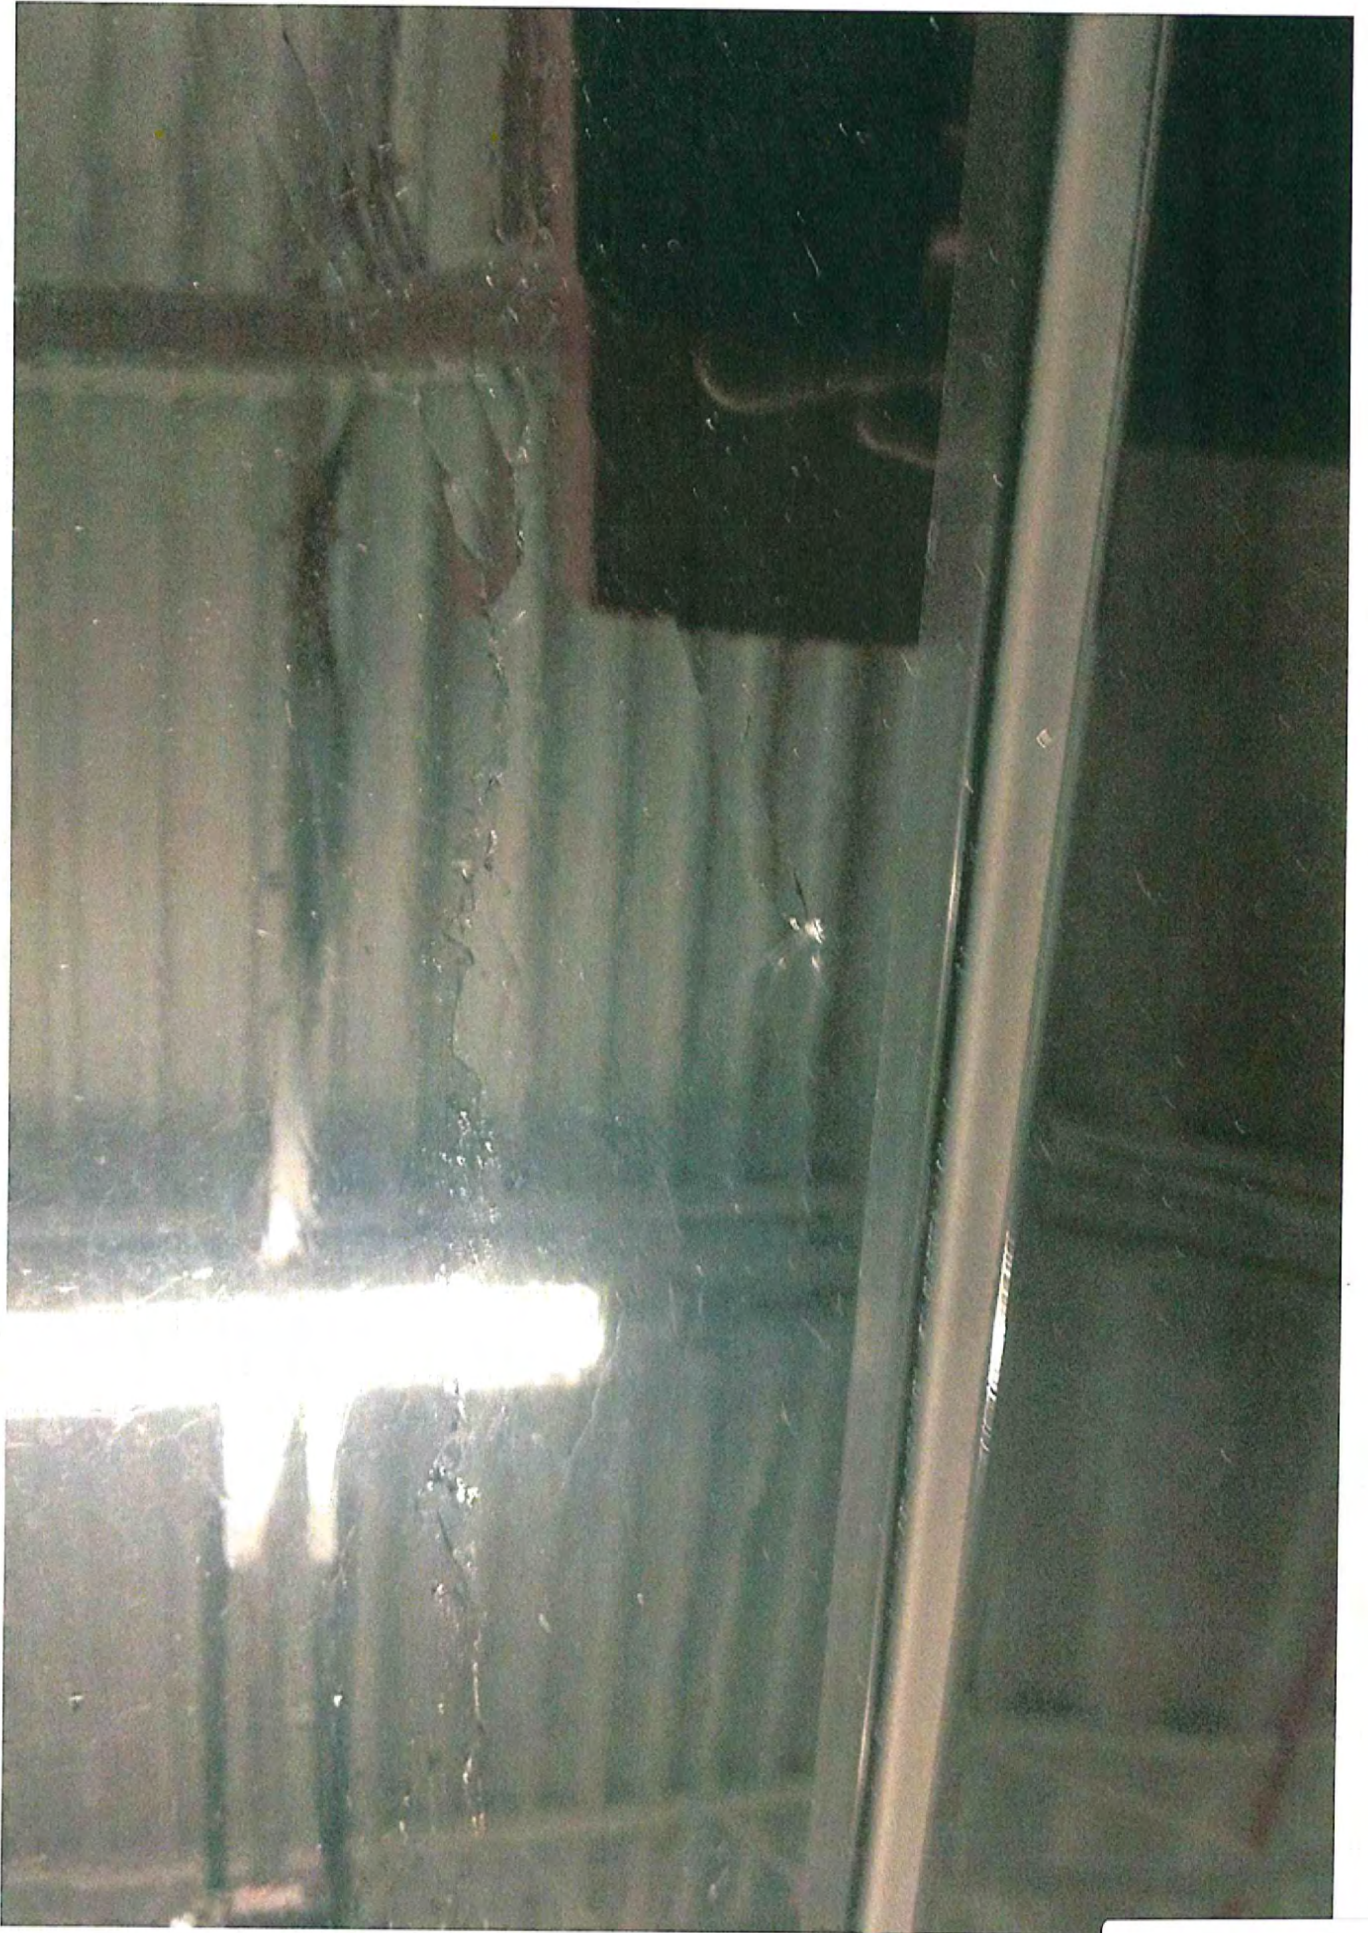
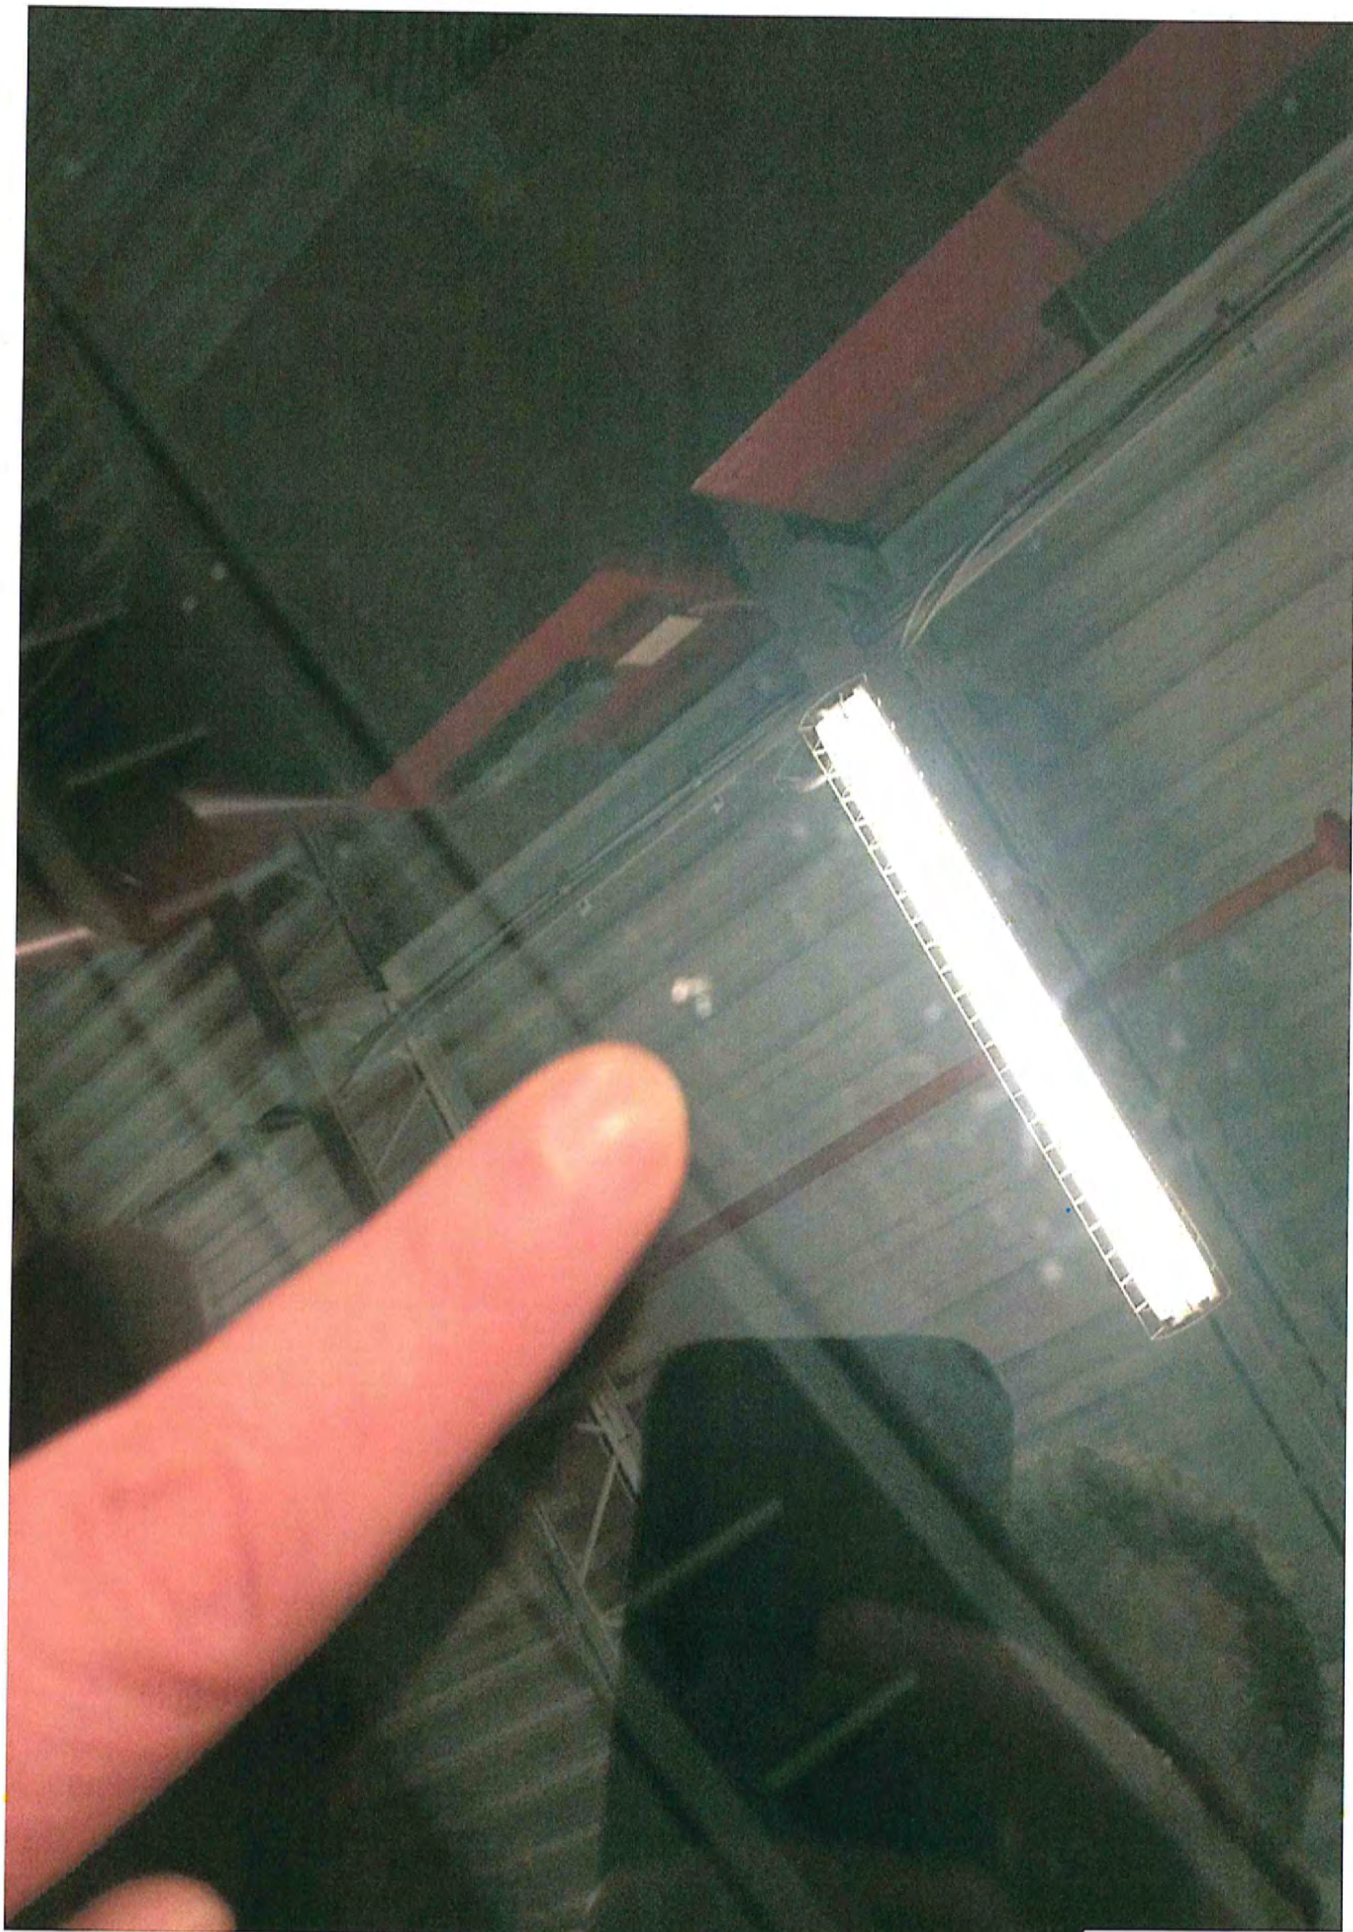
FTR inspected vehicle and found front panel of panoramic roof shattered. The sunroof was closed as well as the sunshade. The glass debris sitting on top of the sunshade.

A hole was in the center of the closed glass sunroof panel. (see photo) An outward crack was at the front of the glass that remained in place and cracks were throughout the rest of the panel. A paint chip was found on the hood down to the metal. No rust was on the exposed metal suggesting the chip was recent. A chip was in the windshield was also found. (see photos attached) other small chips in the paint and windshield were noted as well.

Possible roof glass failure due to impact from outside source resulting in weakening of glass integrity. Signs of impact on hood and windshield was found.

No action taken at this time. Results of inspection reported to Platform Engineer and NCA.

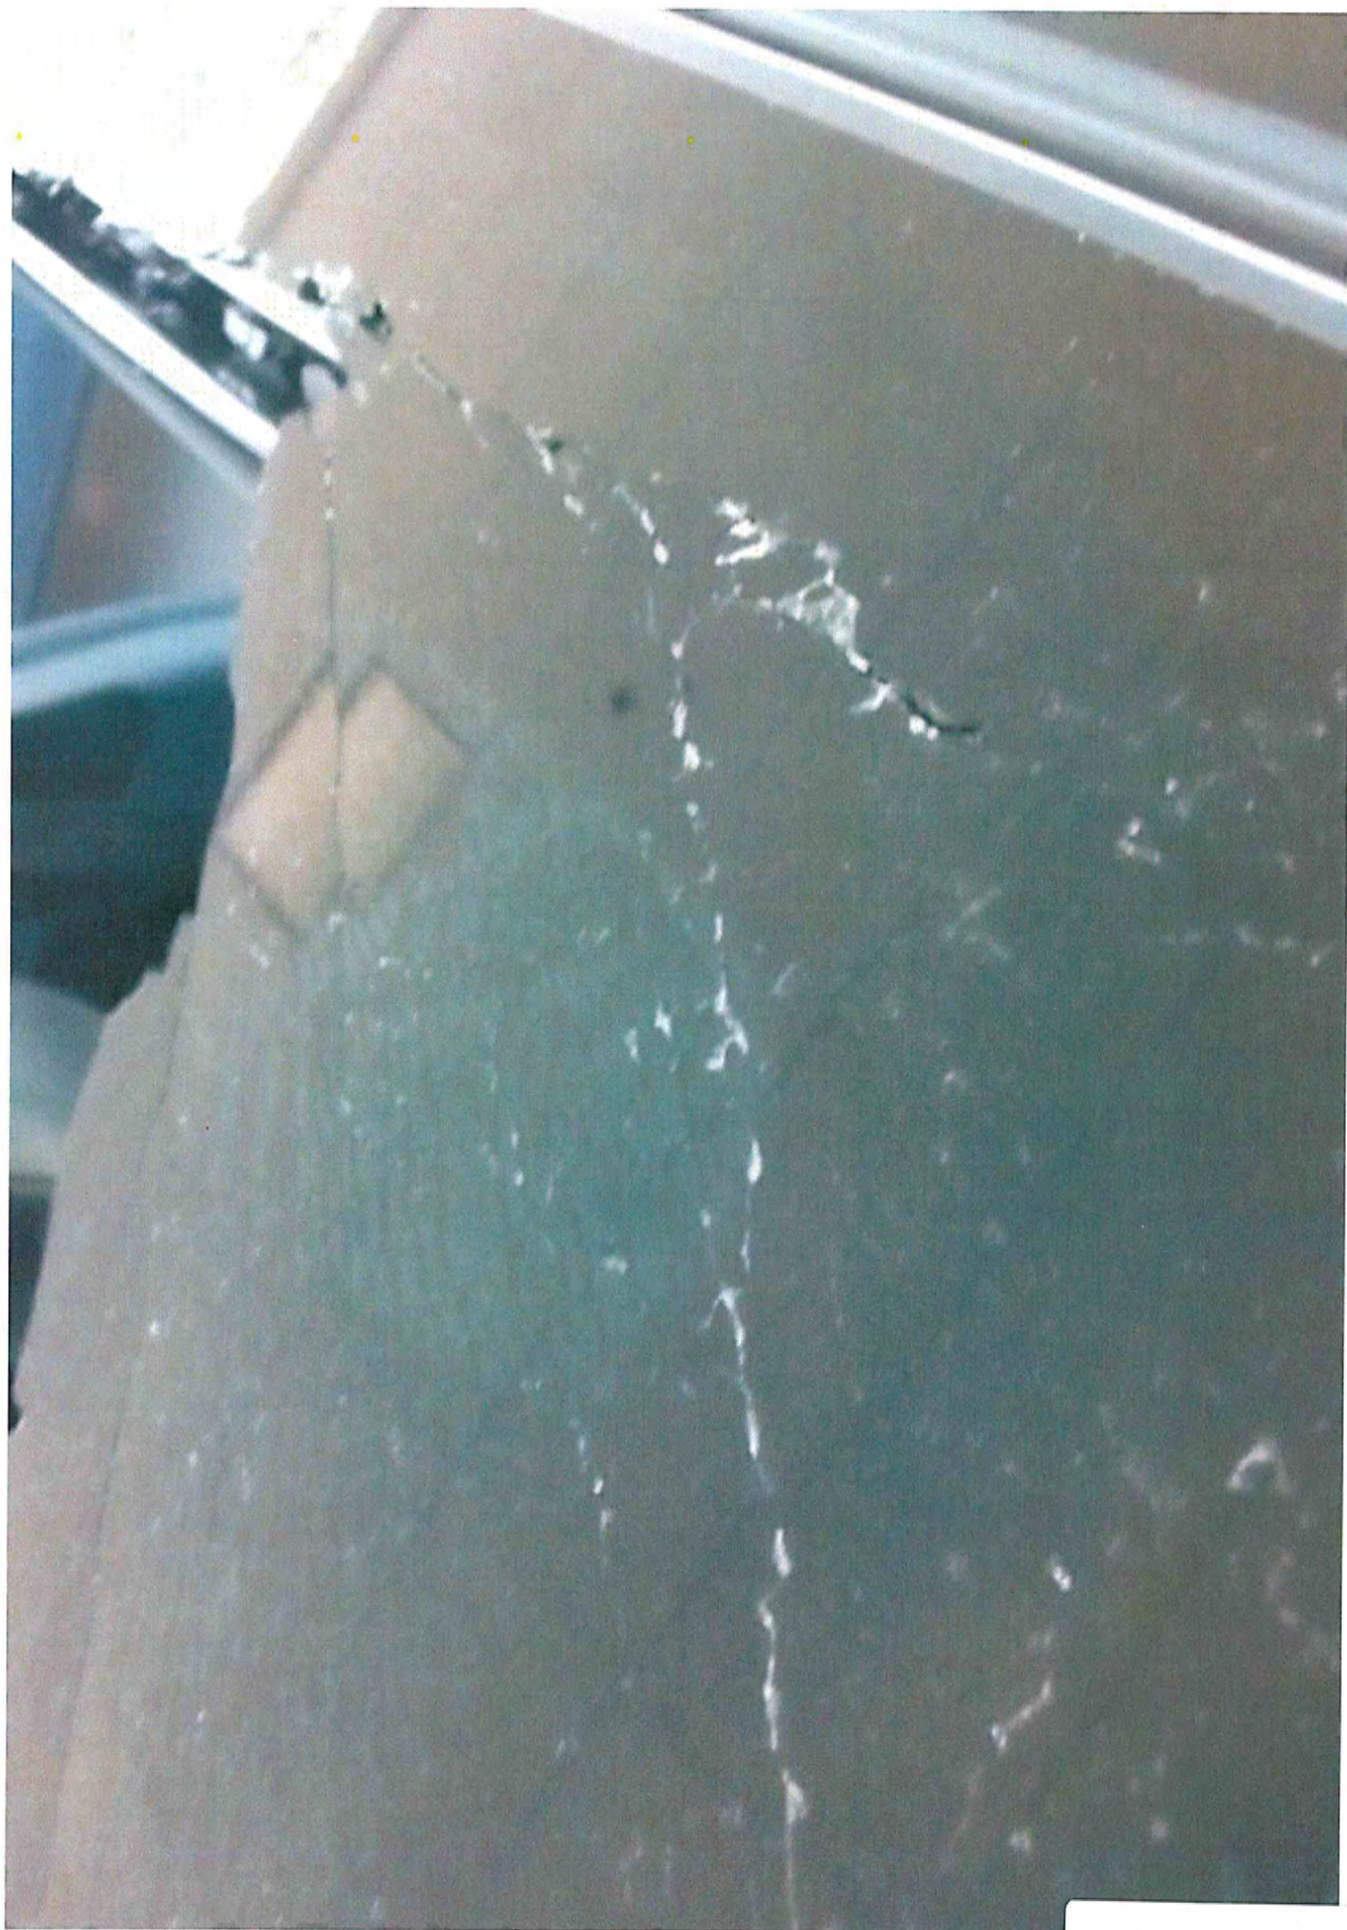
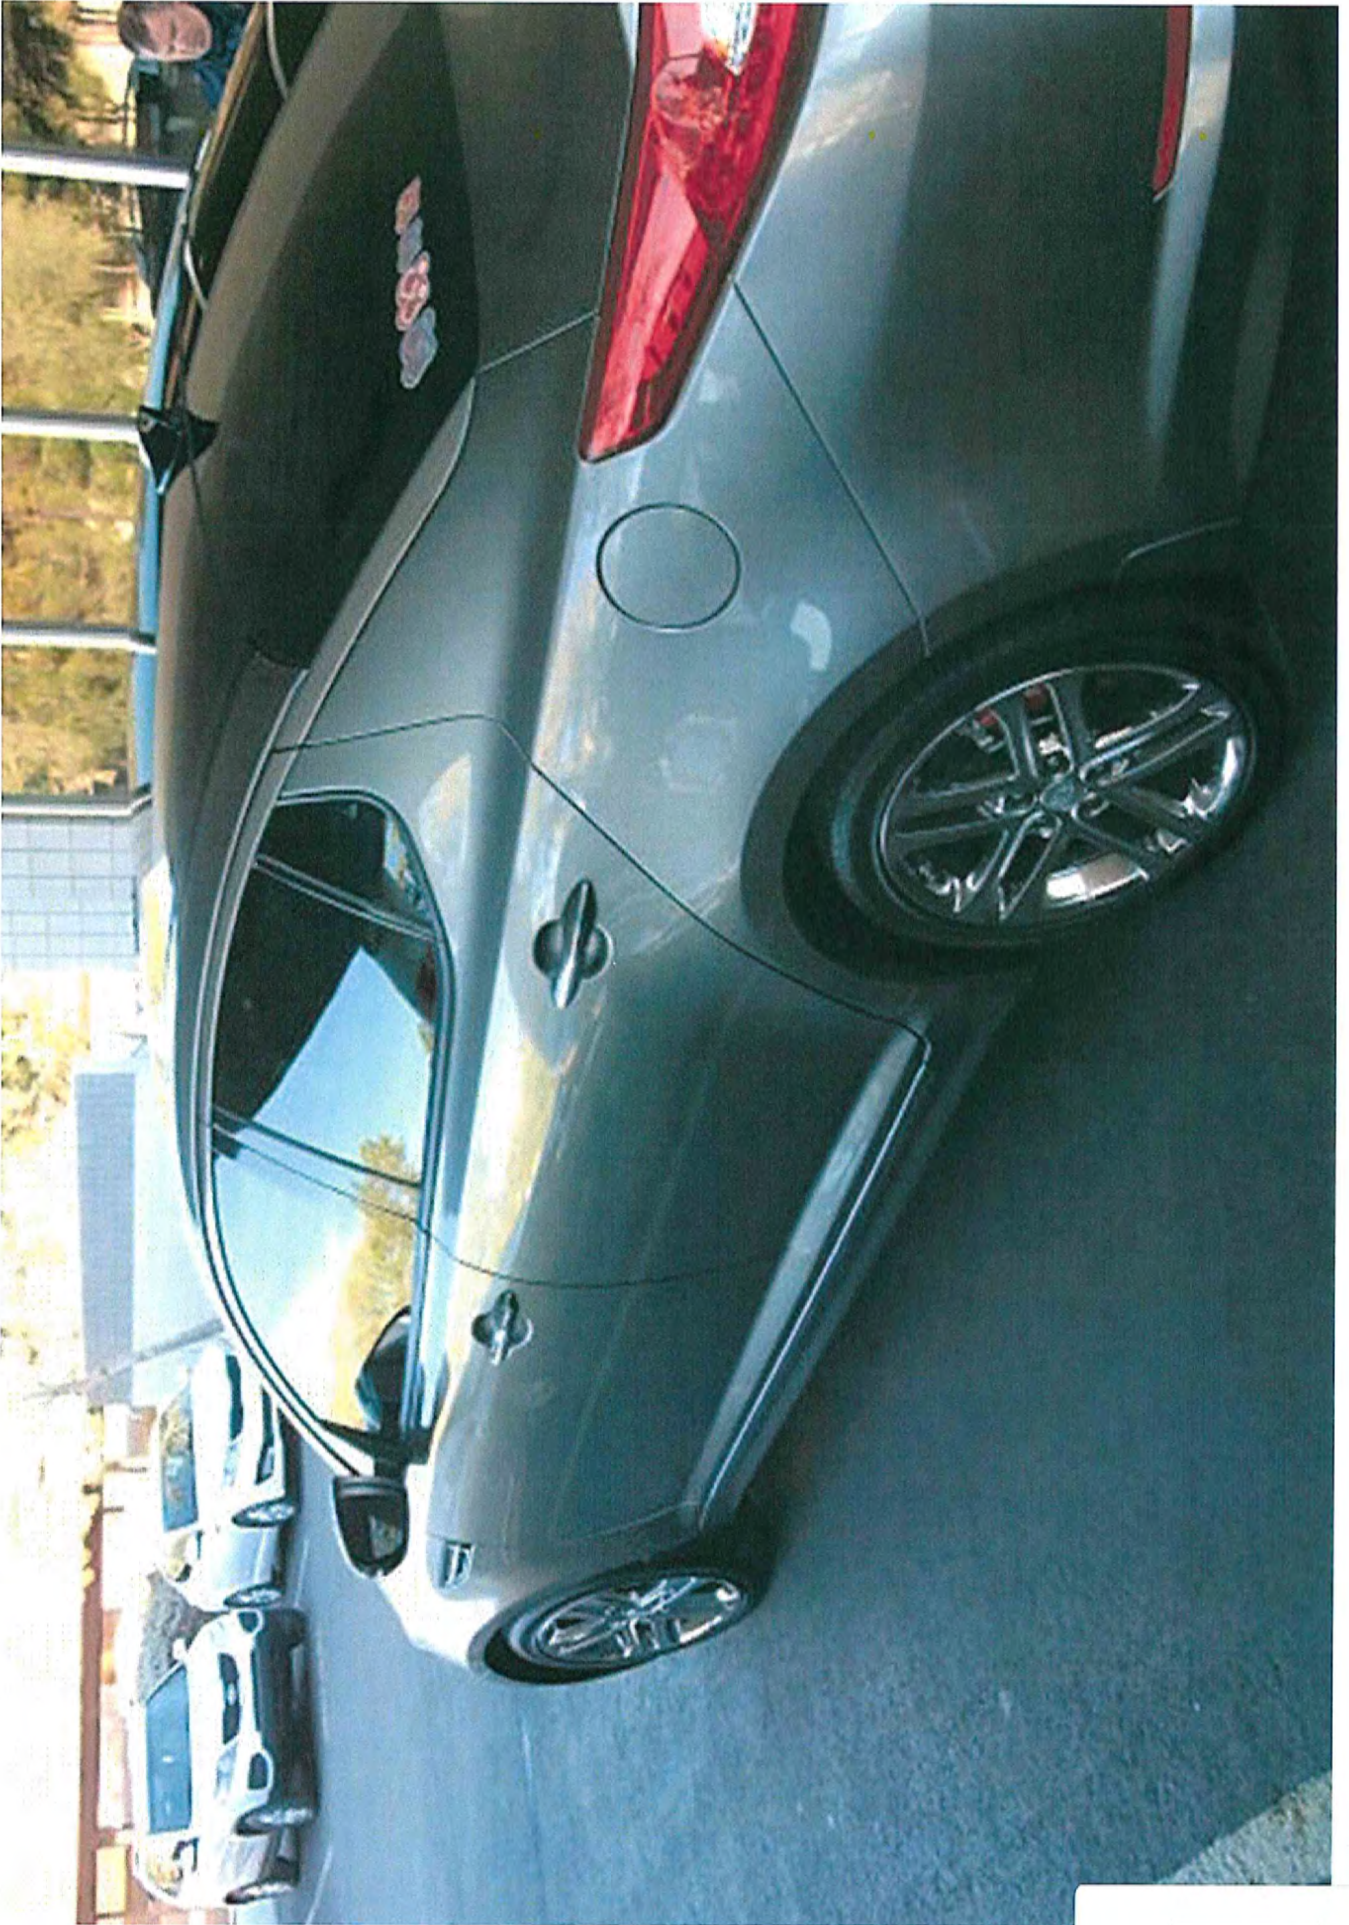
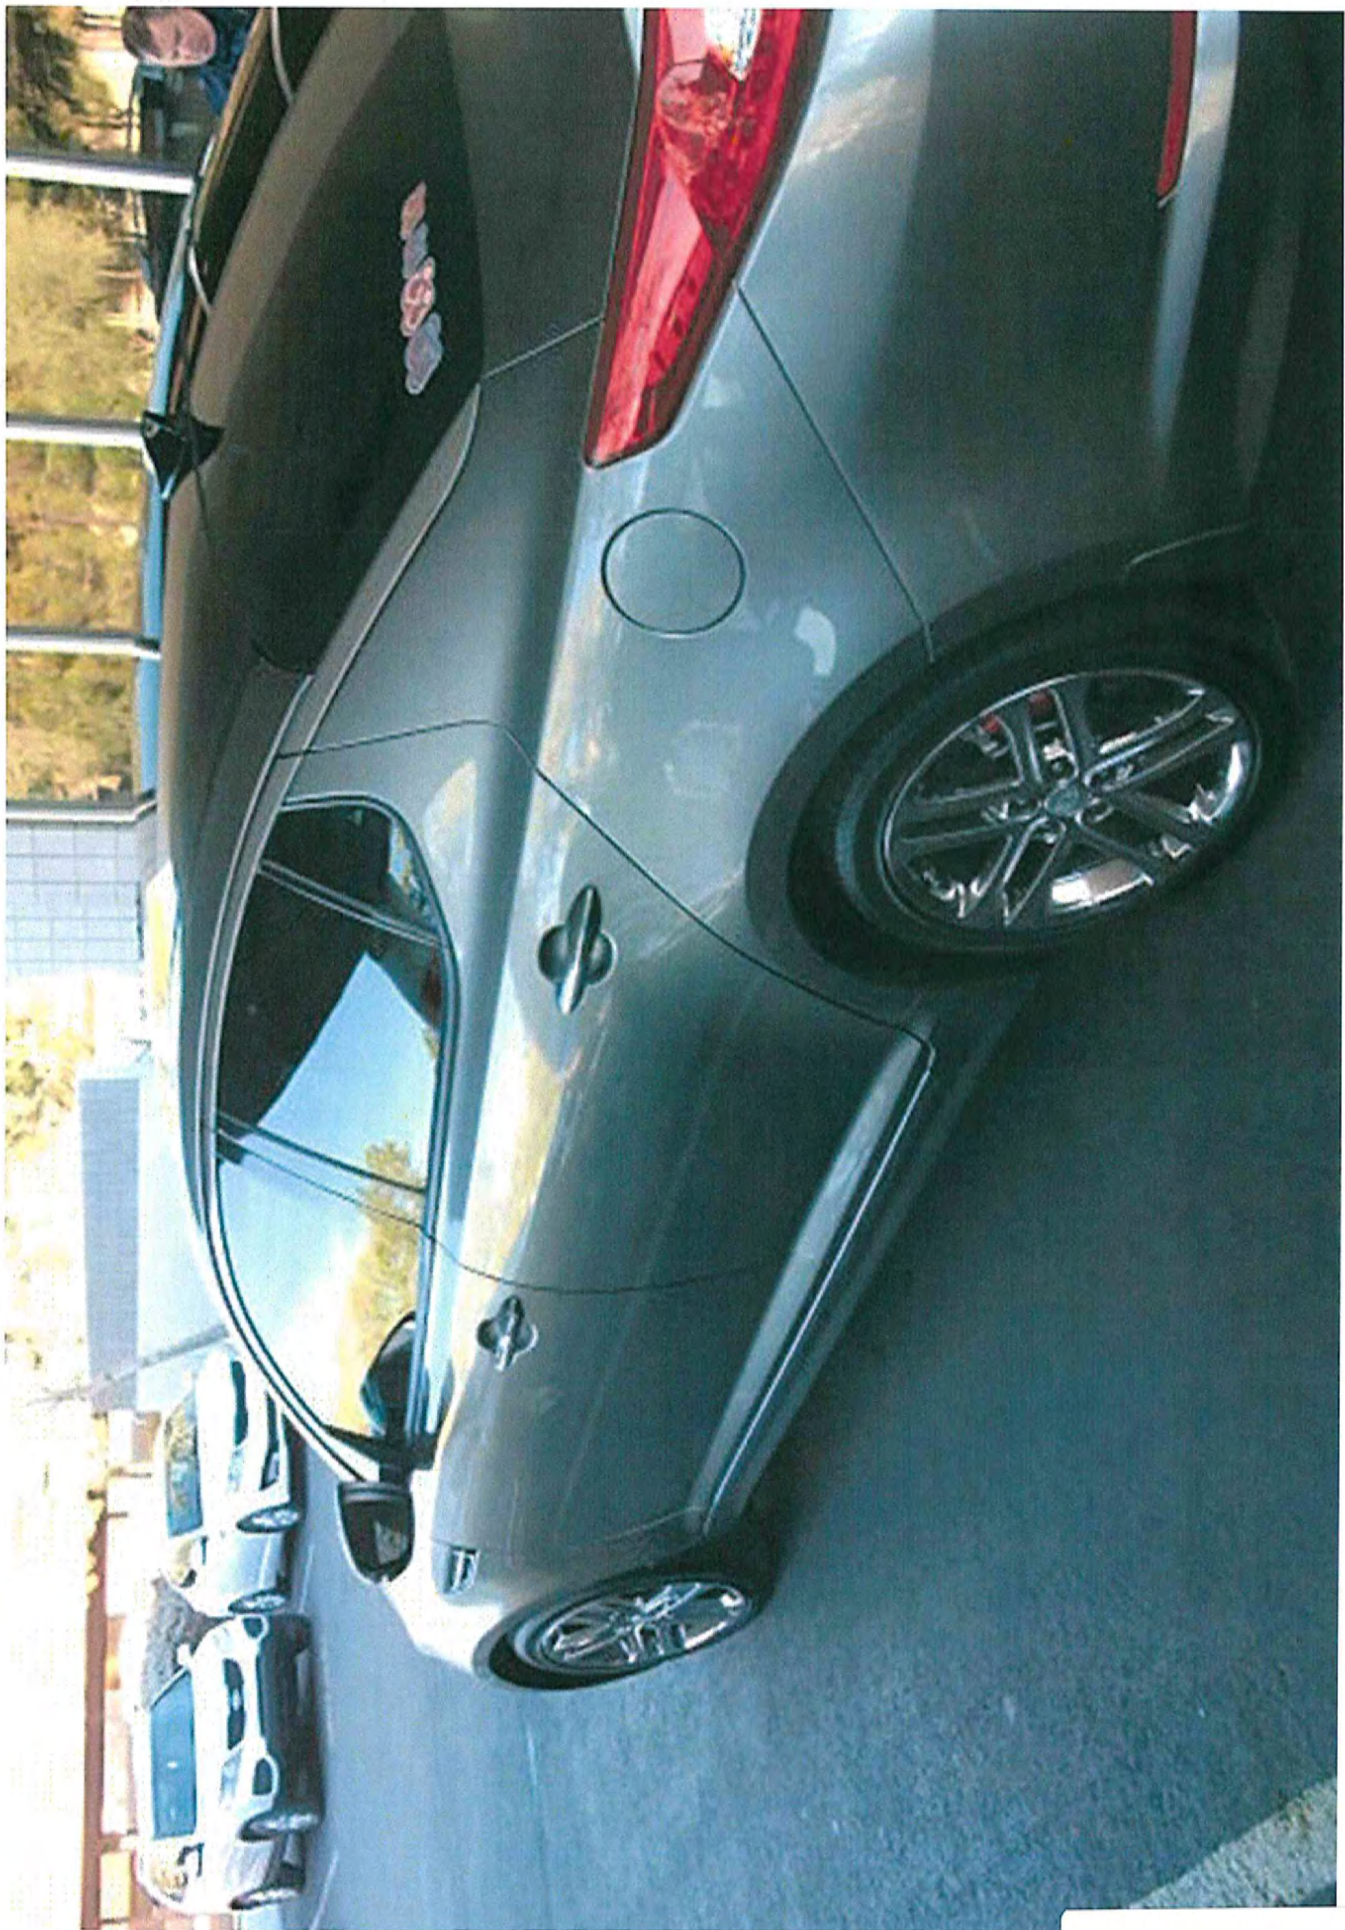
Panoramic sunroof shattered

DPSM inspected vehicle and relayed results to FTR. There are no apparent signs of impact causing the sunroof assy to shatter. Normal signs of windshield pitting for driving around the Metro Phoenix Area.

Undetermined

Replace shattered panoramic sunroof glass
