Kia Motors America Field Product Quality Report

Subject/Title: Panoramic Sunroof Shattered

Model Desc: OPTIMA EX

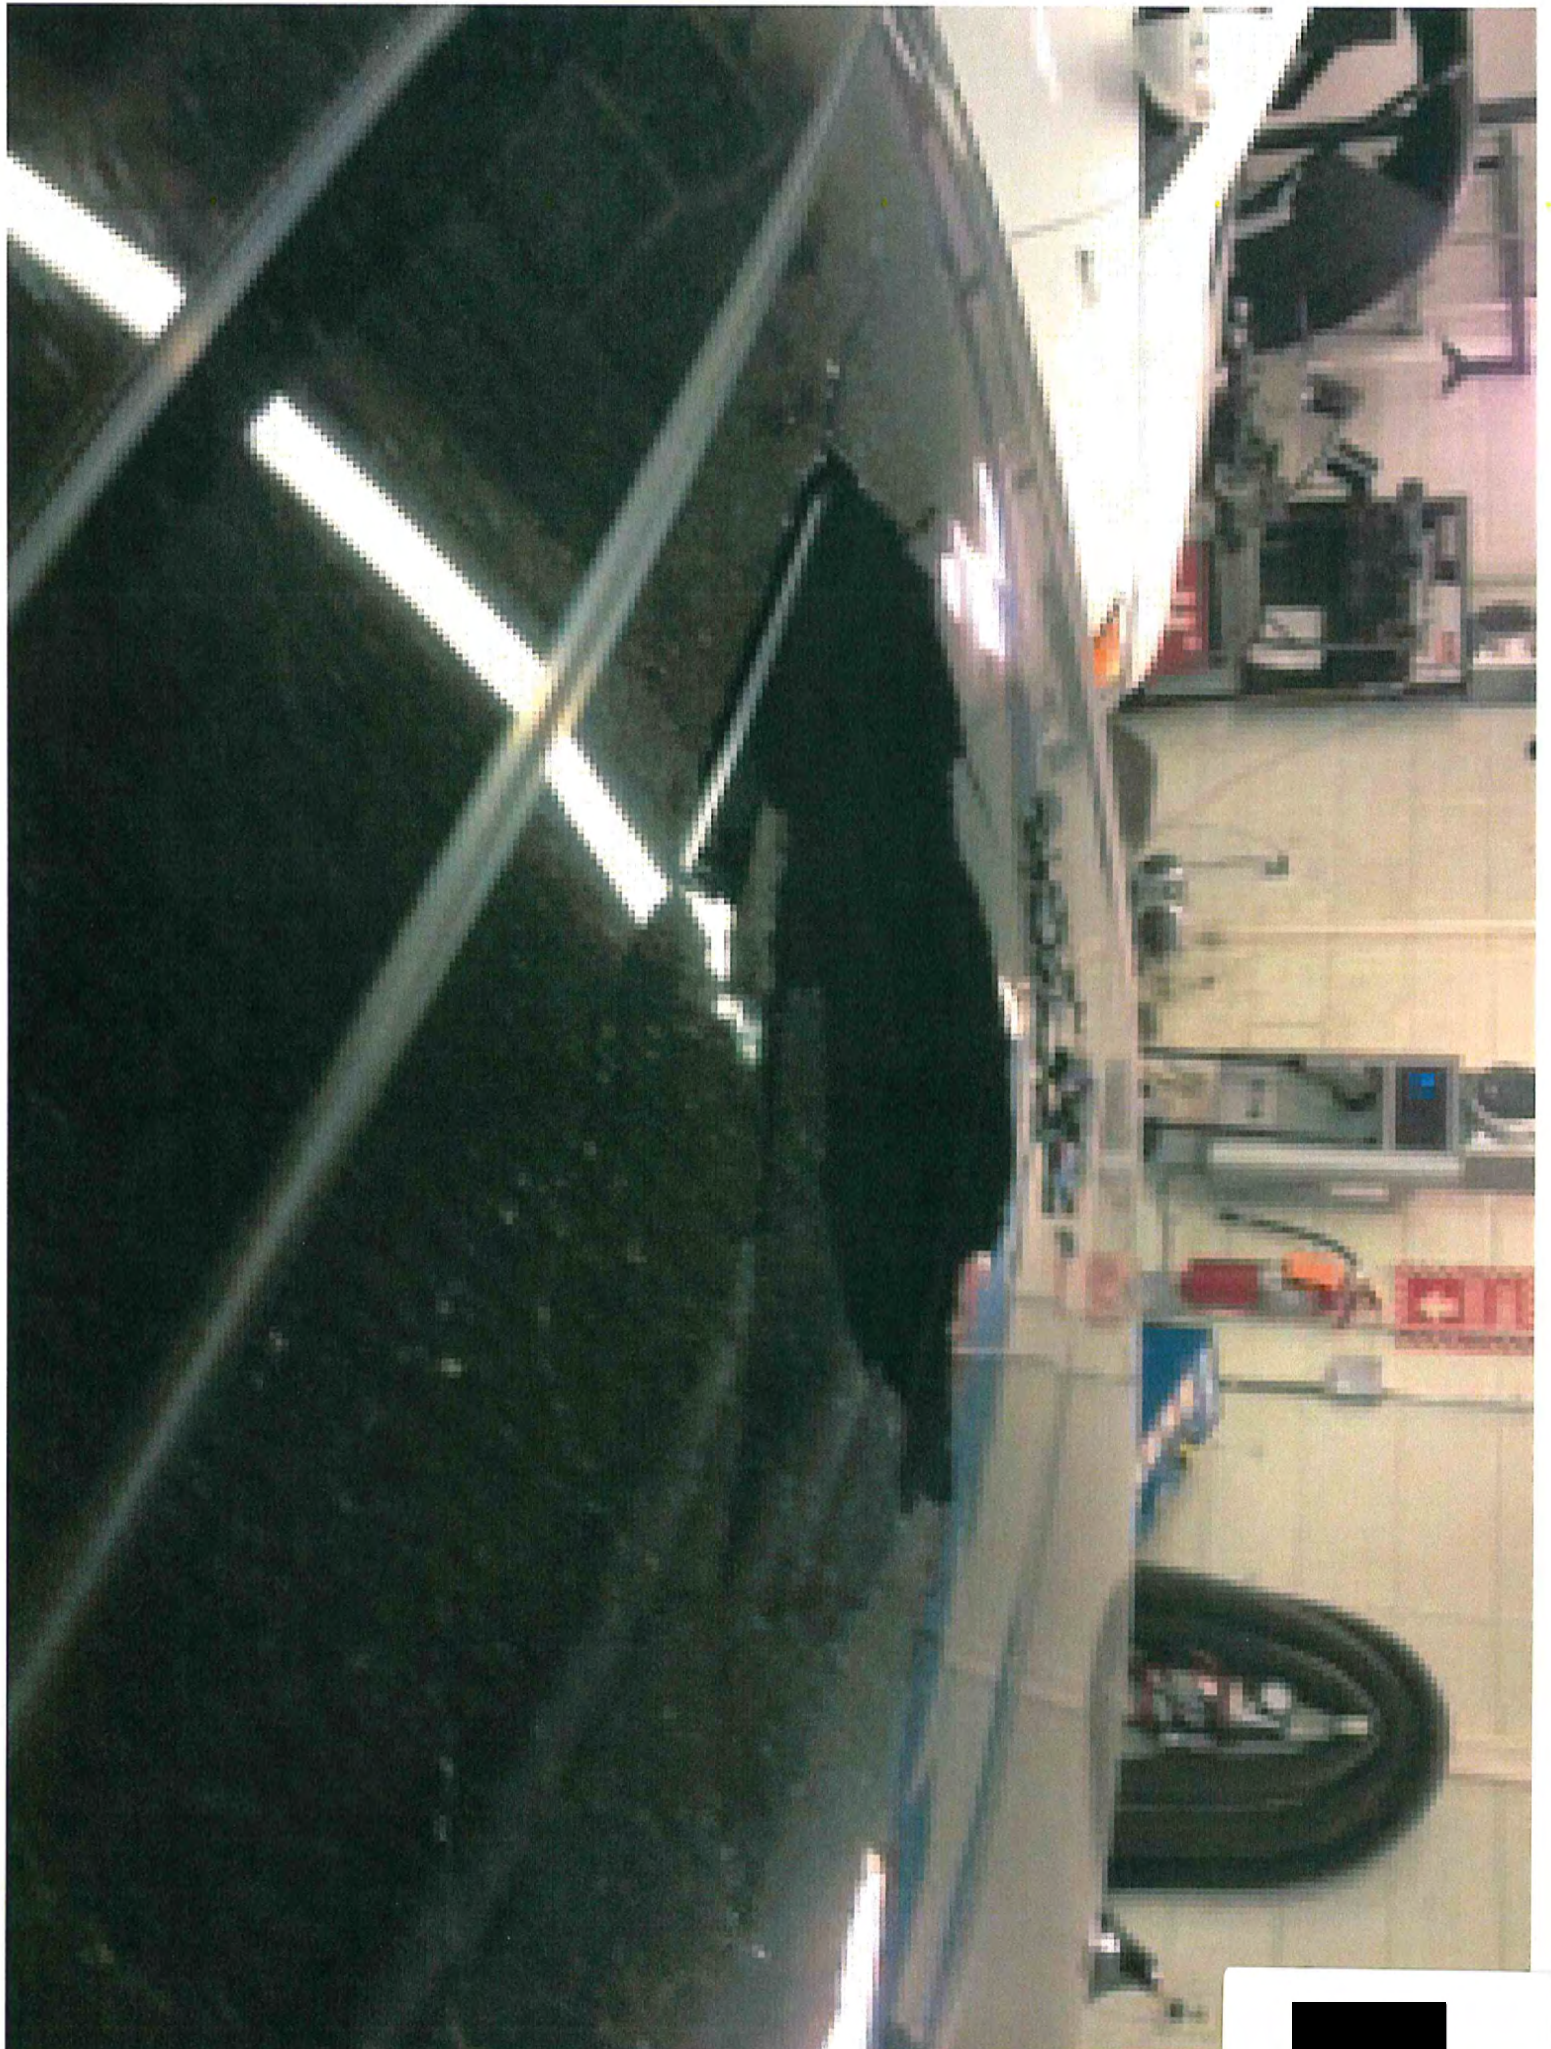
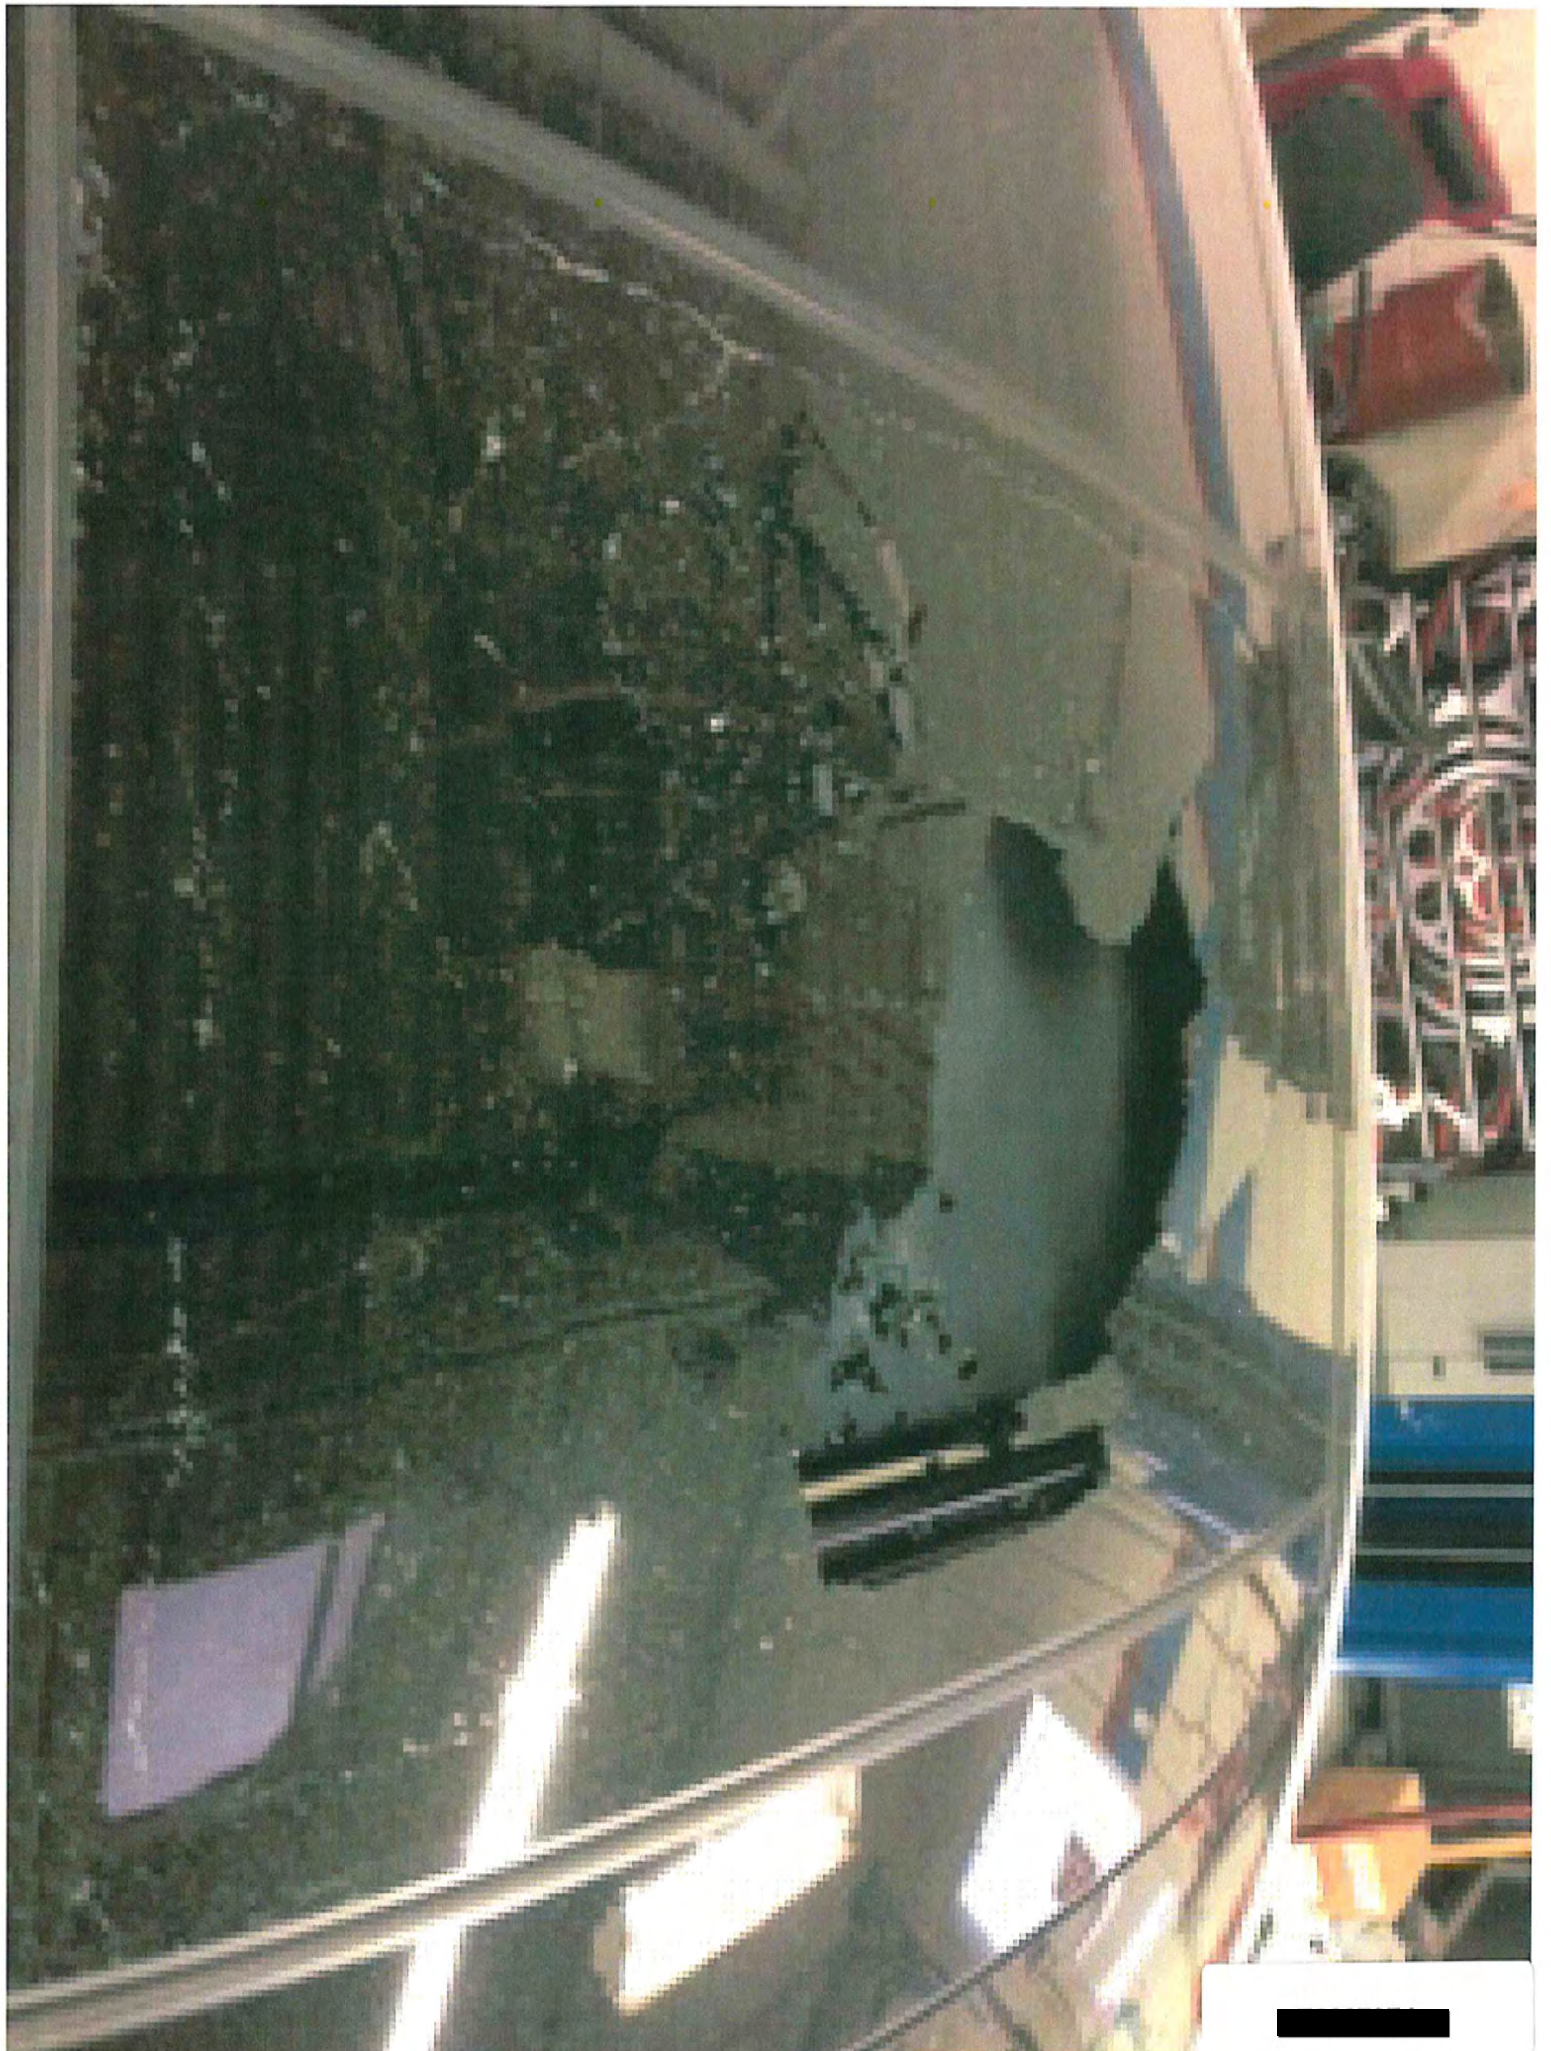
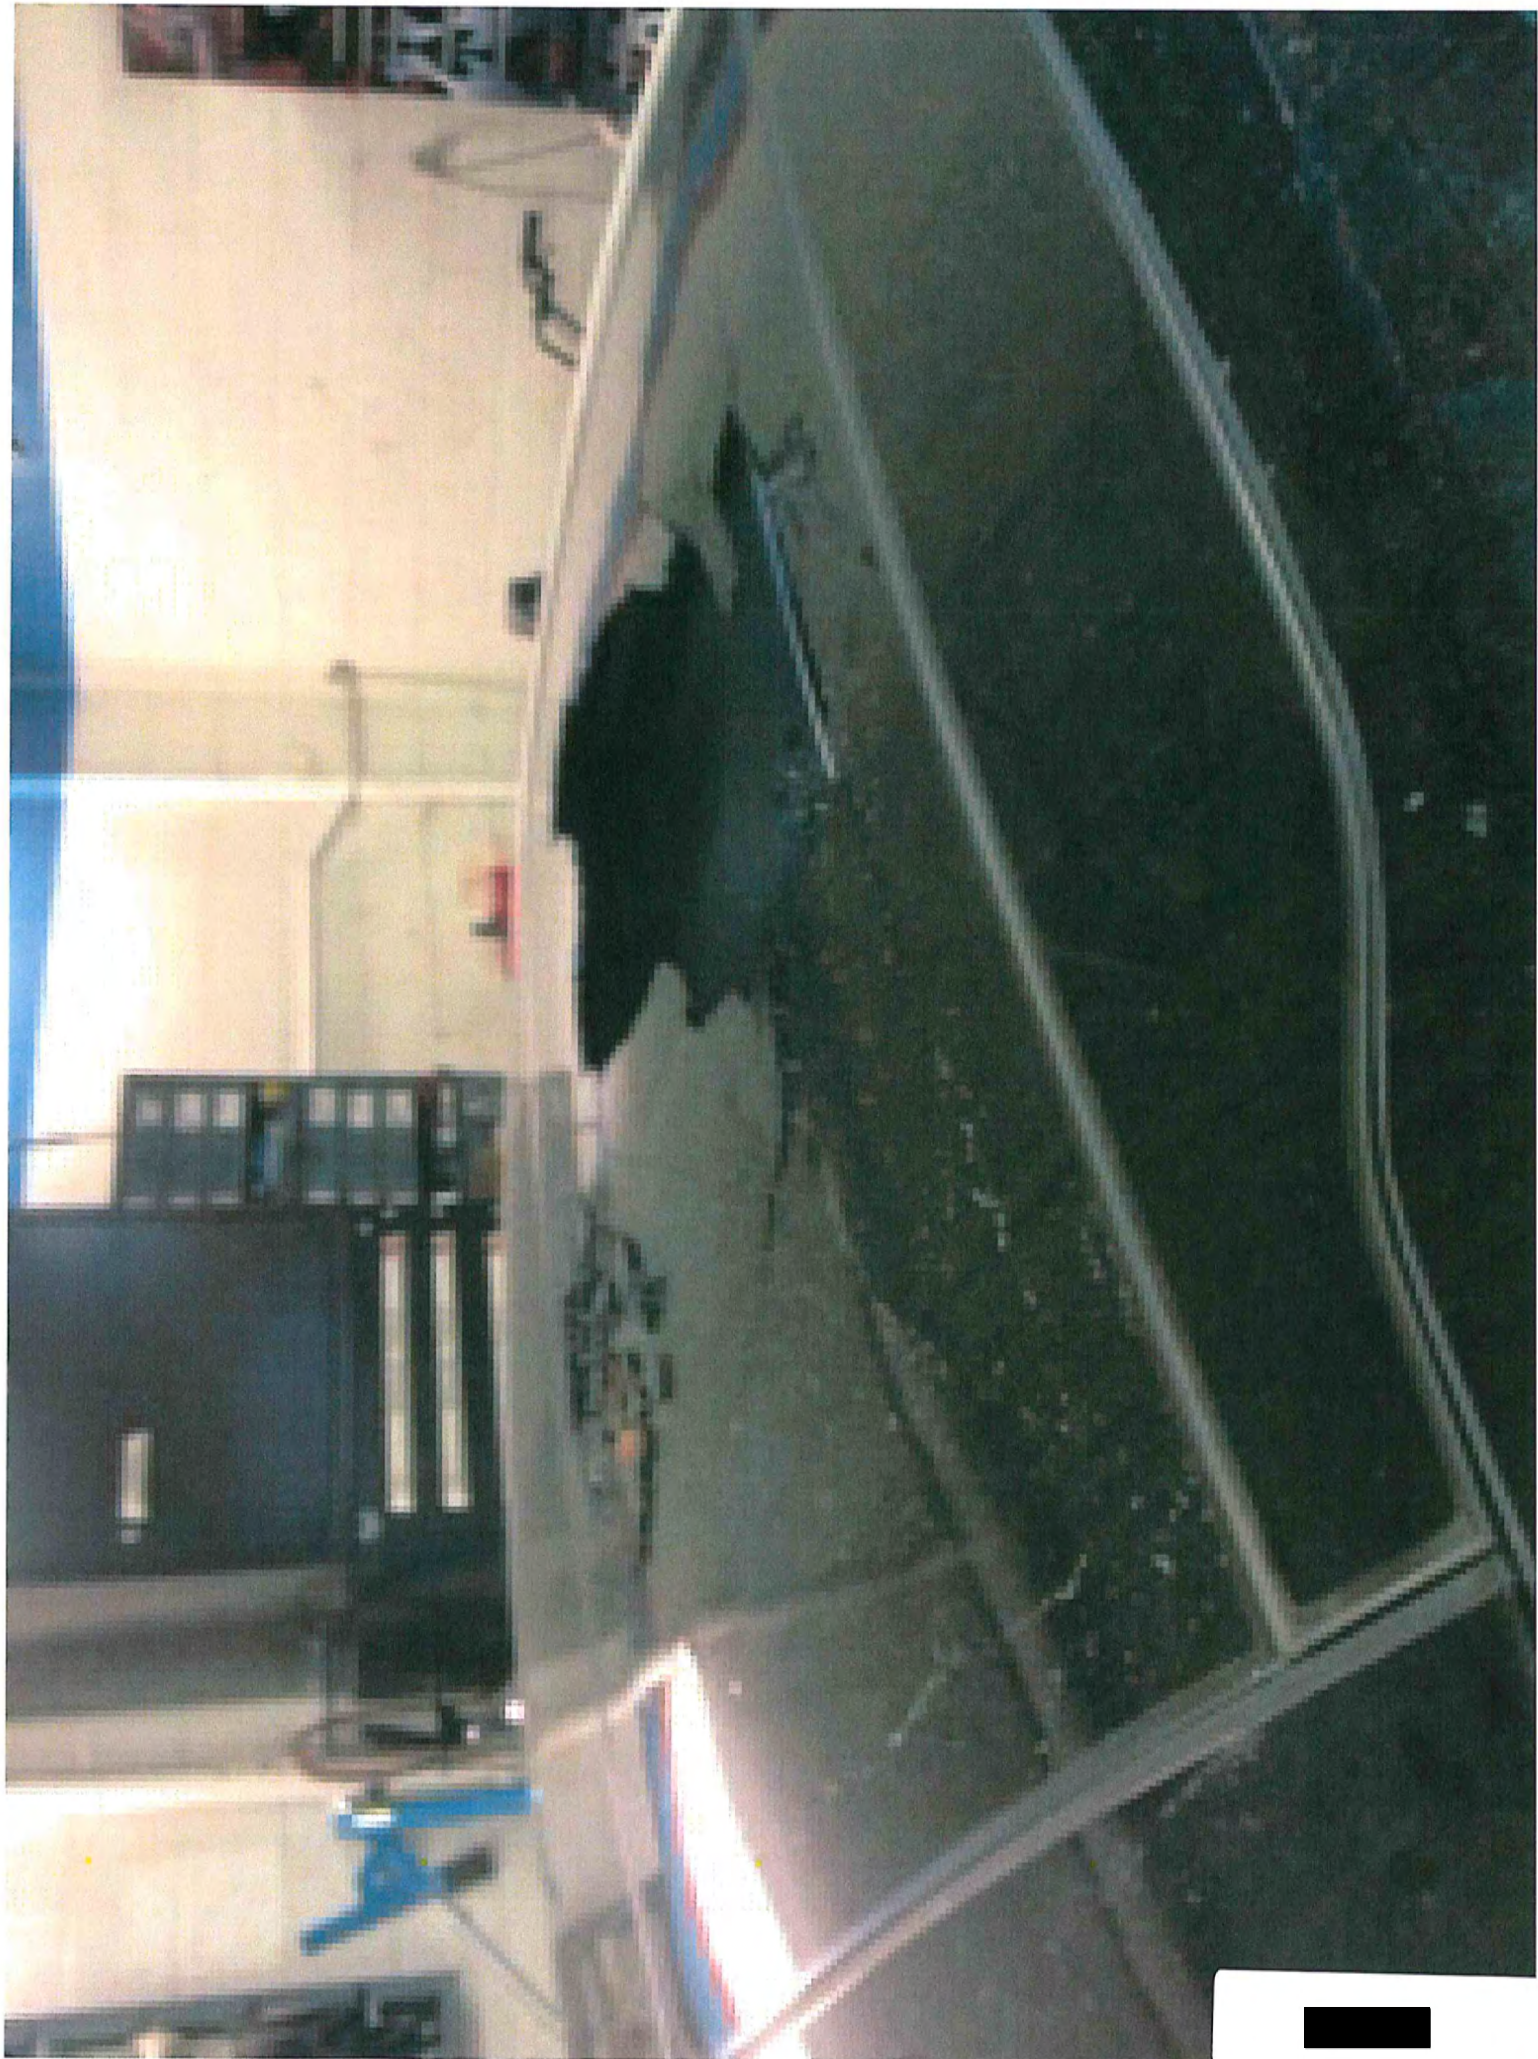
Panoramic roof glass shattered outward

DPSM inspected vehicle and found no signs of impact.

I inspected the vehicle during my dealer visit last week I did not see any evidence of outside influence (no rocks, debris or witness marks of impact around the upper roof). Dealer advised they will need to drop the headliner to fully clean all shattered glass, that's what the PWA below is for. Thanks.

Replace panoramic glass

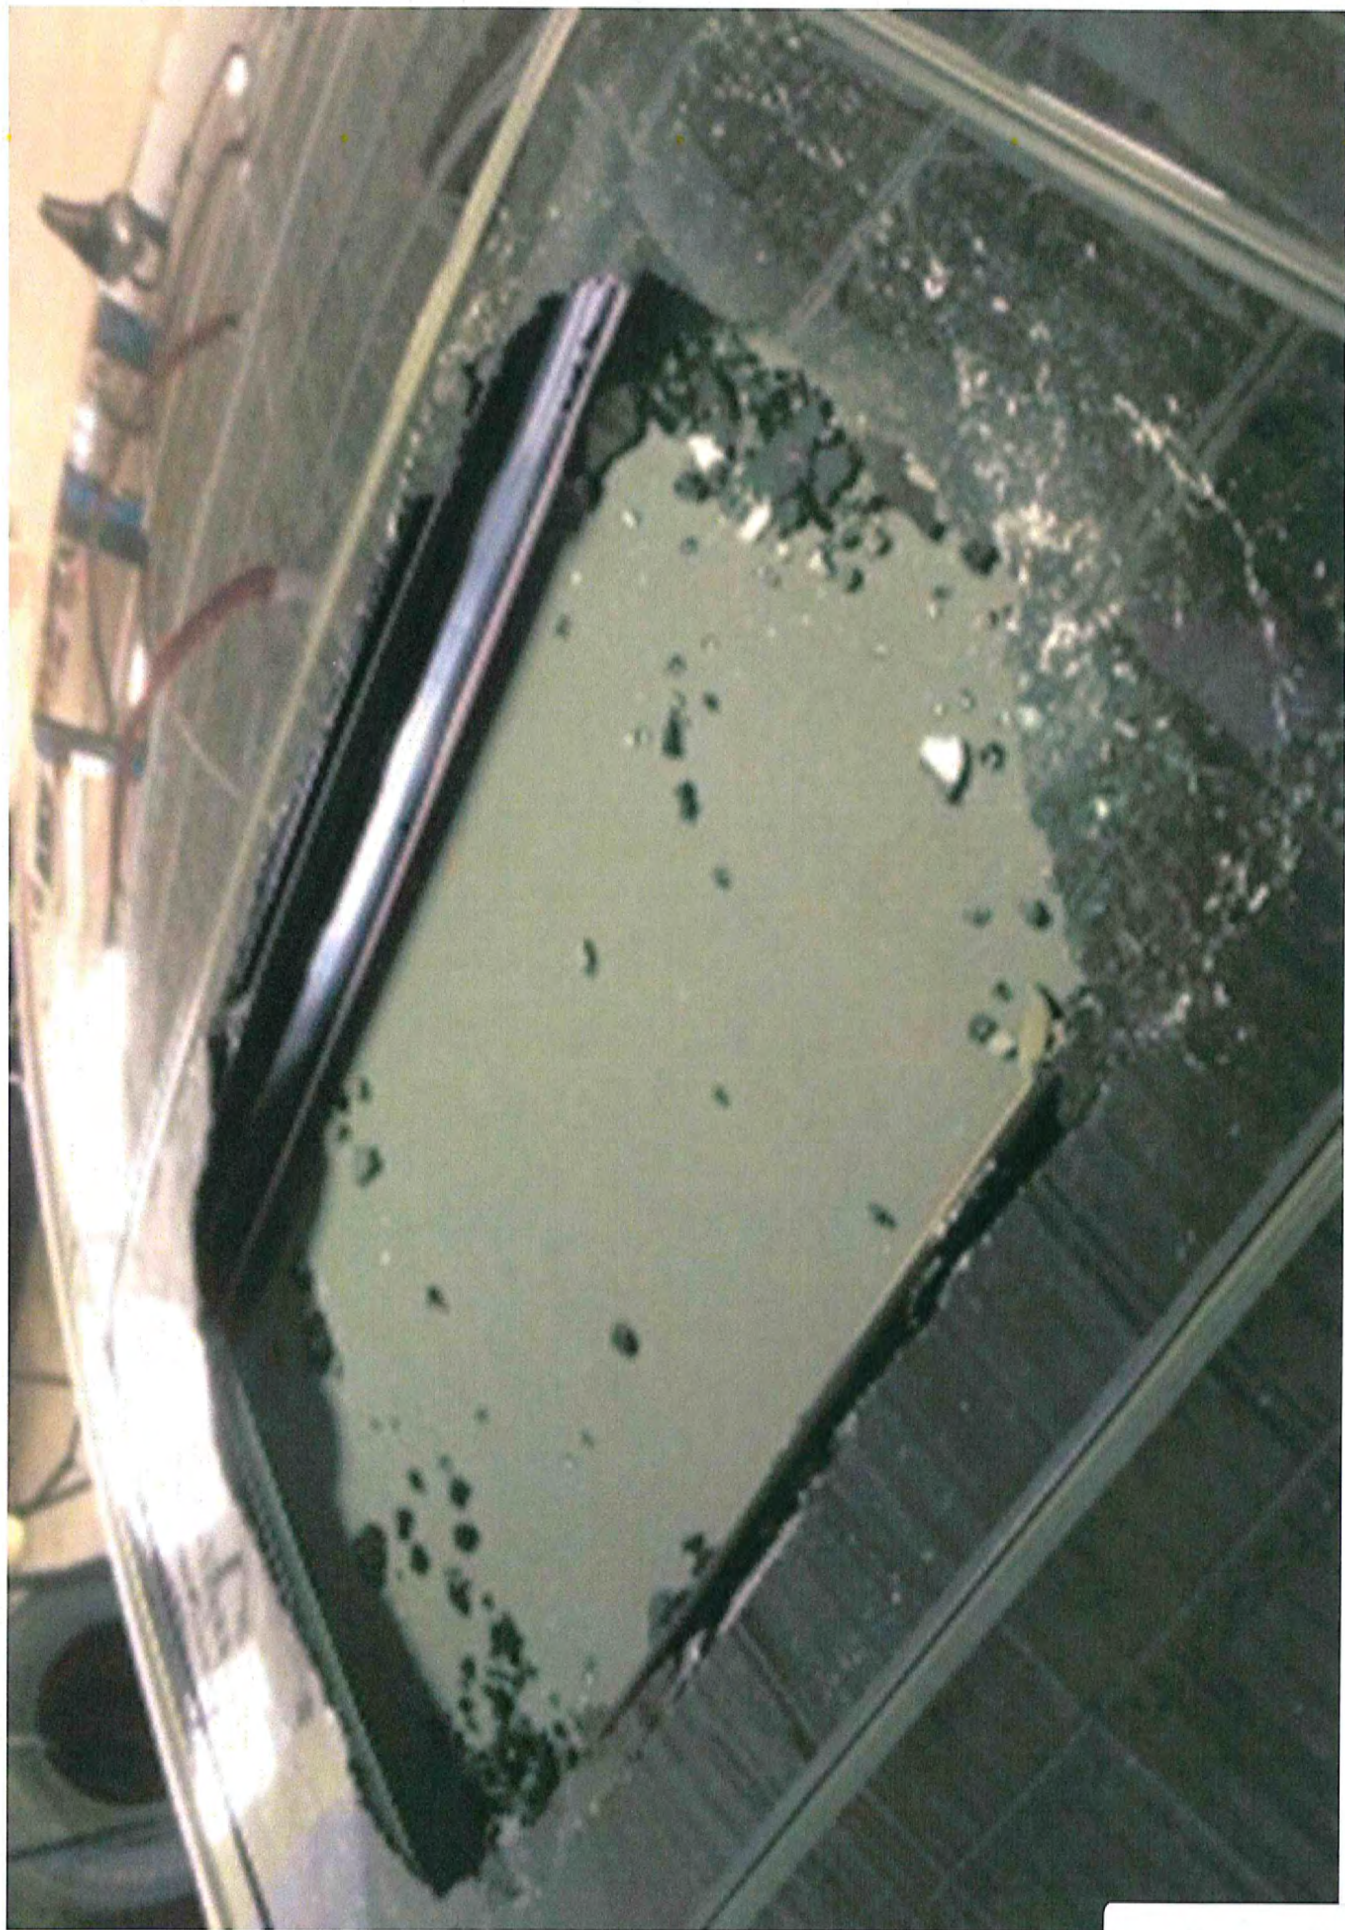
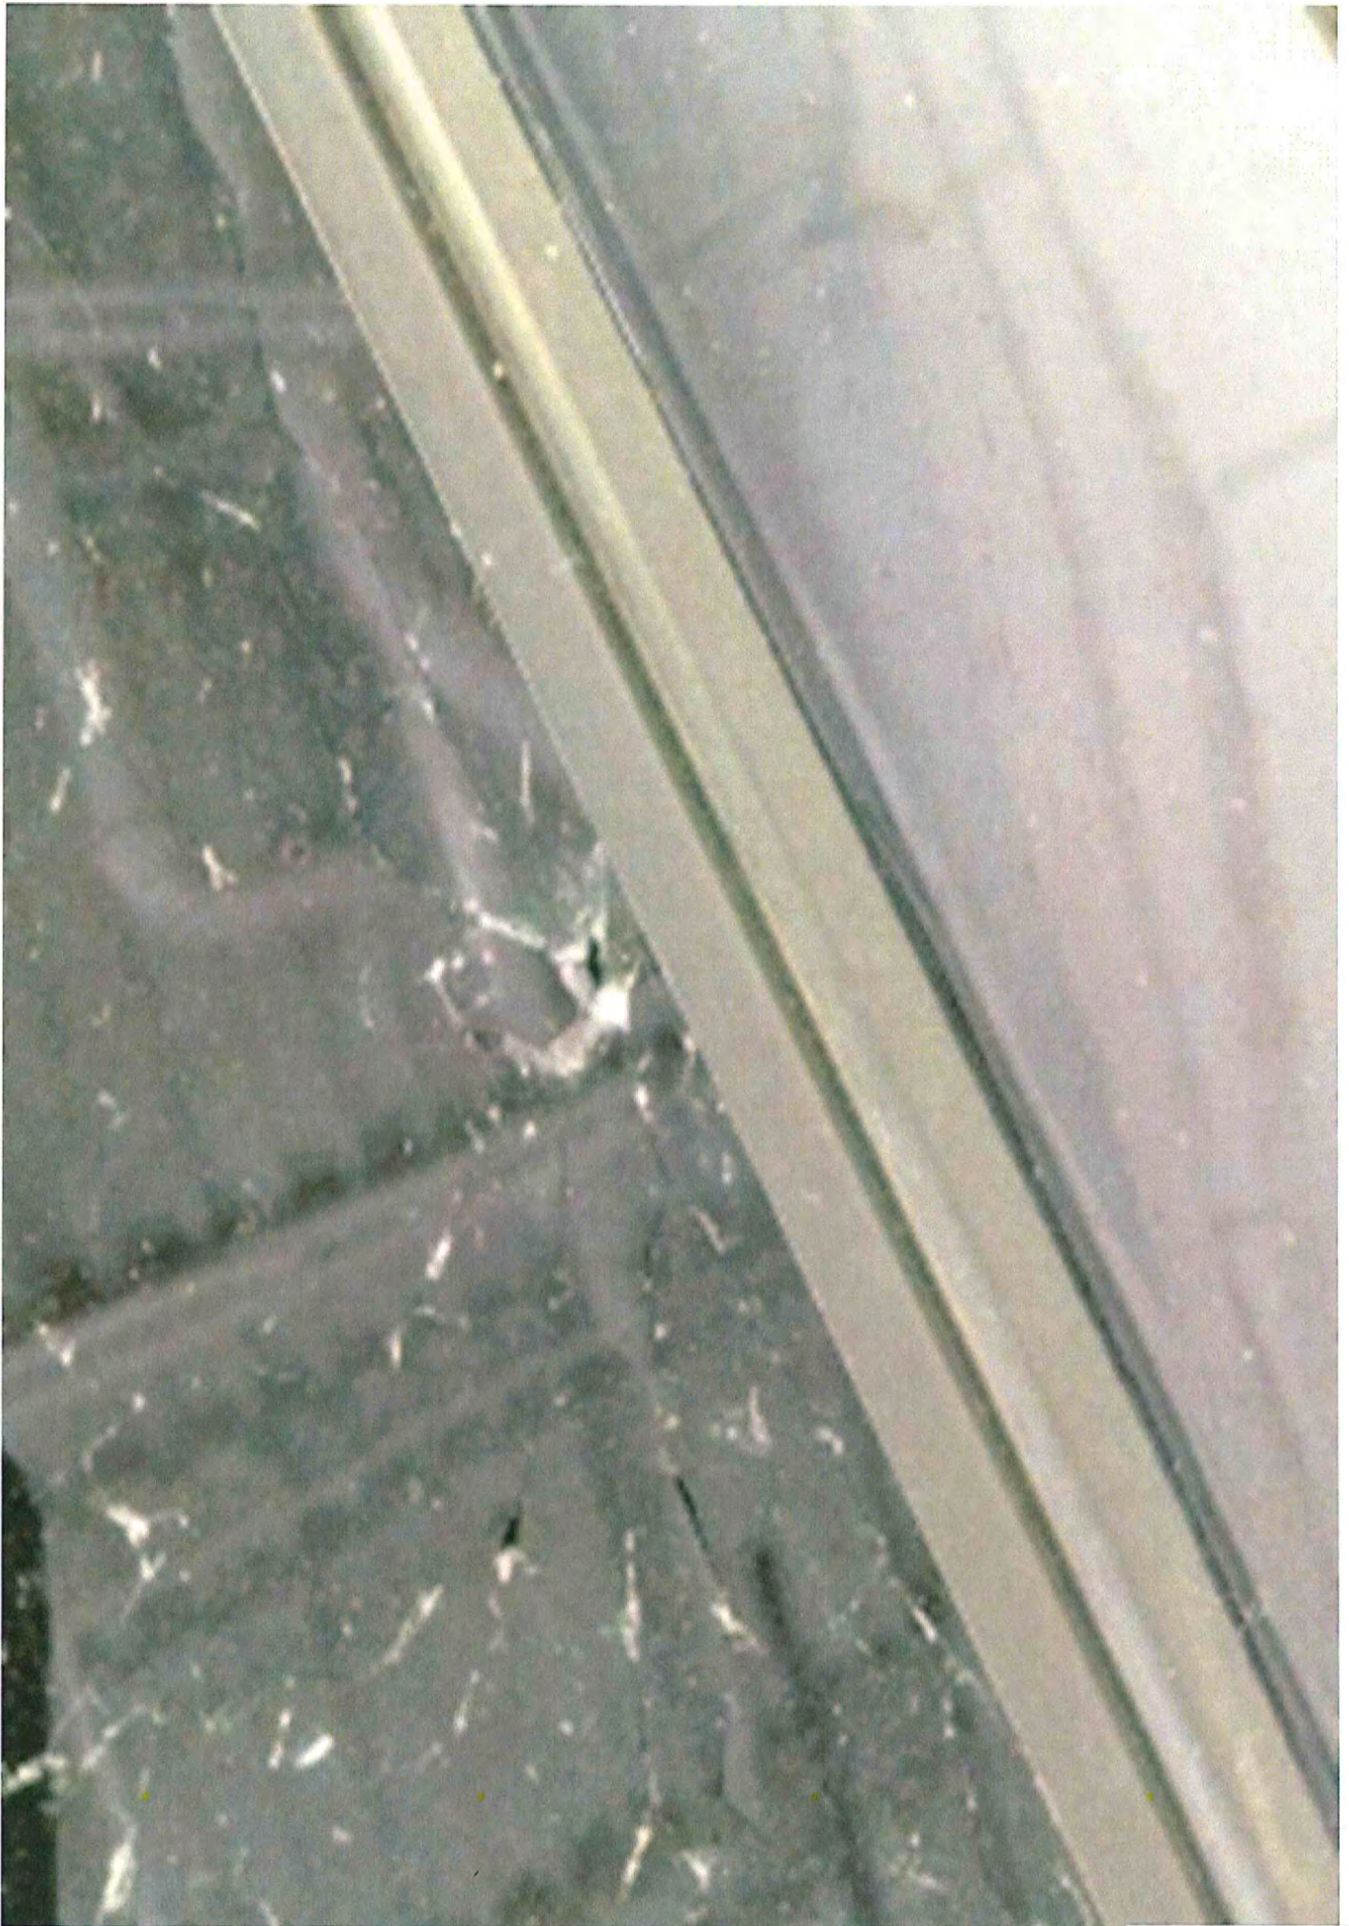
Sunroof Glass was Shattered.

FTR inspected vehicle on 2/27/2014. Verified sunroof glass was shattered. Glass was less than 10% intact on vehicle. Inspected sunroof extensively but did not notice any projectiles or obvious evidence of impact damage to glass except possible areas as noted in attached pictures.

Undetermined.

No action taken at this time. Results of inspection reported to Platform Engineer and NCA.

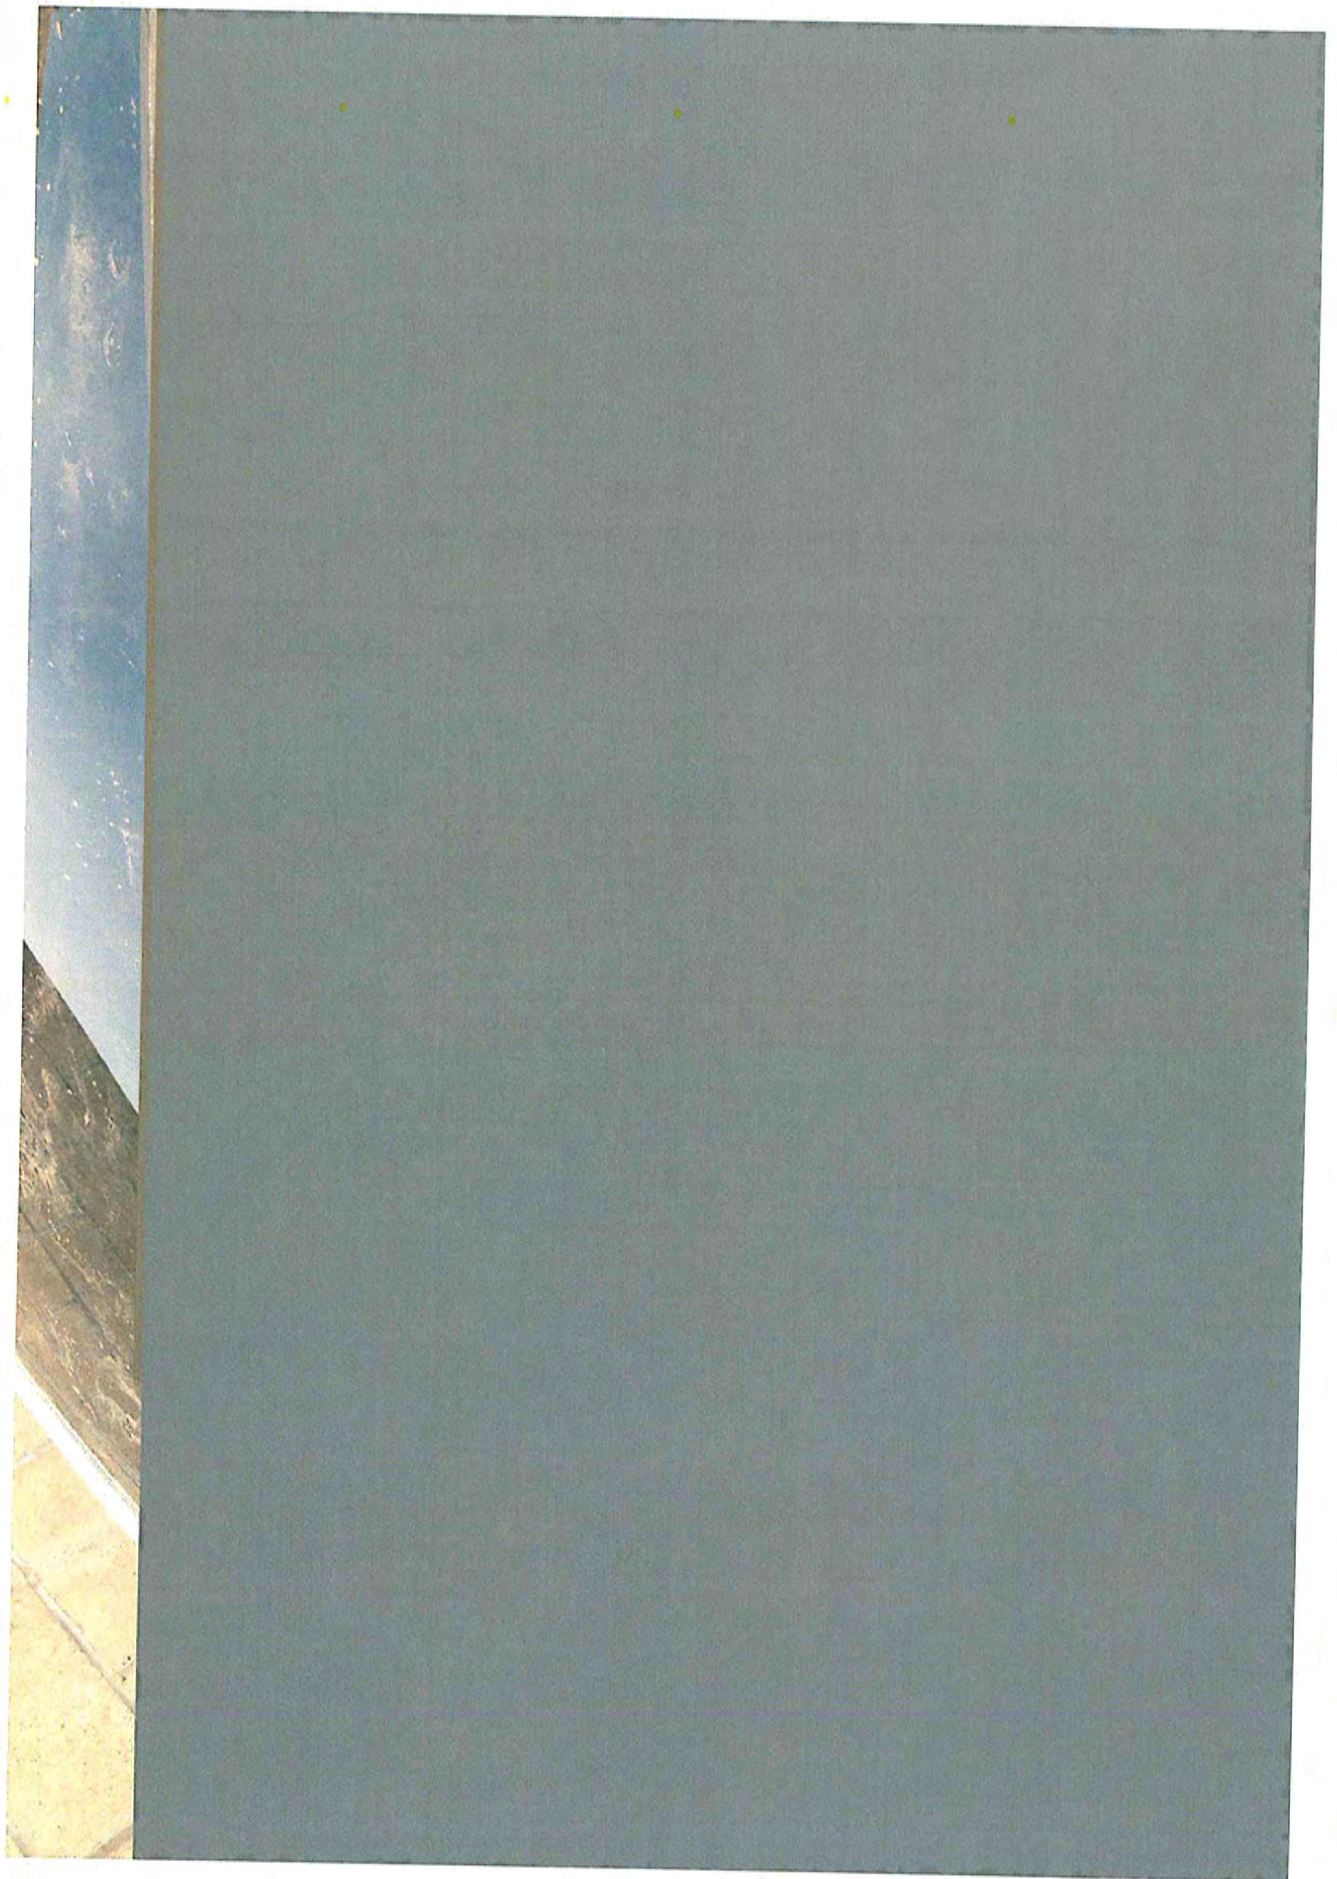
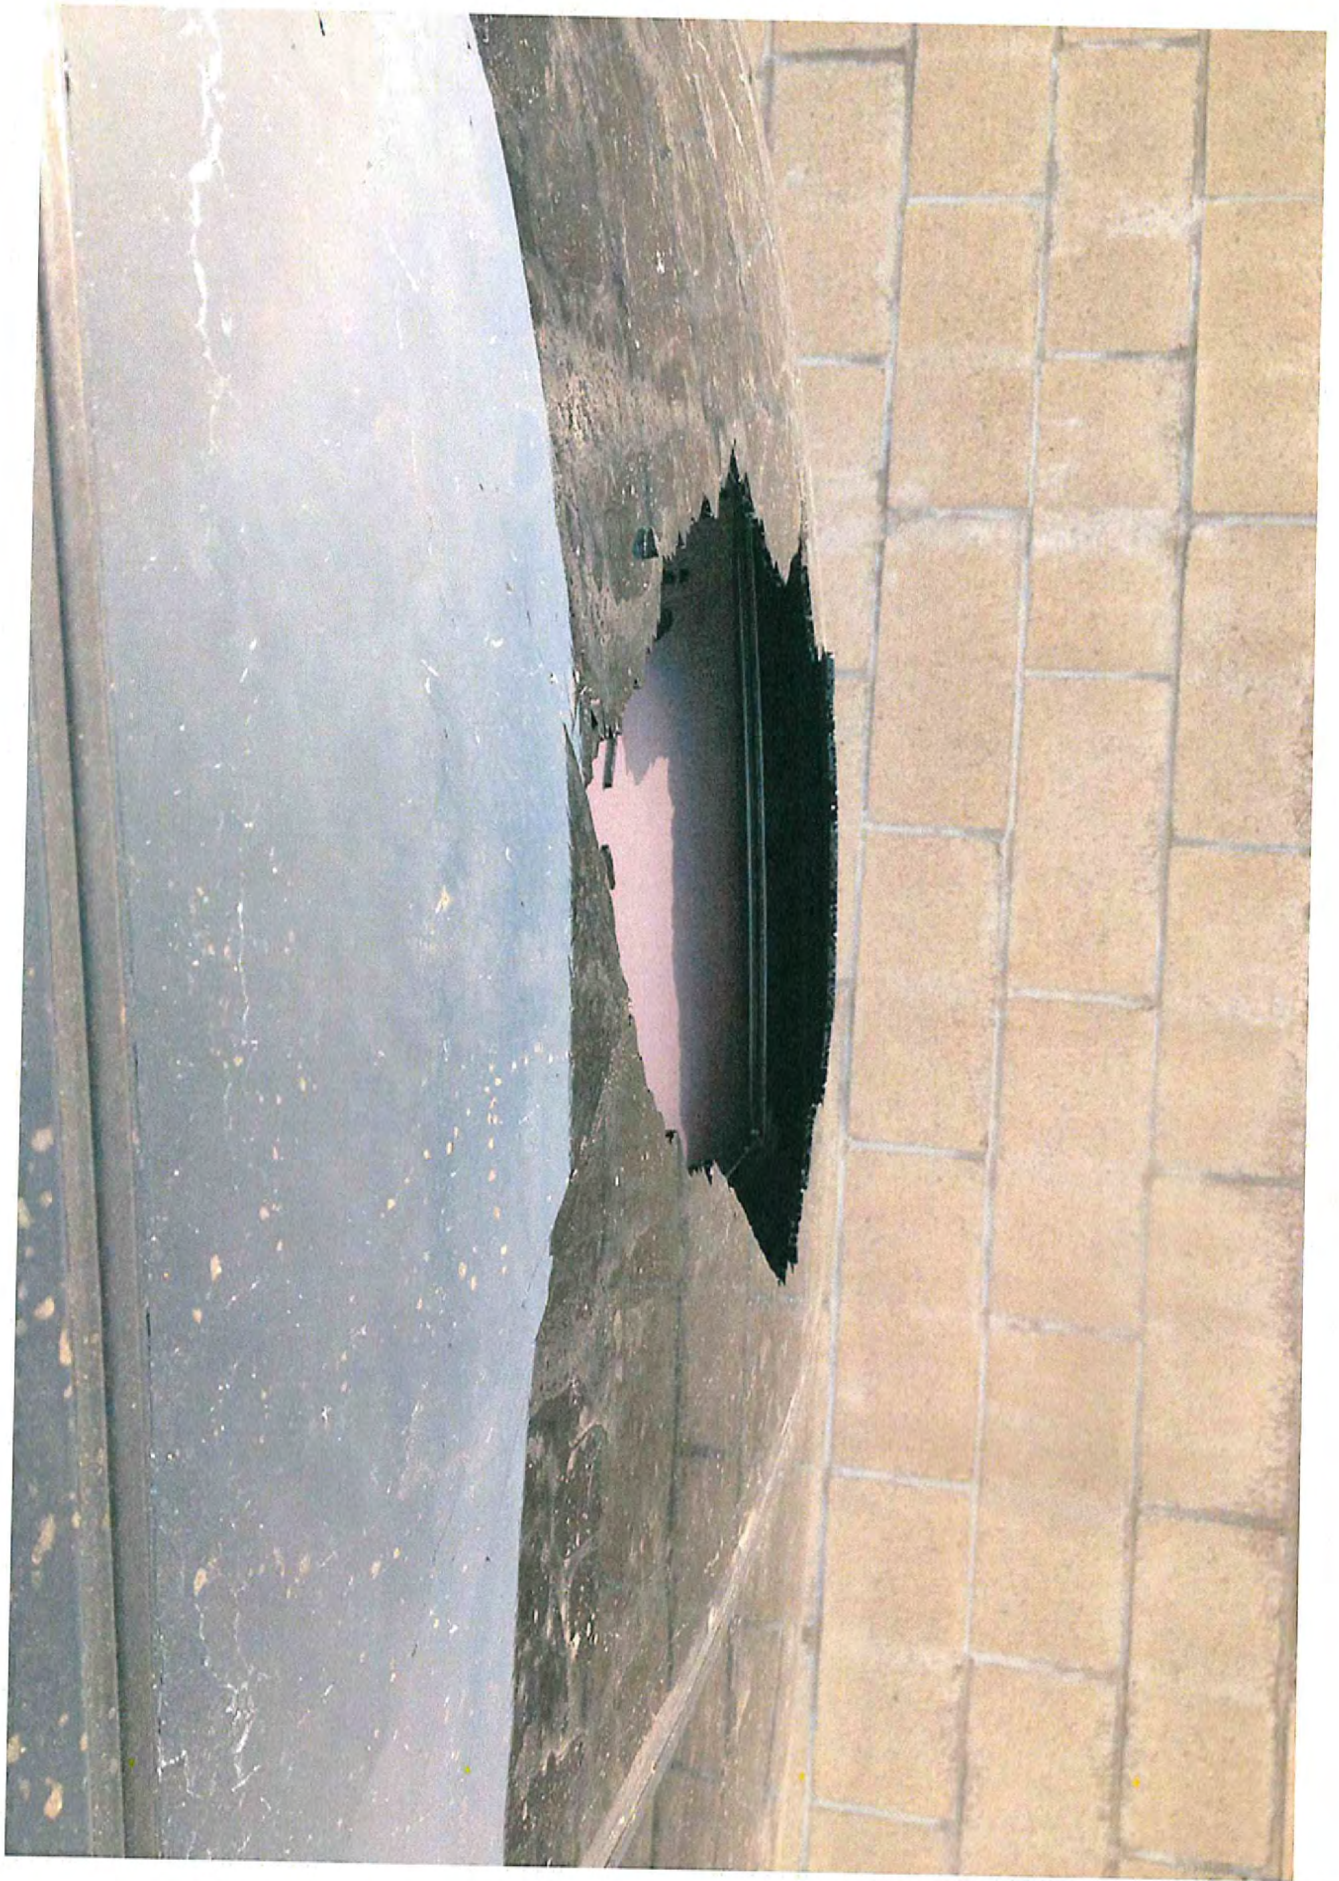
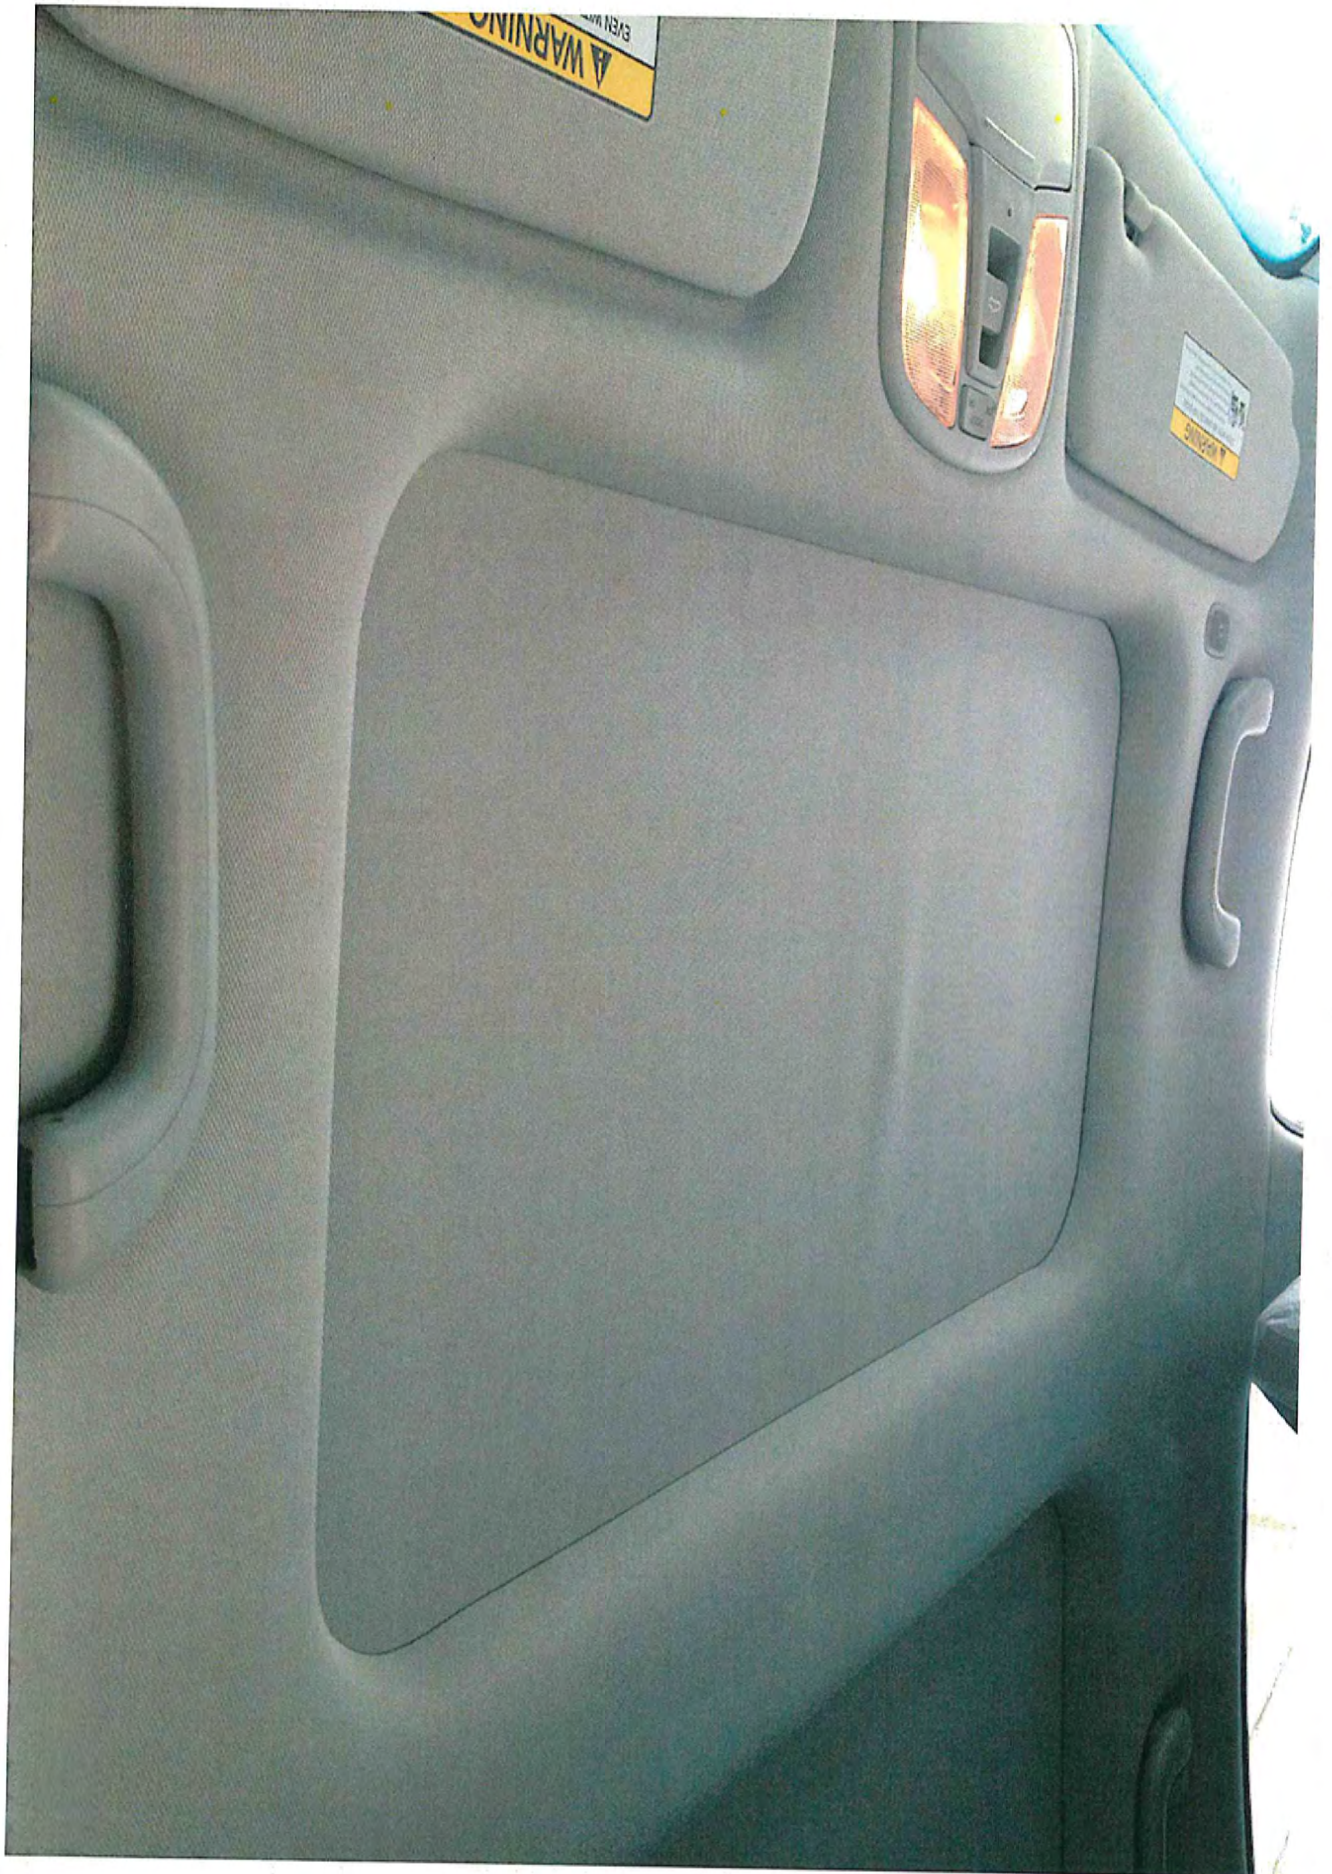
Panoramic roof glass failure.

FTR inspected vehicle on 3/3/2014. Verified panoramic roof was shattered. Panel was still 75% intact on vehicle although entire glass panel was shattered. Inspected roof panel extensively and noted evidence of impact to right outer/rear area of remaining glass.

Possible roof glass failure is unknown.

Recommend to replace sunroof glass assembly. Results of inspection reported to Plattform Engineer and NCA.
