Kia Motors America Field Product Quality Report

Subject/Title: Panoramic Sunroof Shattered

Model Desc: OPTIMA EX

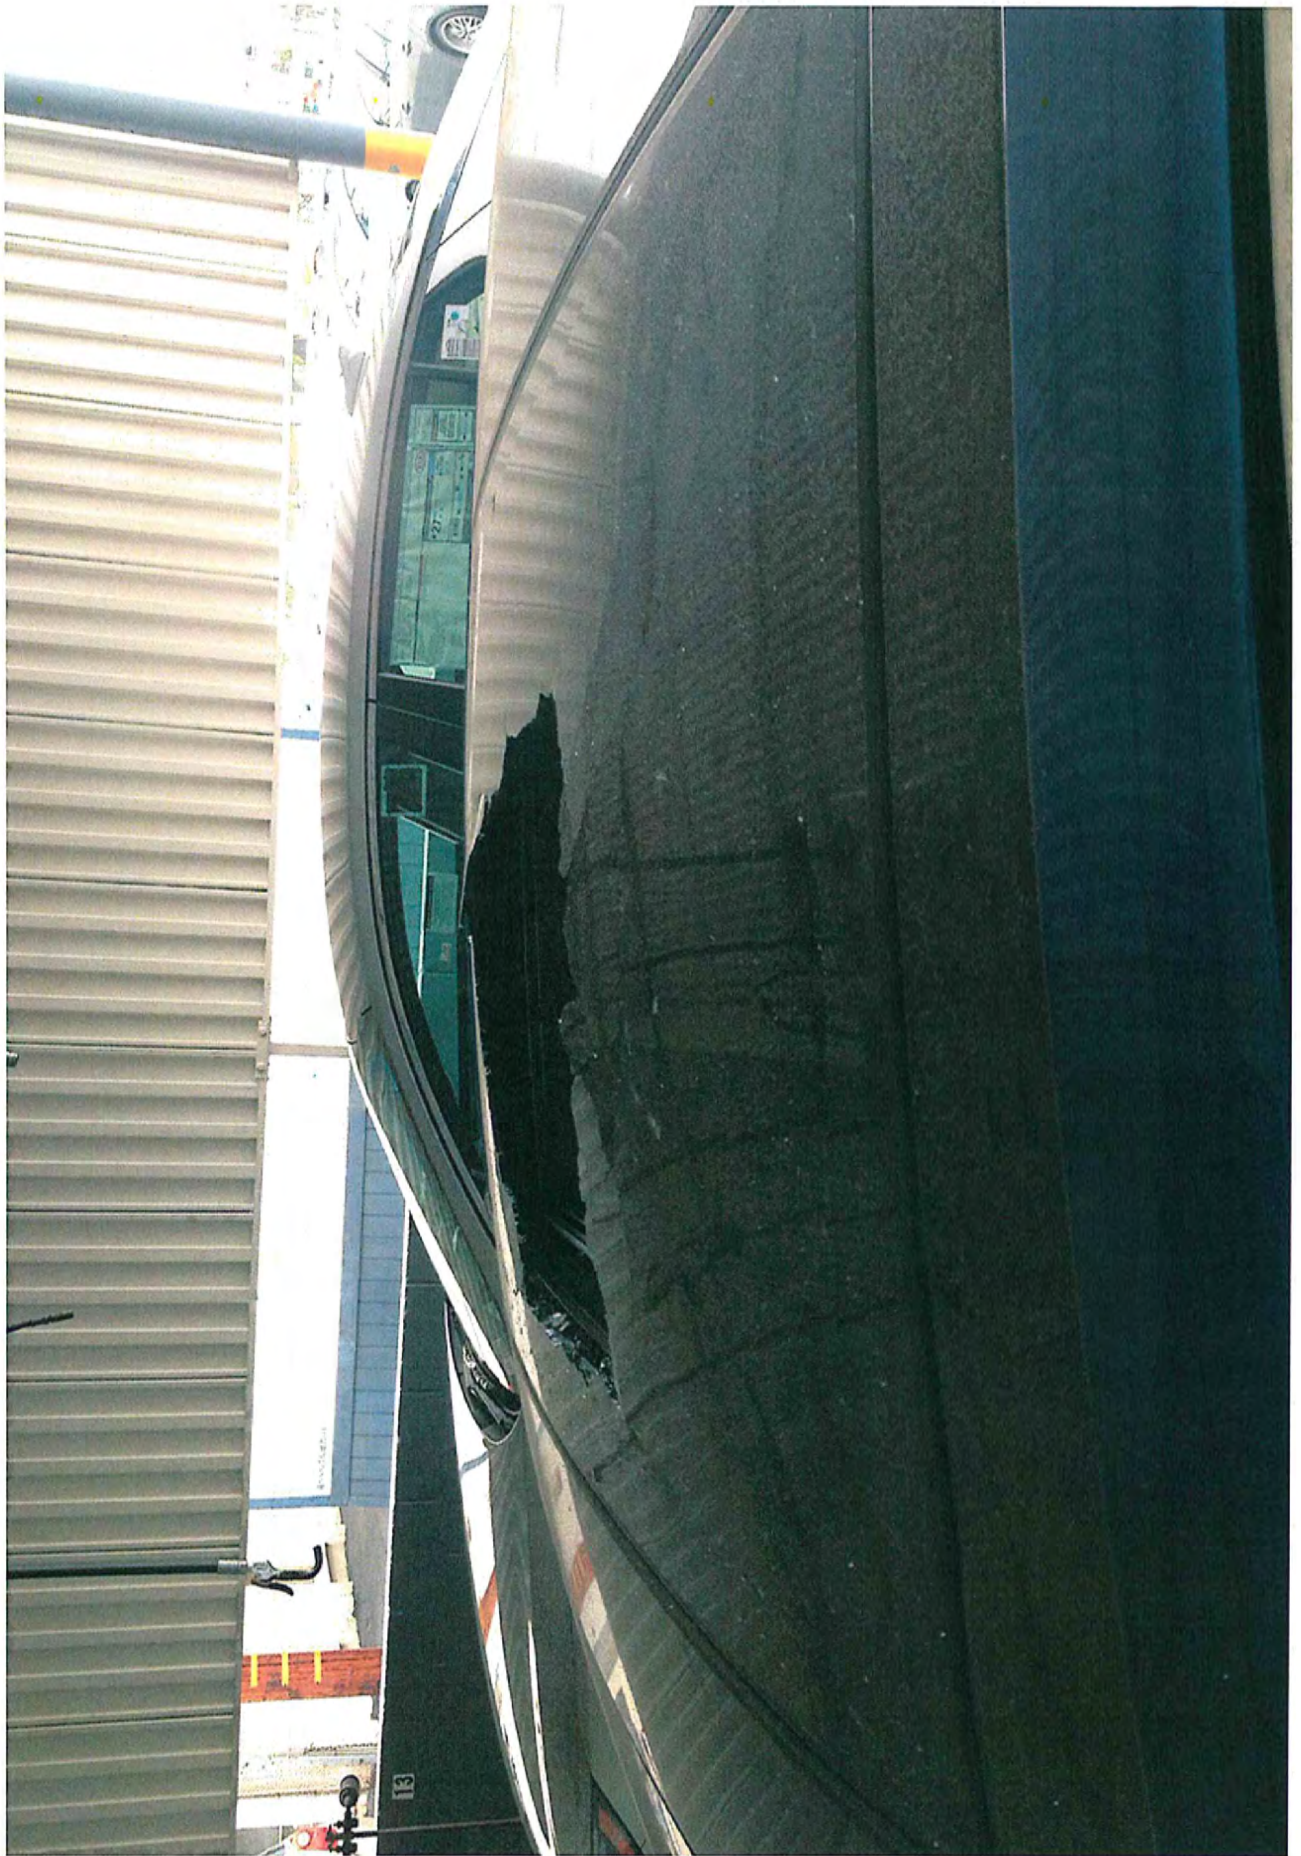
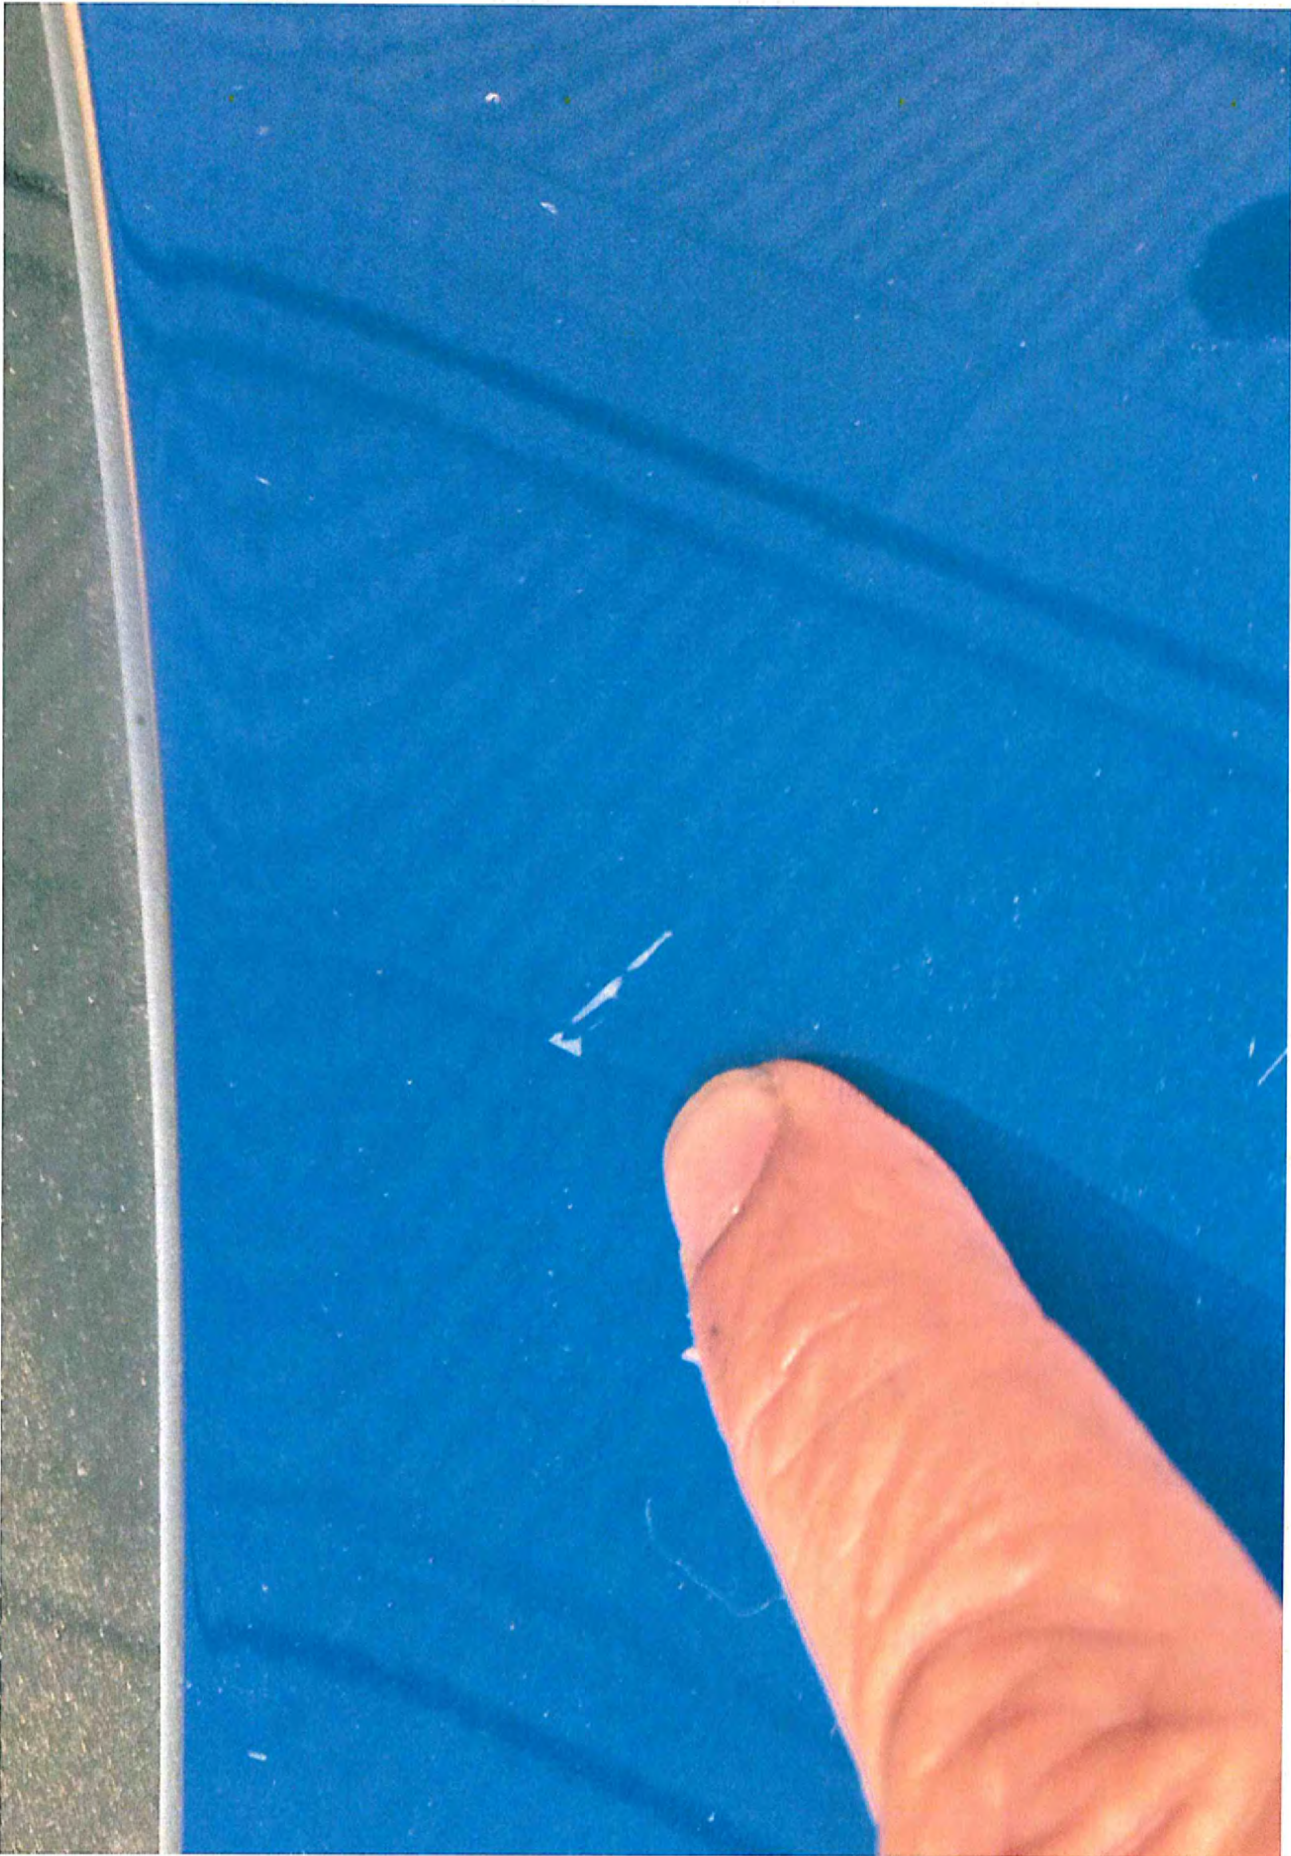
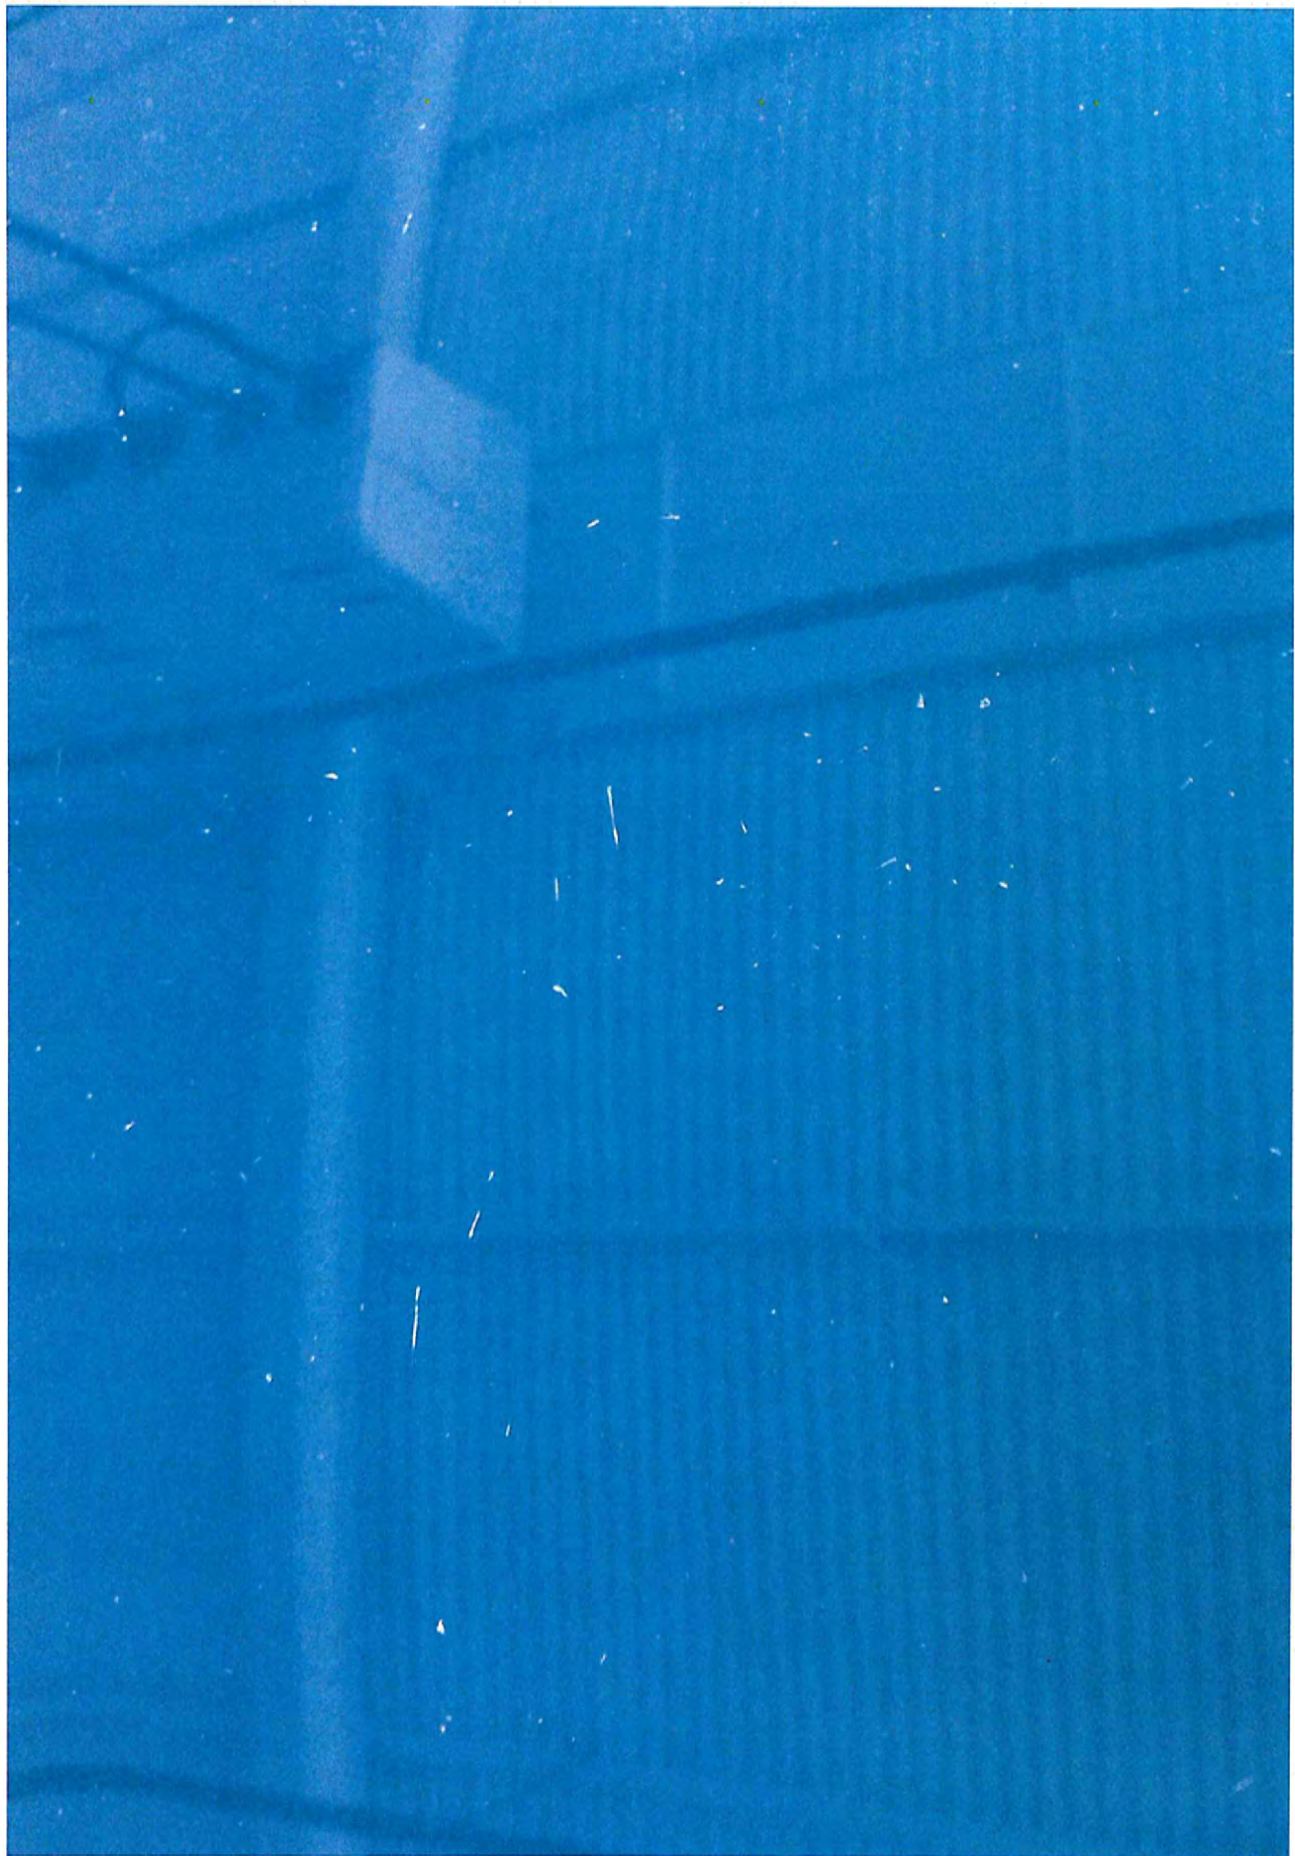
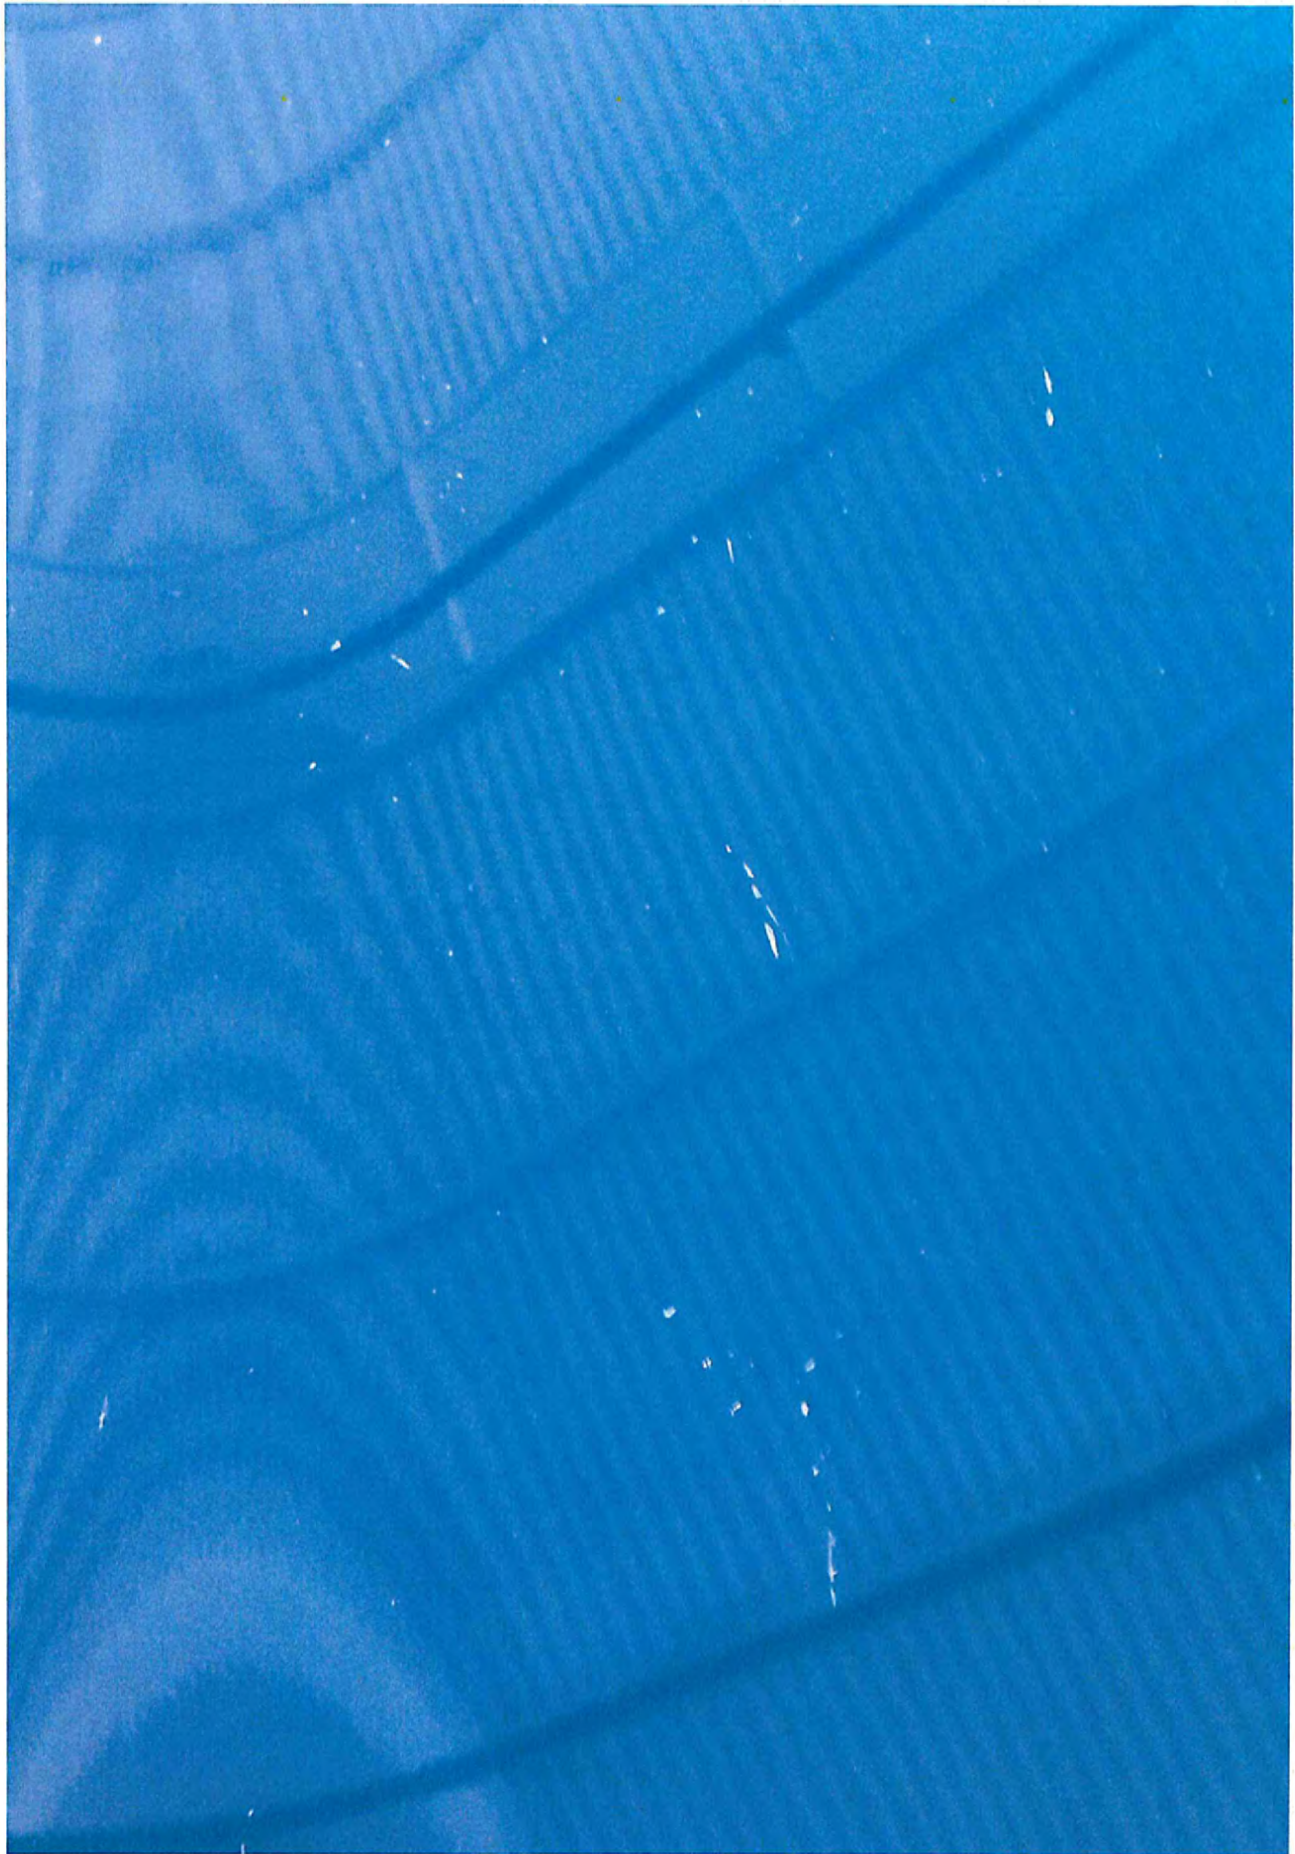
FTR inspected vehicle and found front panel of panoramic roof shattered. The sunroof was closed as well as the sunshade. The glass debris sitting on top of the sunshade

A hole was found at the center of the closed glass sunroof panel. (see photo) An outward crack was at the front of the glass that remained in place and cracks were throughout the rest of the panel. A paint chip was found on the rear of truck led. Multiple chip was also found at rear deck lid lip. (see photos attached).

Evidence of sunroof glass failure due to impact from outside source resulting in weakening of glass integrity. Signs of impact on sunroof glass and rear deck lid lip.

No action taken at this time. Results of inspection reported to Platform Engineer and NCA.
