Kia Motors America Field Product Quality Report

Report No.: EA2013SJ02144

Subject/Title: Panoramic Sunroof Shattered

Model Desc: SORENTO SX AWC

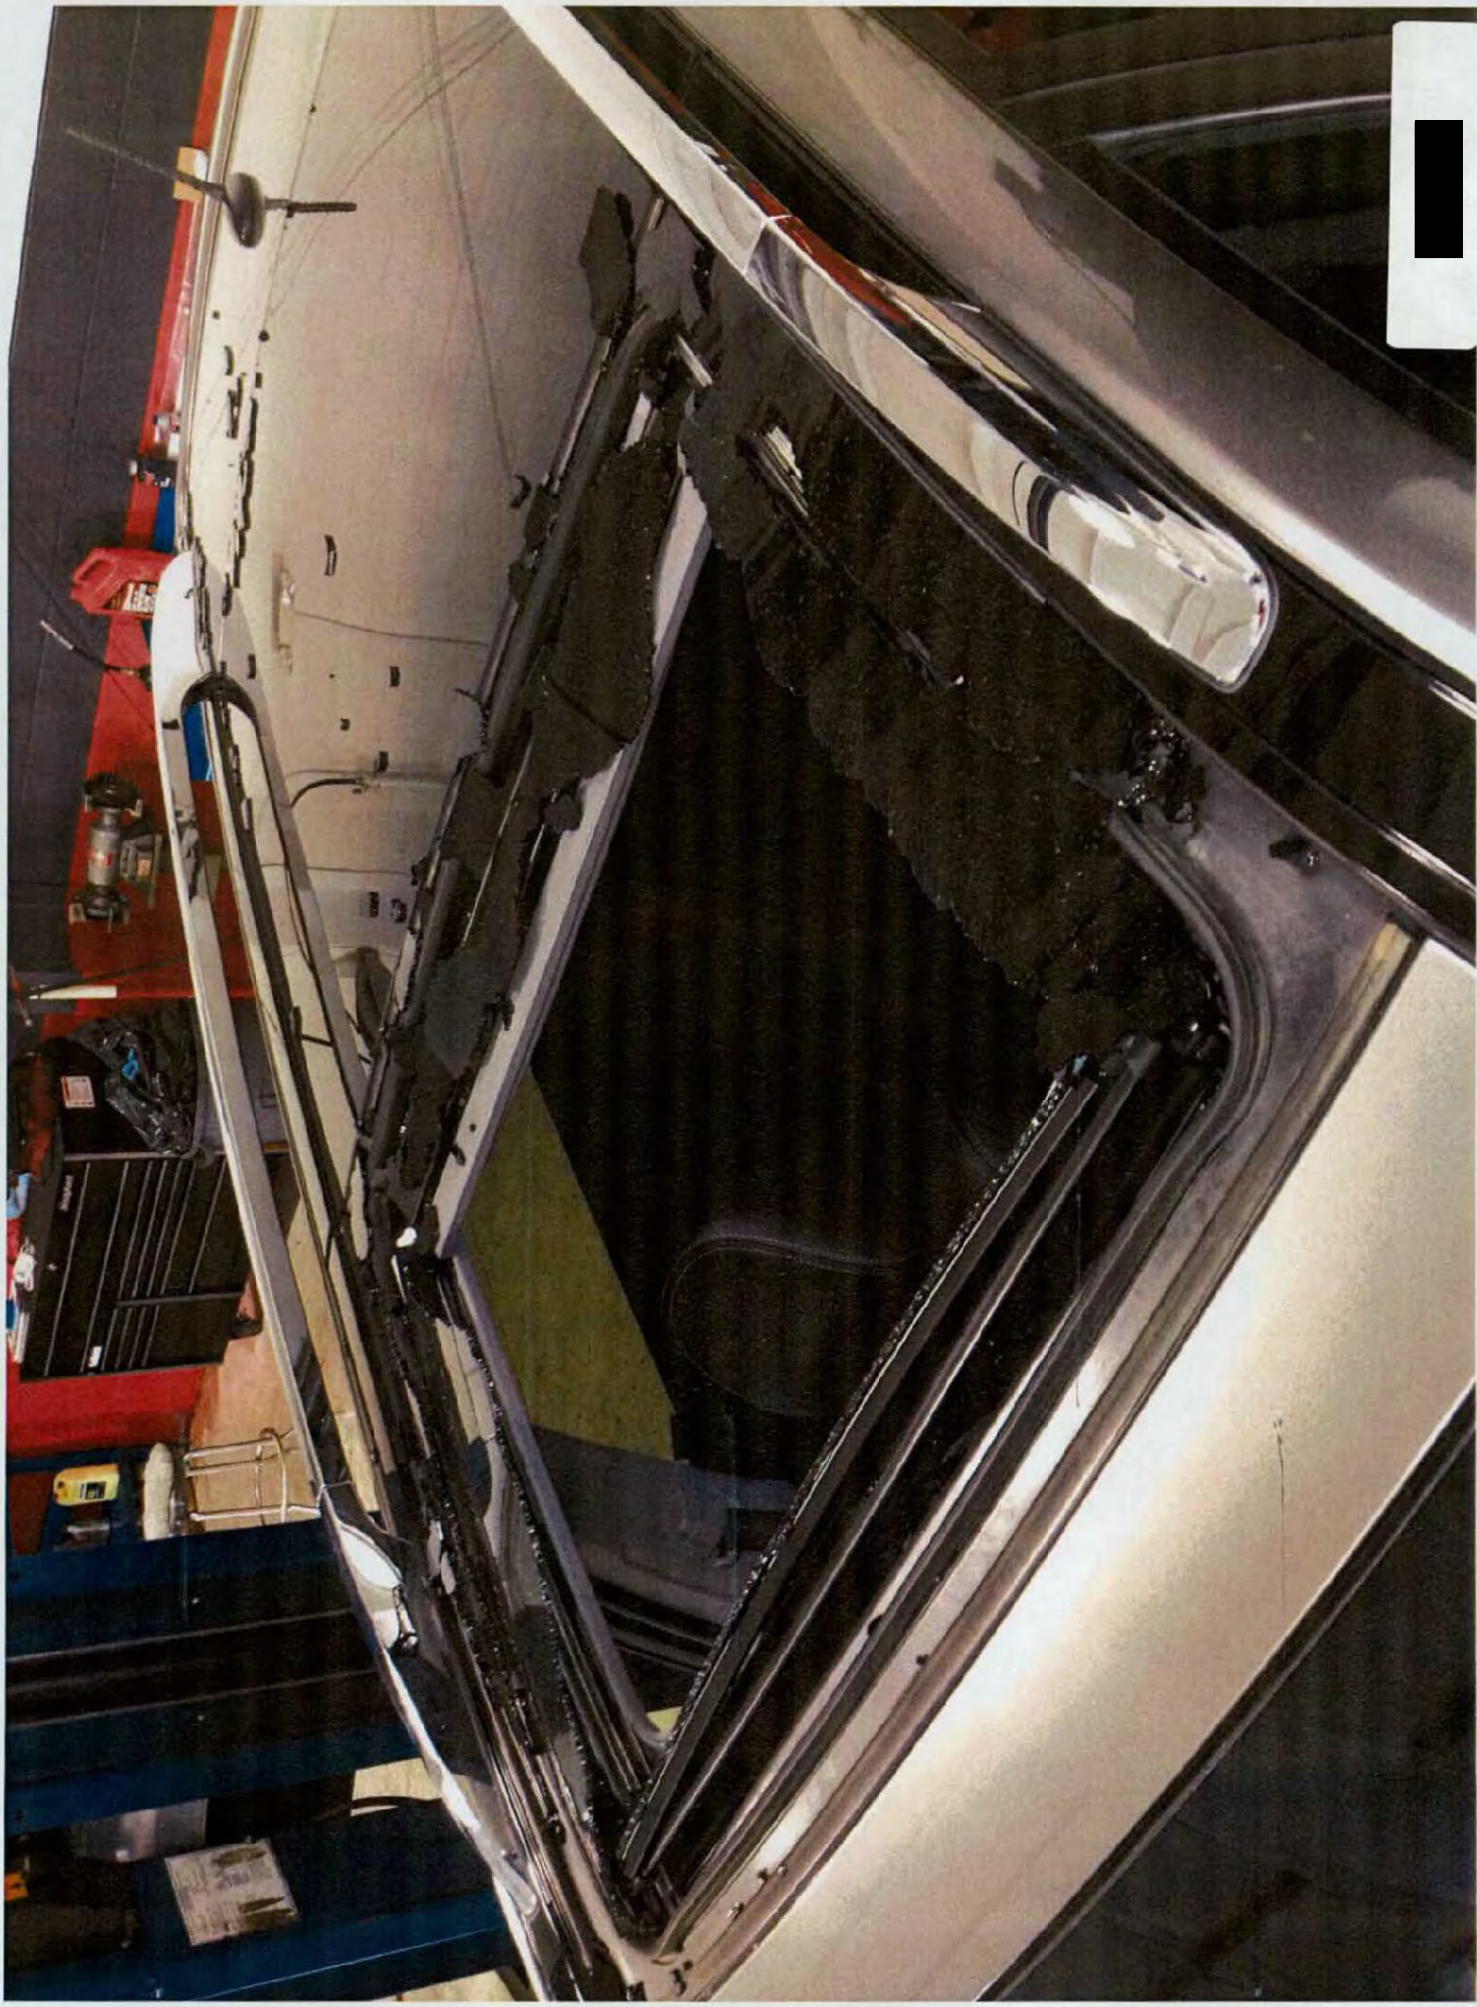
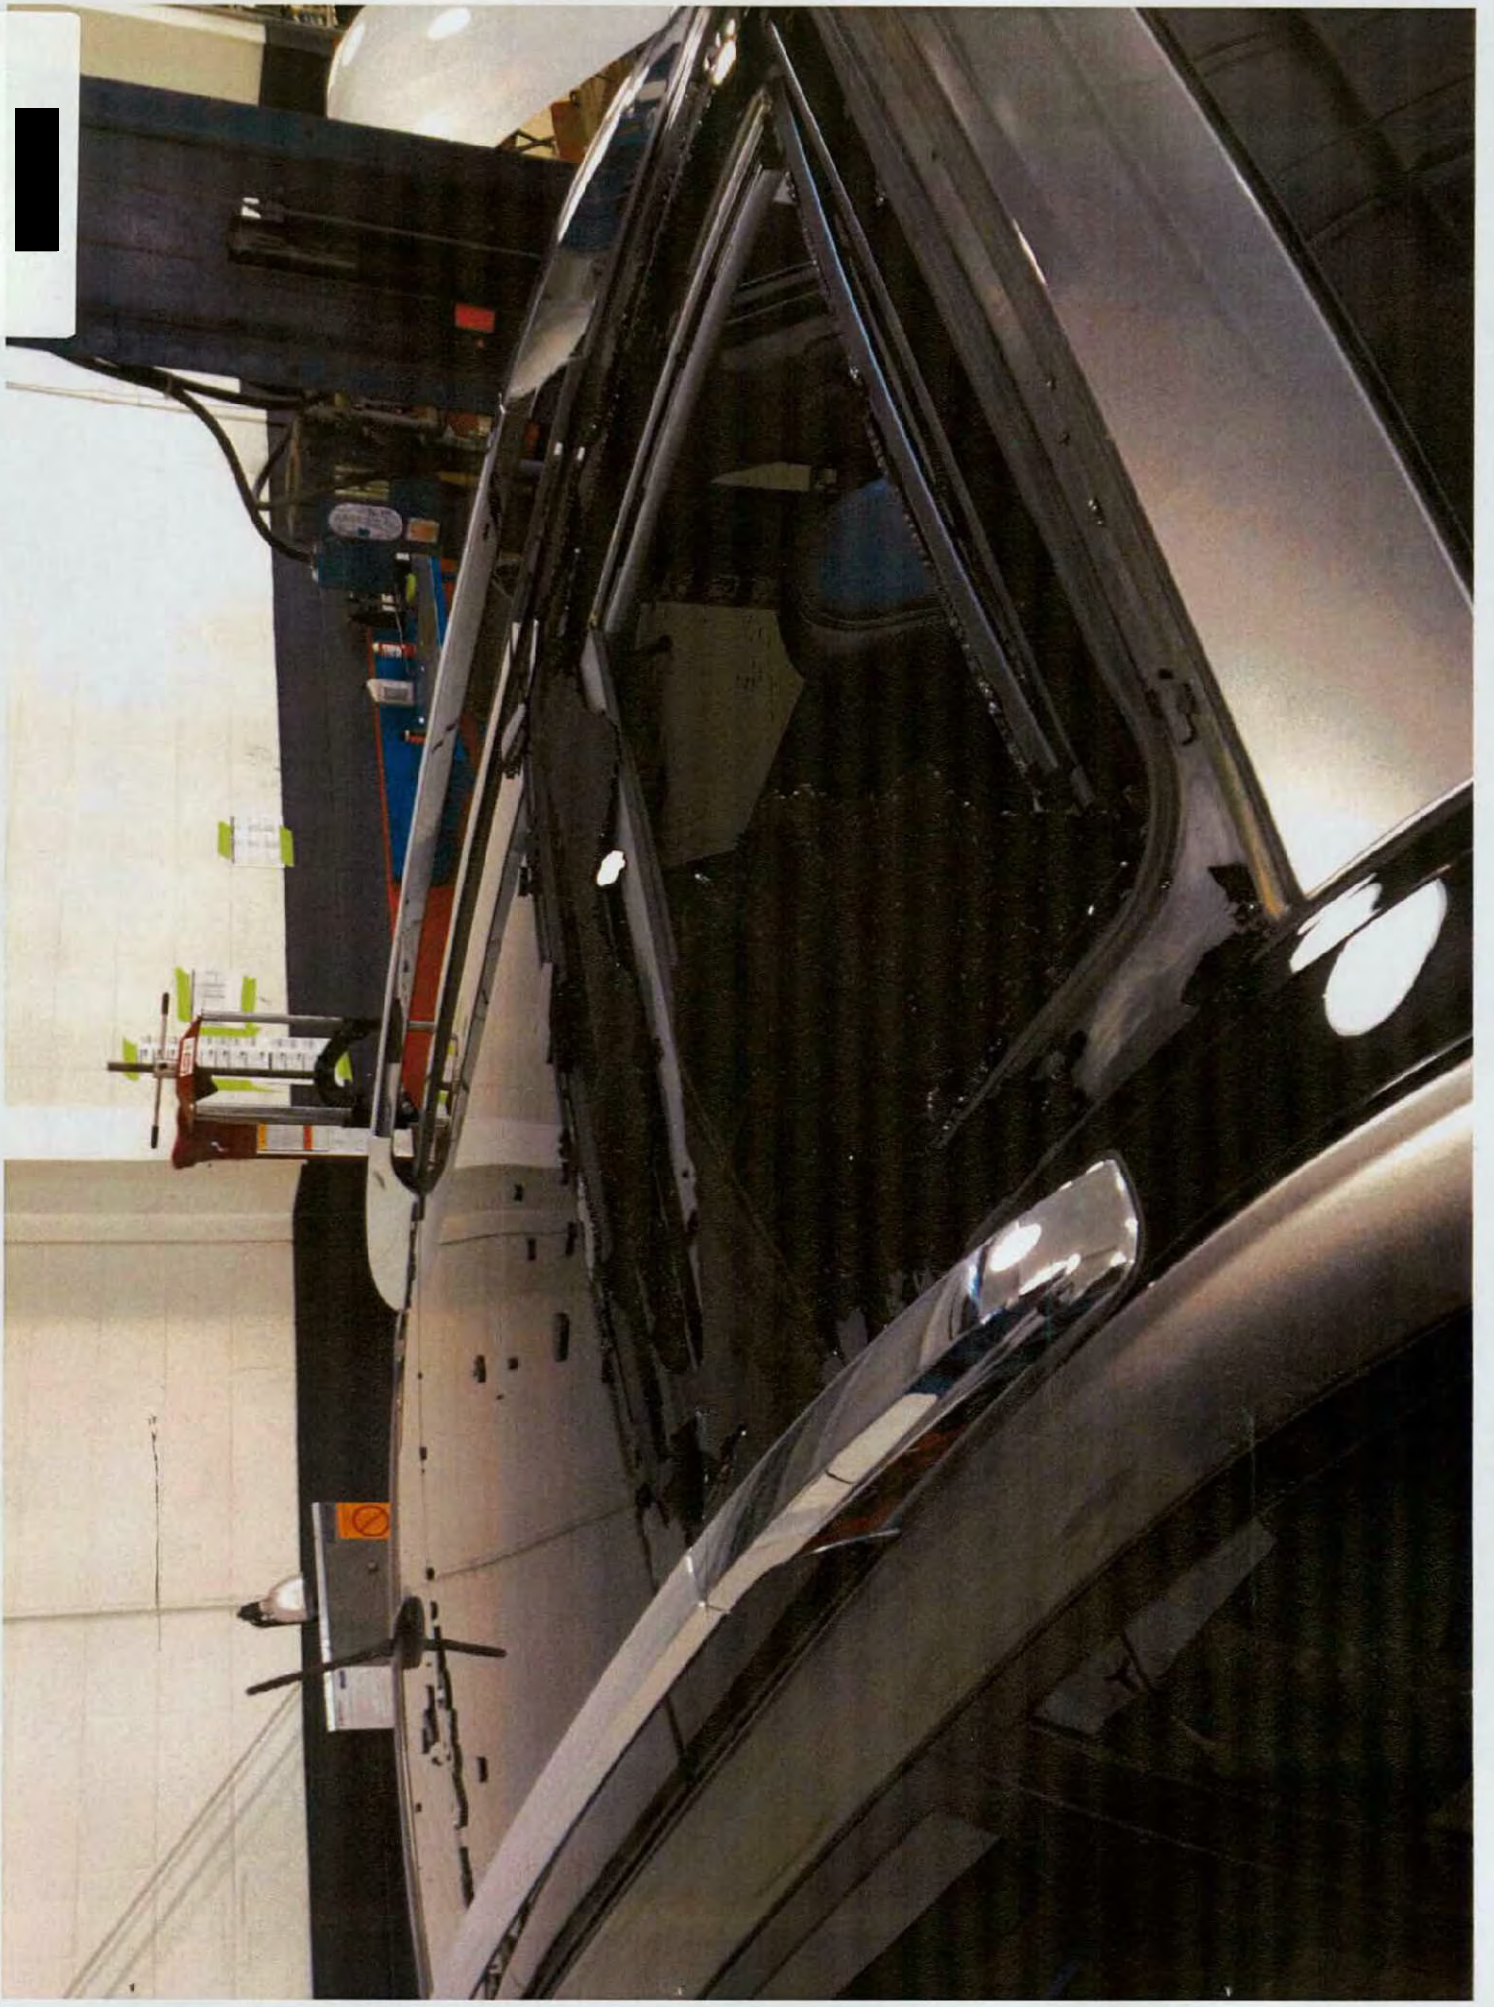
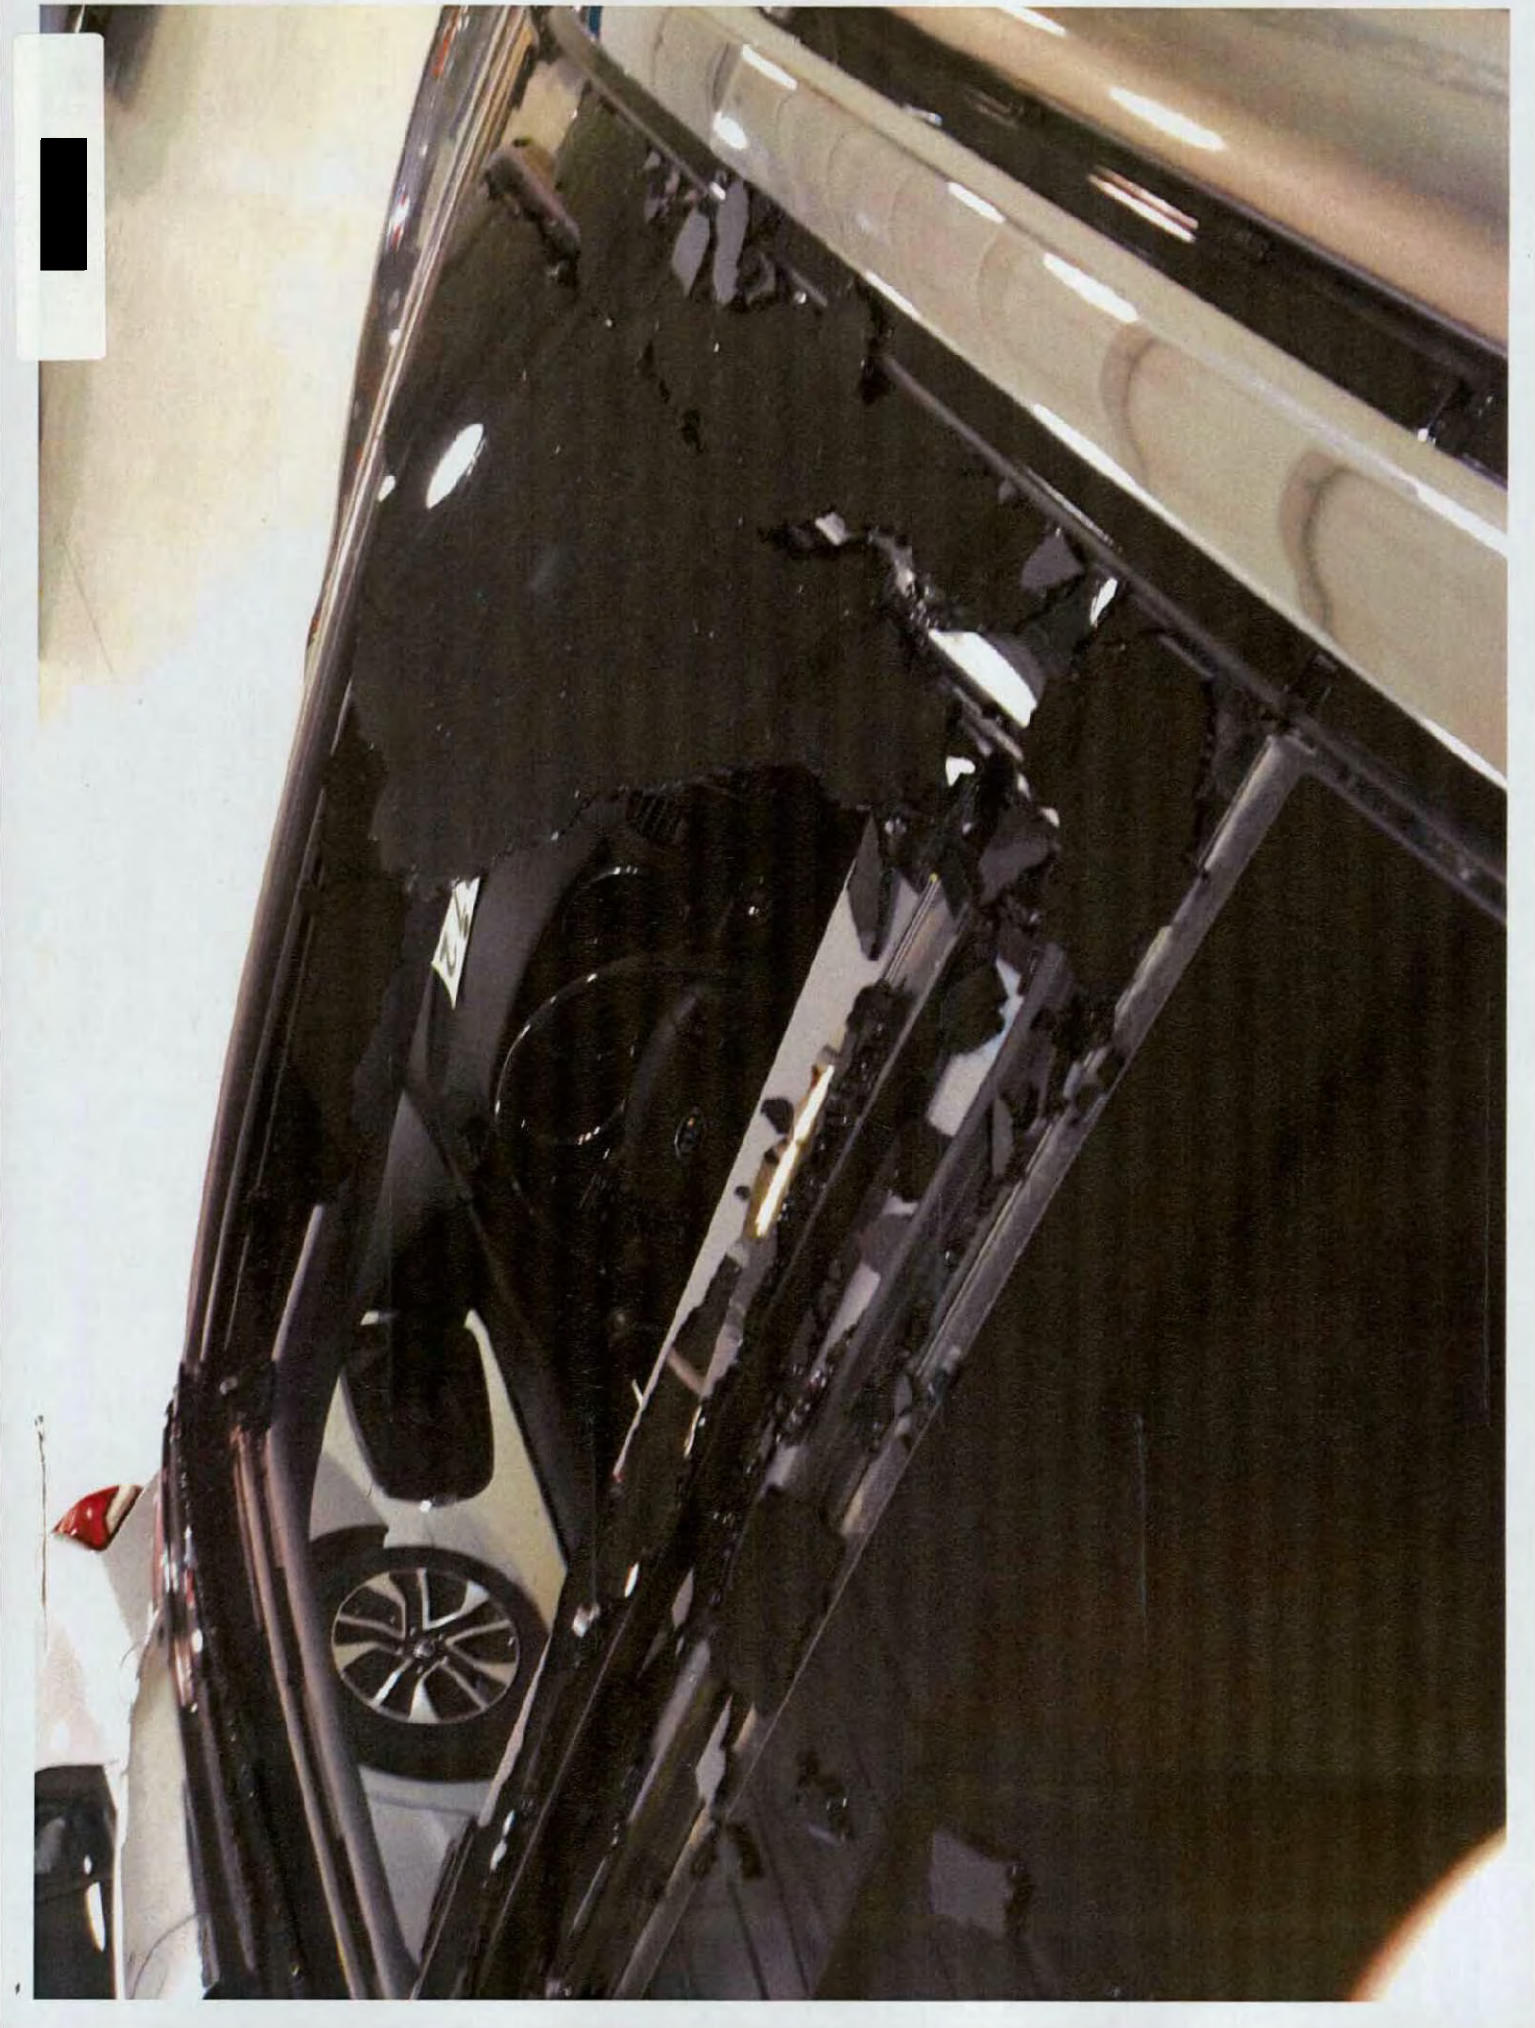
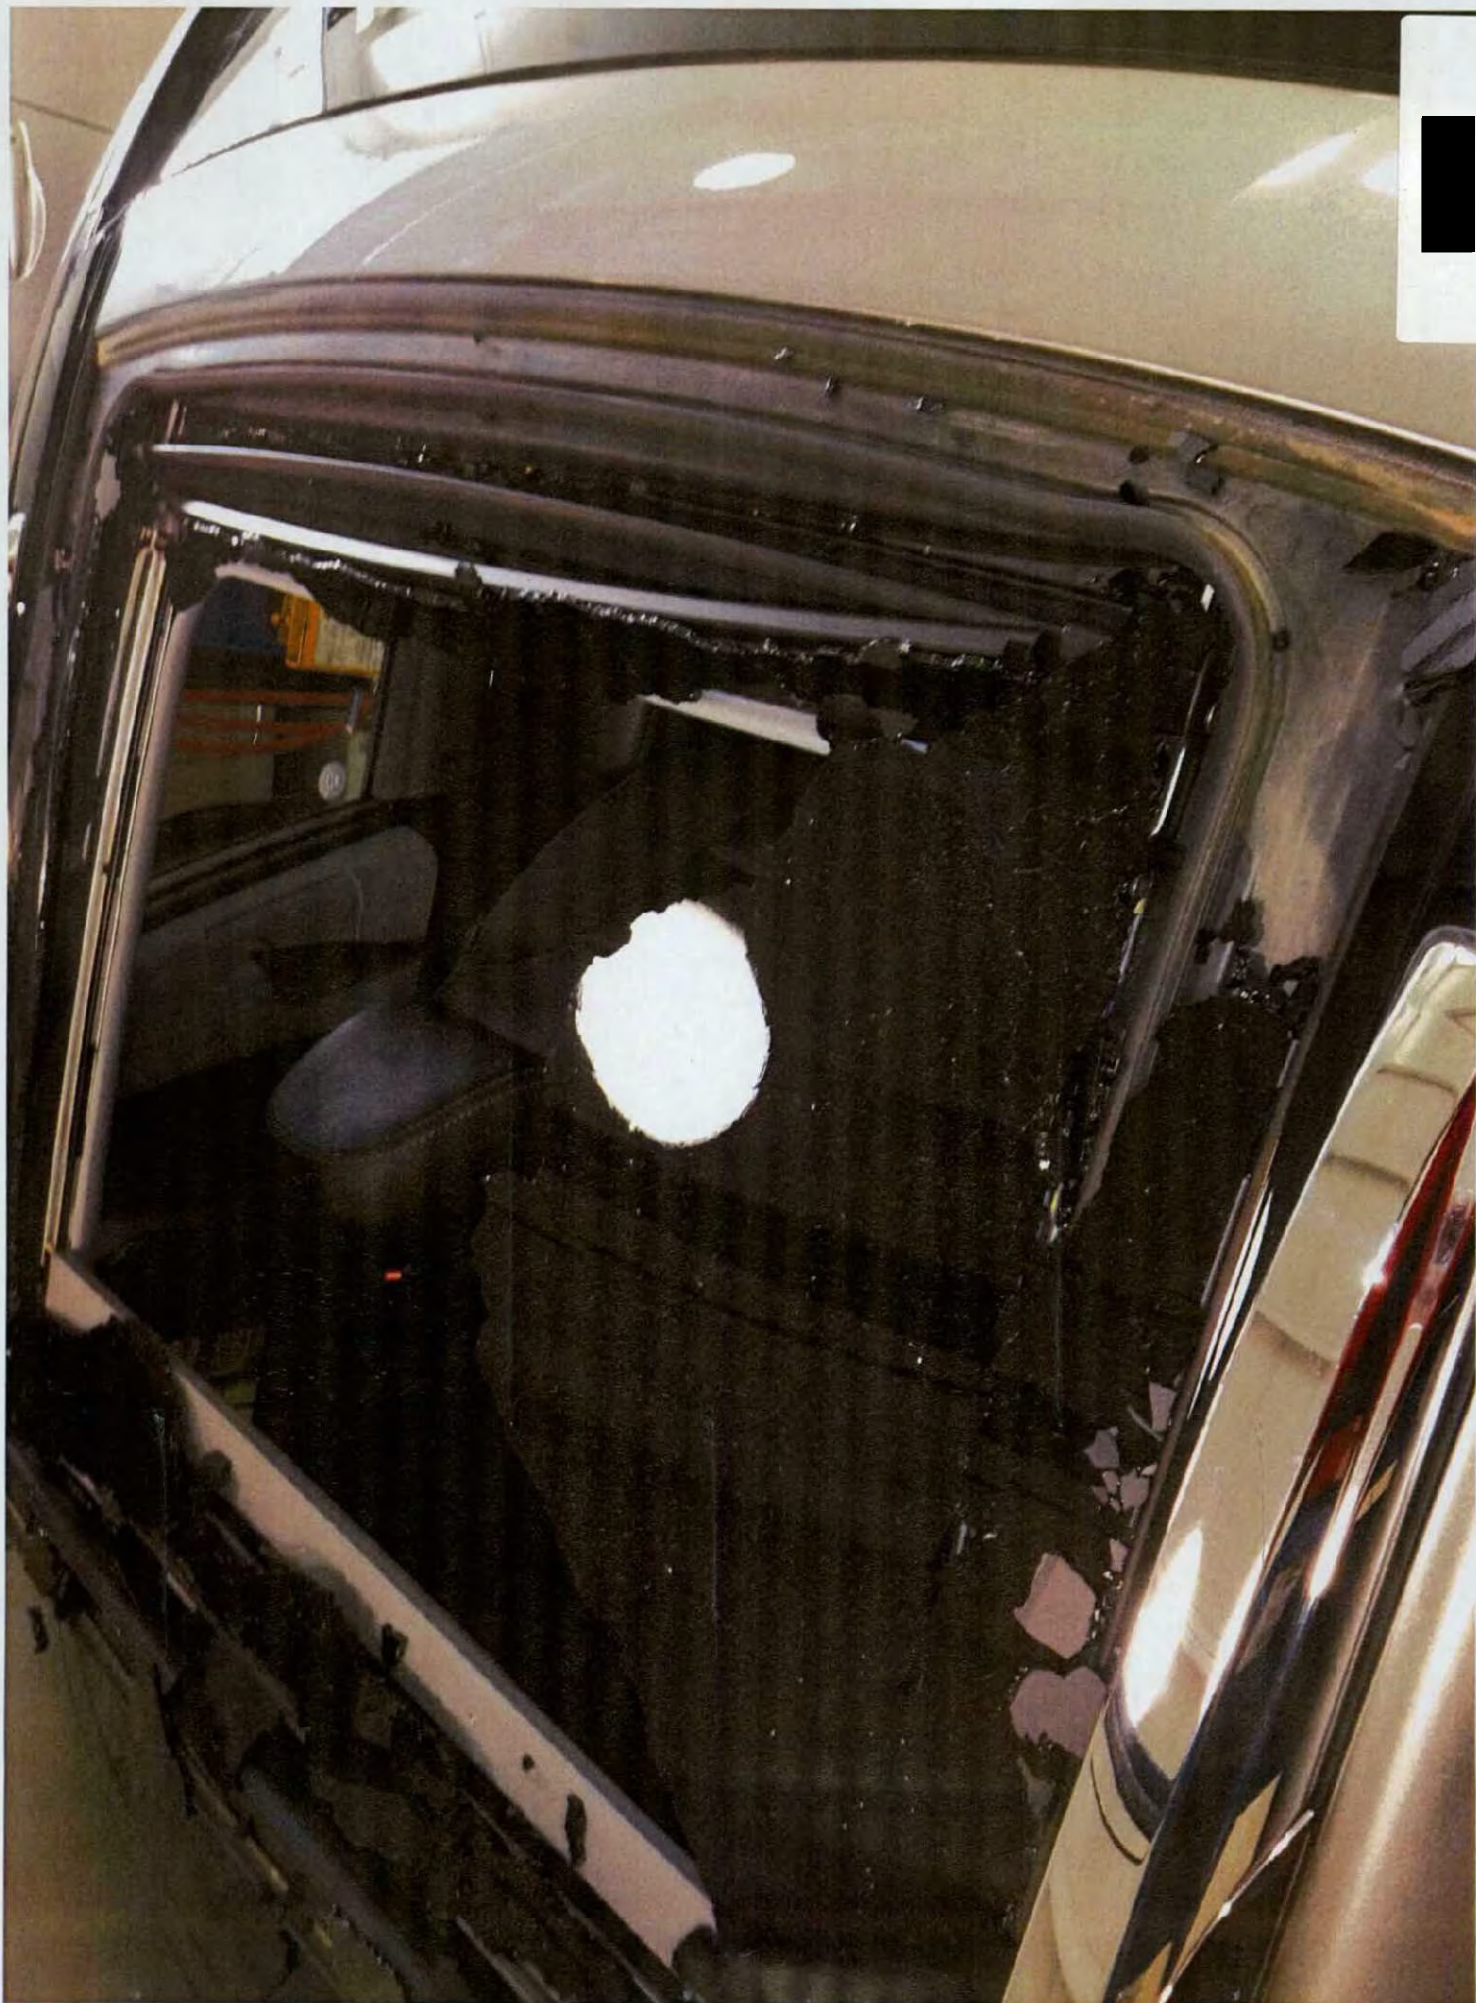
Found the sunroof was cracked and pushed outwards.

DPSM inspected the vehicle and did not see any indication of outside influence causing the stationer part of the sunroof to crack. There were no signs of impact on the roof or roof rails.

Replaced panoramic sunroof glass rear

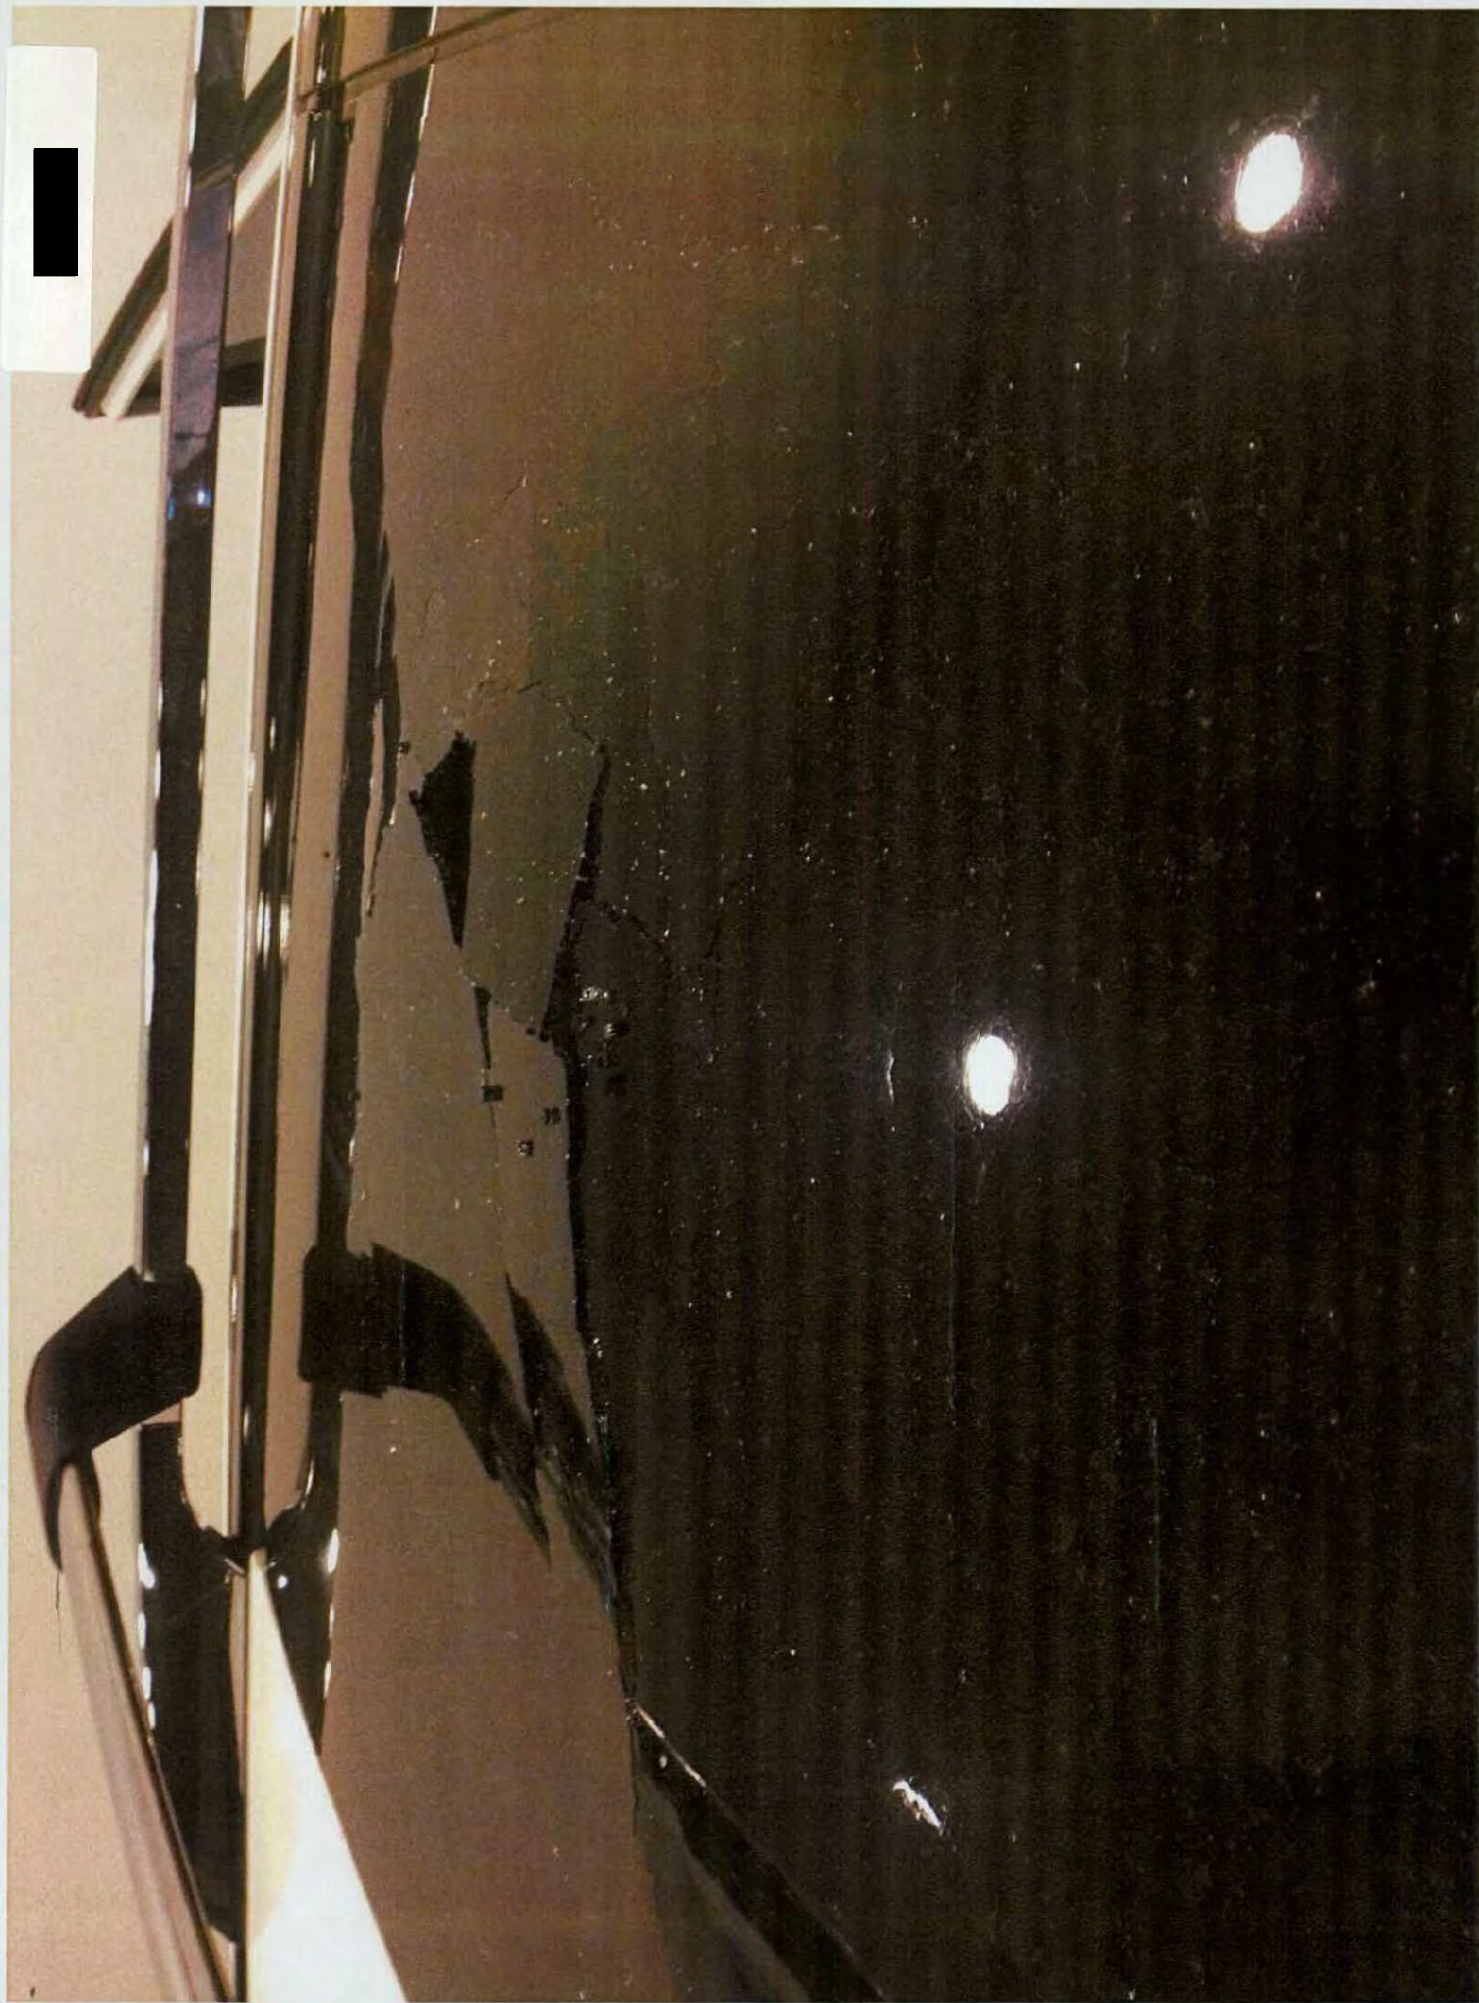
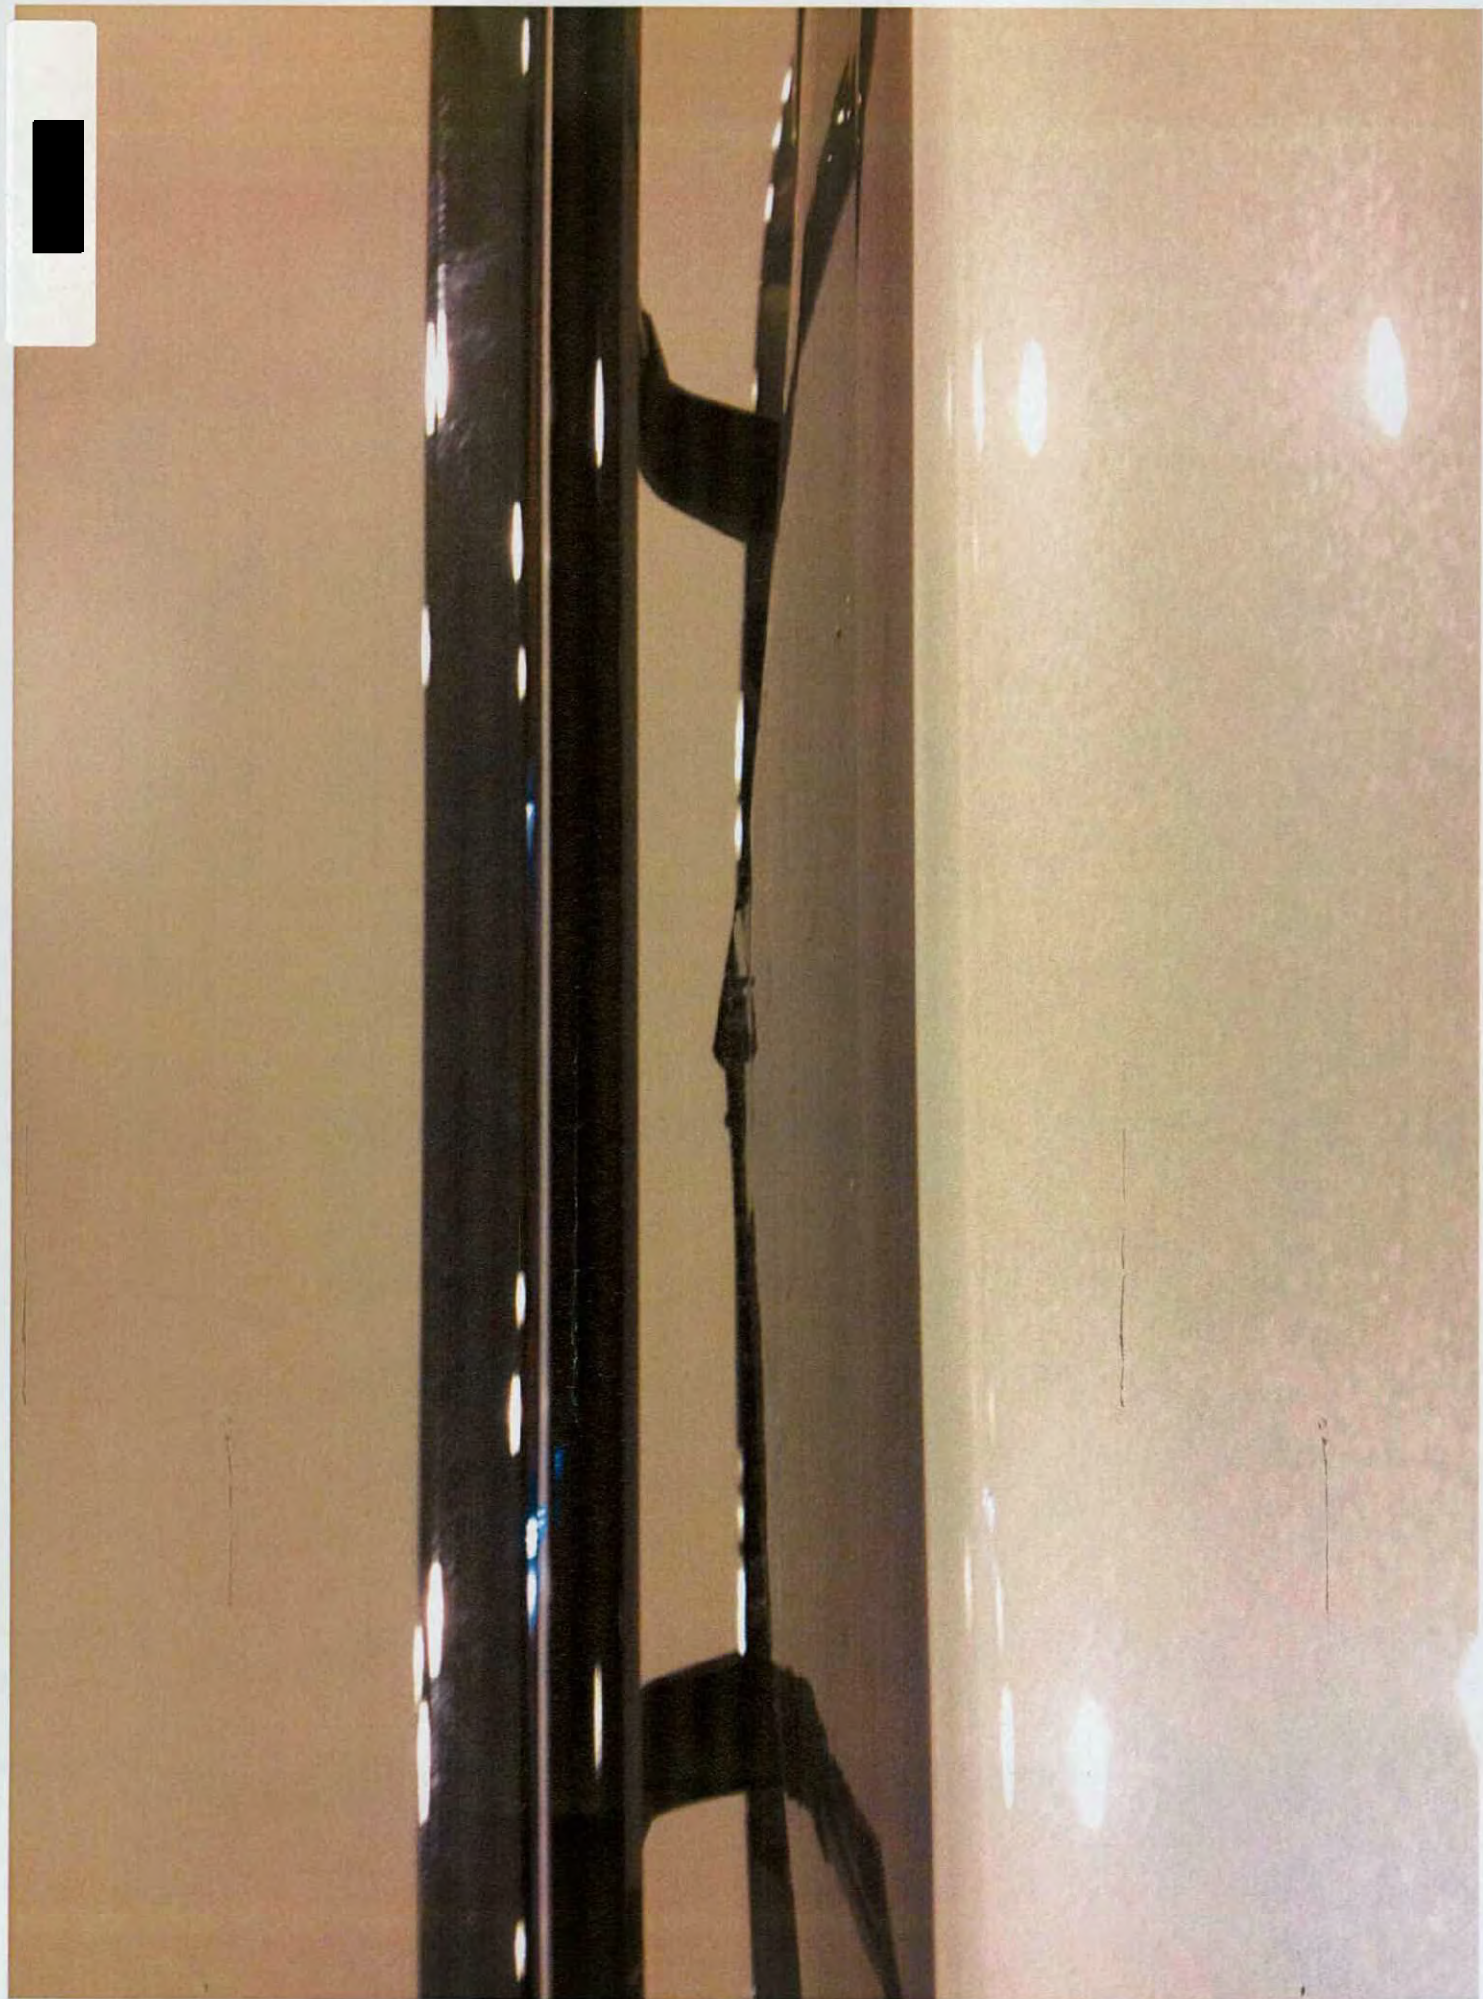
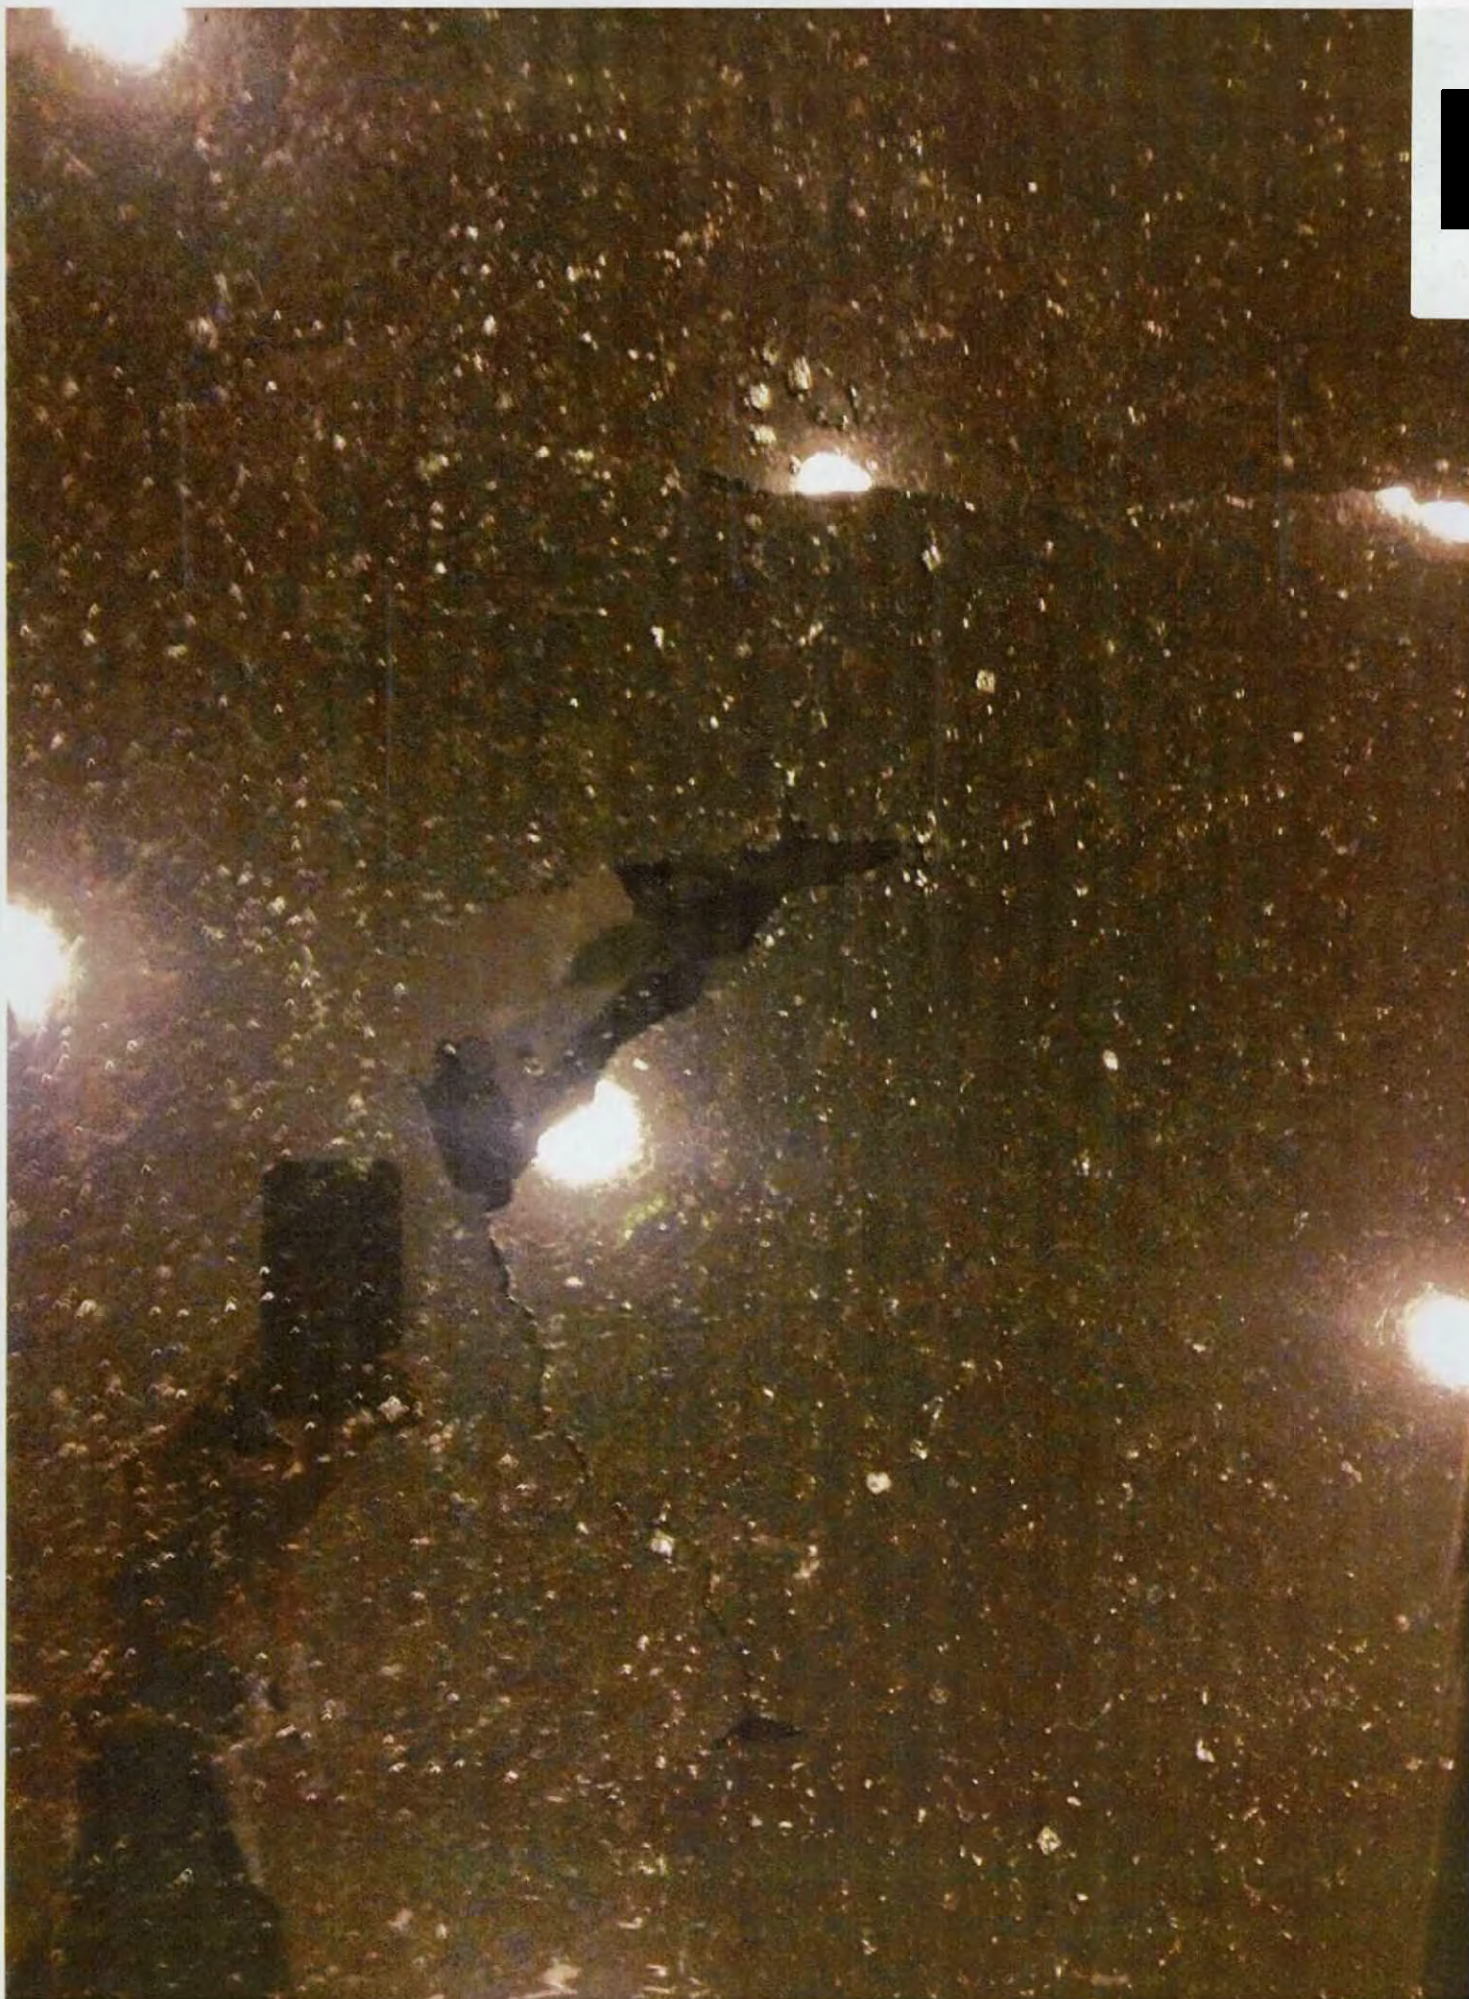
The sunroof shattered while driving at highway speeds.

Found sunroof glass shattered.

Unknown
