Kia Motors America
Field Product Quality Report

Report No.: SO2013PR02151

Subject/Title: Customer states the Sunroof glass

Model Desc: SORENTO SX FWL

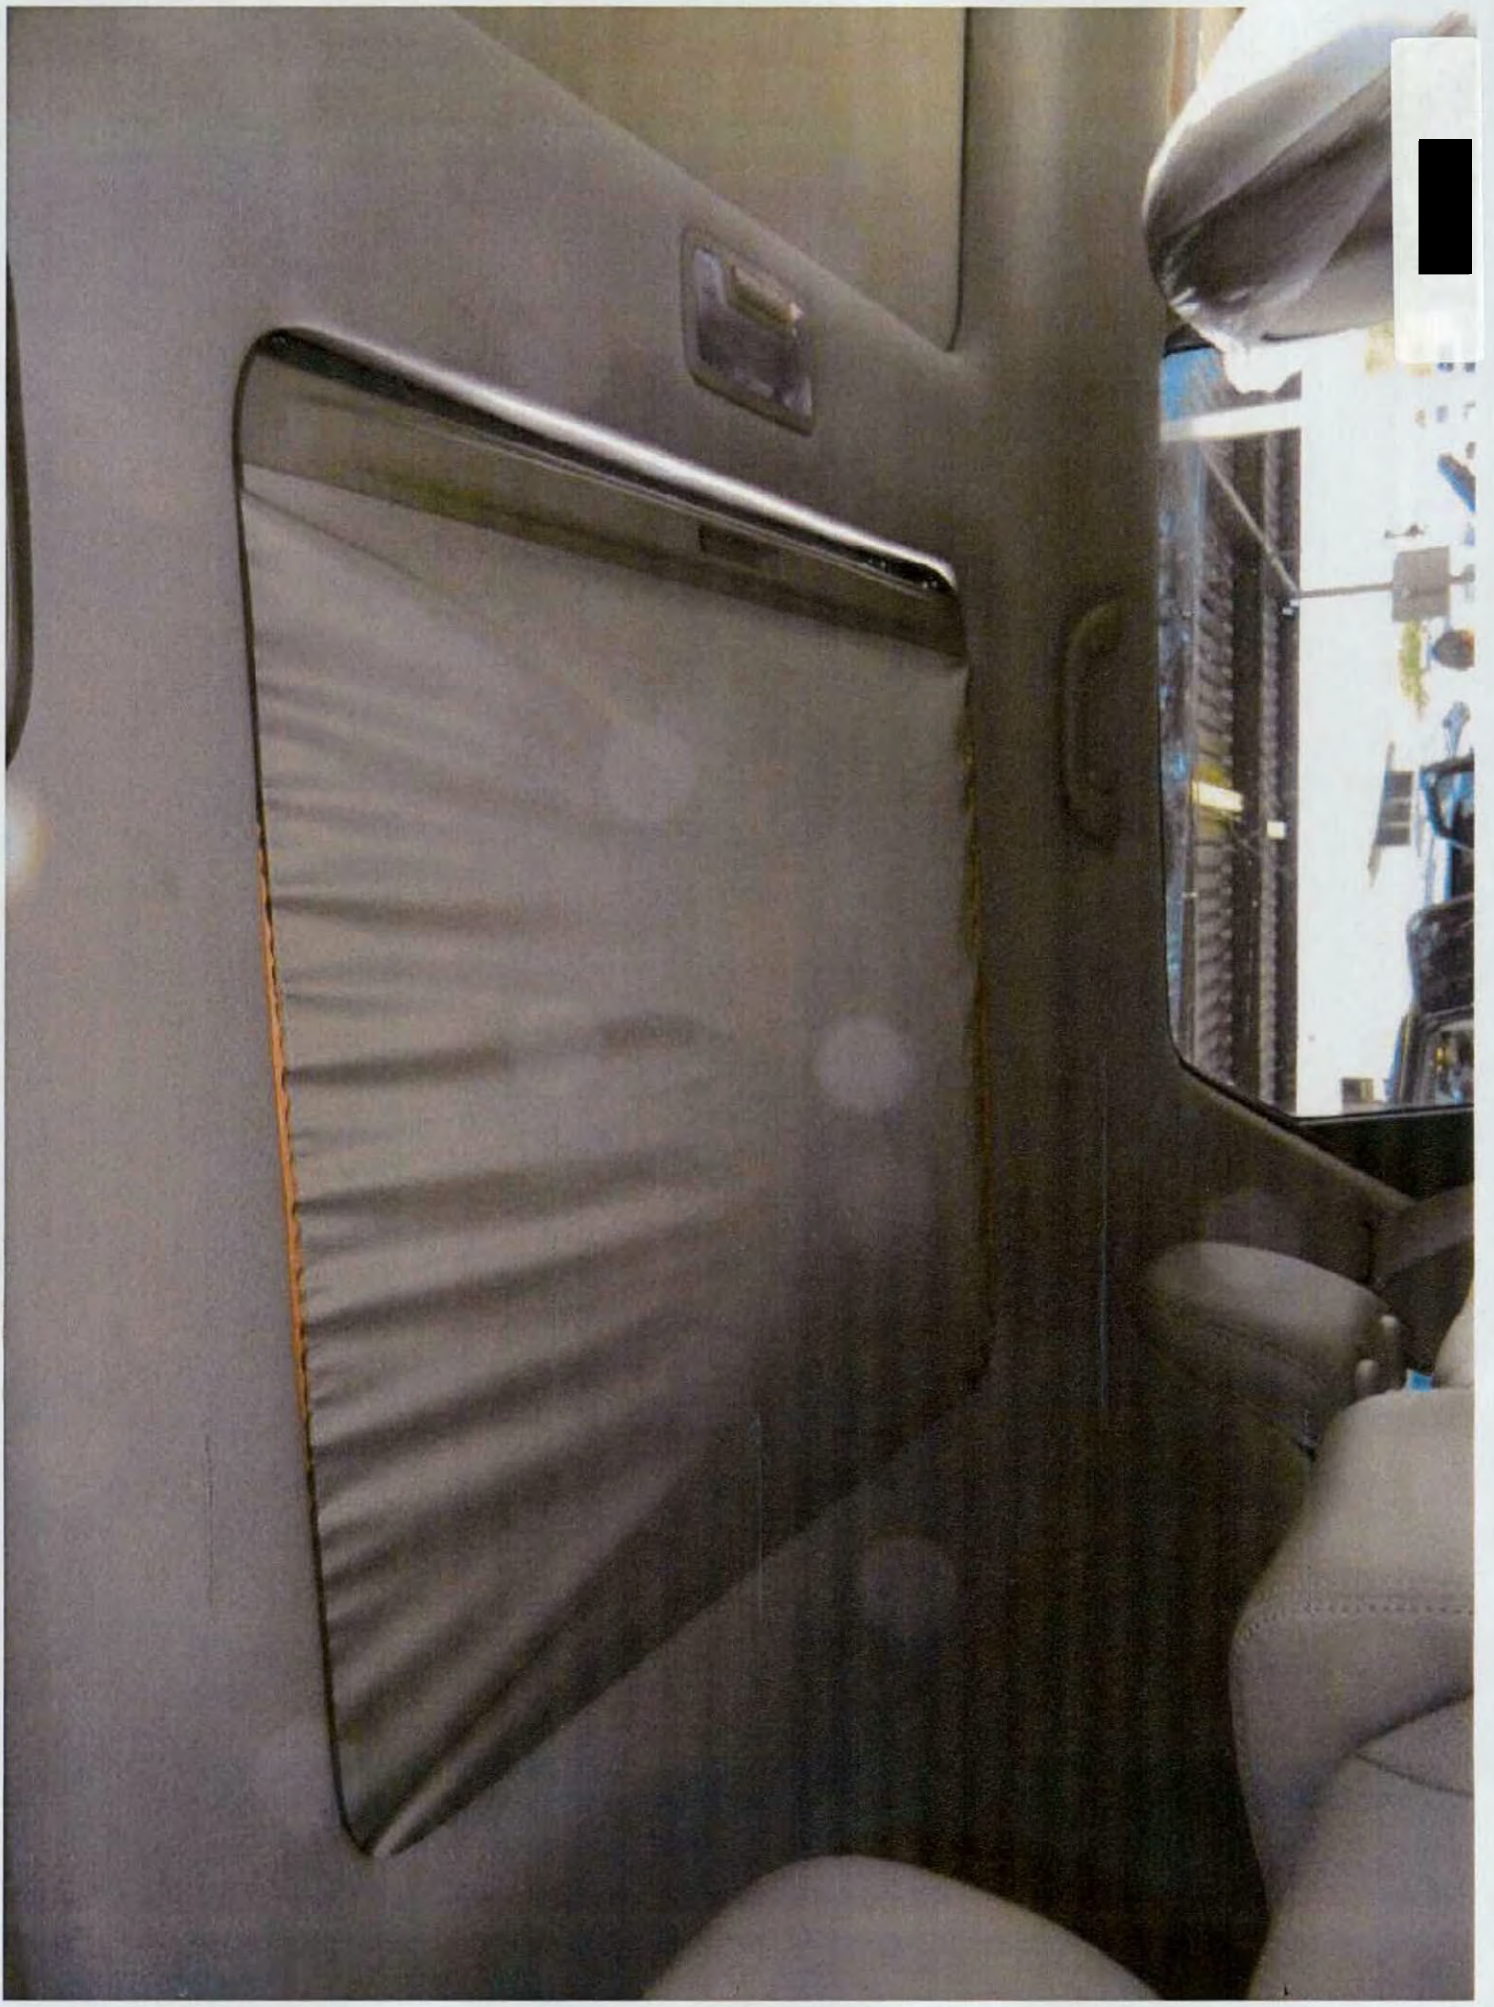
Customer states the Sunroof glass shattered while driving at highway speeds.

Sunroof glass shattered while driving at highway speeds.

Found sunroof glass shattered

Unknown

Replace the sunroof glass

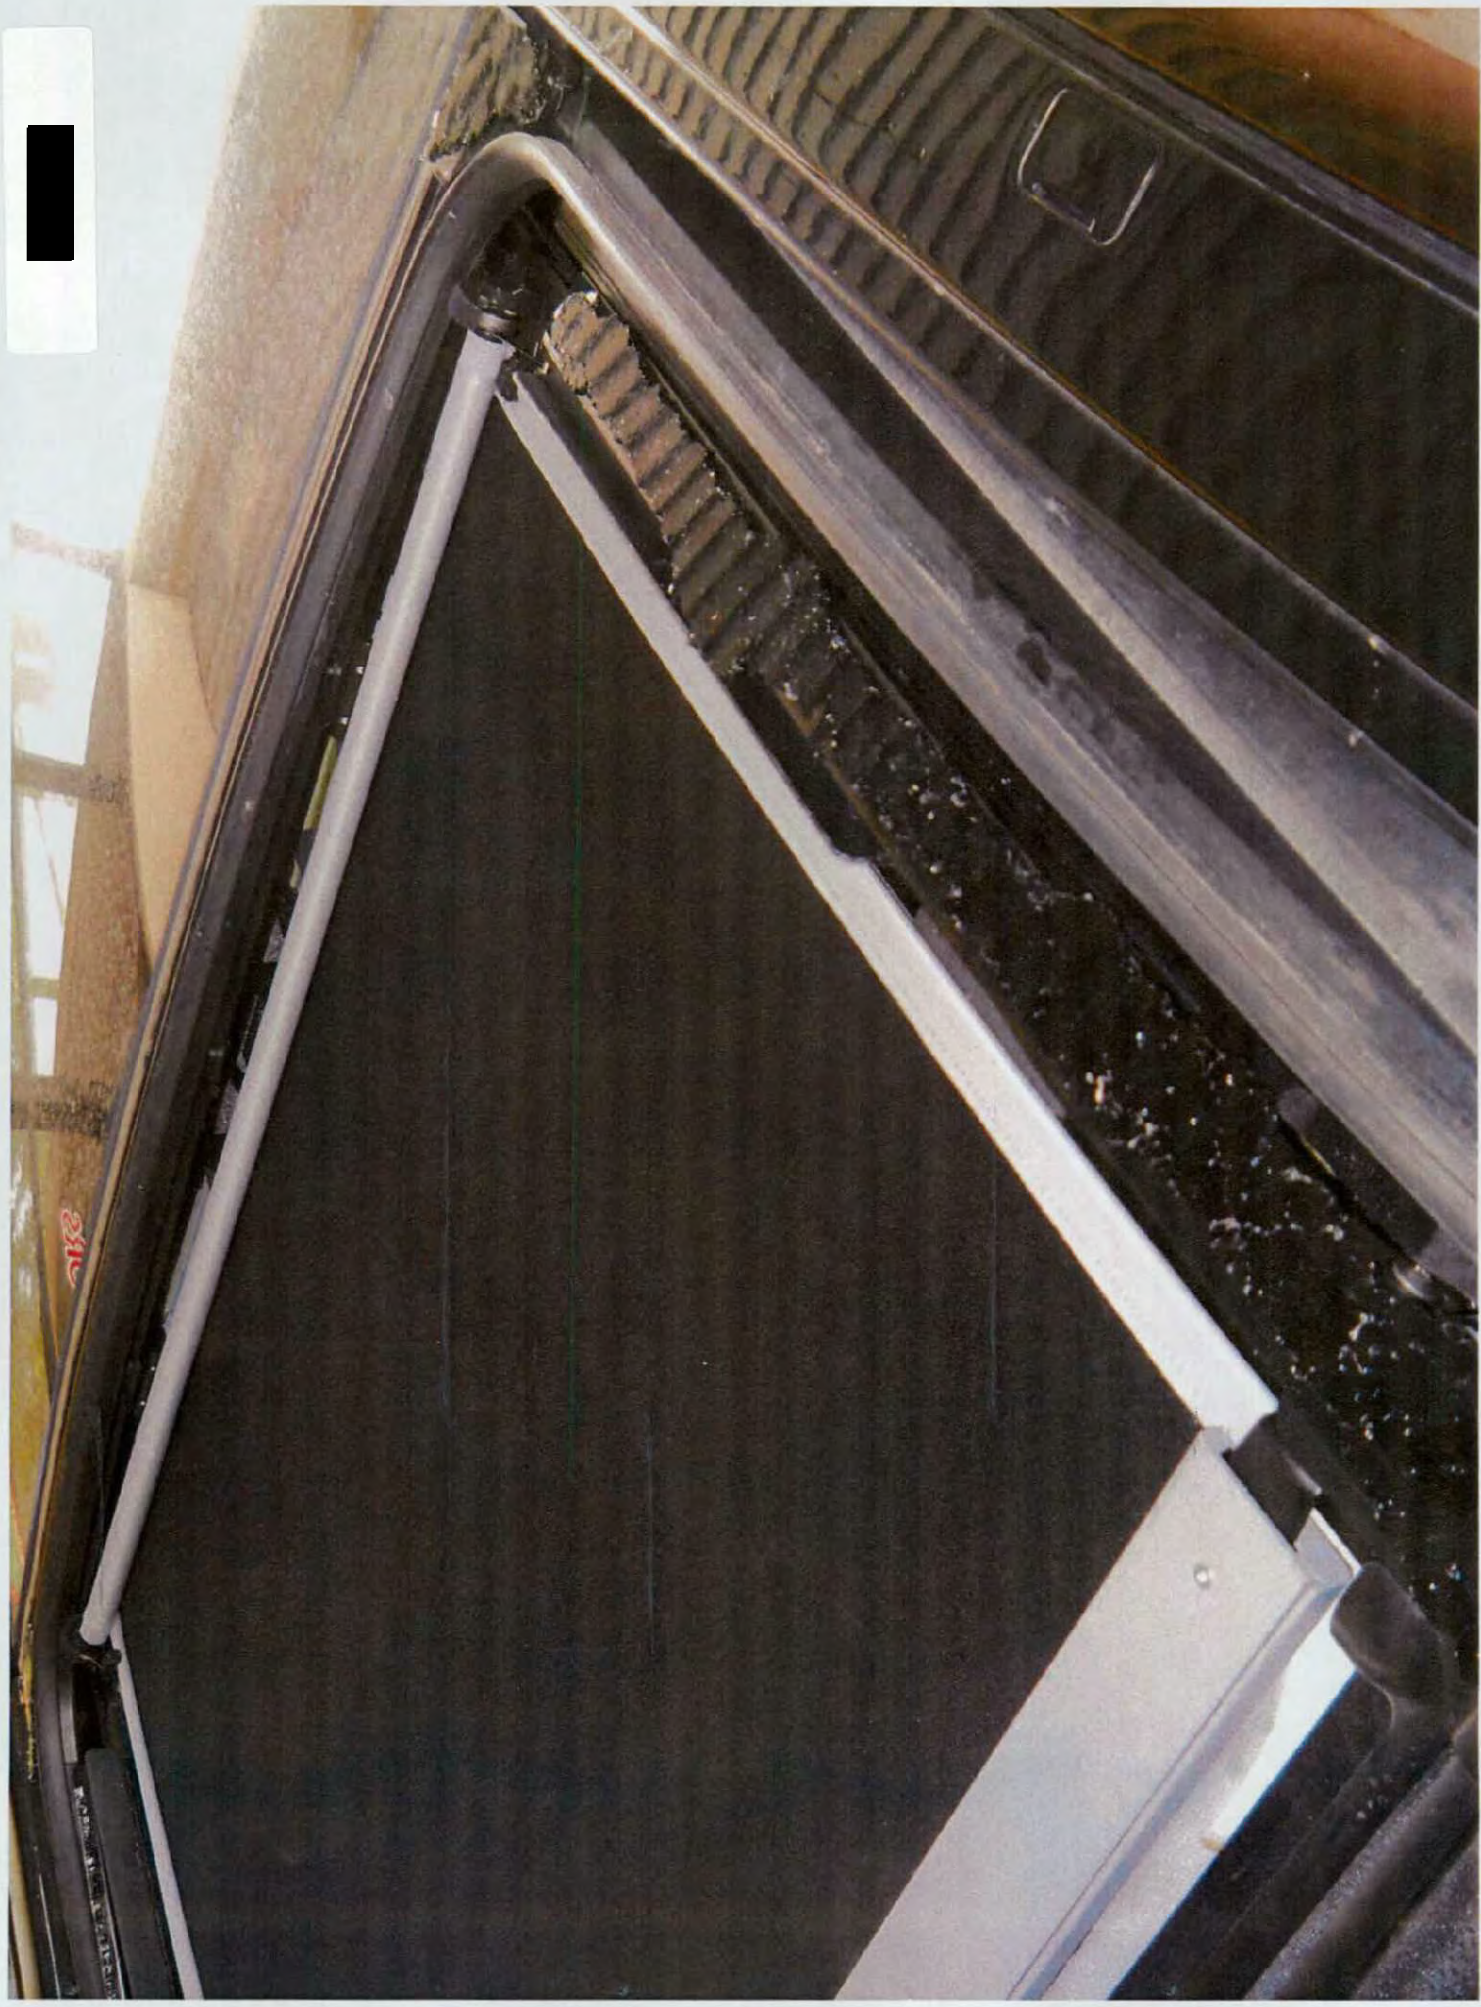
Customer states Sunroof glass shattered while driving at highway speeds.

Sunroof glass shattered while driving at highway speeds.

Found Sunroof glass shattered. Scratches on the top rear of vehicle from glass debris.

Unknown
