Kia Motors America
Field Product Quality Report

Report No.: WE2014LG00047

Subject/Title: Shattered Sunroof

Model Desc: SORENTO EX AWE

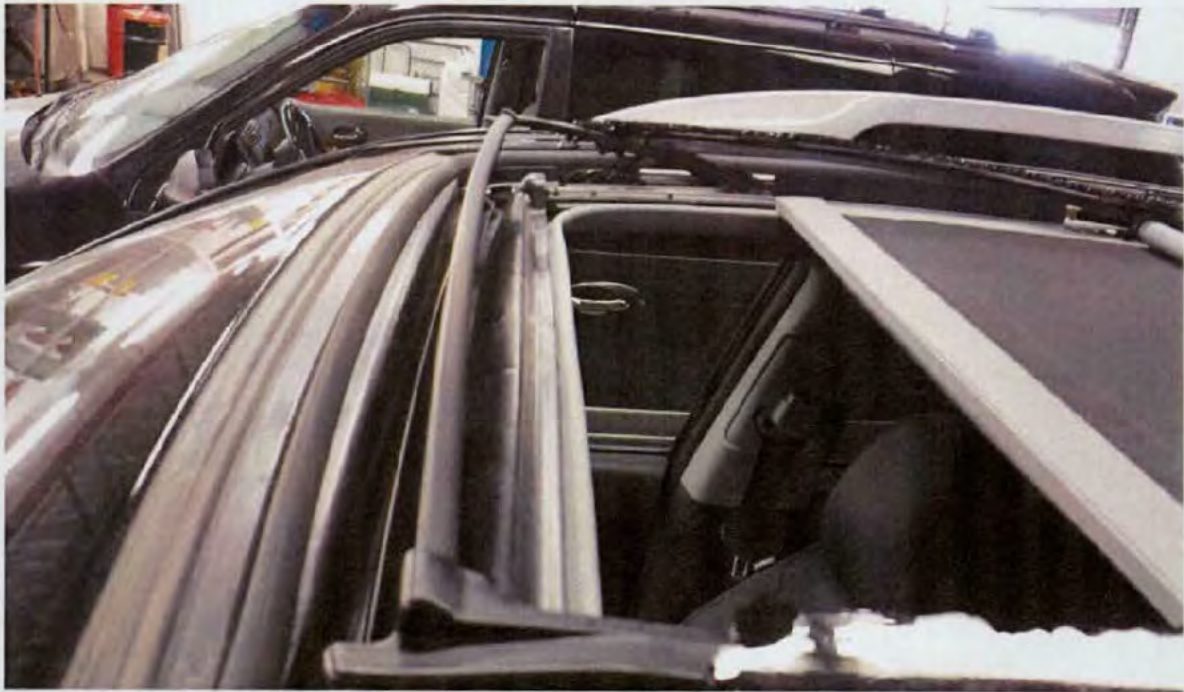
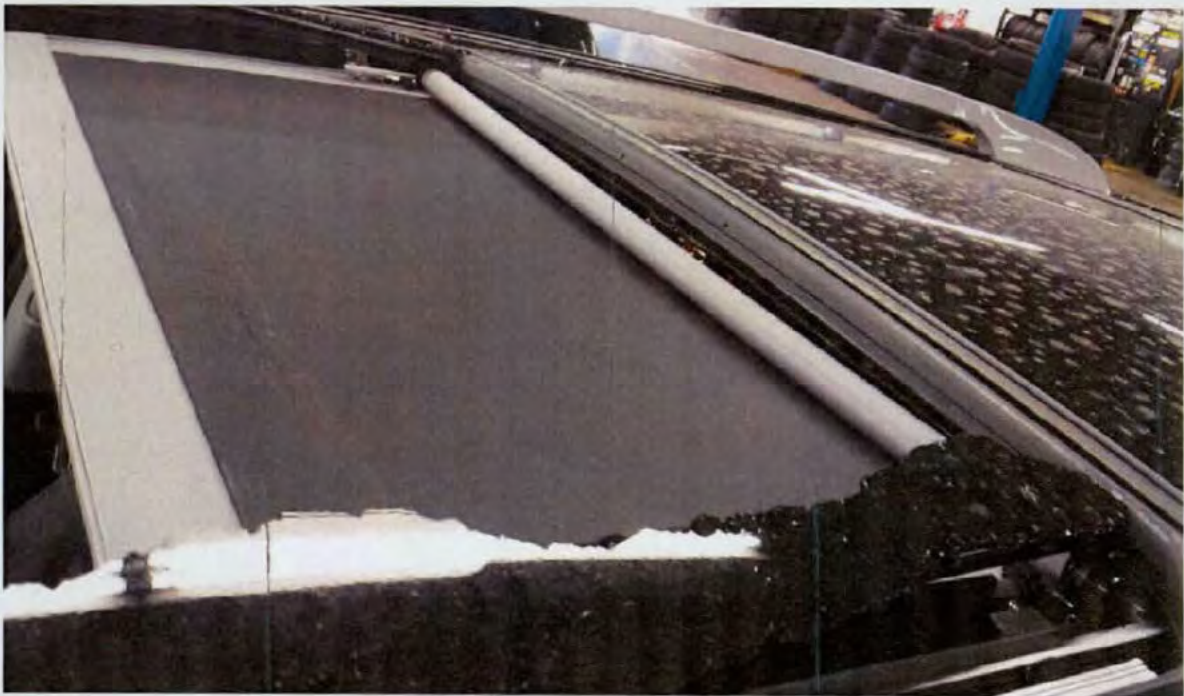
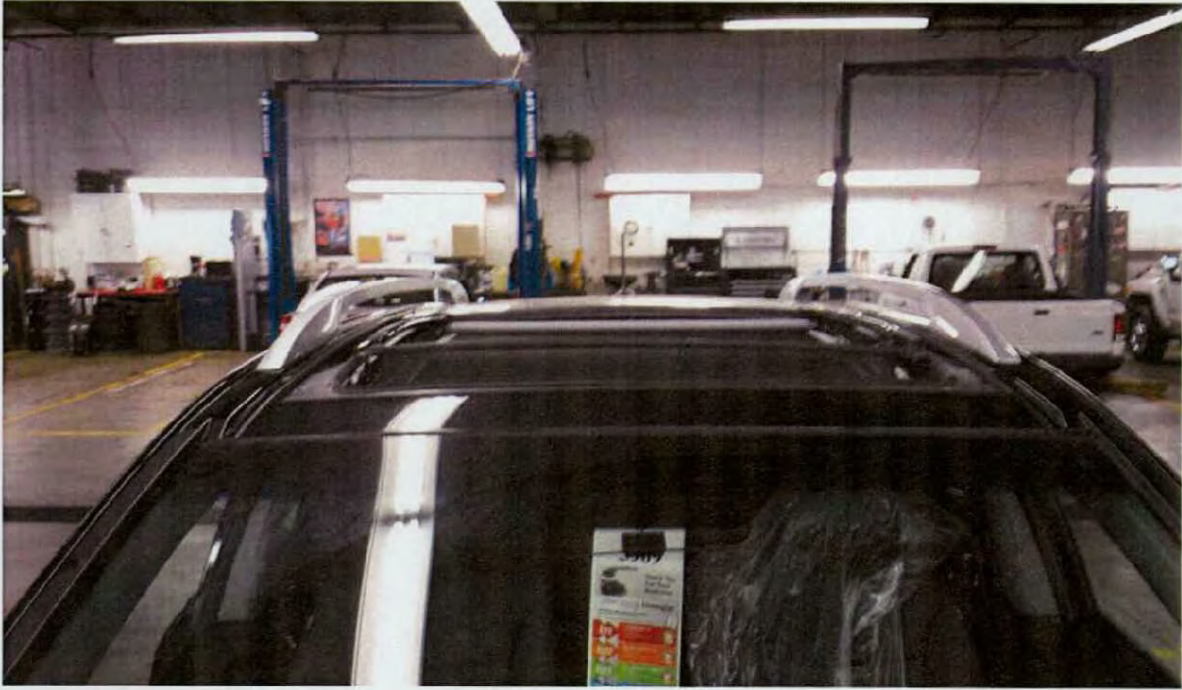
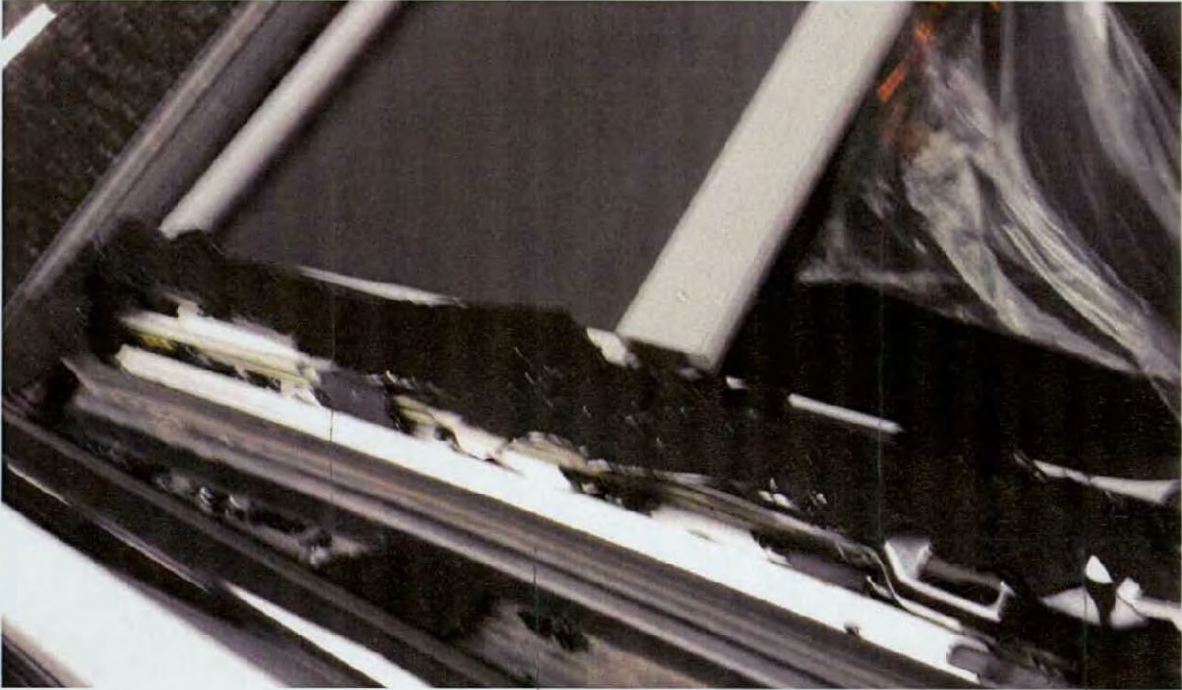
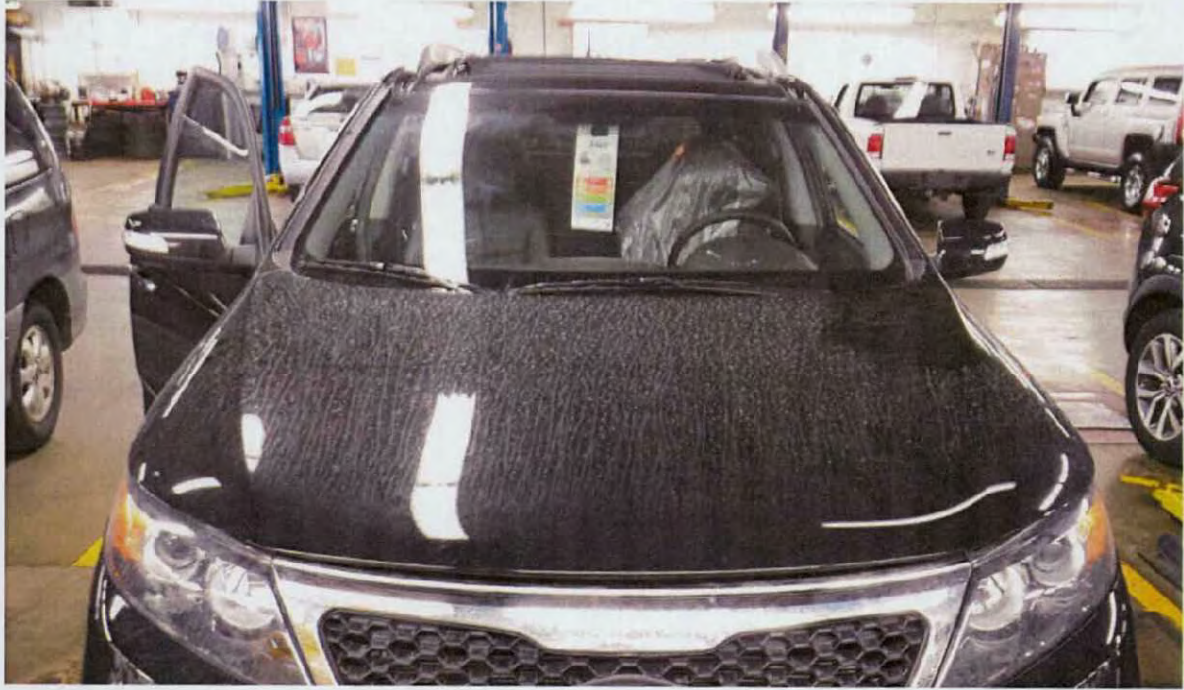
Pictures for sunroof – 2013 Sorento – VIN# 5XYKUDA25DG [REDACTED]

While driving the sunroof glass shattered. Customer did not hear anything impact the glass and we could not find anything inside the vehicle that could have caused it to break.

Panoramic glass shattered outwards away from vehicle

DPSM and dealership inspected vehicle and could not any signs of impact.

Undetermined

Replace Panoramic Glass
