## Kia Motors America Field Product Quality Report

Report No.: SO2014NJ00034

Subject/Title: Customer states sunroof glass sha

Model Desc: SORENTO SX AWT

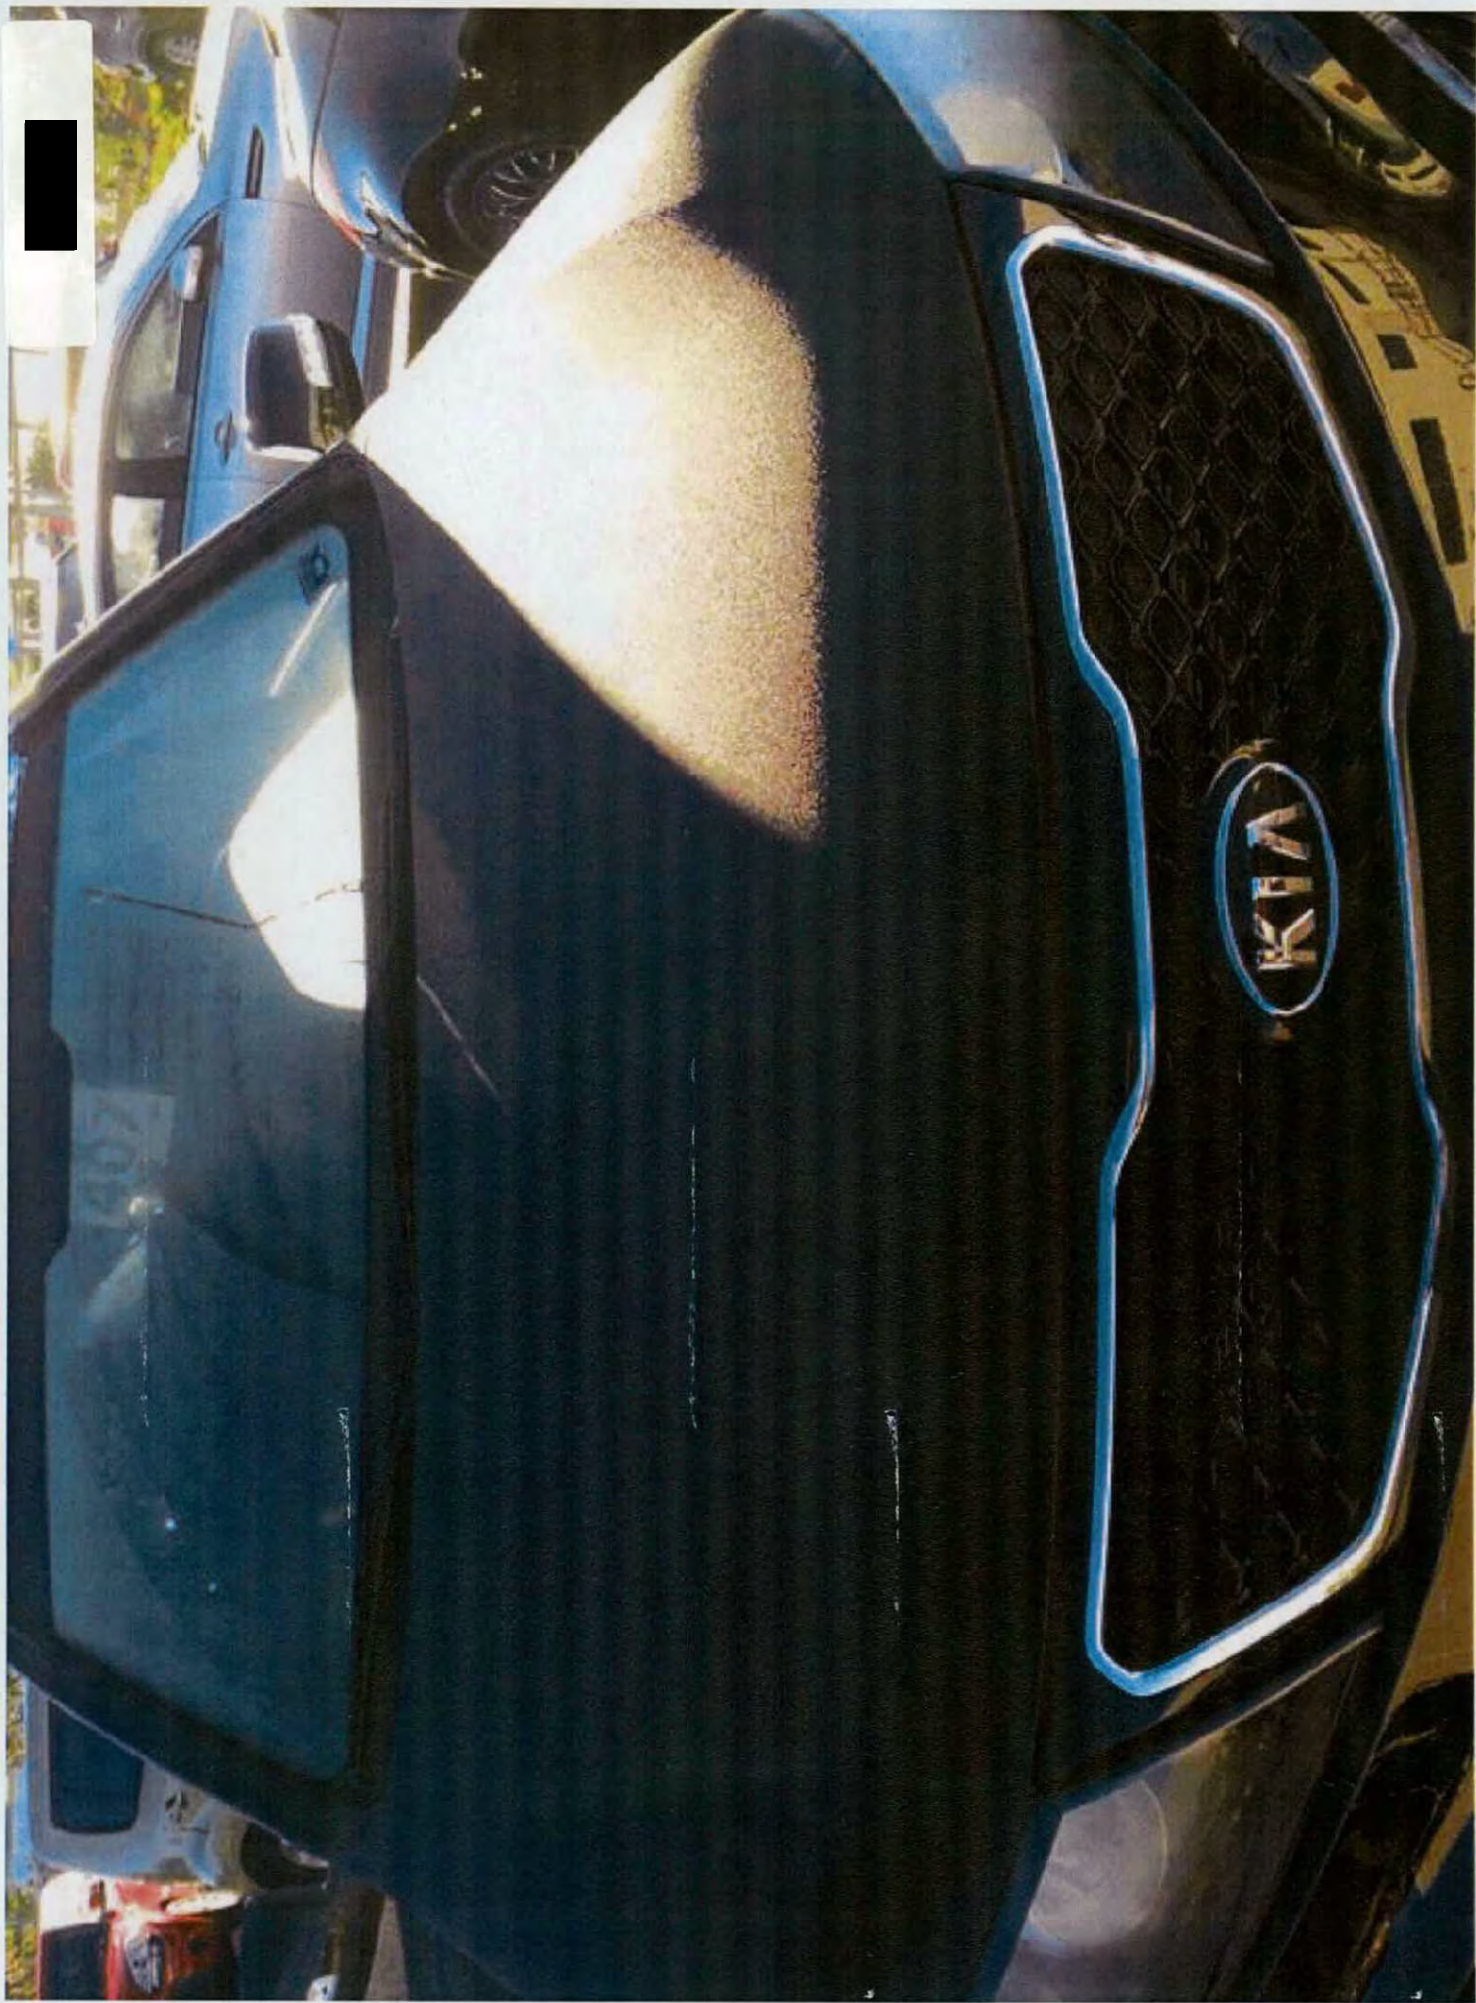
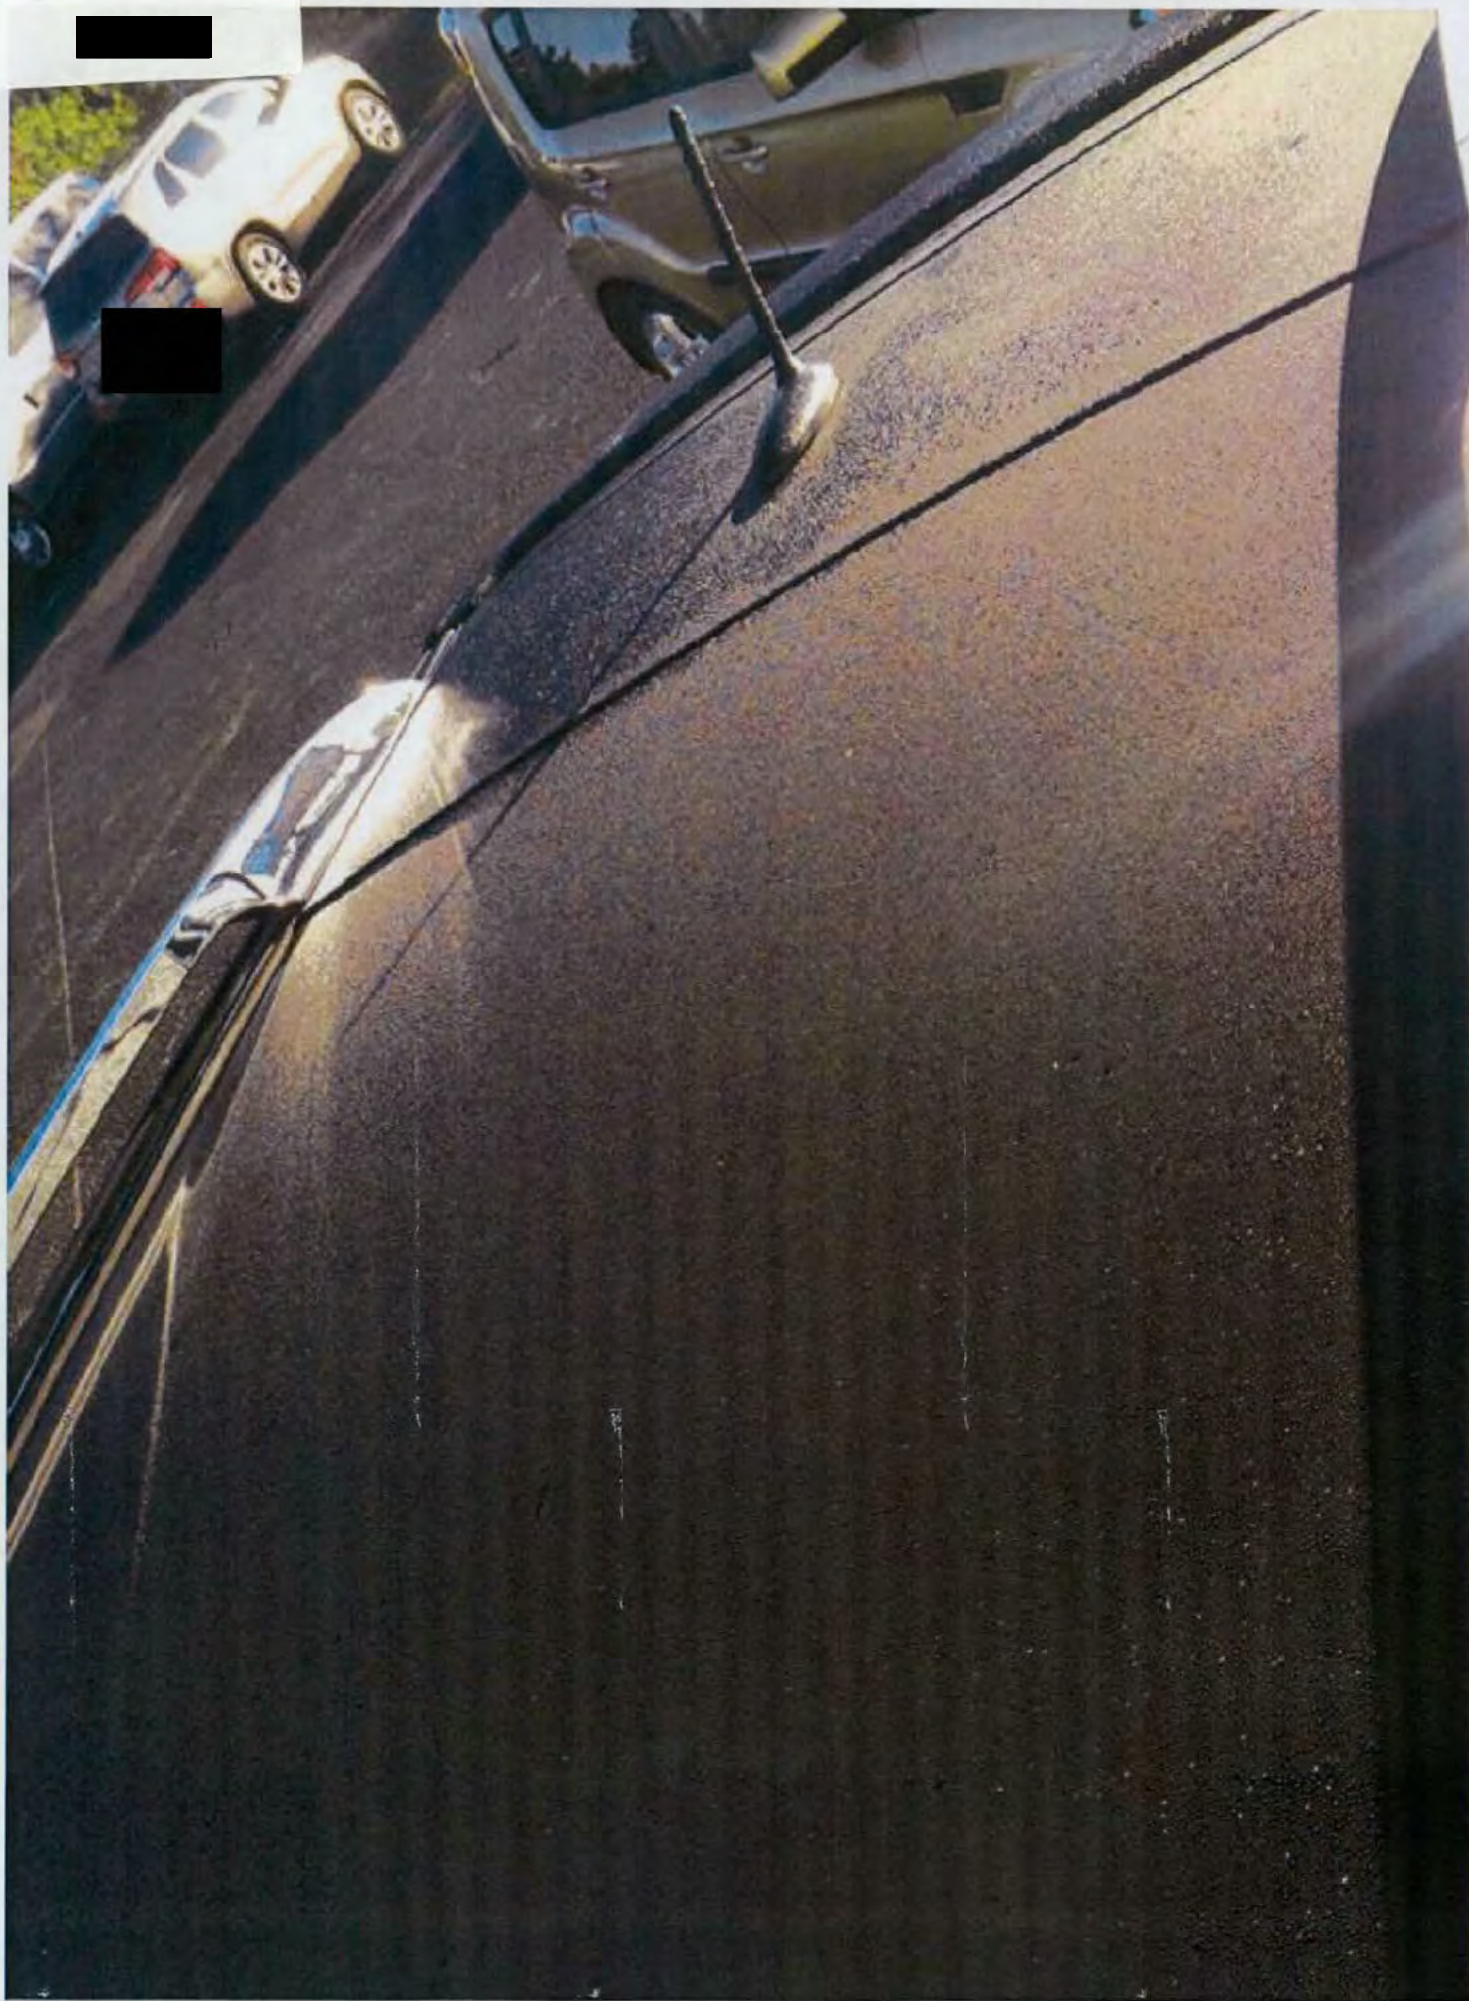
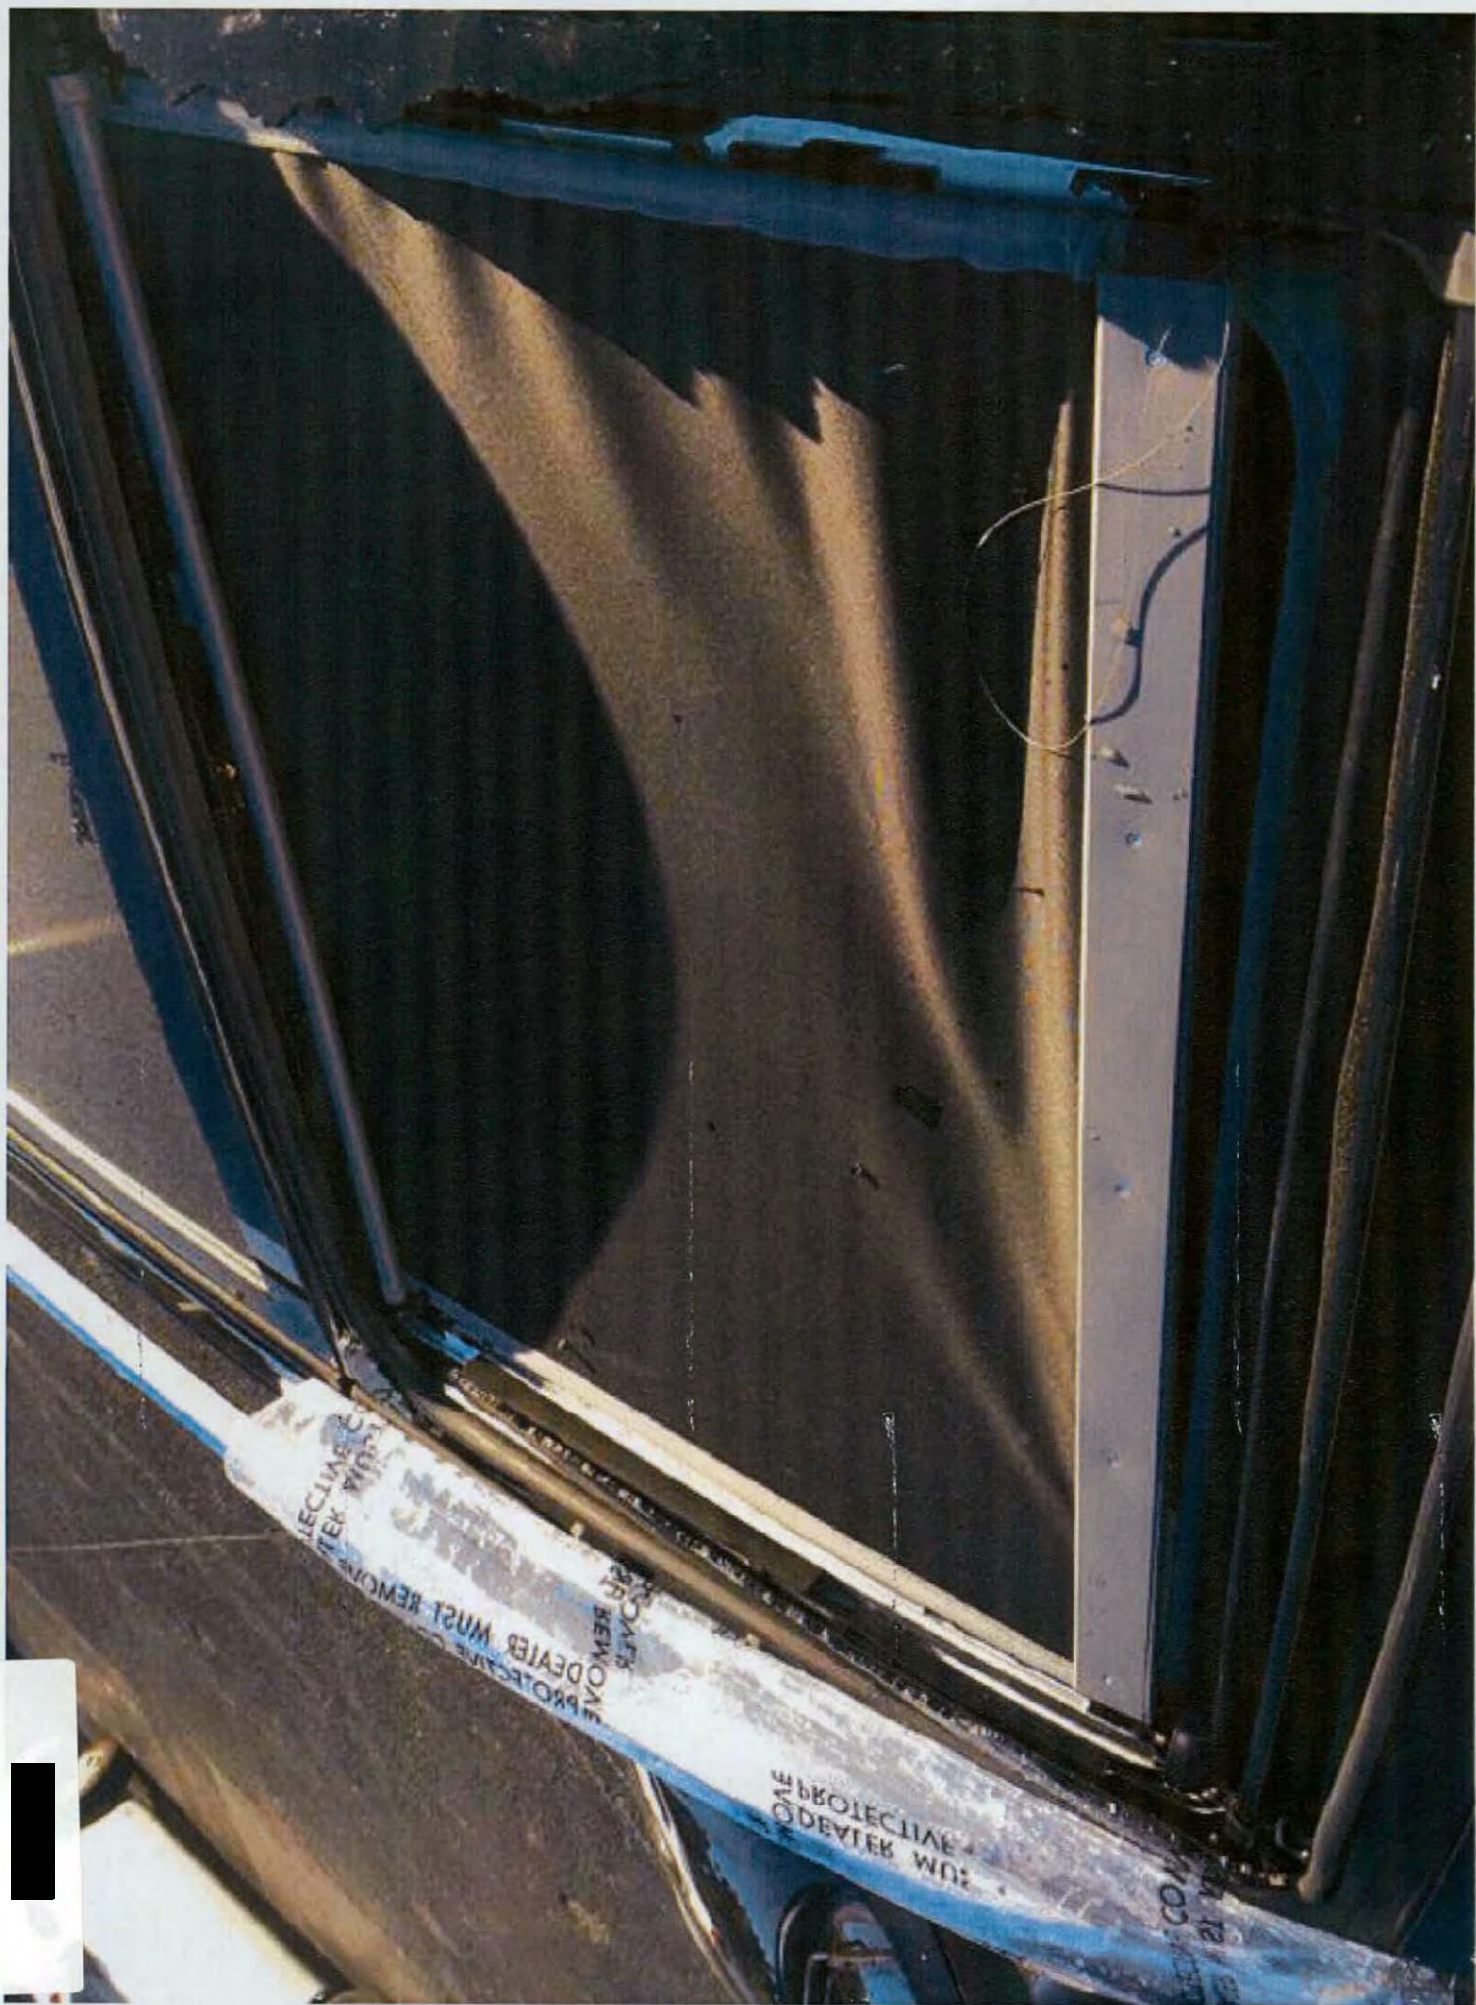
Sunroof glass shattered

Investigation was done by DPSM Found sunroof glass shattered

Unknown

-----  
Replaced sunroof panel assy

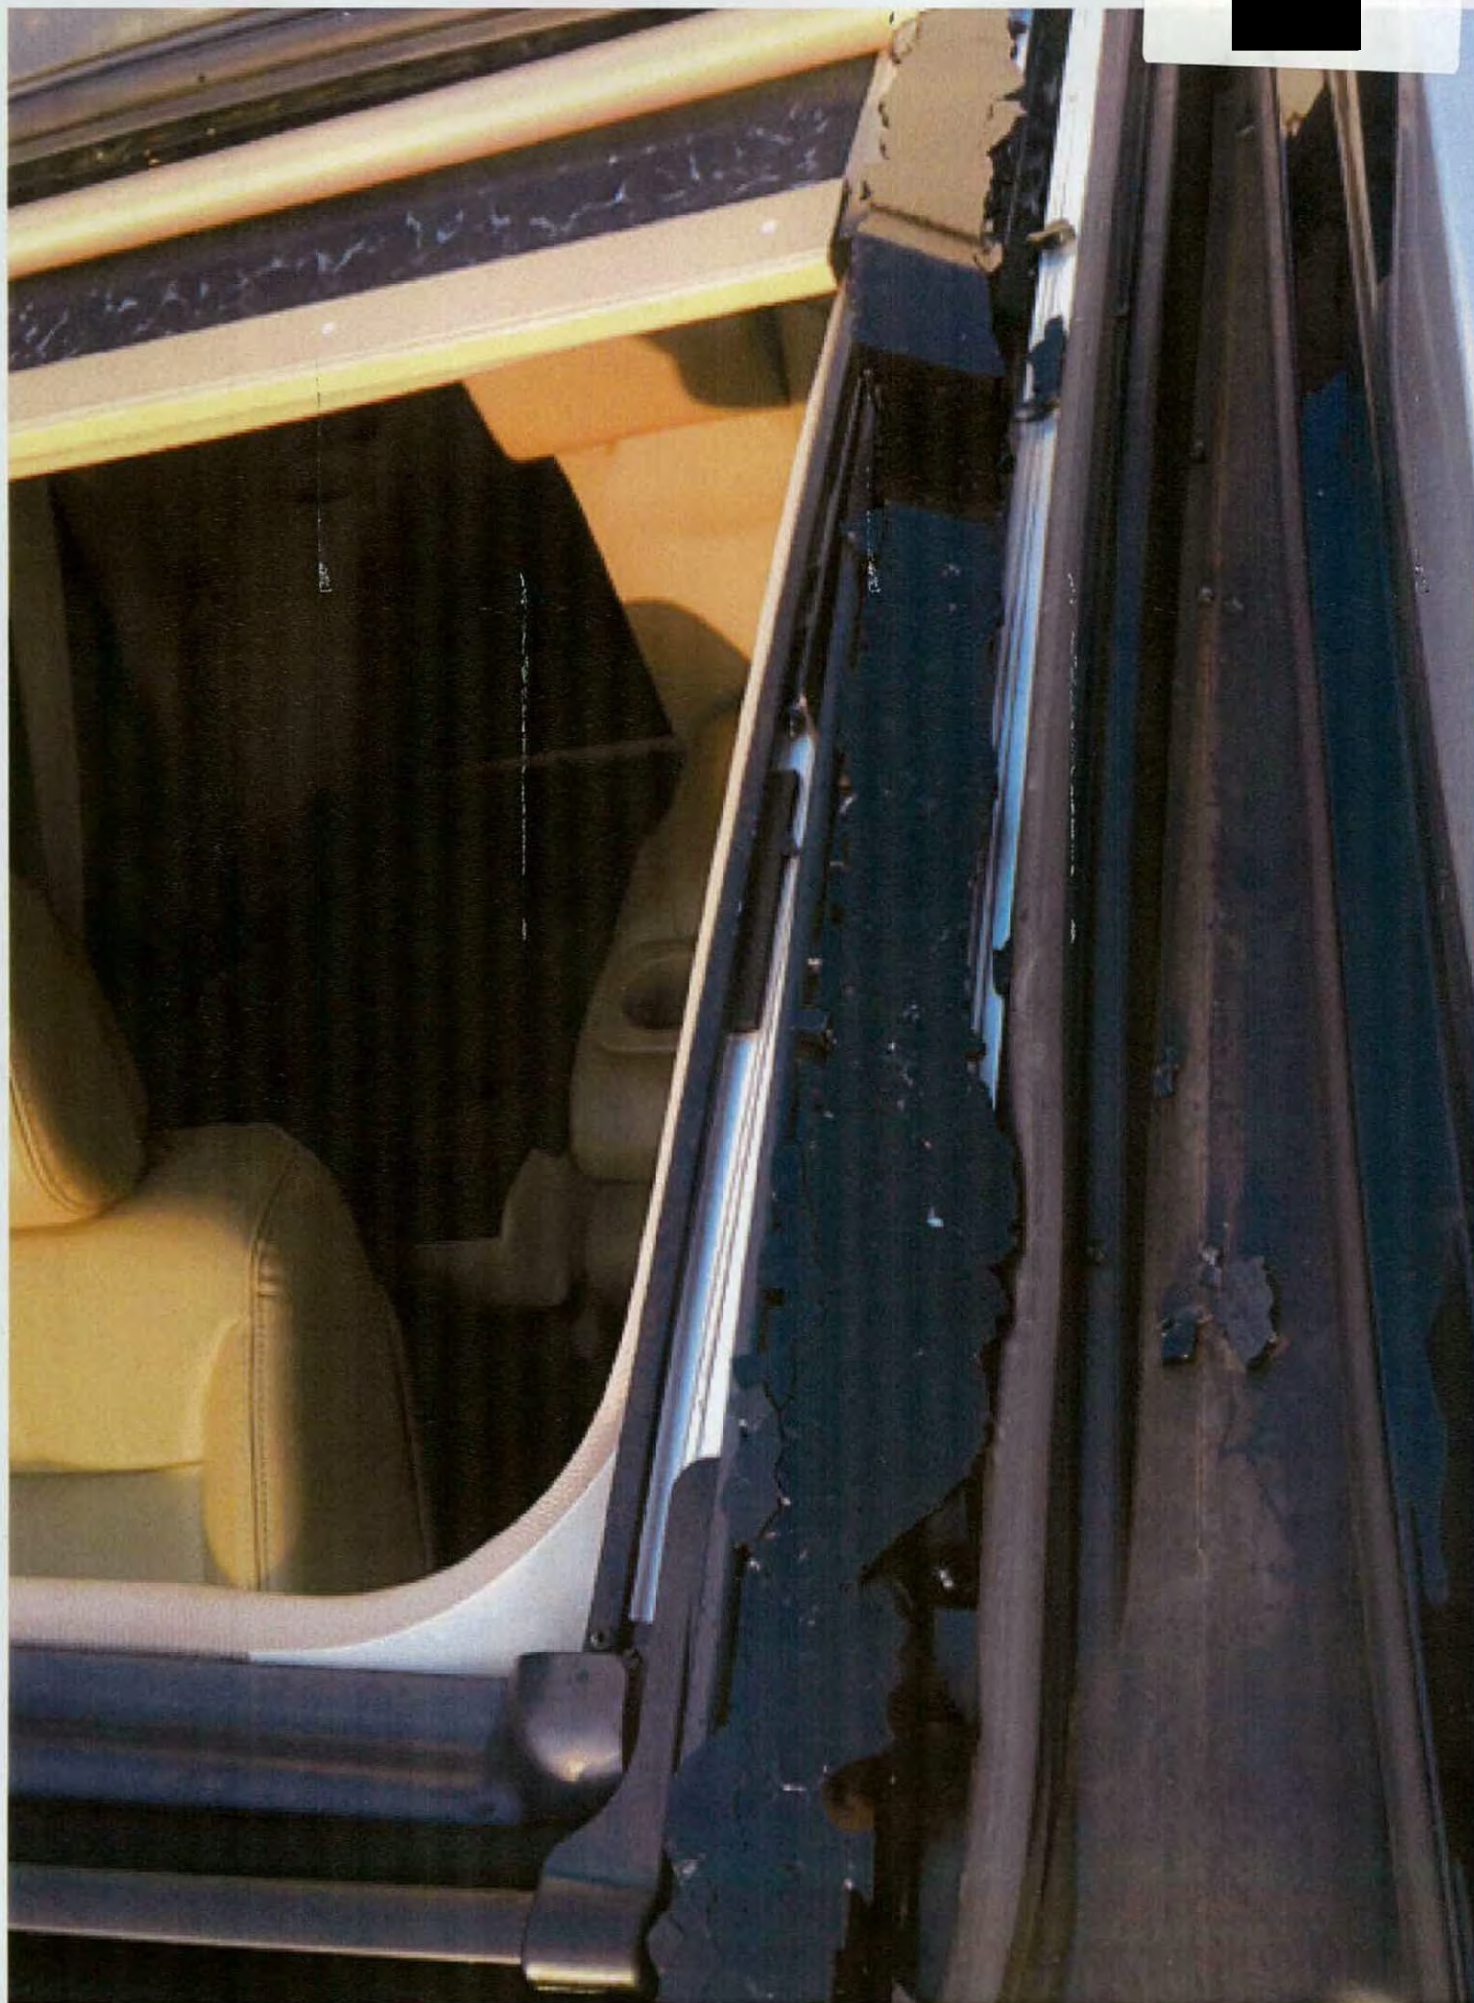
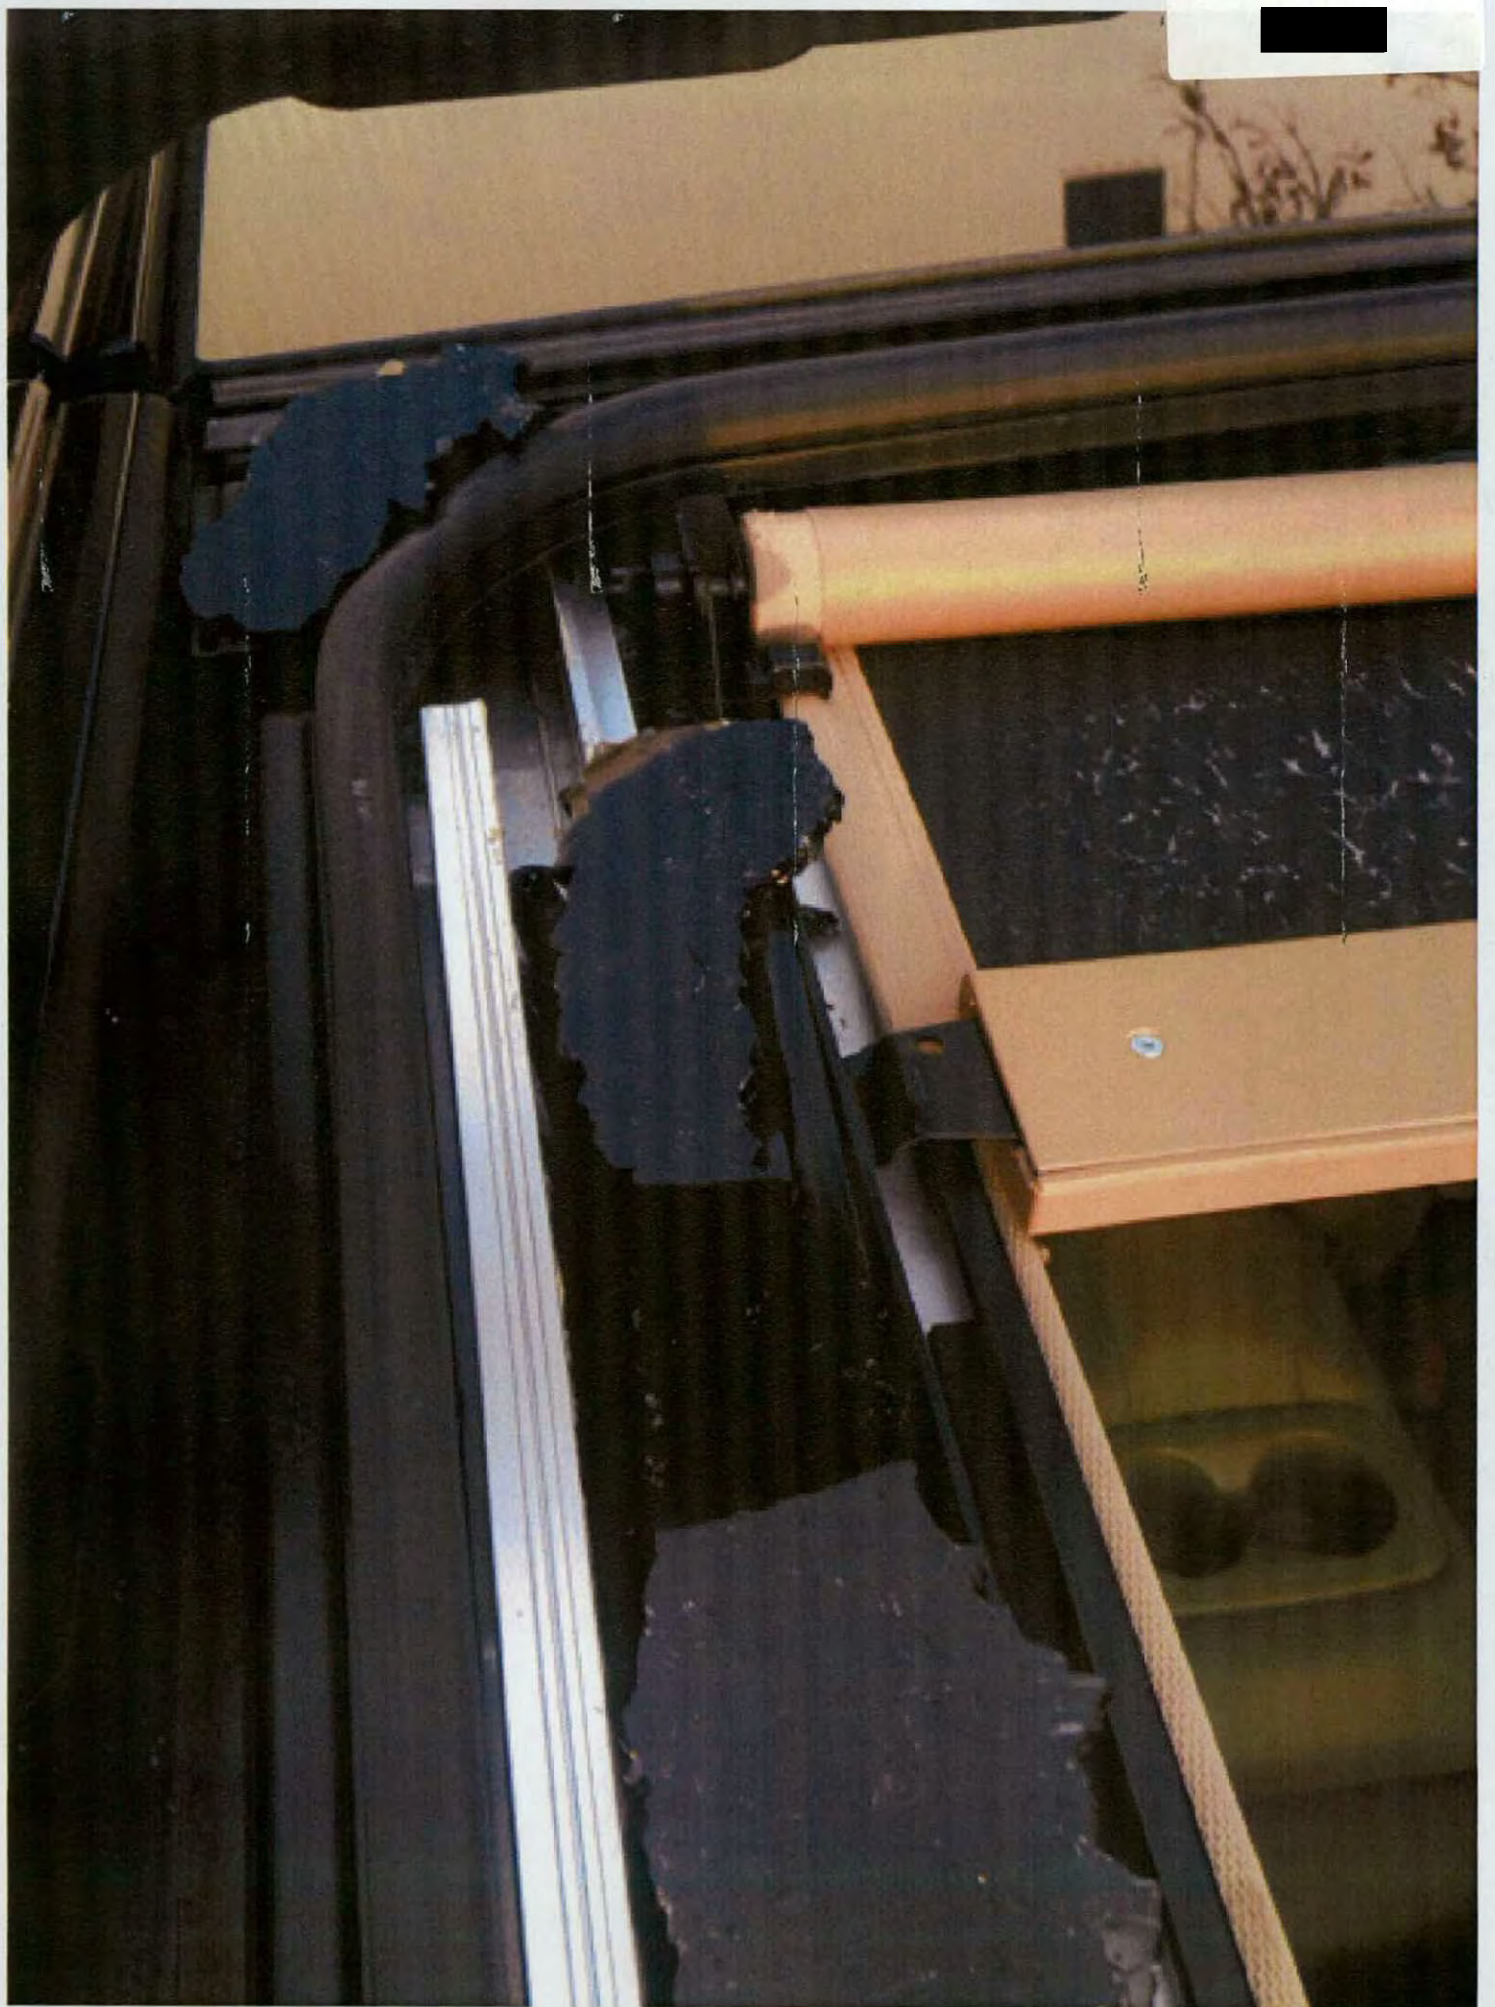
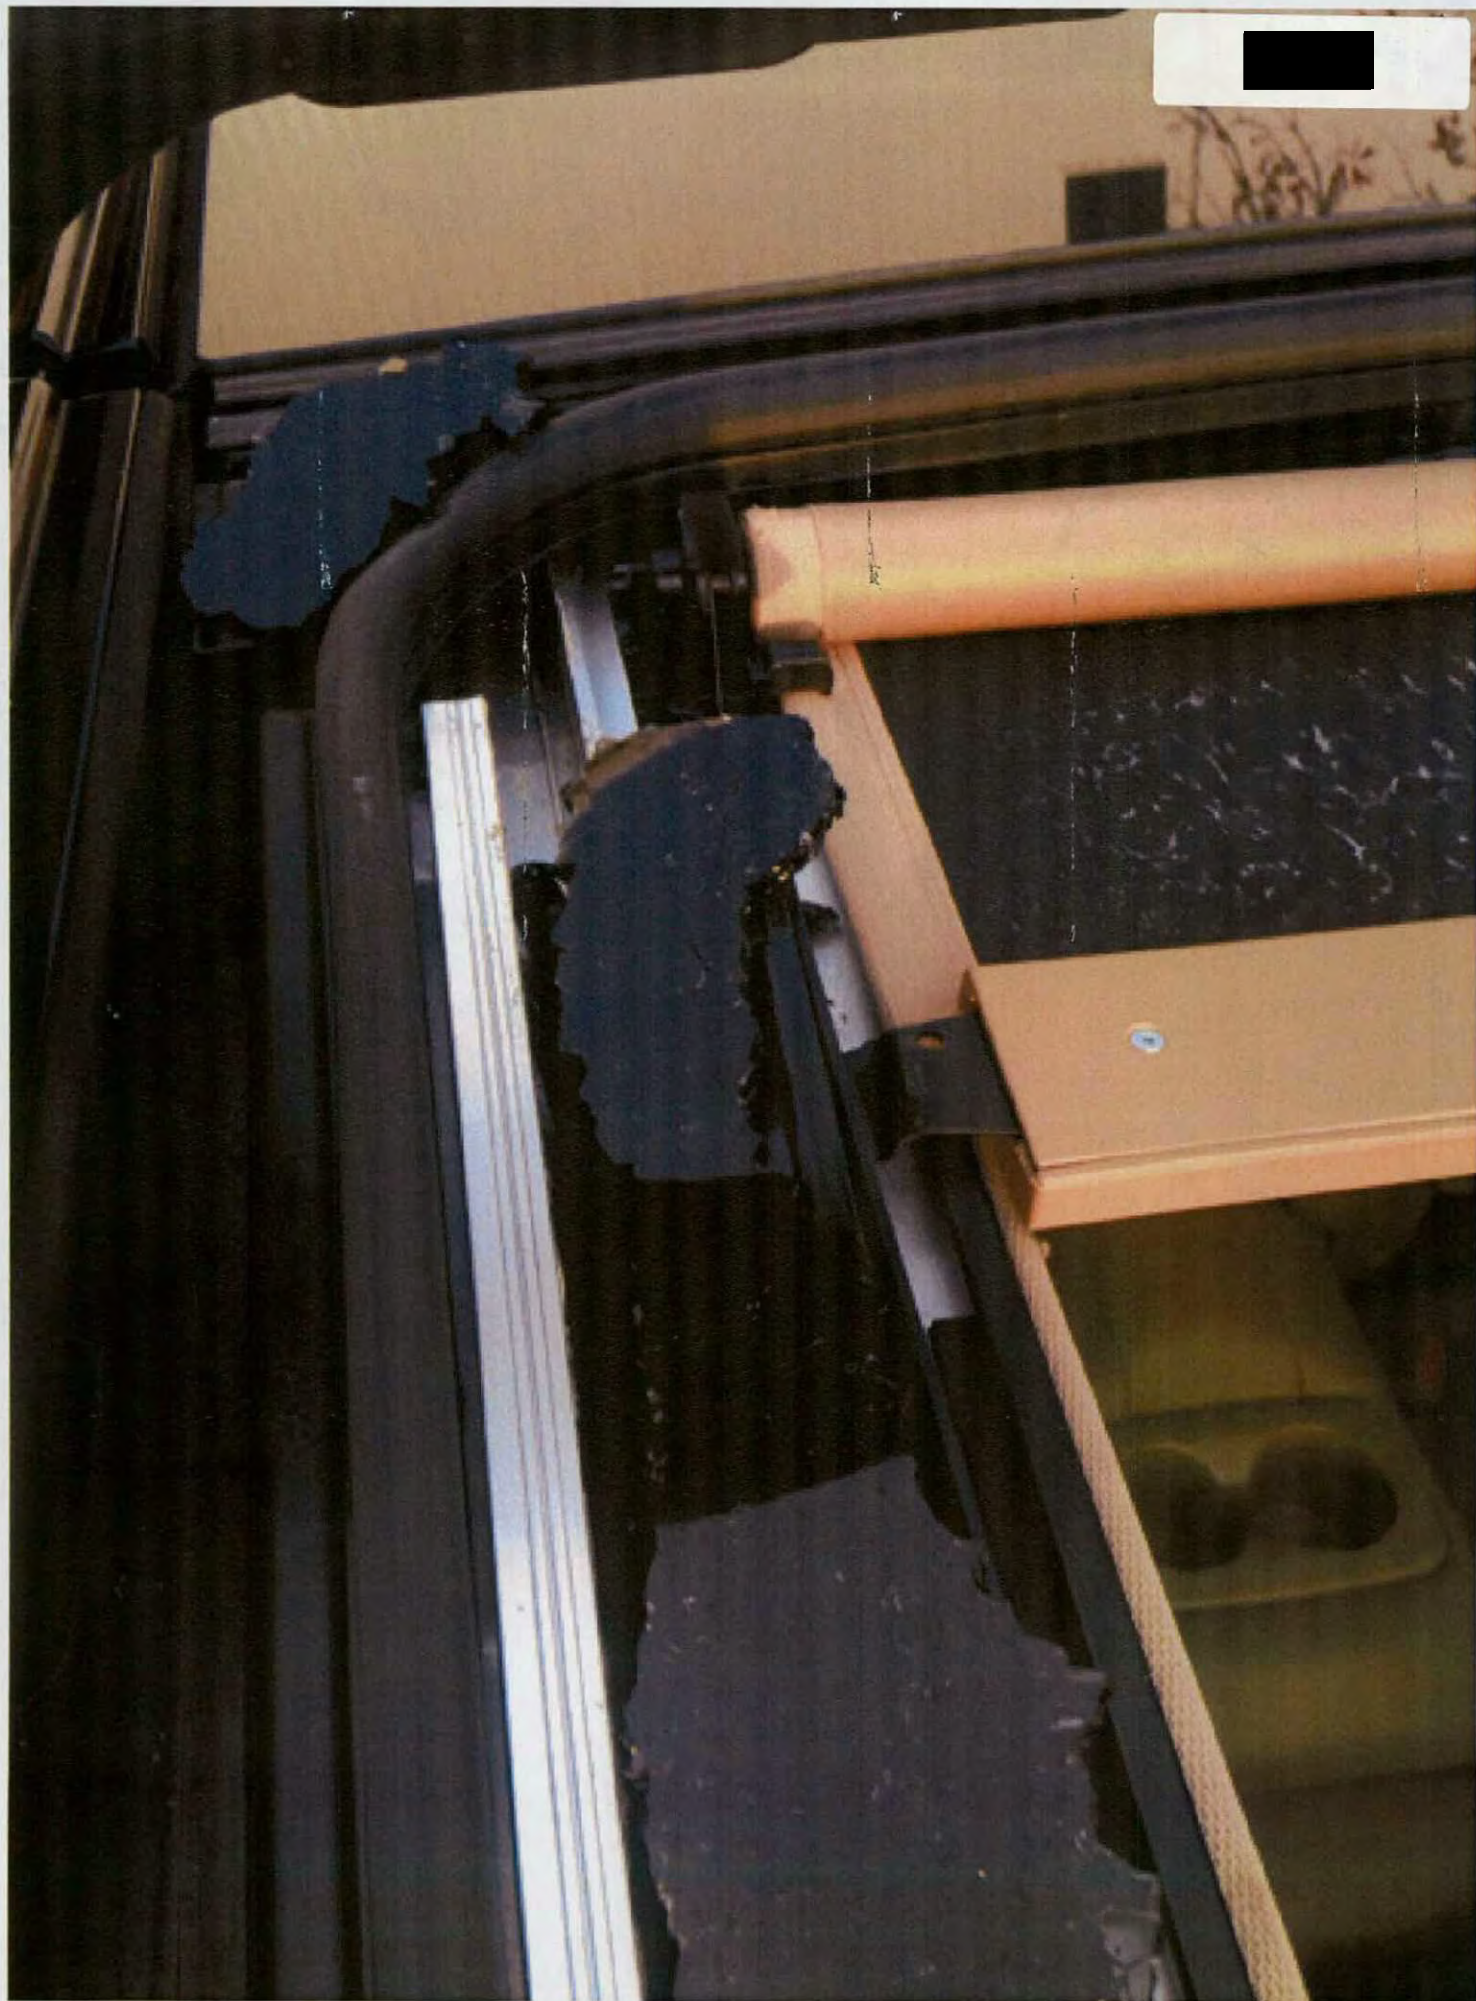
Sunroof glass shattered

Investigation was done by DPSM Found sunroof glass shattered

Unknown

Replaced sunroof panel assy
