Kia Motors America Field Product Quality Report

Report No.: CE2014FJ00081

Subject/Title: Panoramic Roof Investigation

Model Desc: SORENTO SX AWD

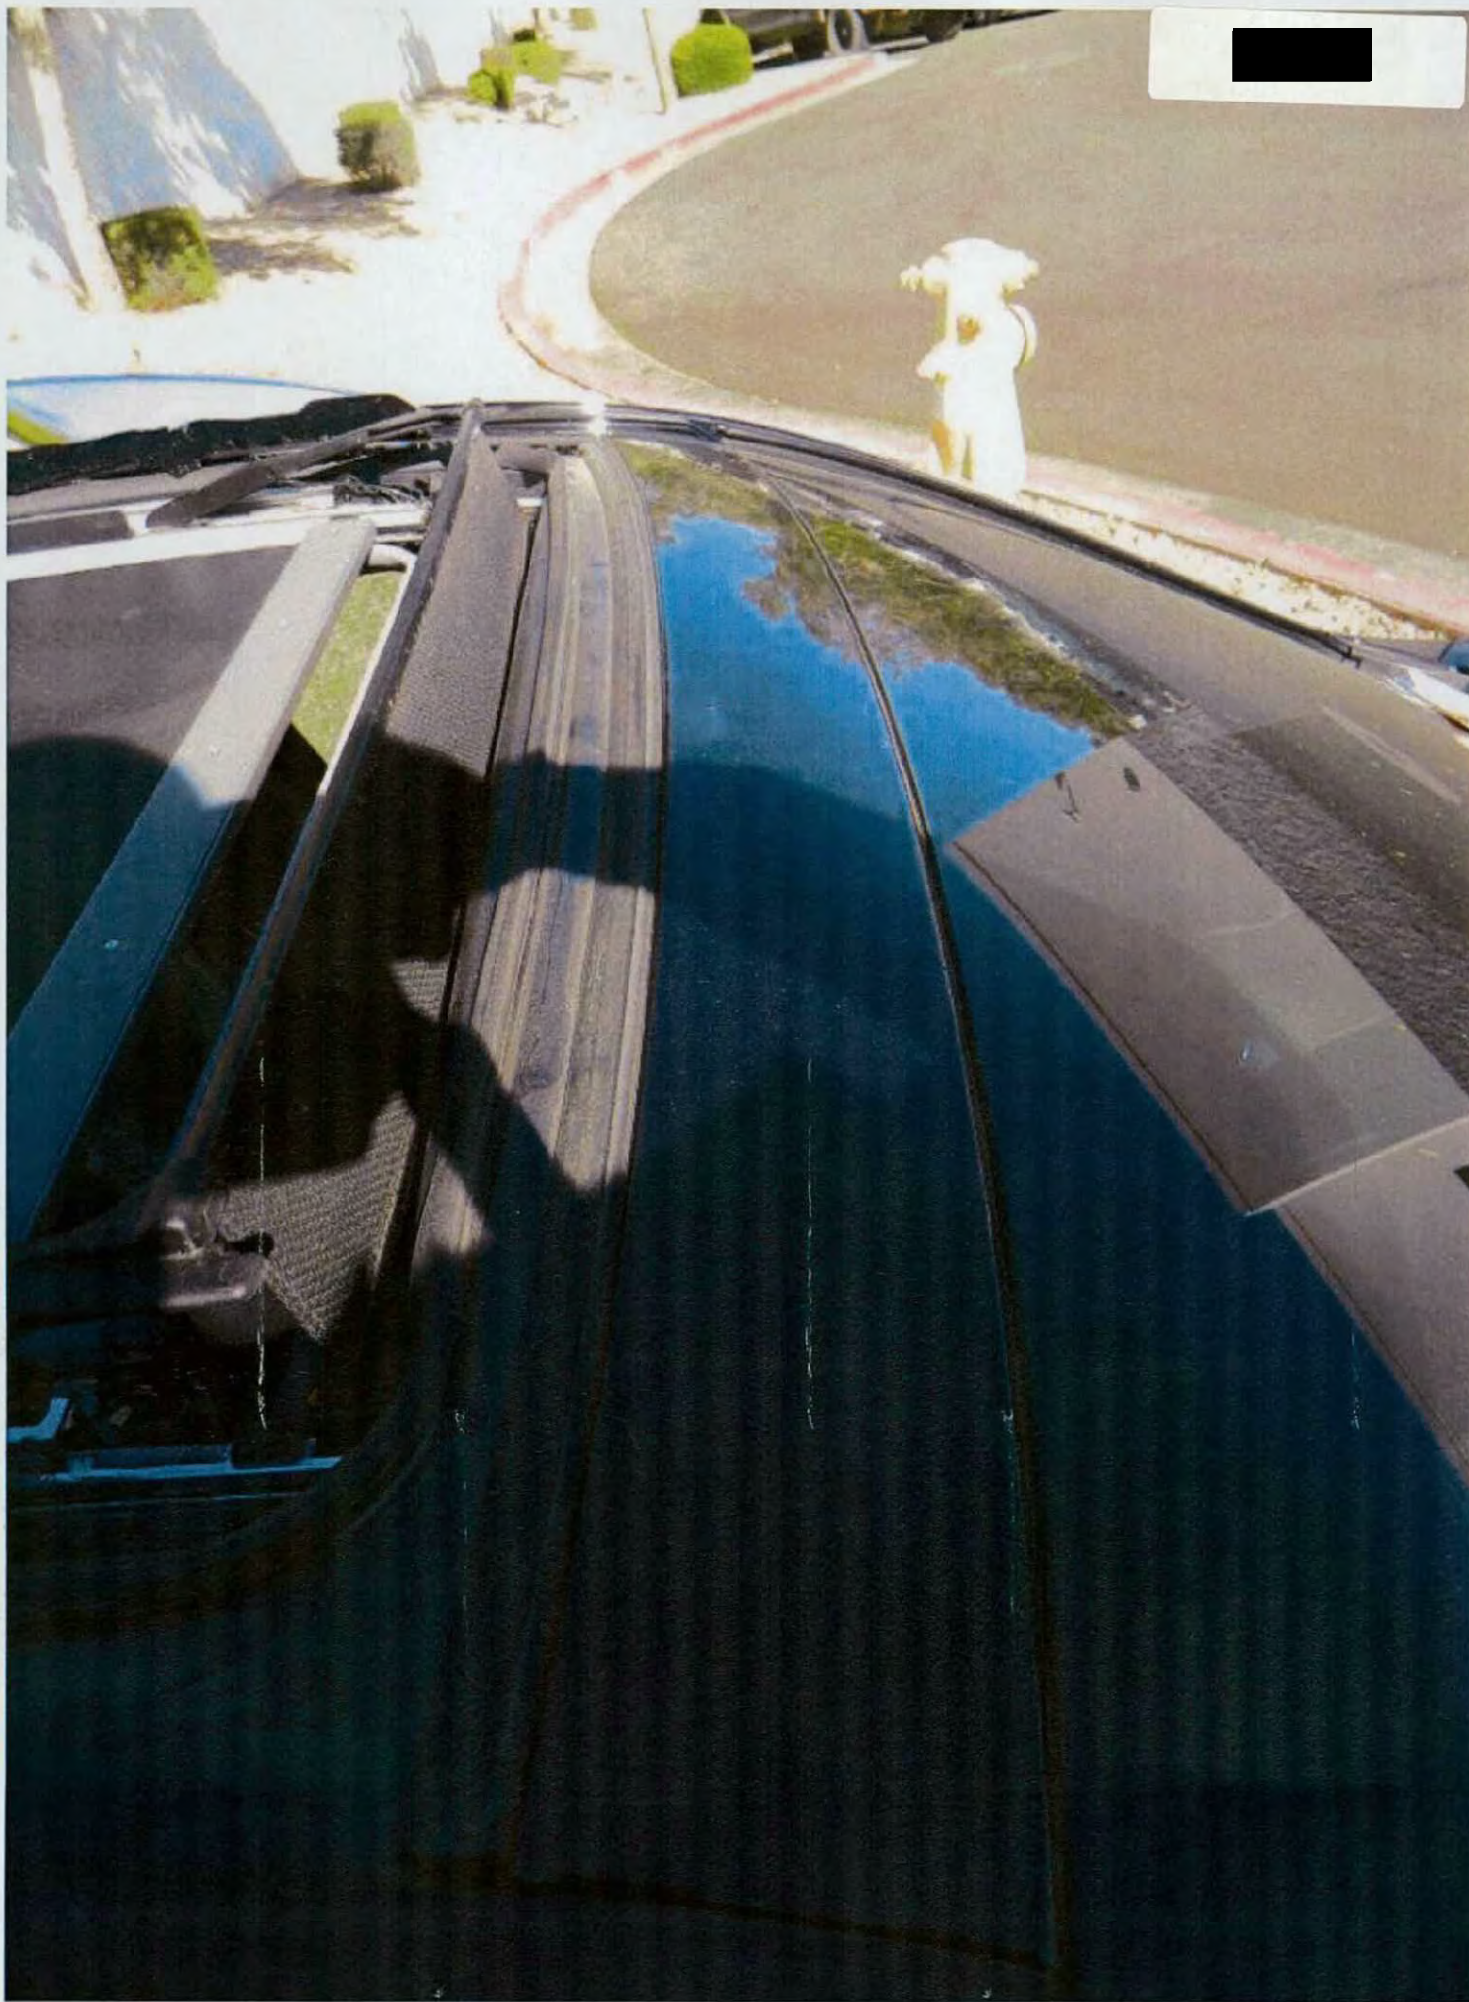
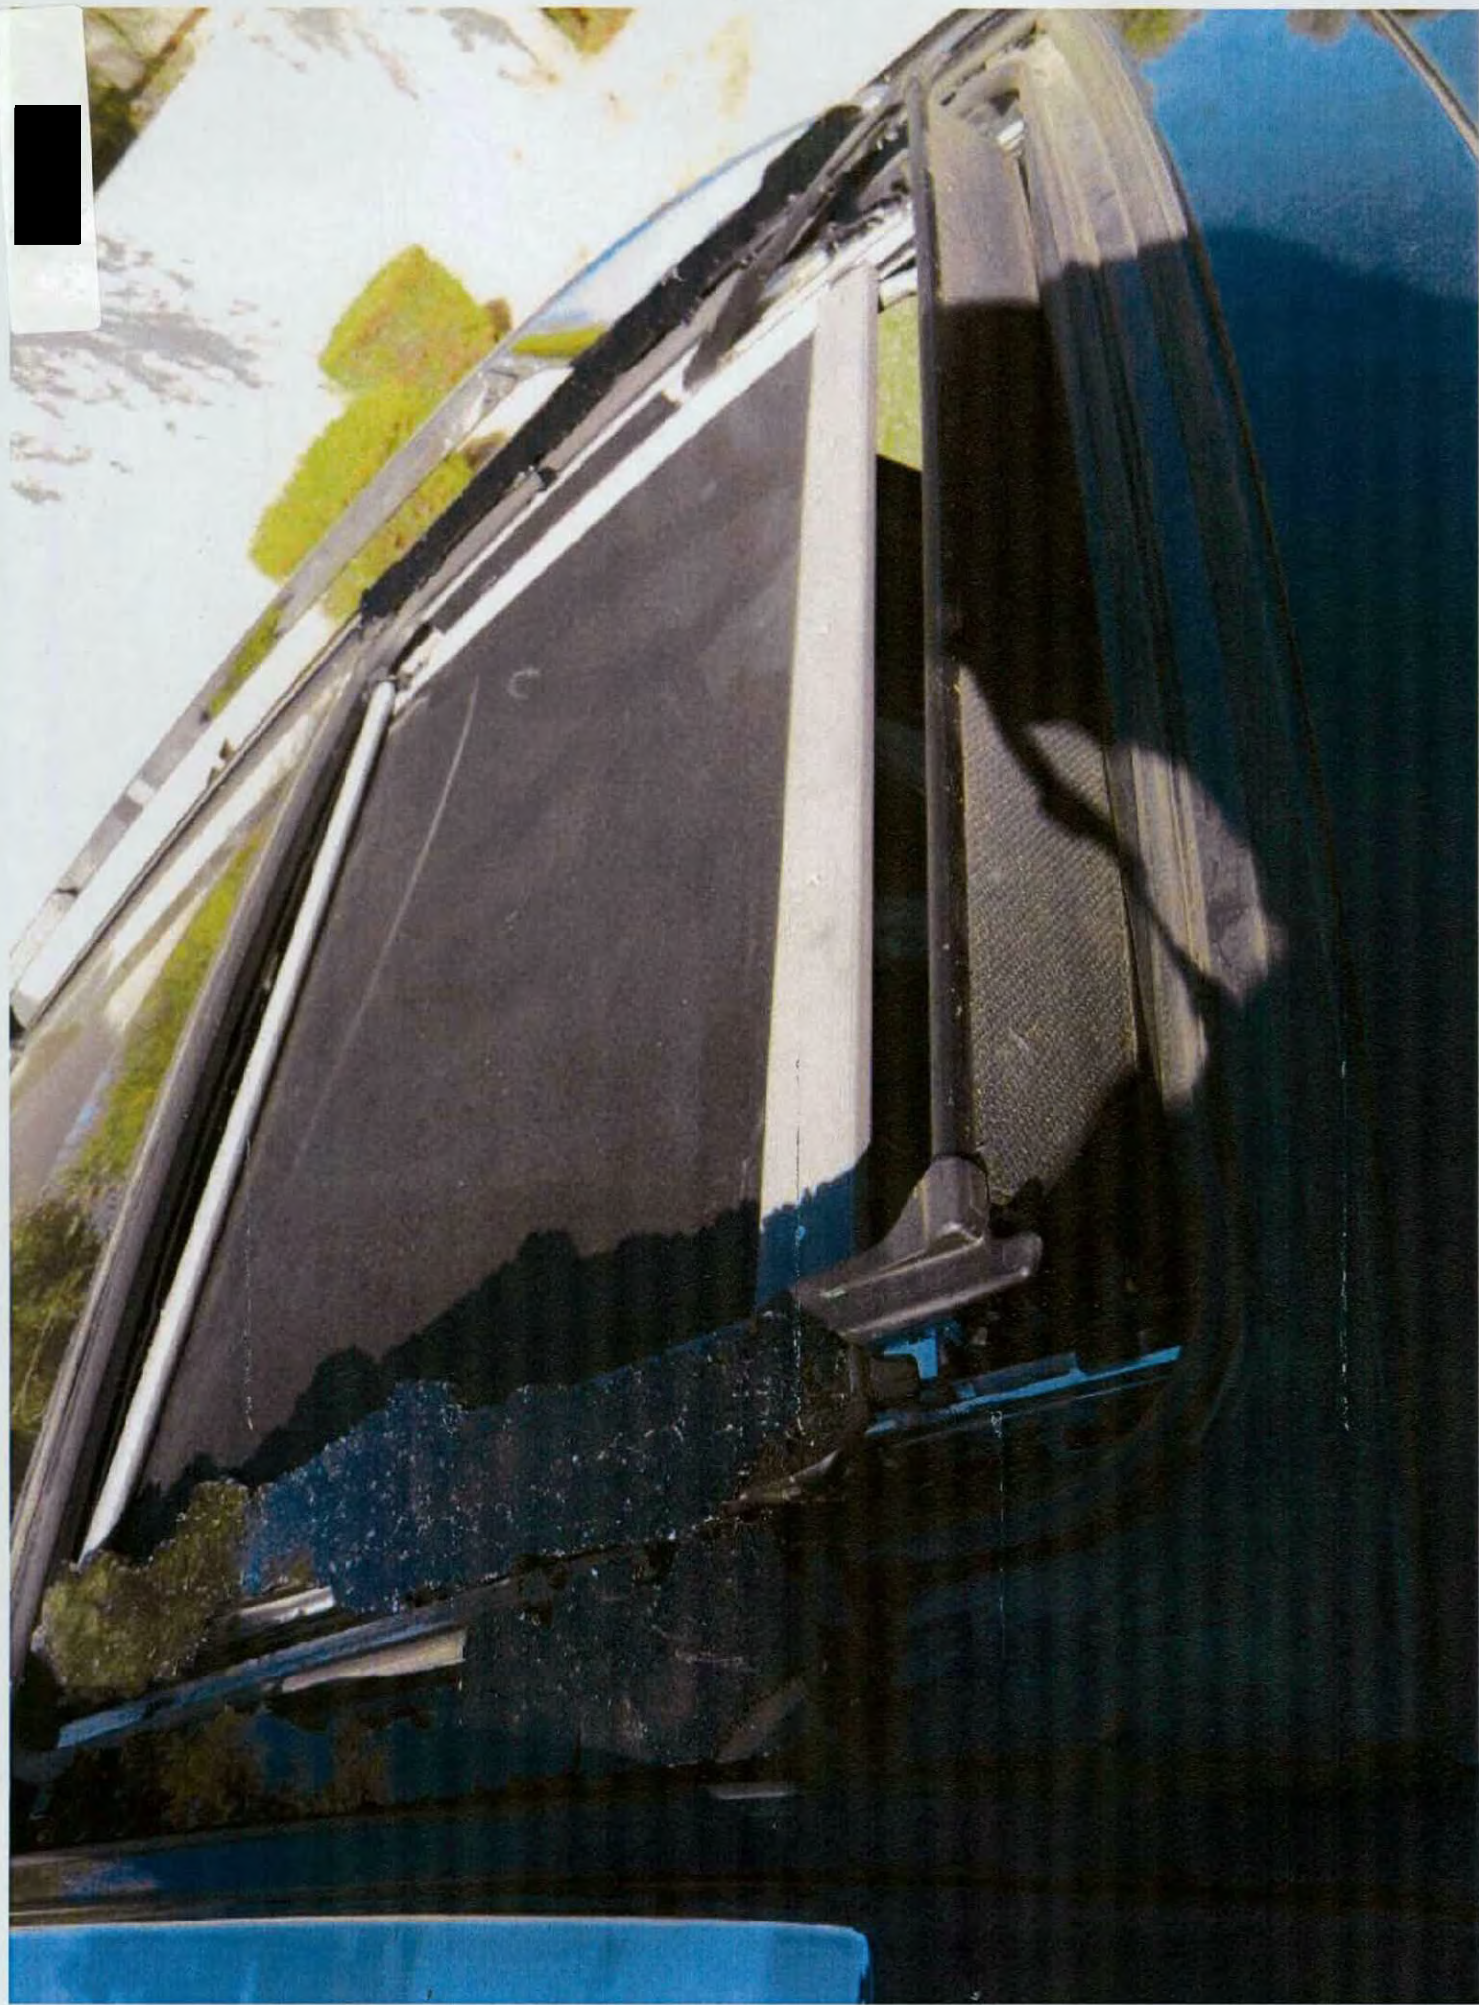
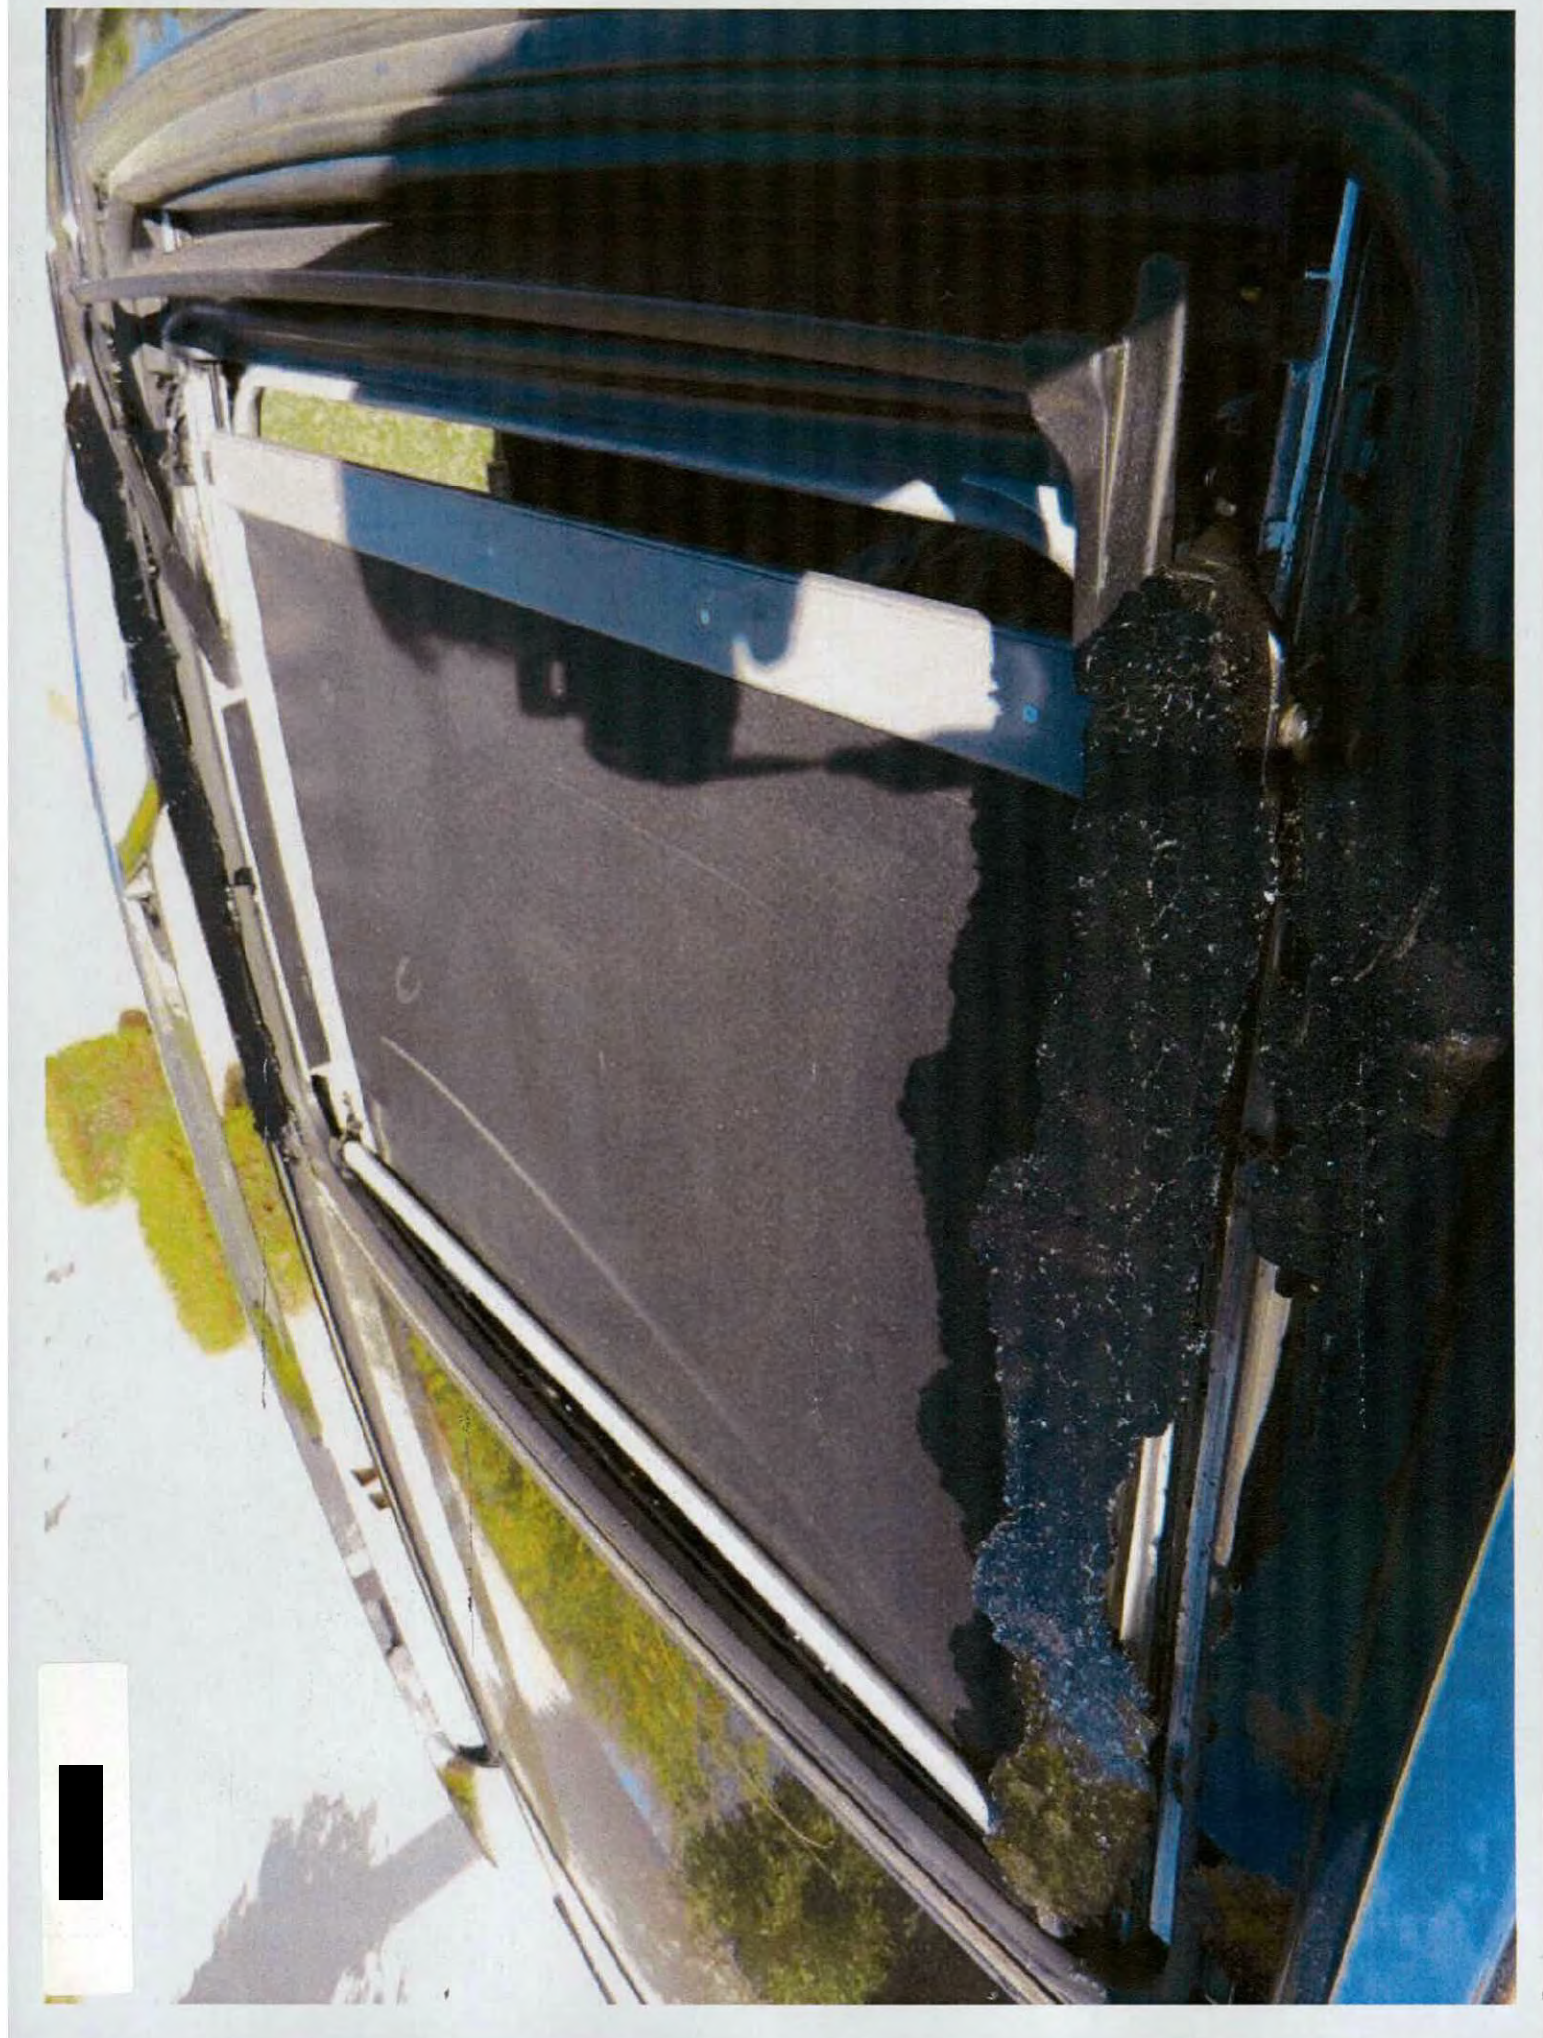
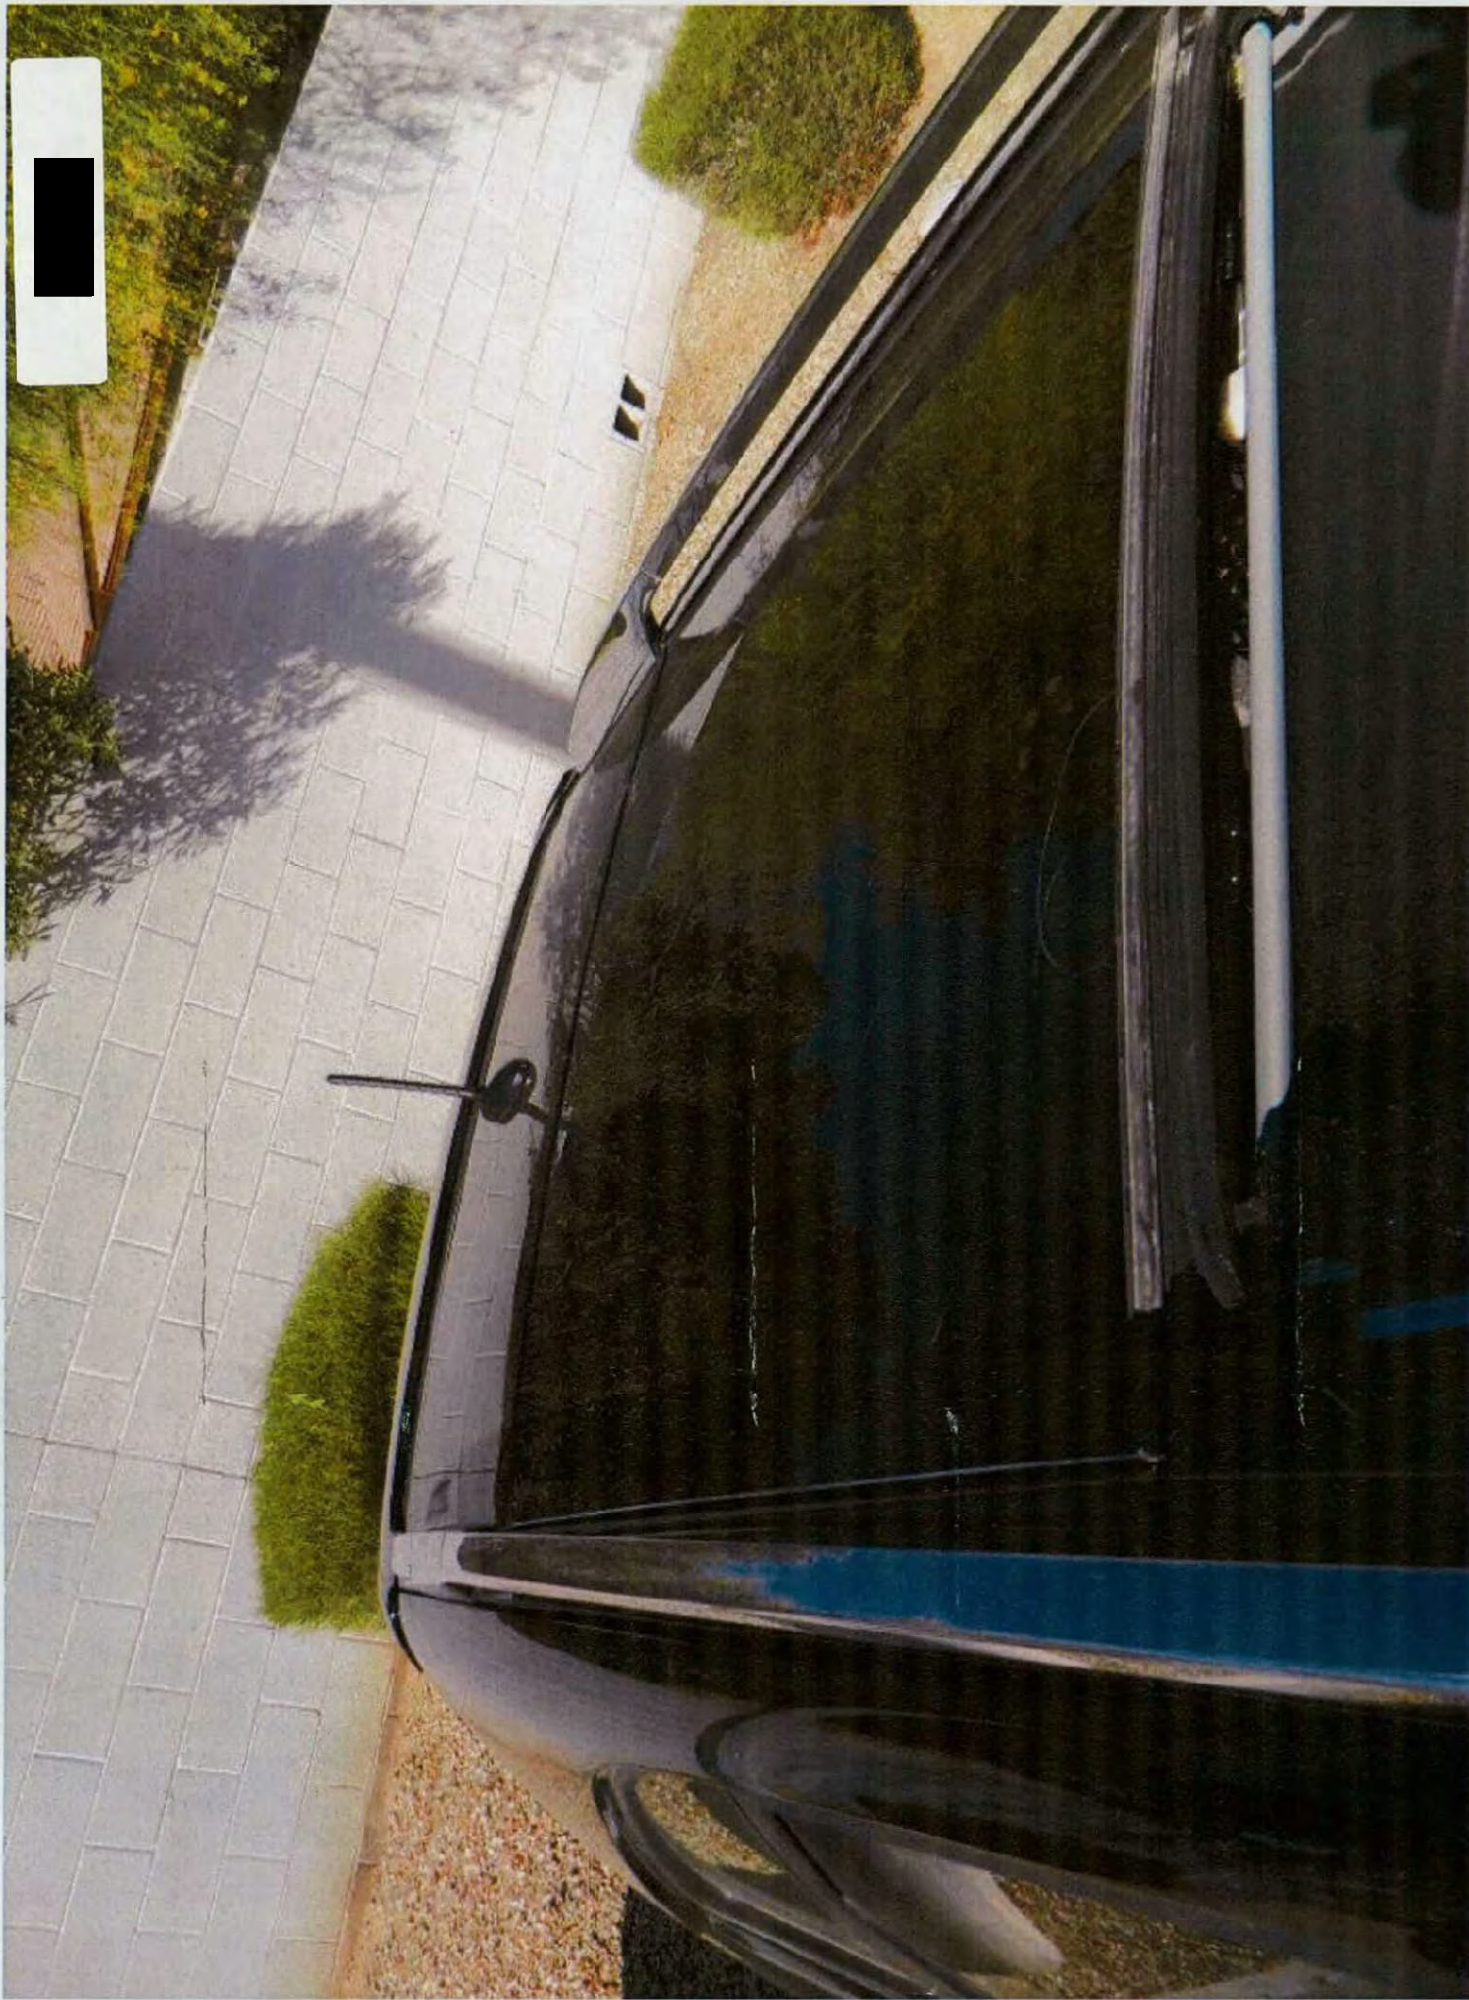
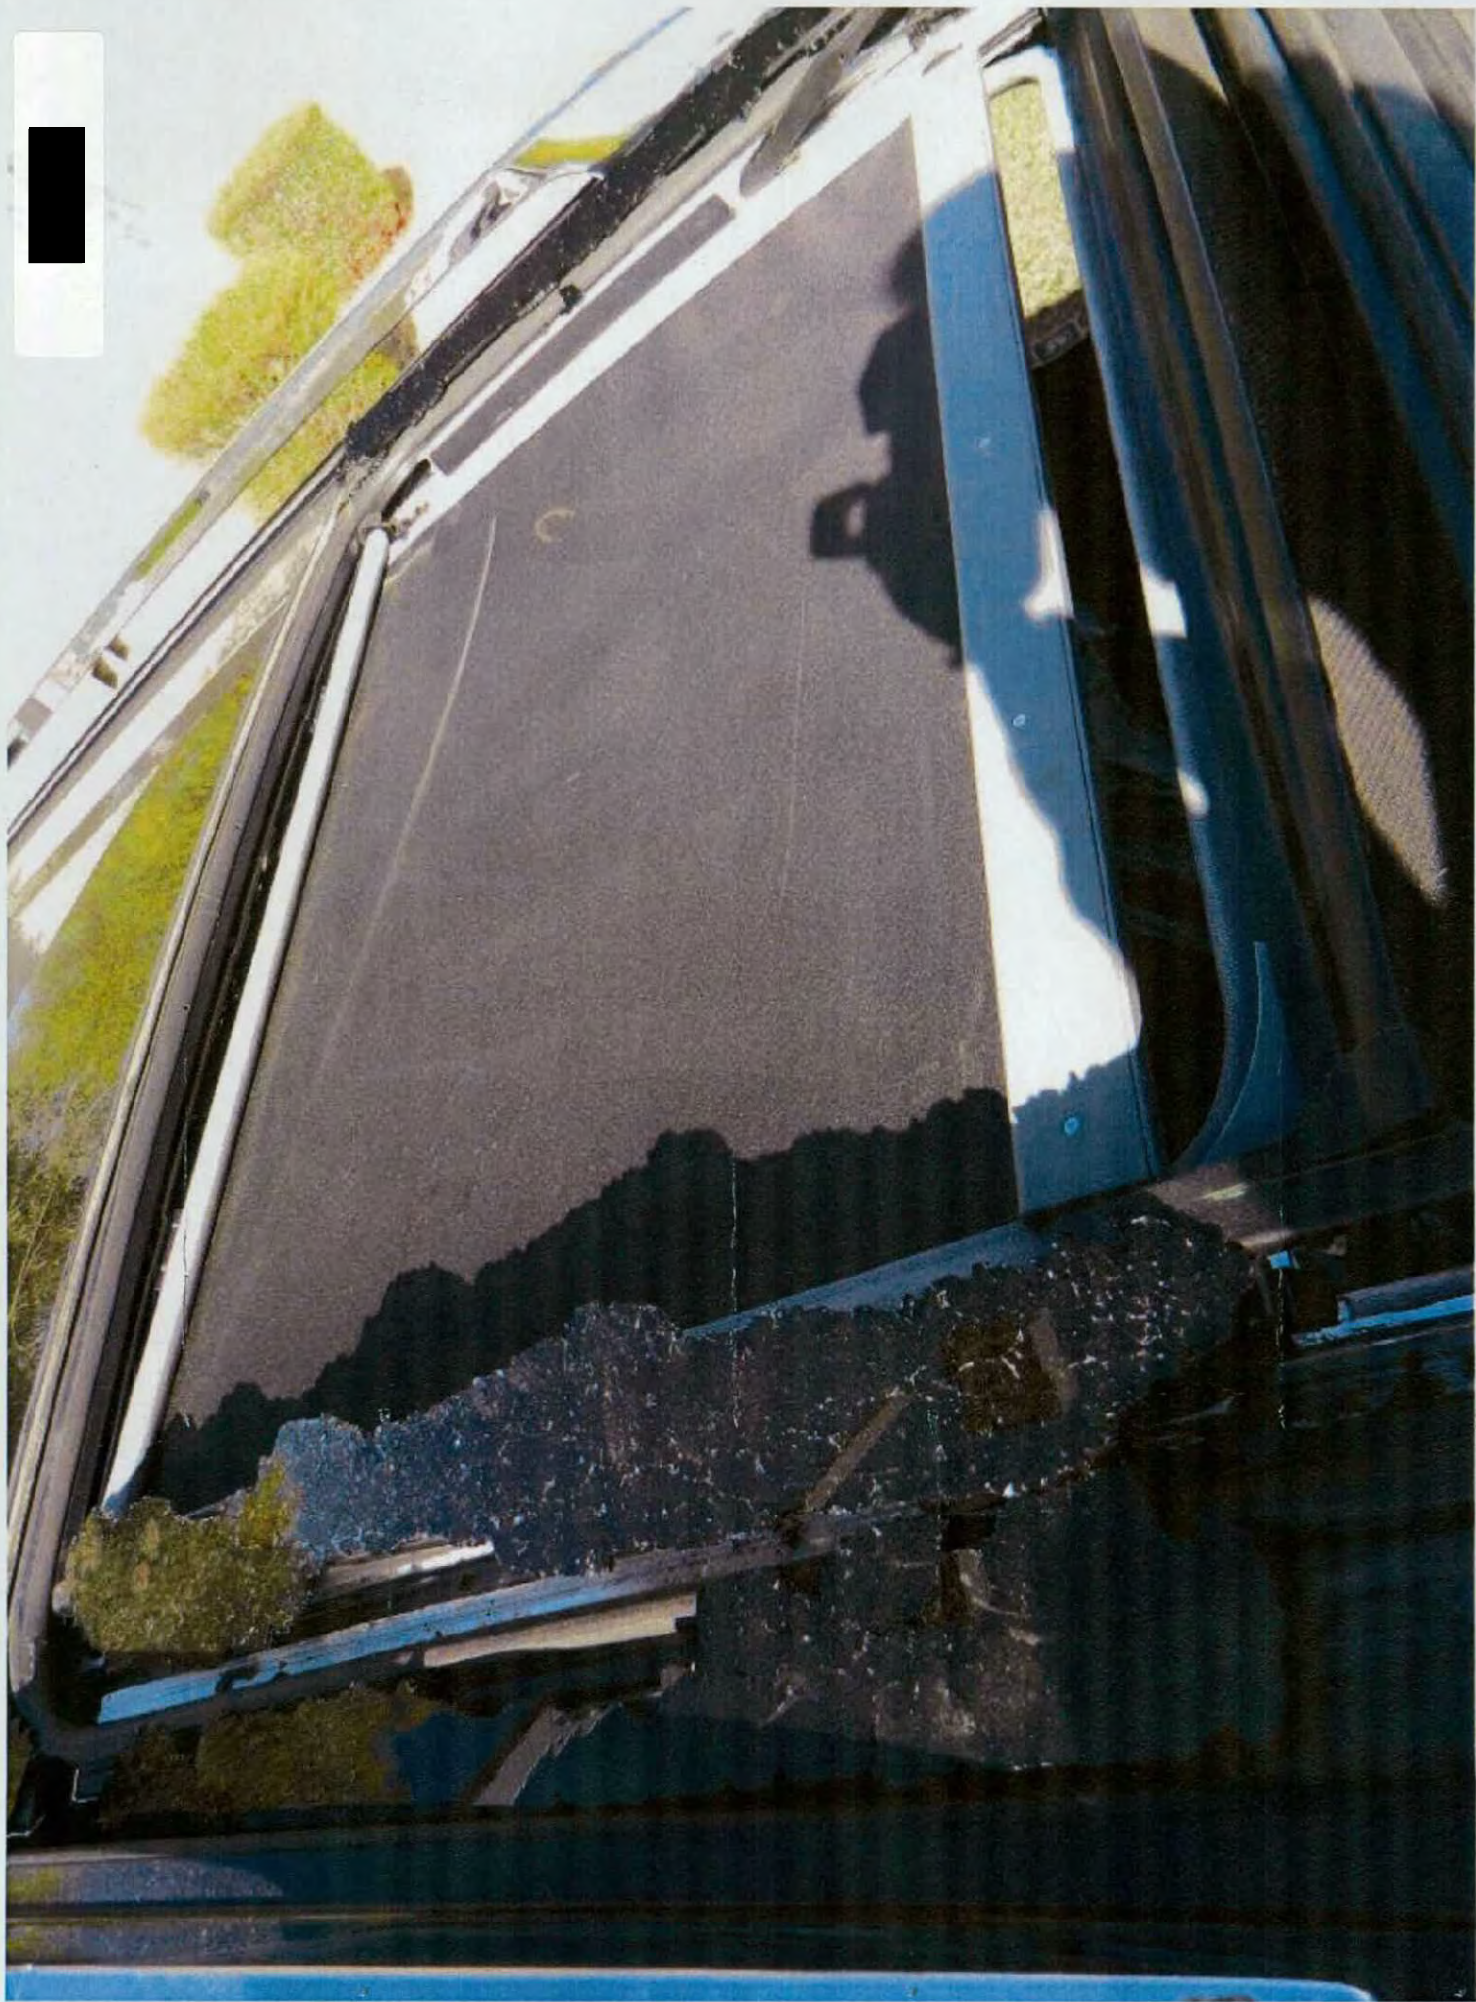
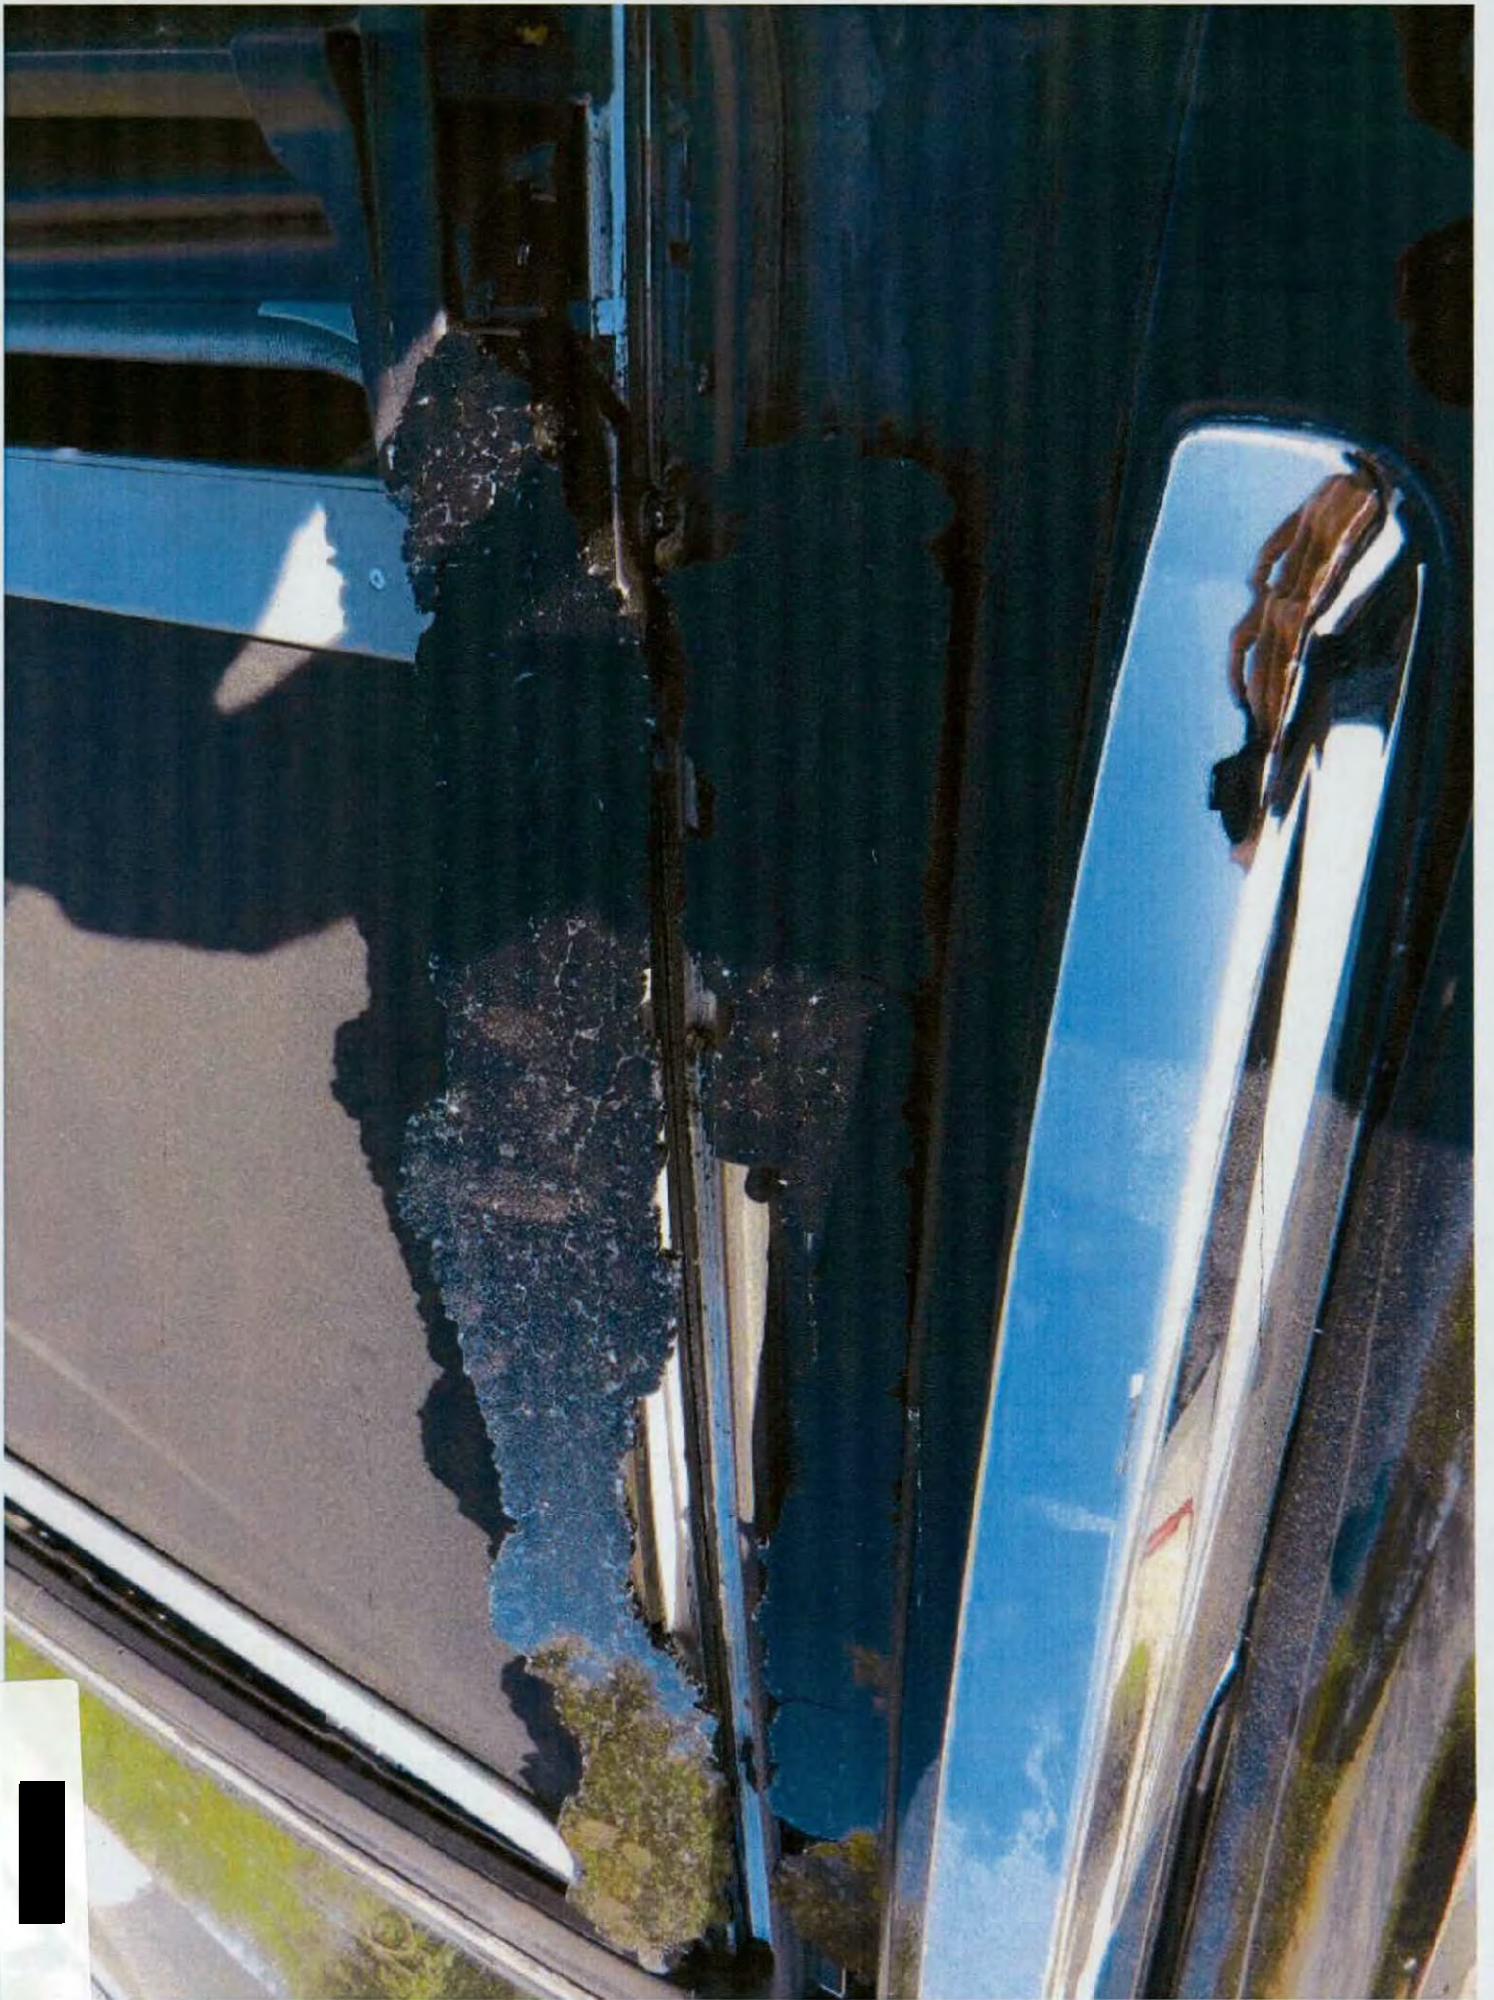
Panoramic roof glass shattered.

FTR inspected vehicle on 4/02/2014. Verified rear panoramic roof glass was shattered. Panel was approximately 80% intact on vehicle although entire glass panel was shattered. Inspected sunroof glass extensively and found "chip" at leading front edge of rear glass panel.

There are no definitive signs of impact. Cause of sunroof fracture is unknown.

No action taken at this time. Results of inspection reported to RCAM and NCA.
