Kia Motors America Field Product Quality Report

Report No.: CE2014FJ00181

Subject/Title: Panoramic Roof

Model Desc: SORENTO SX

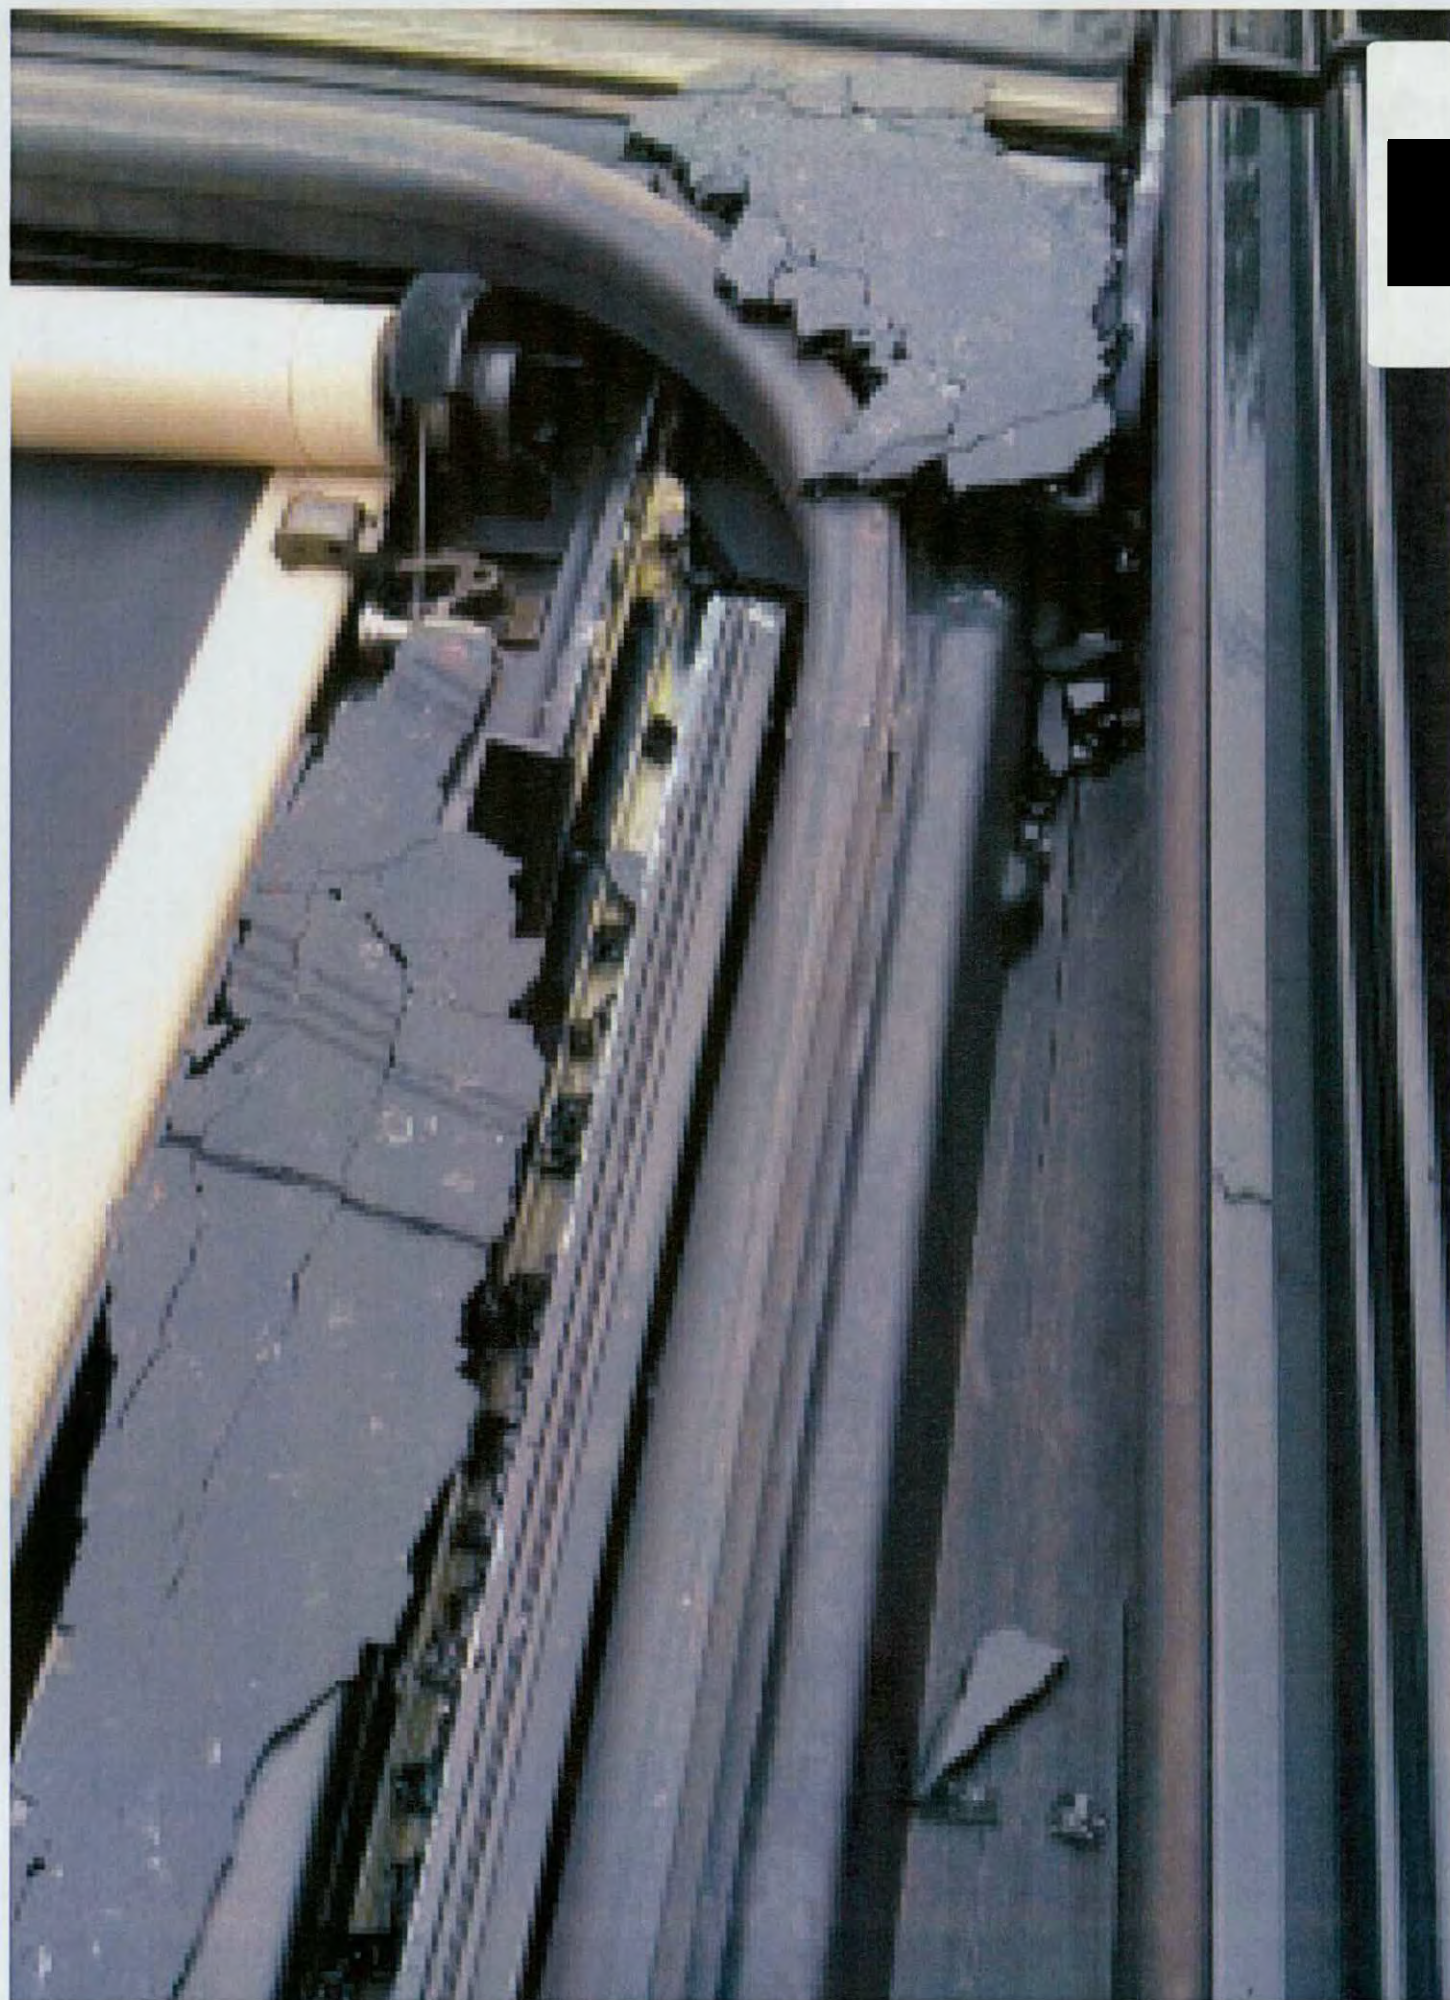
Panoramic roof glass shattered.

FTR inspected vehicle on 8/18/2014. Verified panoramic roof glass was shattered. Panel was approximately 10% intact on vehicle although entire glass panel was shattered. Inspected sunroof glass extensively and found "chip" at front edge of glass panel.

There are no definitive signs of impact. Cause of sunroof fracture is unknown.

No action taken at this time. Results of inspection reported to RCAM and NCA.

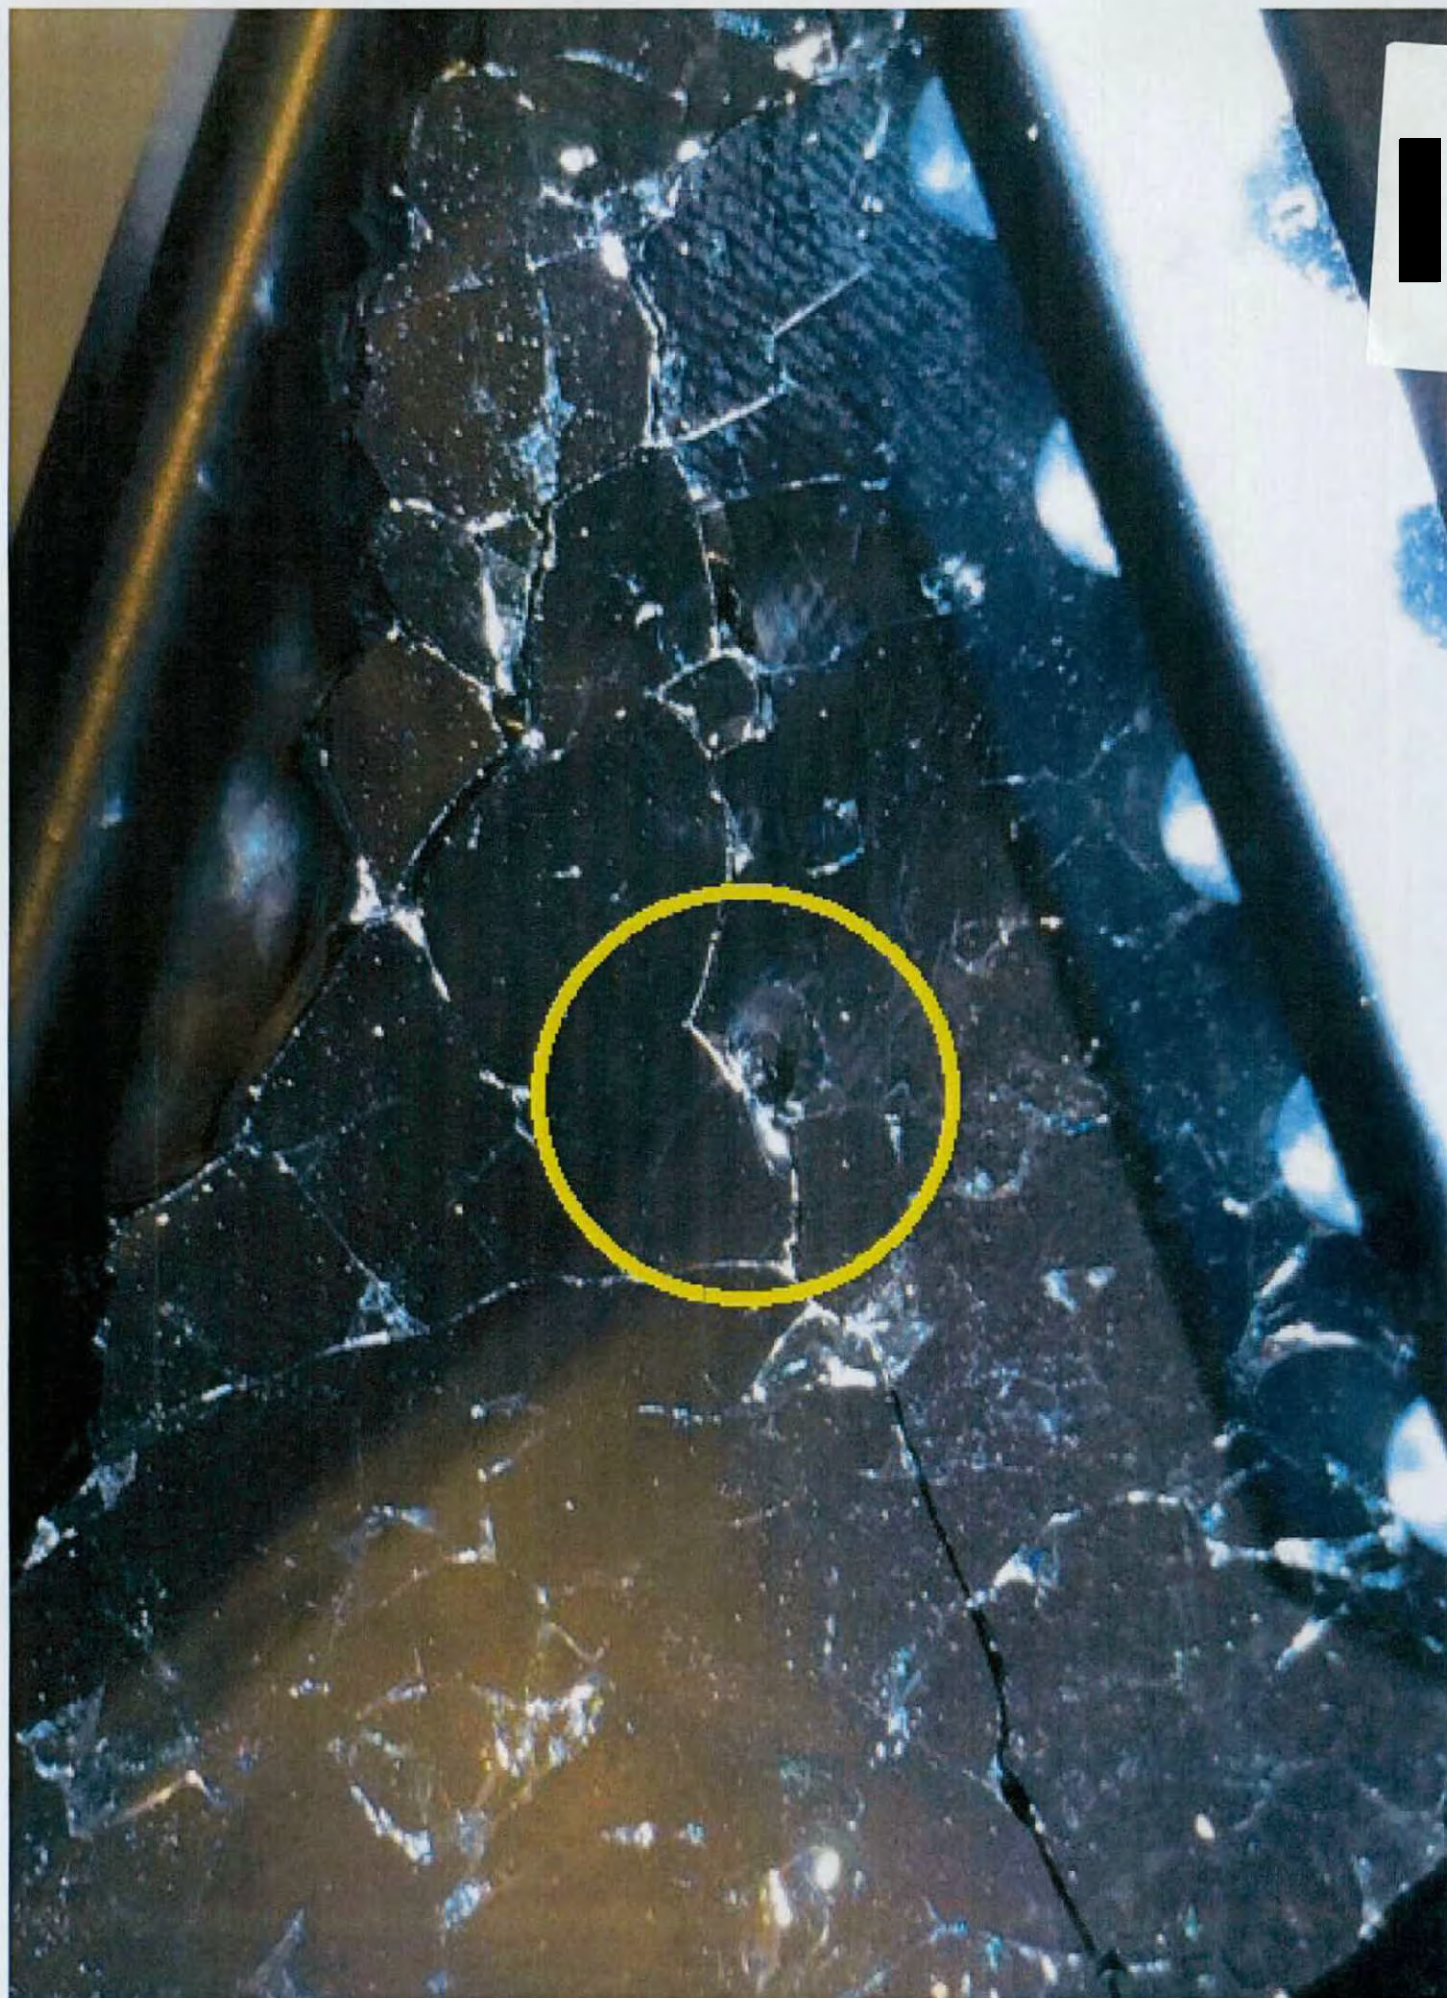
Sunroof shattered while closing rear hatch

All glass gone with the exception of the side rails

Unknown

Replace pano roof assy
