Kia Motors America Field Product Quality Report

Report No.: CE2014GB00174

Subject/Title: Sunroof Investigation

Model Desc: SORENTO EX

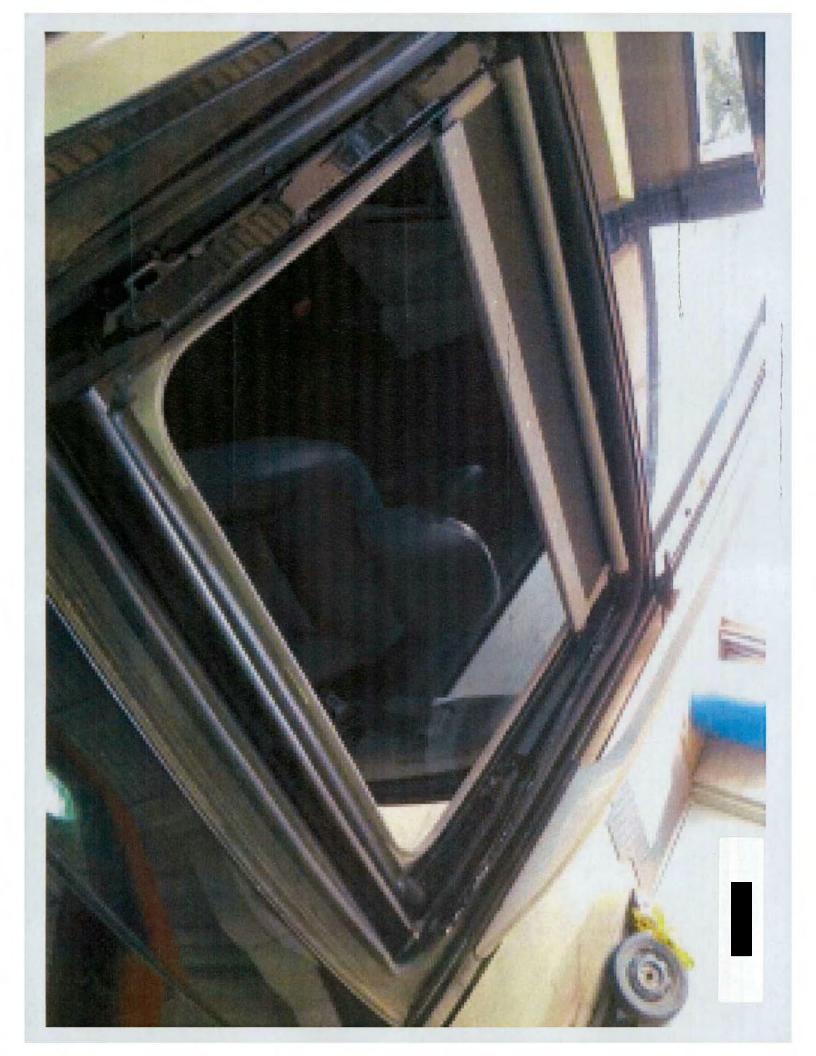
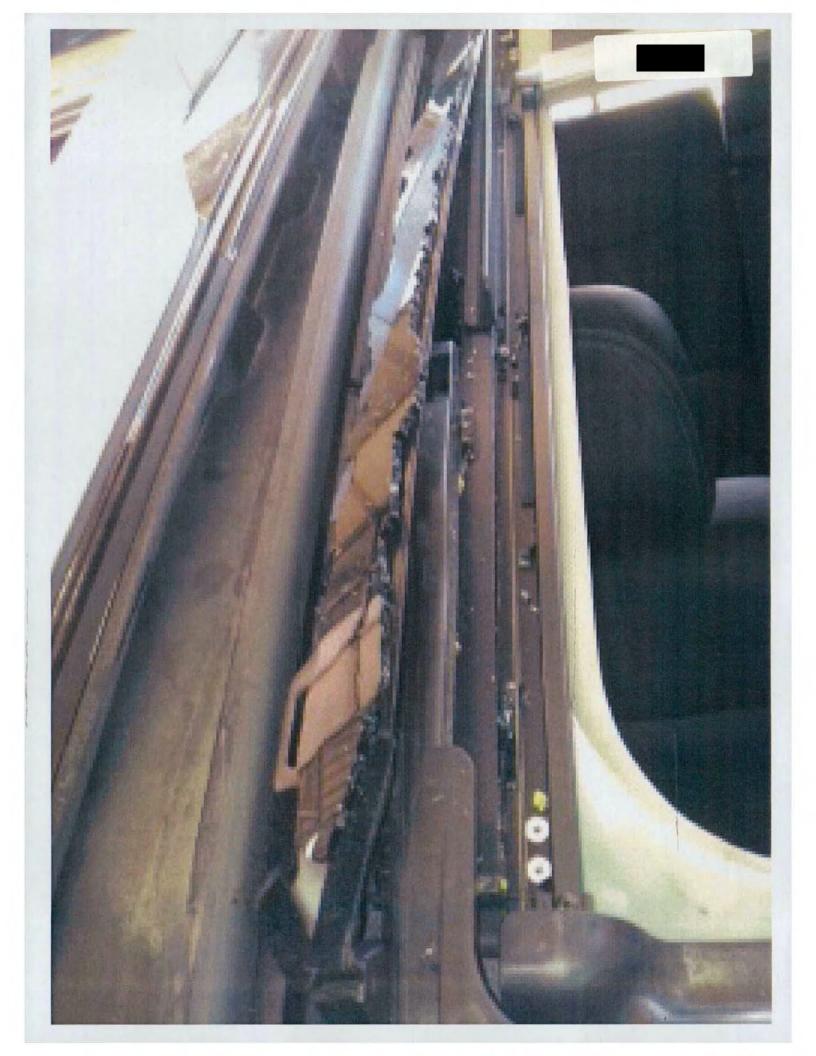
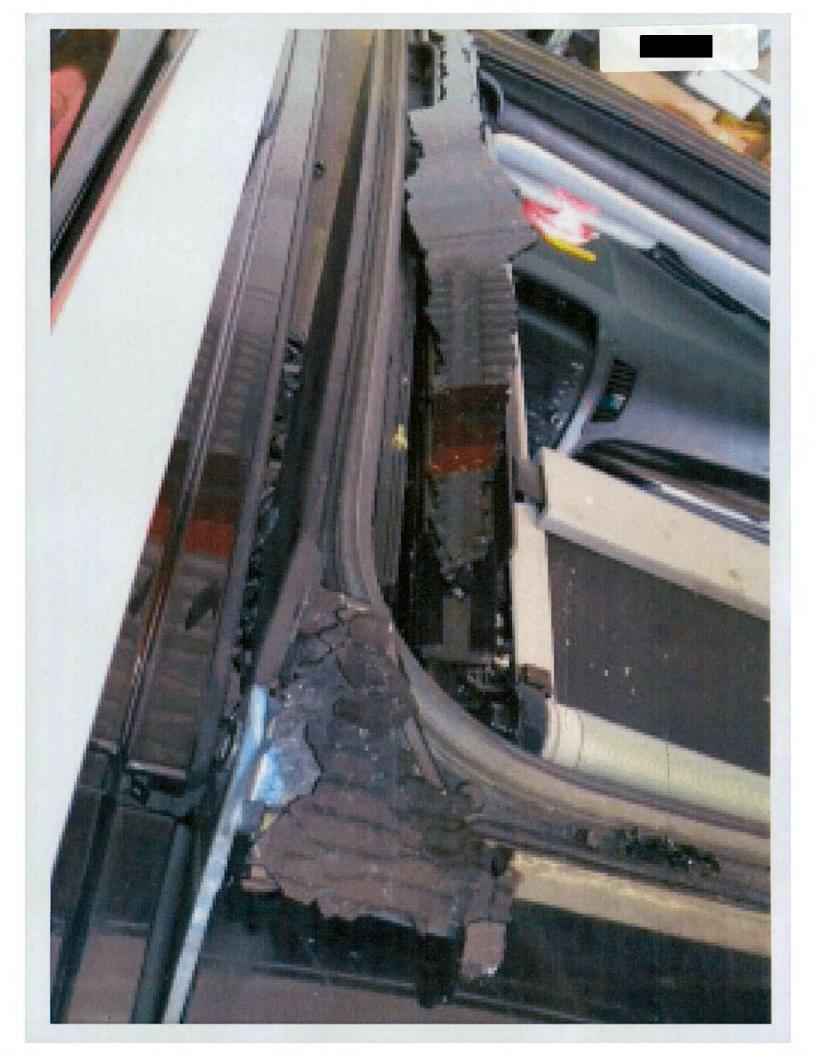
Sunroof Glass was Shattered.

FTR inspected vehicle on 8/5/2014. Verified sunroof glass was shattered. Glass was less than 10% intact on vehicle. Inspected sunroof exitesively but did not notice any projectiles or obvious evidence of impact damage to glass.

Undetermined.

No action taken at this time. Results of inspection reported to Platfom Engineer and NCA.							
RECOMMENDATIONS							
					7 142		
					1500		
					2.00		
				1	14.
