PE14-001

TOYOTA

Additional Consumer
Complaint Documents

FIELD TECHNICAL REPORT - INCIDENT INSPECTION

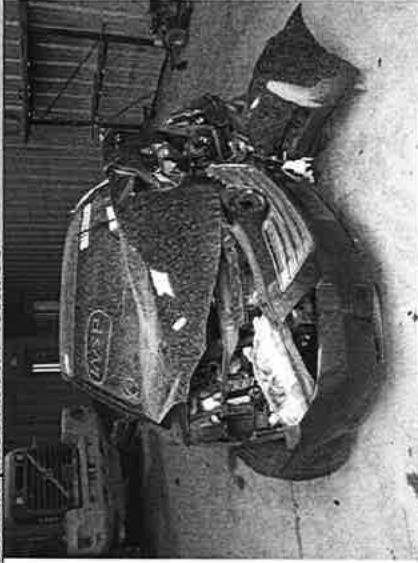
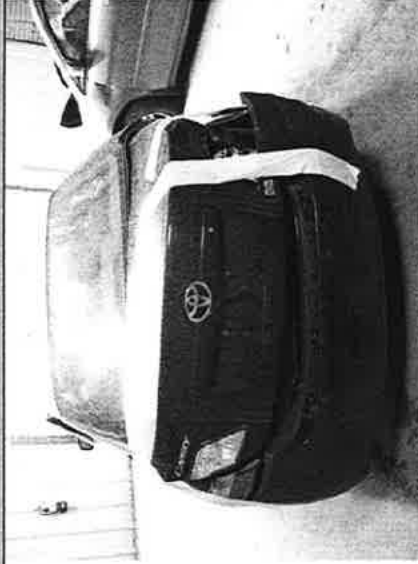
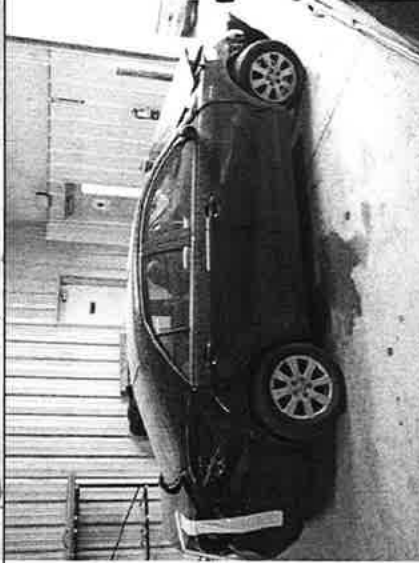
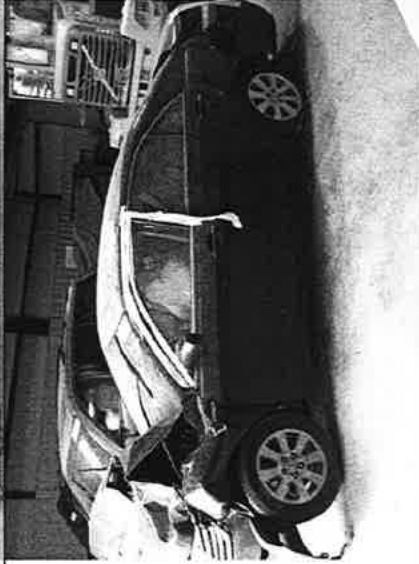
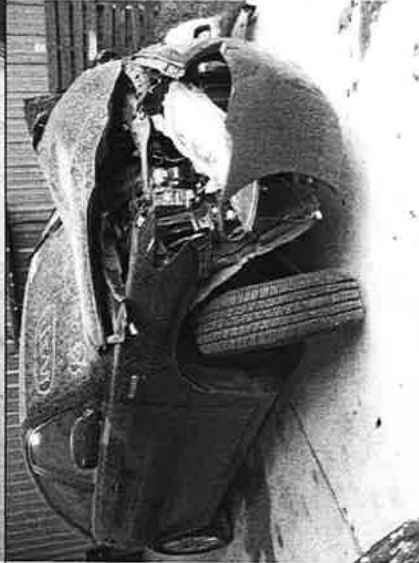
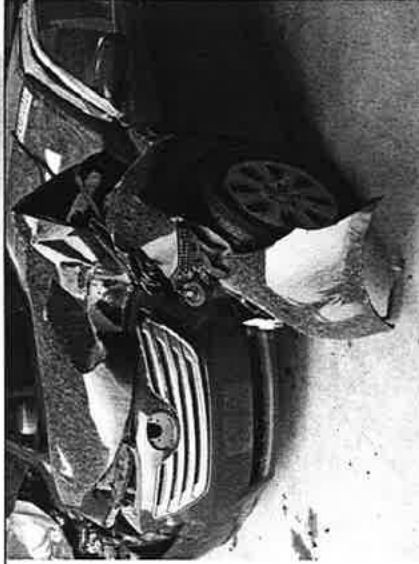
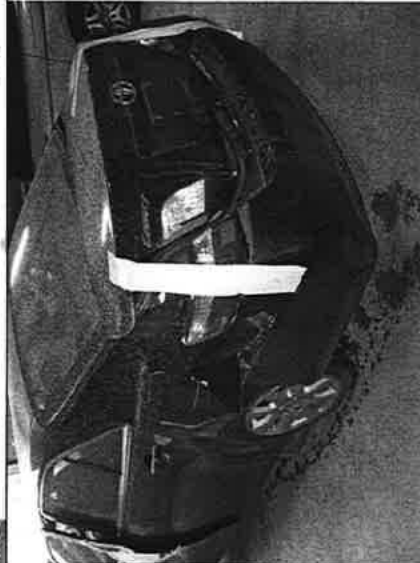
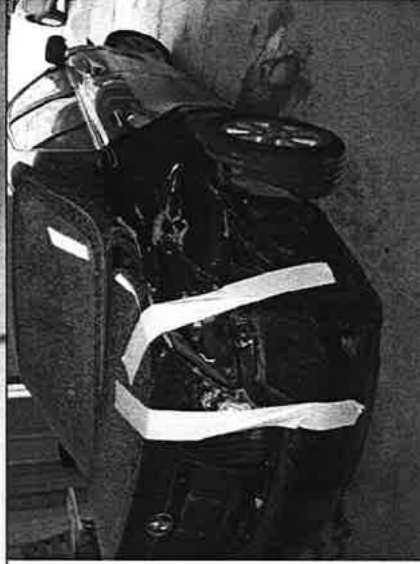
2. Vehicle Identification & Condition (NOTE: If no impact, document overall vehicle condition.) Incident/Impact Area Pictures

This inspection was performed in a salvage yard. Vehicle has extensive frontal impact damage that rendered the electrical system inoperative and prevented obtaining a Techstream scan. Engine and hybrid drive assemblies are displaced rearward making brake master cylinder and related components inaccessible for even visual inspection w/o major disassembly of surrounding components. Right side wheels were removed for brake inspection. No leaks or other discrepancies were noted on any right side brake component. Left wheels could not be removed. As viewed between wheel spokes using flashlight and mirrors, no evidence of leaks or other discrepancies were noted on left front and rear brake components. ABS controller is displaced but all lines appear to be intact and no leaks are visible. Driver's floor area is displaced upward and rearward against brake pedal preventing pedal movement. Brake pedal and linkage appear to be otherwise intact. The console was disassembled for access to the SRS-ECU and a successful EDR image was obtained directly from the SRS-ECU.

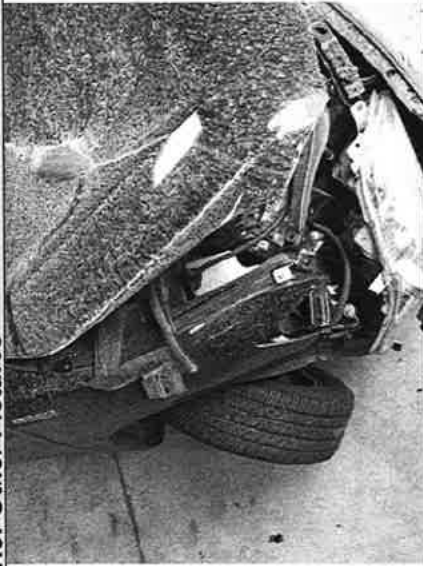
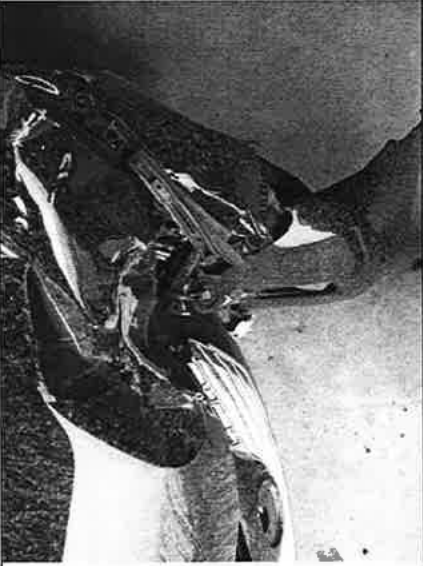
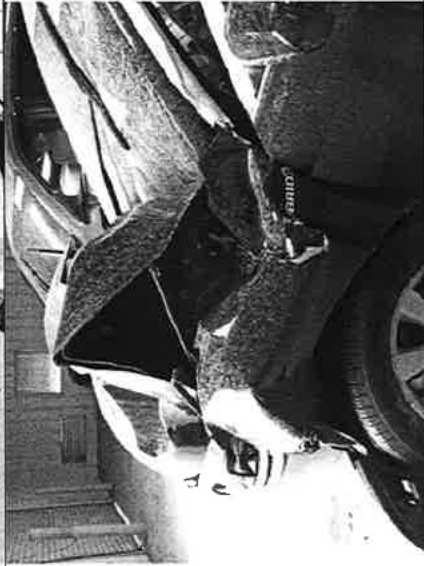
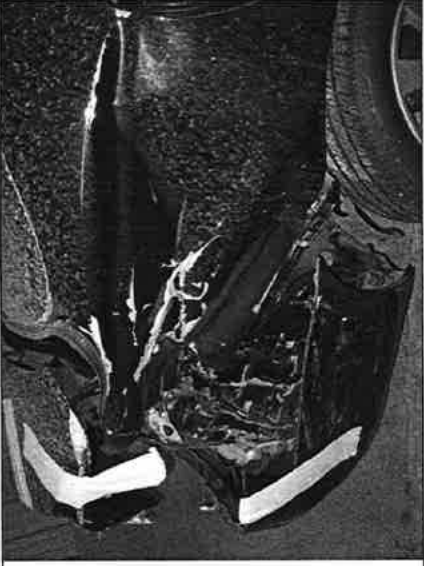
Exterior Other Pictures

Inspection Area	Notes & Observations	Exterior Other
Headlights / Taillights	Both headlights and RT taillight destroyed. LT taillight is present but displaced.	
Brake Lights	RR brake light destroyed. LR brake light is displaced. CHMSL appears intact.	
Turn Signals	Both front and Rt rear turn signals are destroyed. LR turn signal is present but displaced.	
Glass & External Mirrors	Windshield is destroyed. Exterior mirrors and all other glass are intact.	
Hood Latch	Hood latch components are functional but had to be partially disassembled to get hood open. Damaged hood will not close.	
Hatch / Trunk Latch	Trunk lid and opening are distorted preventing closure.	
Door Latch & Lock	RT side doors function normally mechanically. Power function could not be tested. LT side doors do not fully close and could not be tested.

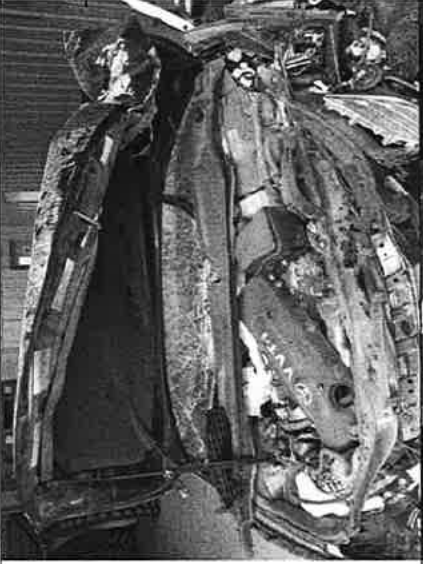
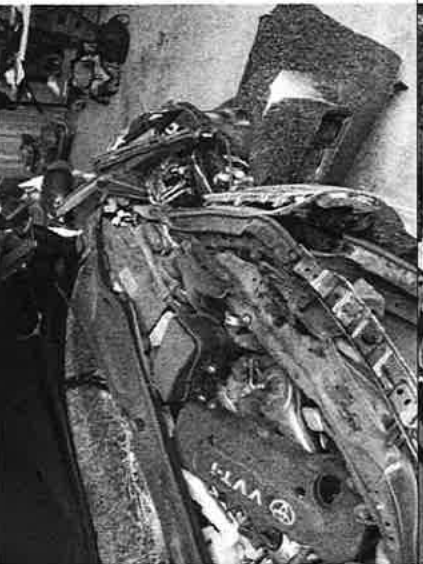
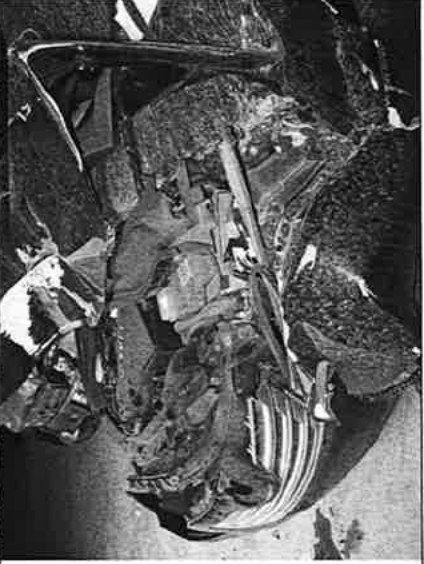
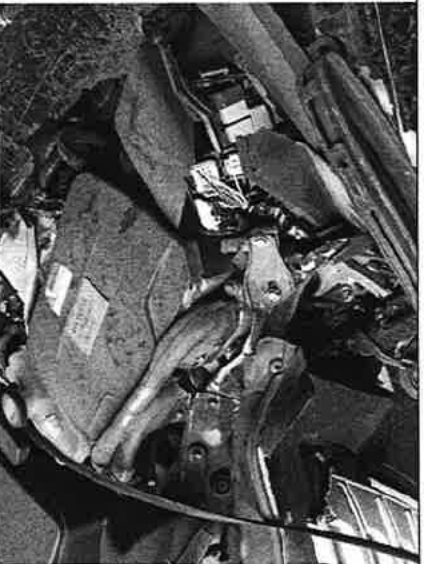
Condition	
Coolant	Level	High <input type="checkbox"/> Normal <input checked="" type="checkbox"/> Low <input type="checkbox"/> N/A <input type="checkbox"/>
	Condition	Radiator is crushed
12V Battery	SOC	<input type="checkbox"/> Pass <input checked="" type="checkbox"/> Fail <input type="checkbox"/> N/A
	Condition	Using Midtronics tester or open circuit voltage / failure code or OC voltage Battery tests 0 volts & cables are disconnected. Battery carrier is crushed.
Radiator, Radiator Hoses & Condenser		Radiator, condenser and hoses all crushed.
Engine Compartment Wire Harness		Harness is pulled apart and/or broken in multiple places.
Engine Compartment Fuel Lines		Visible fuel lines bent in some areas but appear intact
Engine / Transmission Mounts		Displaced, bent, broken.
Underhood Pictures

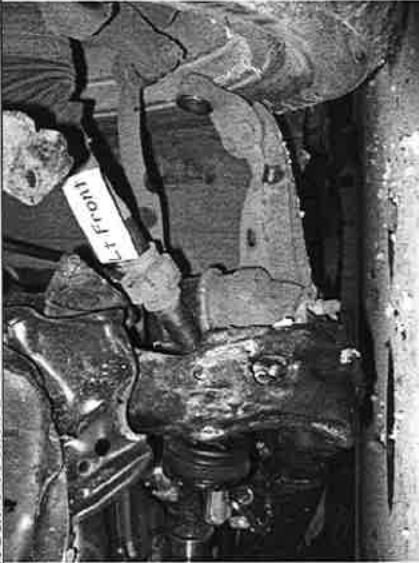
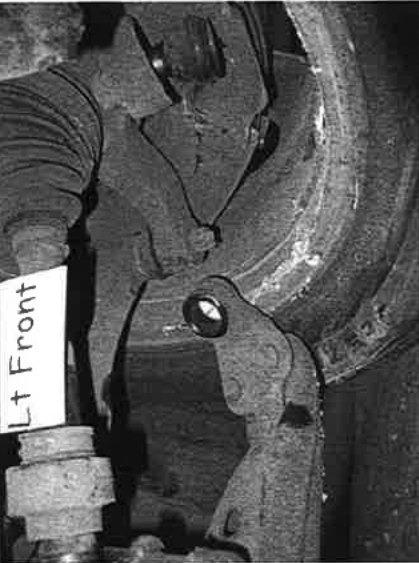
Inspection Area		Notes & Observations
Undercar		
Suspension	Left Front	Strut tower crushed. Lower ball joint is separated from A-frame.
	Right Front	Strut tower crushed.
	Left Rear	Appears displaced but extent of damage undetermined.
	Right Rear	Appears displaced but extent of damage undetermined.
Steering Gear and Linkage		Components bent/broken.
Drive axle / Driveshaft		Components bent/broken.
Transmission / Transaxle		Condition unknown.
Differential/rear axle assembly		N/A
Exhaust System		Crushed at engine.
Fuel Tank and Lines		Other than bent lines in engine area, no other damage was observed.
Undercar Pictures

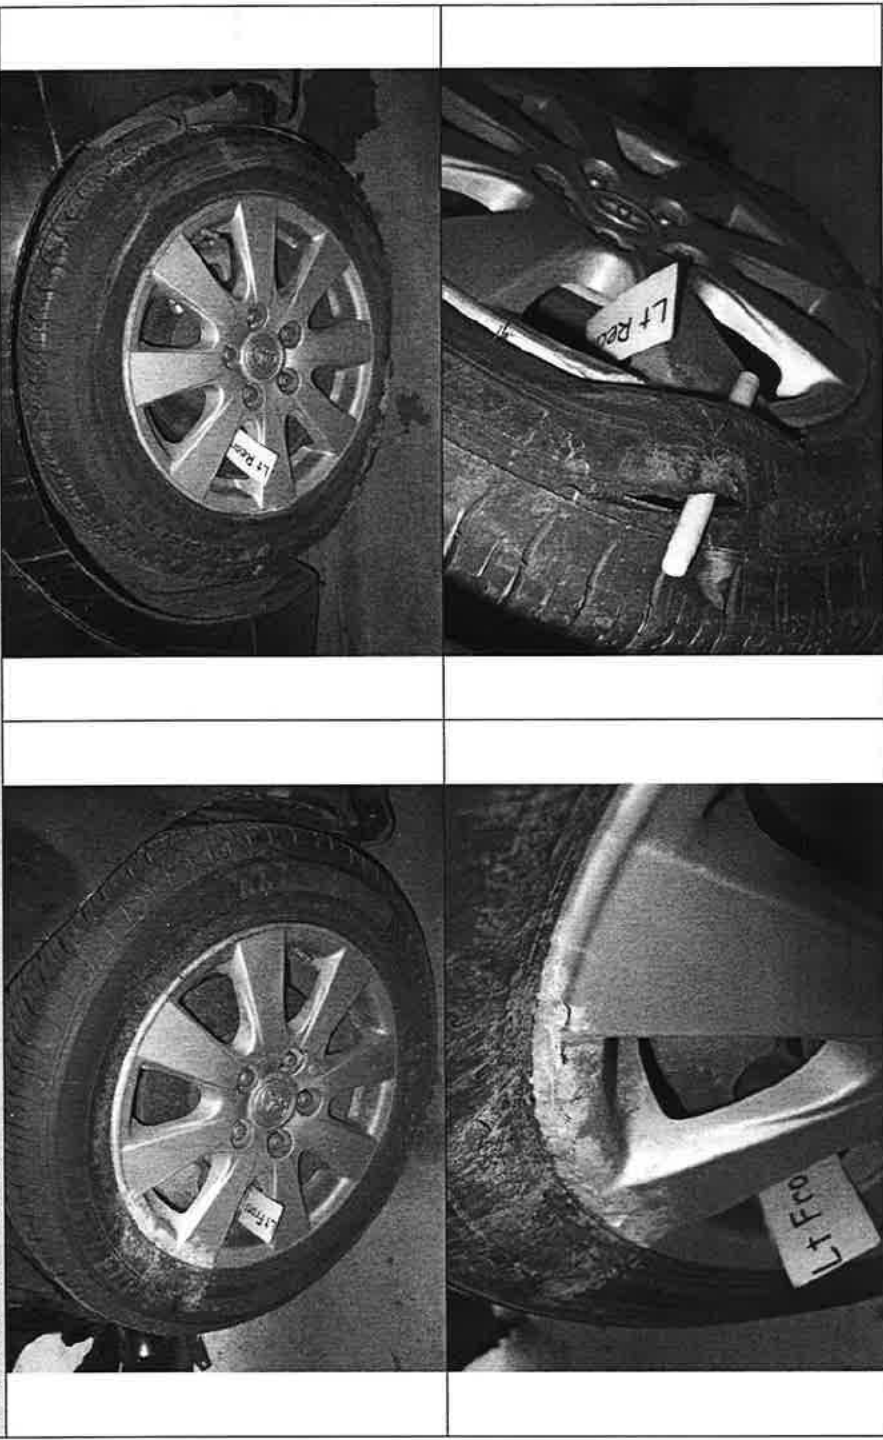
Tire & Wheel Pictures

Inspection Area	Left Front		Right Front		Left Rear		Right Rear	
	Tire Brand / Model	Michelin	Michelin	Michelin	Michelin	Michelin	Michelin	Michelin
Tire Model Name - Code	Destiny		Destiny		Destiny		Destiny	
Tire Size	P215/60R16 94T		P215/60R16 94T		P215/60R16 94T		P215/60R16 94T	
Tire DOT #	B349 R1UX 2211		B349 R1UX 2211		B349 R1UX 2211		B349 R1UX 2211	
Cold Tire Pressure (psi)	32.0		31.5		Flat		32.5	
Tread Depth (Measured in 32 nd of an inch)	I	C	O	I	C	O	I	C
	10	10	10	10	10	10	10	10
Tire Wear Condition	OK		OK		Multiple punctures		OK	
Wheel Condition	Rim has severe impact damage		OK		Rim has severe impact damage		OK

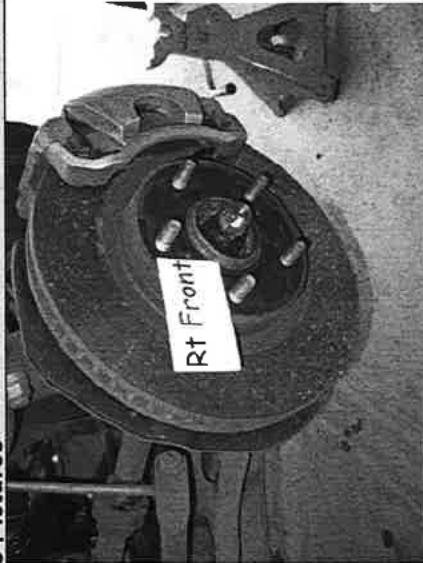
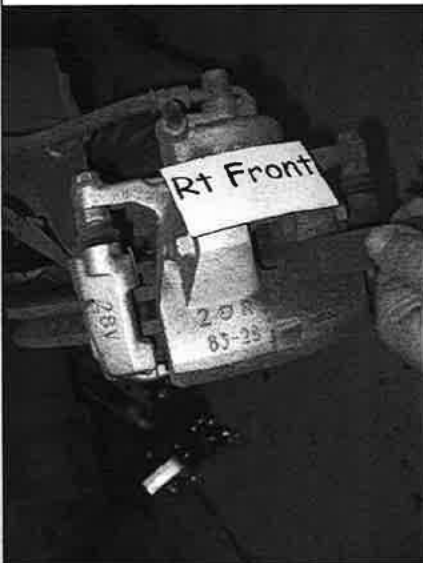
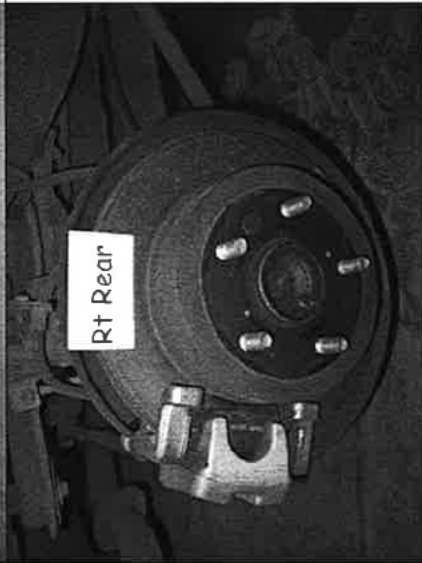
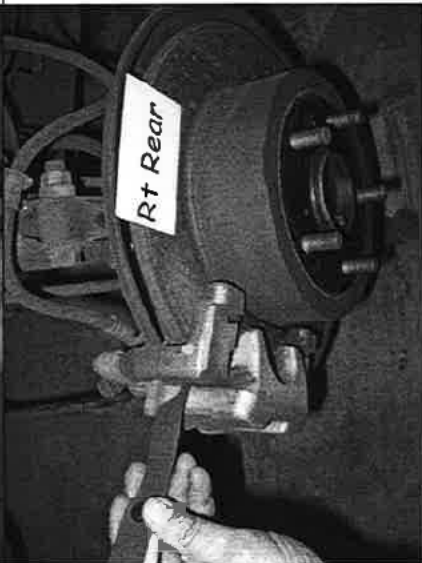
Inspection Area	Brake System			
	Left Front (LF)	Right Front (RF)	Left Rear (LR)	Right Rear (RR)
Pad / Shoe Thickness (mm)	Unable to measure Unable to measure	8 8	Unable to measure Unable to measure	8 8
Calipers / Wheel Cylinders	No visible leaks			
Pad / Shoe Condition	Appear normal			
Caliper Slide Pins & Other Hardware	RT side OK. Unable to access LT side to inspect.			
Rotor / Drum Condition	Heavy surface rust but otherwise appear serviceable.			
Wheel Speed Sensor & Wiring Condition	RT side OK. Unable to access LT side to inspect.			
Master Cylinder	Not visible. Unable to access w/o disassembly of crushed surrounding components.			
ABS Actuator	Displaced in mount but otherwise appears to be intact.			
Brake Lines & Hoses	All visible lines/hoses appear intact. Lines from master cylinder to remote reservoir are not visible due to crushed surrounding components.			
LSPV - Load Sensing Proportioning Valve	N/A

Parking Brake Operation	Cannot be applied due to displaced cowl and floor pan			
Brake Pictures

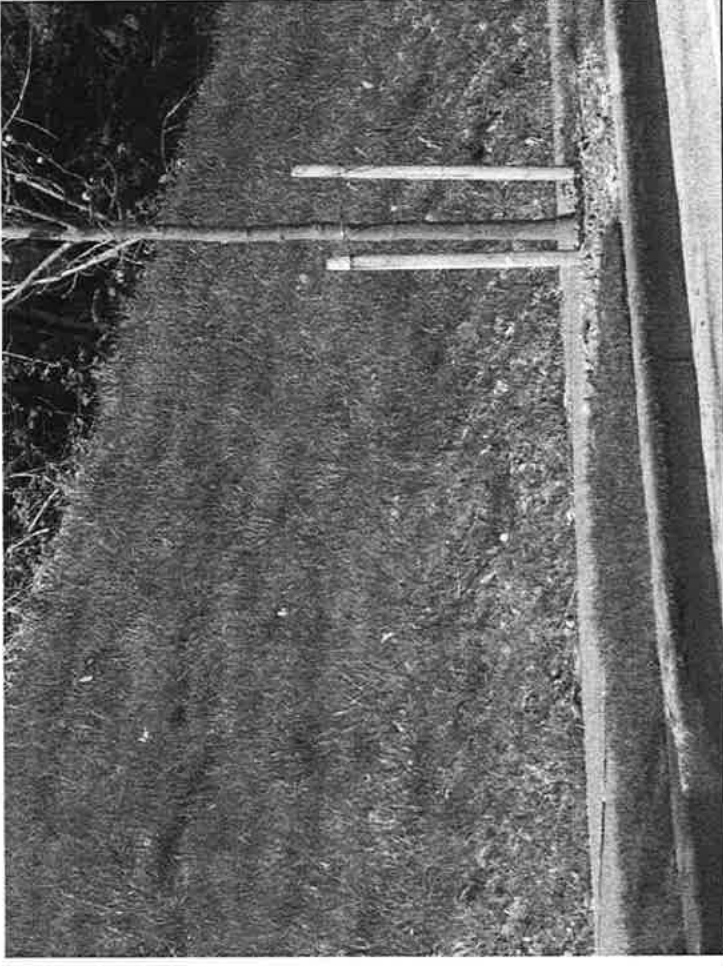
Inspector photos of the incident scene, taken on 4/15/12, were submitted with this report. Witness marks are visible on the curb. The damaged tree had already been replaced.

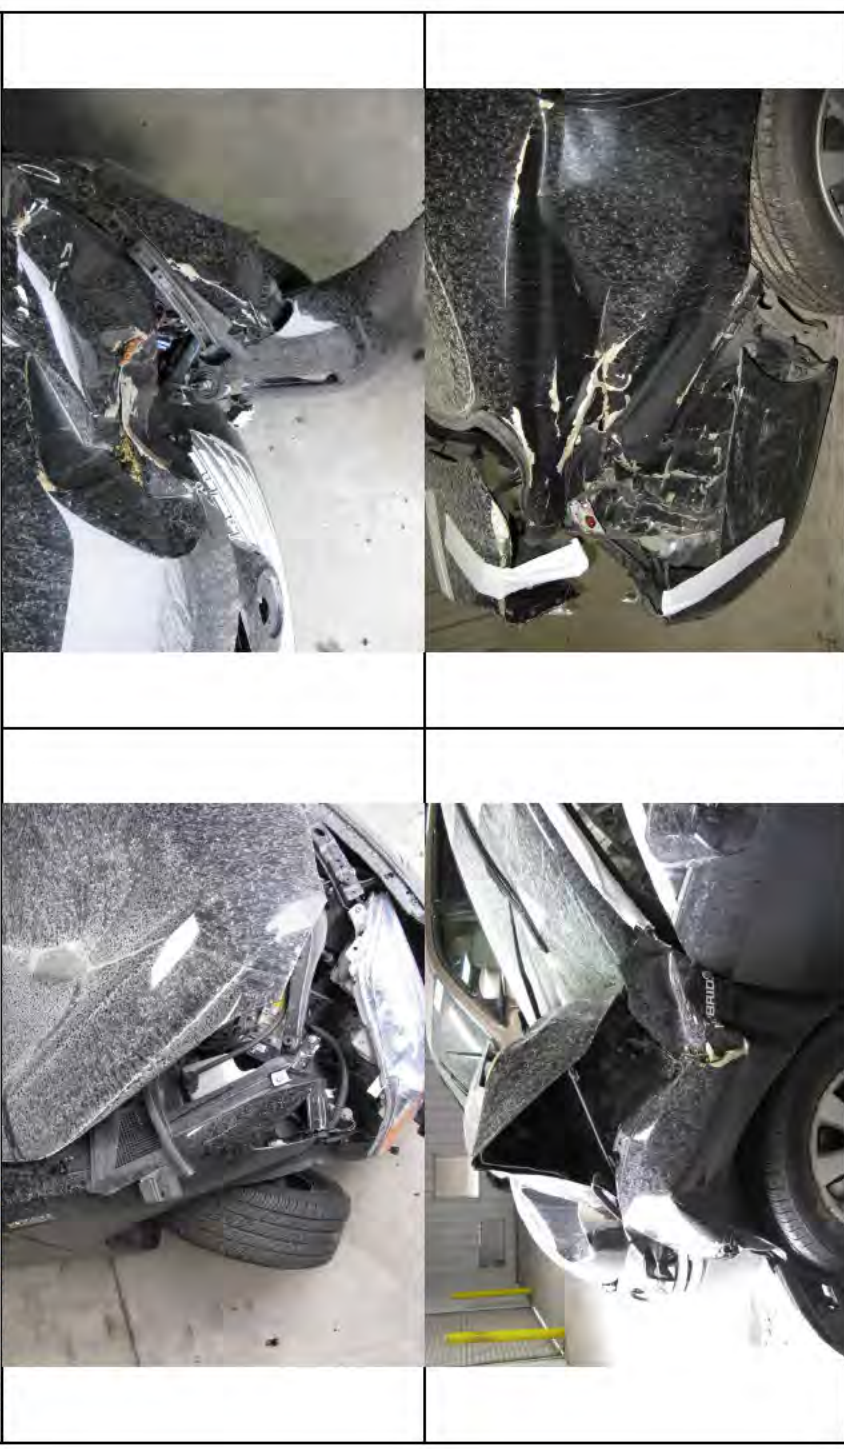
Exterior Other	
Inspection Area	Notes & Observations
Headlights / Taillights	Both headlights and RT taillight destroyed. LT taillight is present but displaced.
Brake Lights	RR brake light destroyed. LR brake light is displaced. CHMSL appears intact.
Turn Signals	Both front and Rt rear turn signals are destroyed. LR turn signal is present but displaced.
Glass & External Mirrors	Windshield is destroyed. Exterior mirrors and all other glass are intact.
Hood Latch	Hood latch components are functional but had to be partially disassembled to get hood open. Damaged hood will not close.
Hatch / Trunk Latch	Trunk lid and opening are distorted preventing closure.
Door Latch & Lock	RT side doors function normally mechanically. Power function could not be tested. LT side doors do not fully close and could not be tested.
Exterior Other Pictures

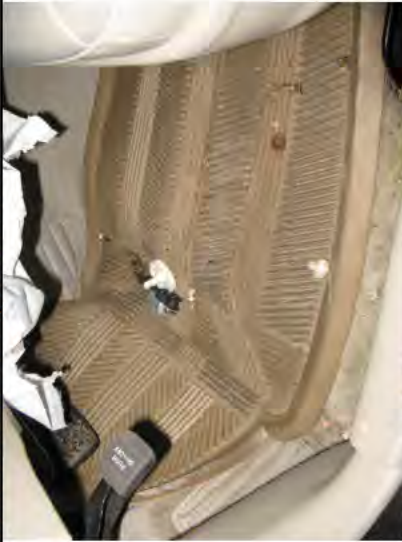
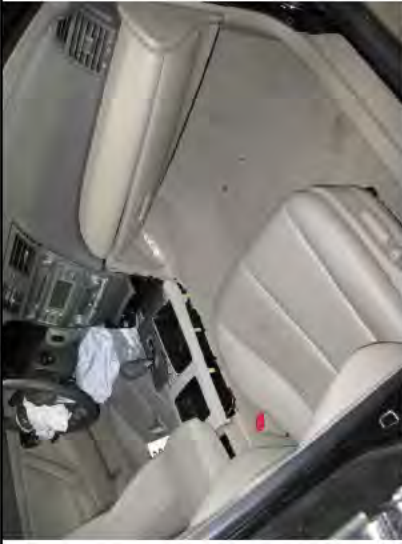
Inspection Area		Notes & Observations
Warning Light Status		<input checked="" type="checkbox"/> Unable to check, vehicle will not start / Ready ON <input type="checkbox"/> Equipped with Safety Connect, note system status here:
Instrument Cluster		Housing is distorted. Visible part of cluster appears intact but is inoperative due to no power.
Steering Wheel & Column		Lower column is displaced rearward.
Shift Lever & Linkage		Moves when manually released. Otherwise, condition is unknown.
Pedal Assembly	Accelerator	Pedal movement is restricted by contact with carpet, caused by displaced floor pan. When carpet is pulled away, pedal appears to operate normally.
	Brake	Brake pedal is trapped at the top of its normal travel by the displaced floor pan, preventing pedal from moving up or down.
	Clutch N/A: <input checked="" type="checkbox"/>	
Floormat & Floorpan	Left Front	Unretained aftermarket rubber floor mat on top of a properly positioned and retained OEM mat. Floor pan is displaced upward and rearward trapping mats against brake pedal.

Right Front	No mat present. Floor pan appears slightly displaced in LF corner of passenger foot area.
Floormat / Interior Floorpan Pictures

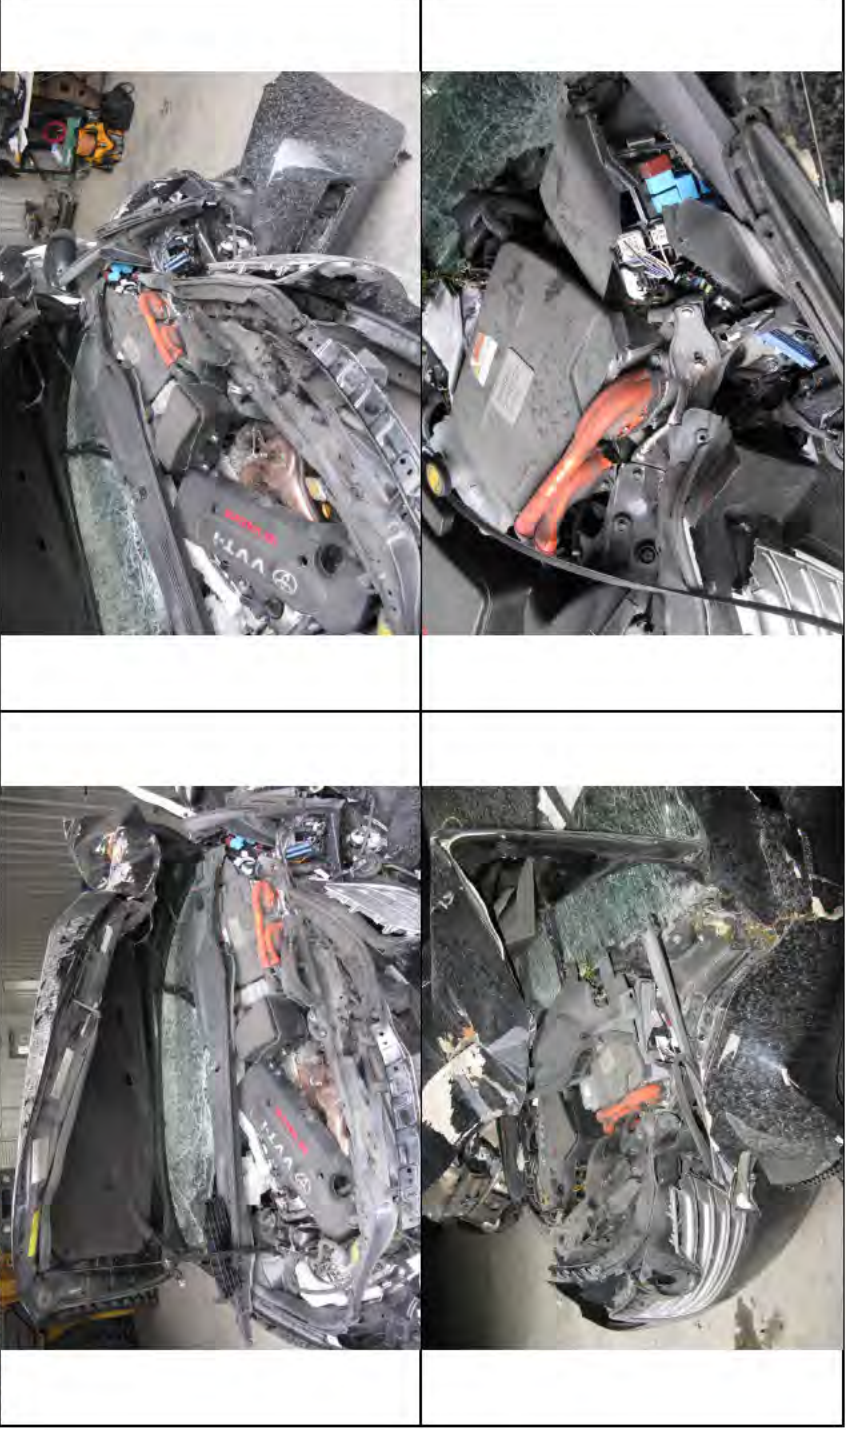
Condition			
Coolant	Level	<input type="checkbox"/> High	<input type="checkbox"/> Normal	<input checked="" type="checkbox"/> Low <input type="checkbox"/> N/A
	Condition	Radiator is crushed		
12V Battery	SOC	<input type="checkbox"/> Pass	<input checked="" type="checkbox"/> Fail	<input type="checkbox"/> N/A
	Condition	Using Midtronics tester or open circuit voltage / failure code or OC voltage Battery tests 0 volts & cables are disconnected. Battery carrier is crushed.		
Radiator, Radiator Hoses & Condenser		Radiator, condenser and hoses all crushed.		
Engine Compartment Wire Harness		Harness is pulled apart and/or broken in multiple places.		
Engine Compartment Fuel Lines		Visible fuel lines bent in some areas but appear intact.		
Engine / Transmission Mounts		Displaced, bent, broken.		
Underhood Pictures

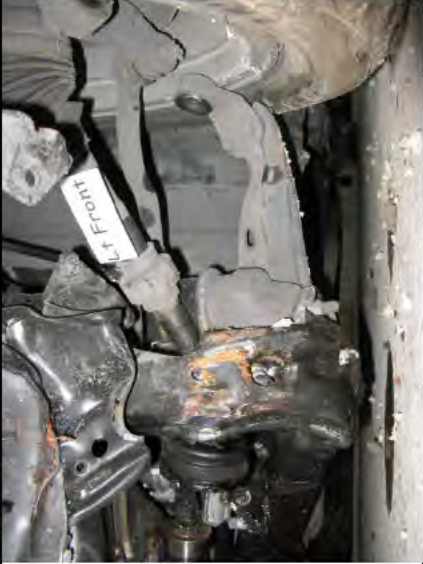
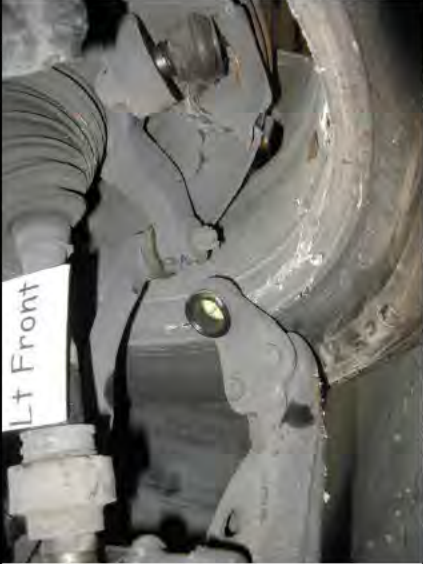
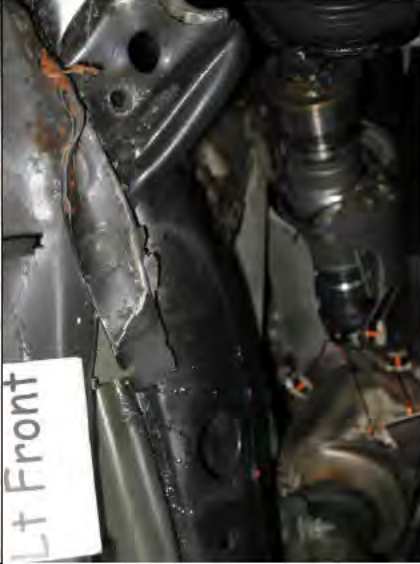
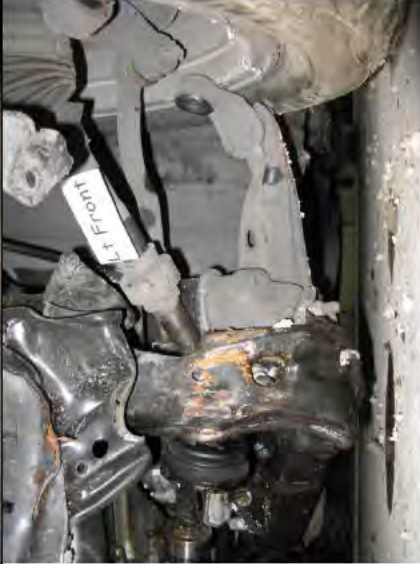
Inspection Area		Notes & Observations
Undercar		
Suspension	Left Front	Strut tower crushed. Lower ball joint is separated from A-frame.
	Right Front	Strut tower crushed.
	Left Rear	Appears displaced but extent of damage undetermined.
	Right Rear	Appears displaced but extent of damage undetermined.
Steering Gear and Linkage		Components bent/broken.
Drive axle / Driveshaft		Components bent/broken.
Transmission / Transaxle		Condition unknown.
Differential/rear axle assembly		N/A
Exhaust System		Crushed at engine.
Fuel Tank and Lines		Other than bent lines in engine area, no other damage was observed.
Undercar Pictures

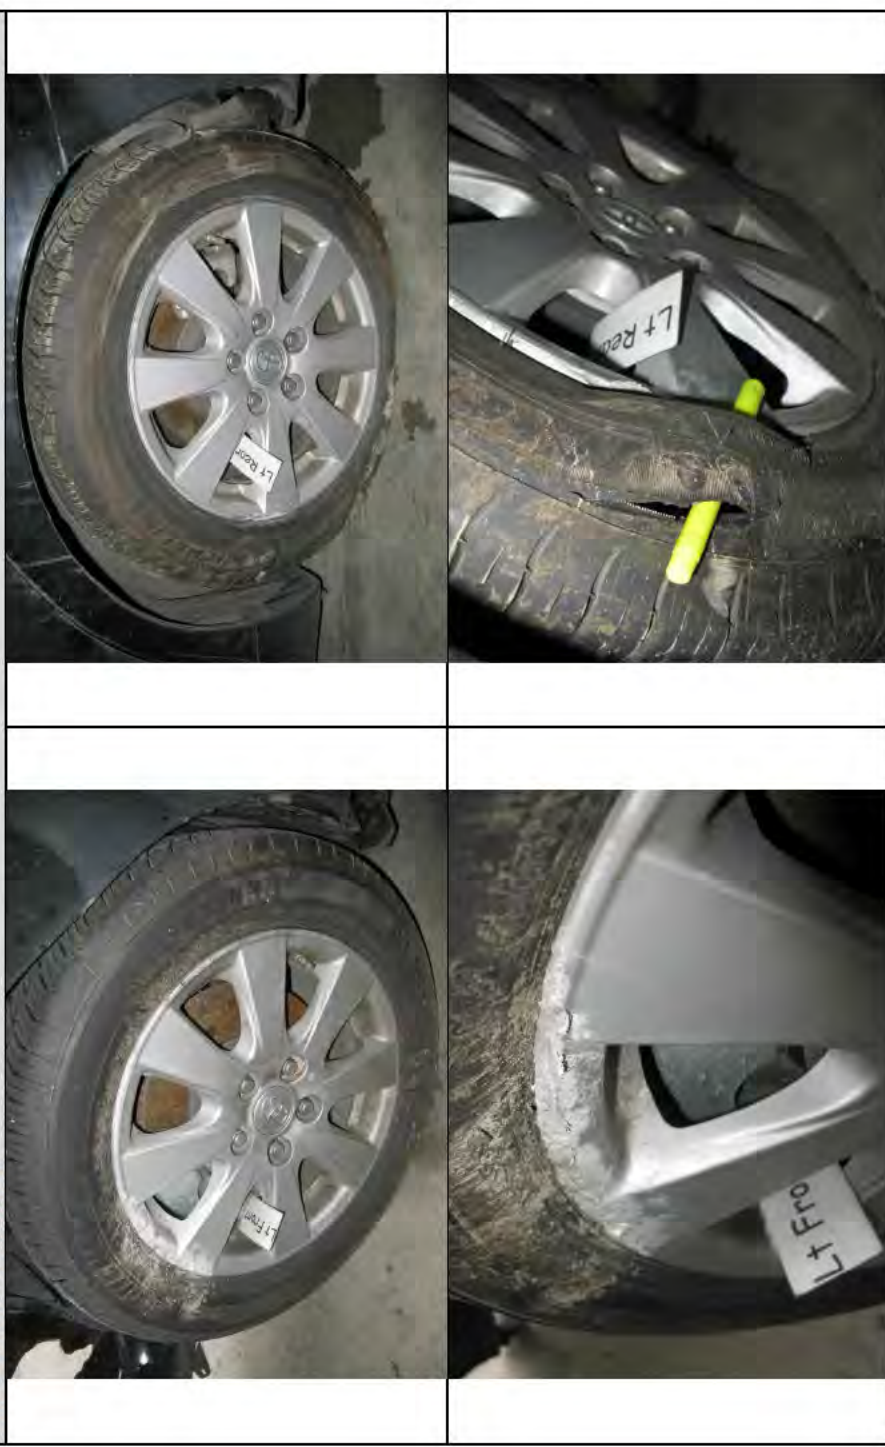
Tire & Wheel Pictures

Inspection Area	Left Front	Right Front	Left Rear	Right Rear
Tire Brand / Model	Michelin	Michelin	Michelin	Michelin
Tire Model Name - Code	Destiny	Destiny	Destiny	Destiny
Tire Size	P215/60R16 94T	P215/60R16 94T	P215/60R16 94T	P215/60R16 94T
Tire DOT #	B349 R1UX 2211	B349 R1UX 2211	B349 R1UX 2211	B349 R1UX 2211
Cold Tire Pressure (psi)	32.0	31.5	Flat	32.5
Tread Depth (Measured in 3 rd of an inch)	I C O I C O 10 10 10 10 10 10	I C O I C O 10 10 10 10 10 10	I C O I C O 10 10 10 10 10 10	I C O I C O 10 10 10 10 10 10
Tire Wear Condition	OK	OK	Multiple punctures	OK
Wheel Condition	Rim has severe impact damage	OK	Rim has severe impact damage	OK

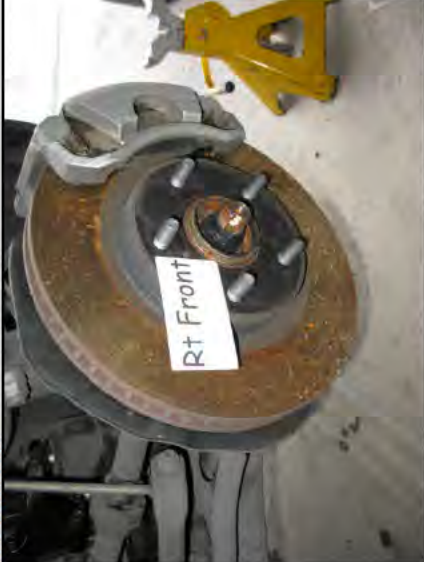
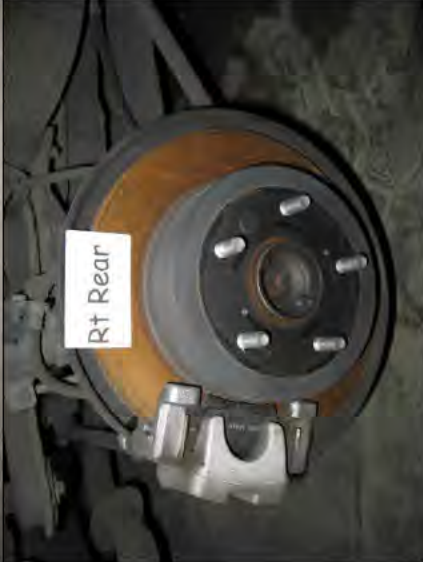
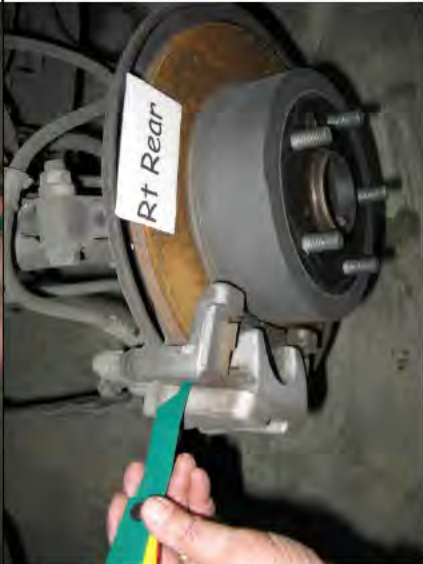
Brake Pictures

Parking Brake Operation	Cannot be applied due to displaced cowl and floor pan

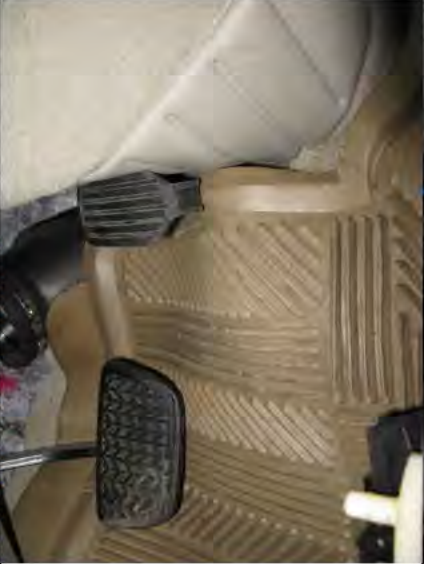
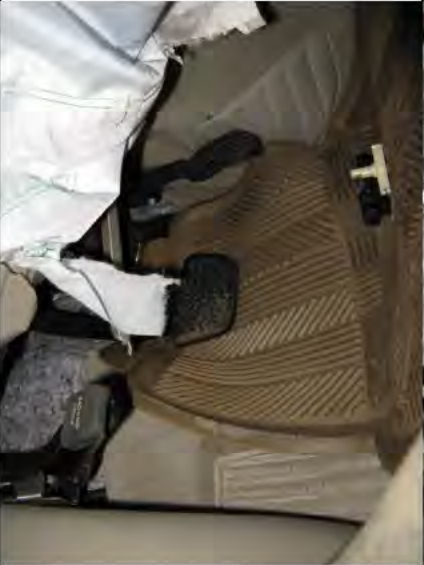
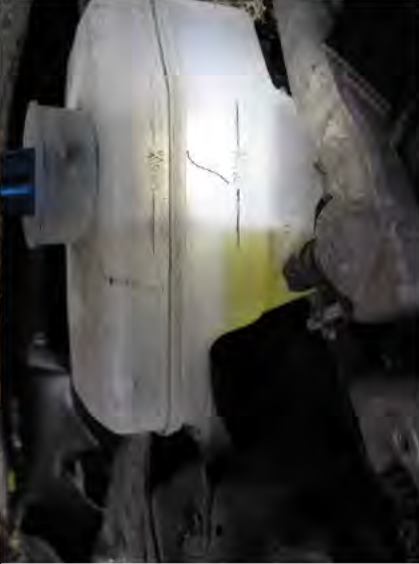
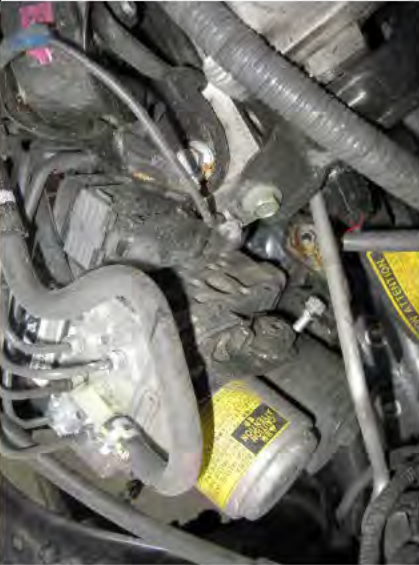
Brake System - Pedal Pictures

Measurement: 0 (due to displaced floor pan)

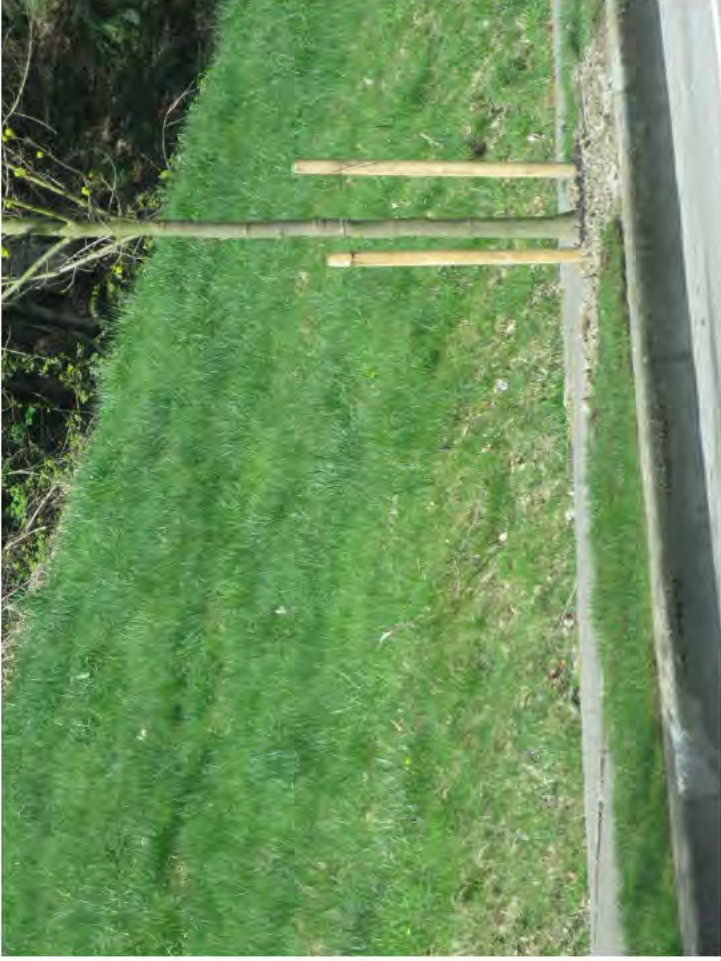
Inspector photos of the incident scene, taken on 4/15/12, were submitted with this report. Witness marks are visible on the curb. The damaged tree had already been replaced.
