PE14-019

CHRYSLER

9.25 Axles-NHTSA Inquiry 6/16/14
Potential Previous Recall Associations (Recall M34-MY2009-MY2010)- (Recall N08-MY2009-MY2012)

Dodge Ram 1500 rear axle pinion nut retention issue
New NHTSA PE for MY2005-(NHTSA Previous Recall #'s M34 & N08).
MY2005 Work Order 2005-1929-9.25 Axle-3.92 Ratio-Loose Pinion Nut.

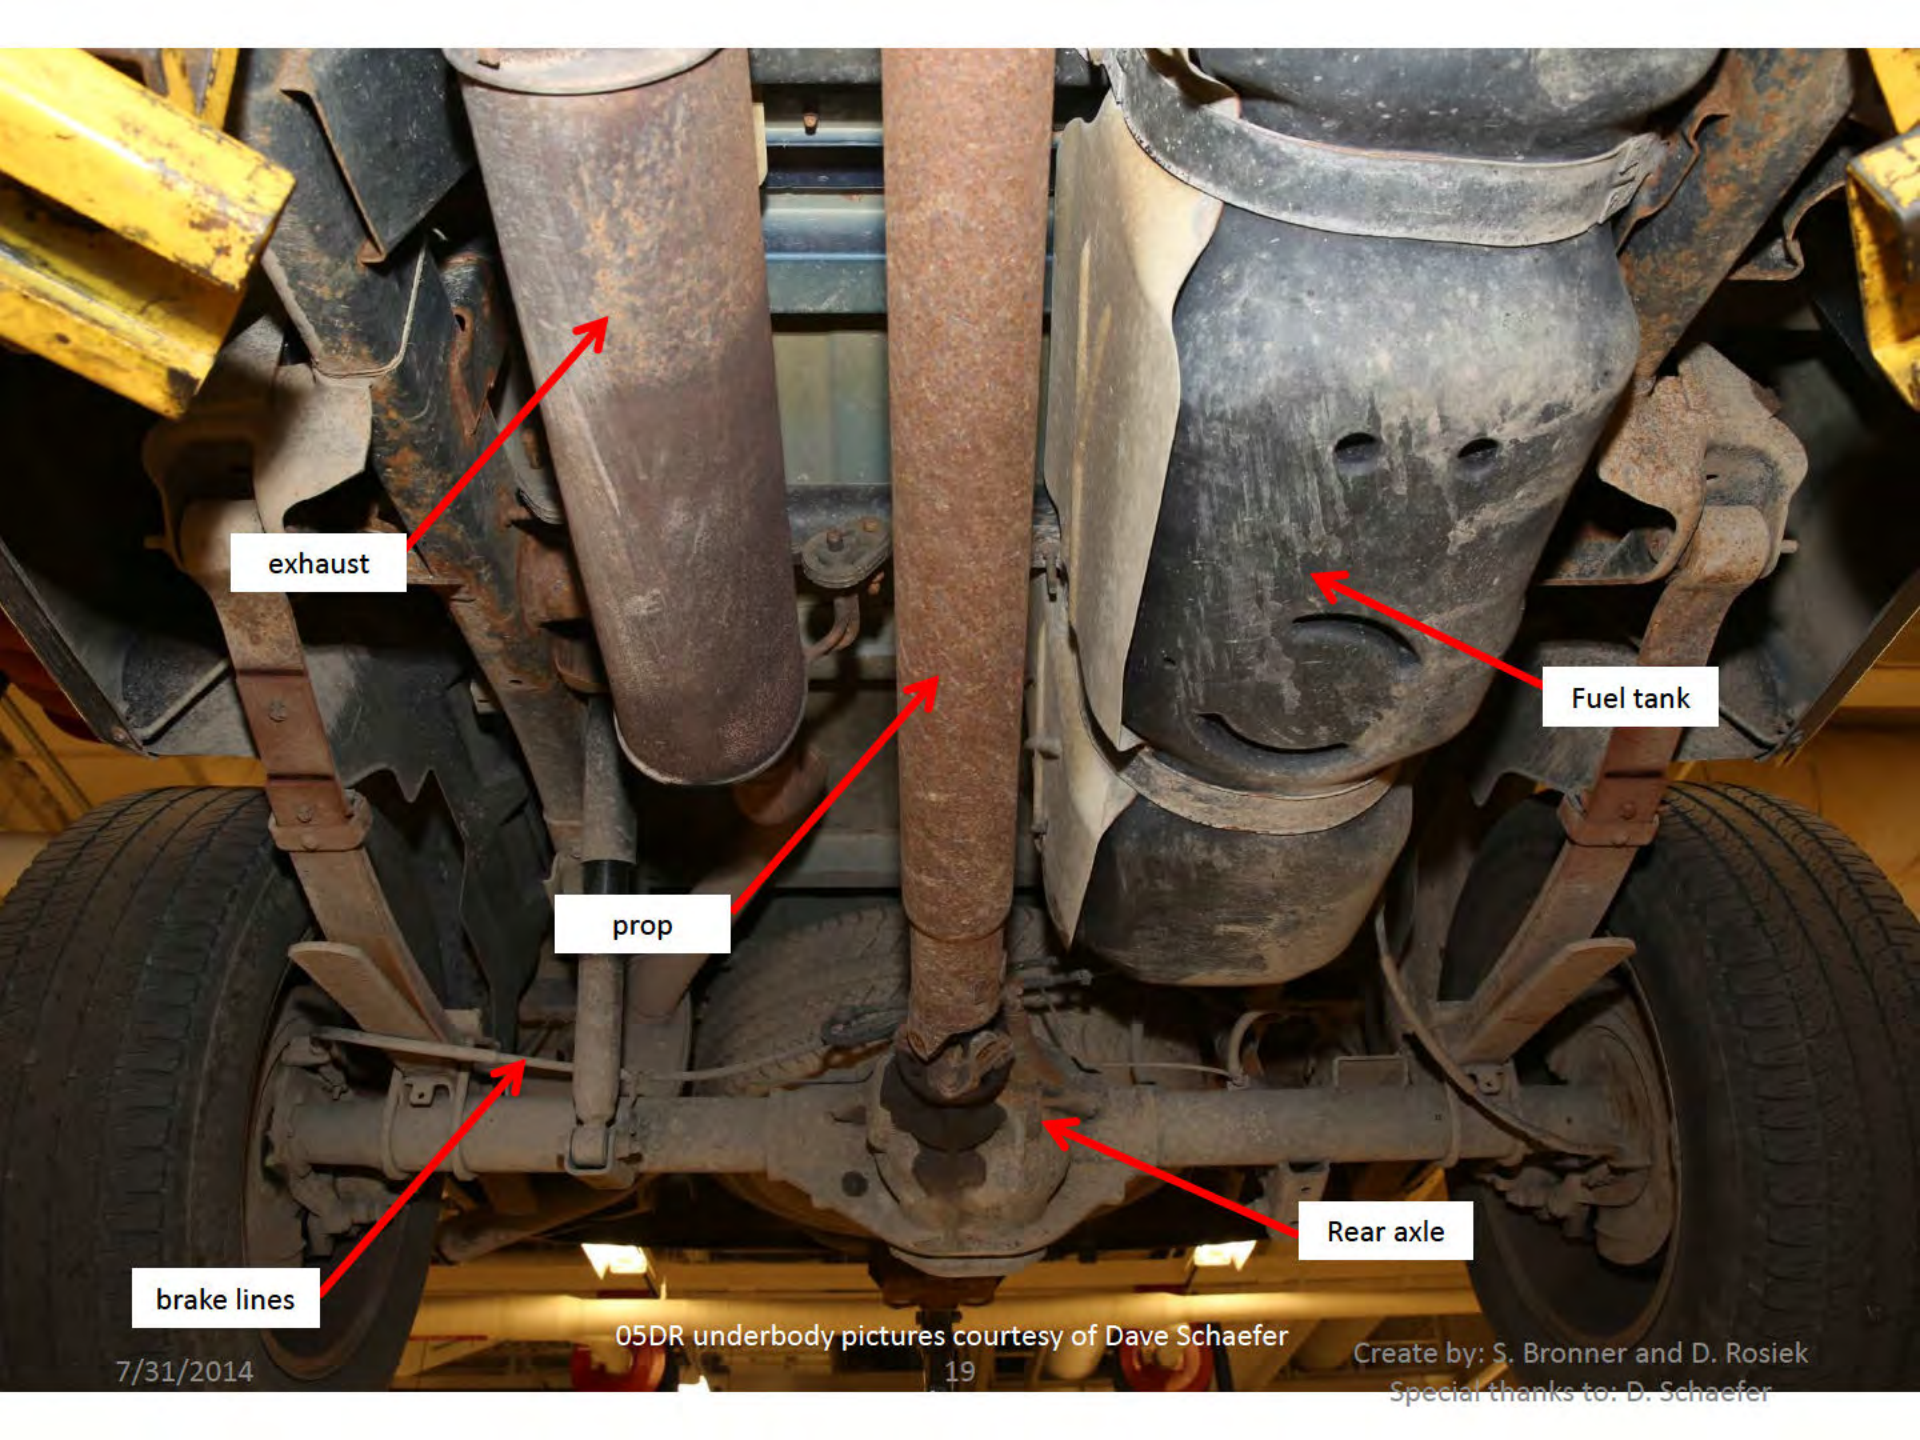
Actual
05DR 4x4
140.5WB
Single piece
propshaft

exhaust

prop

brake lines

Fuel tank

Rear axle

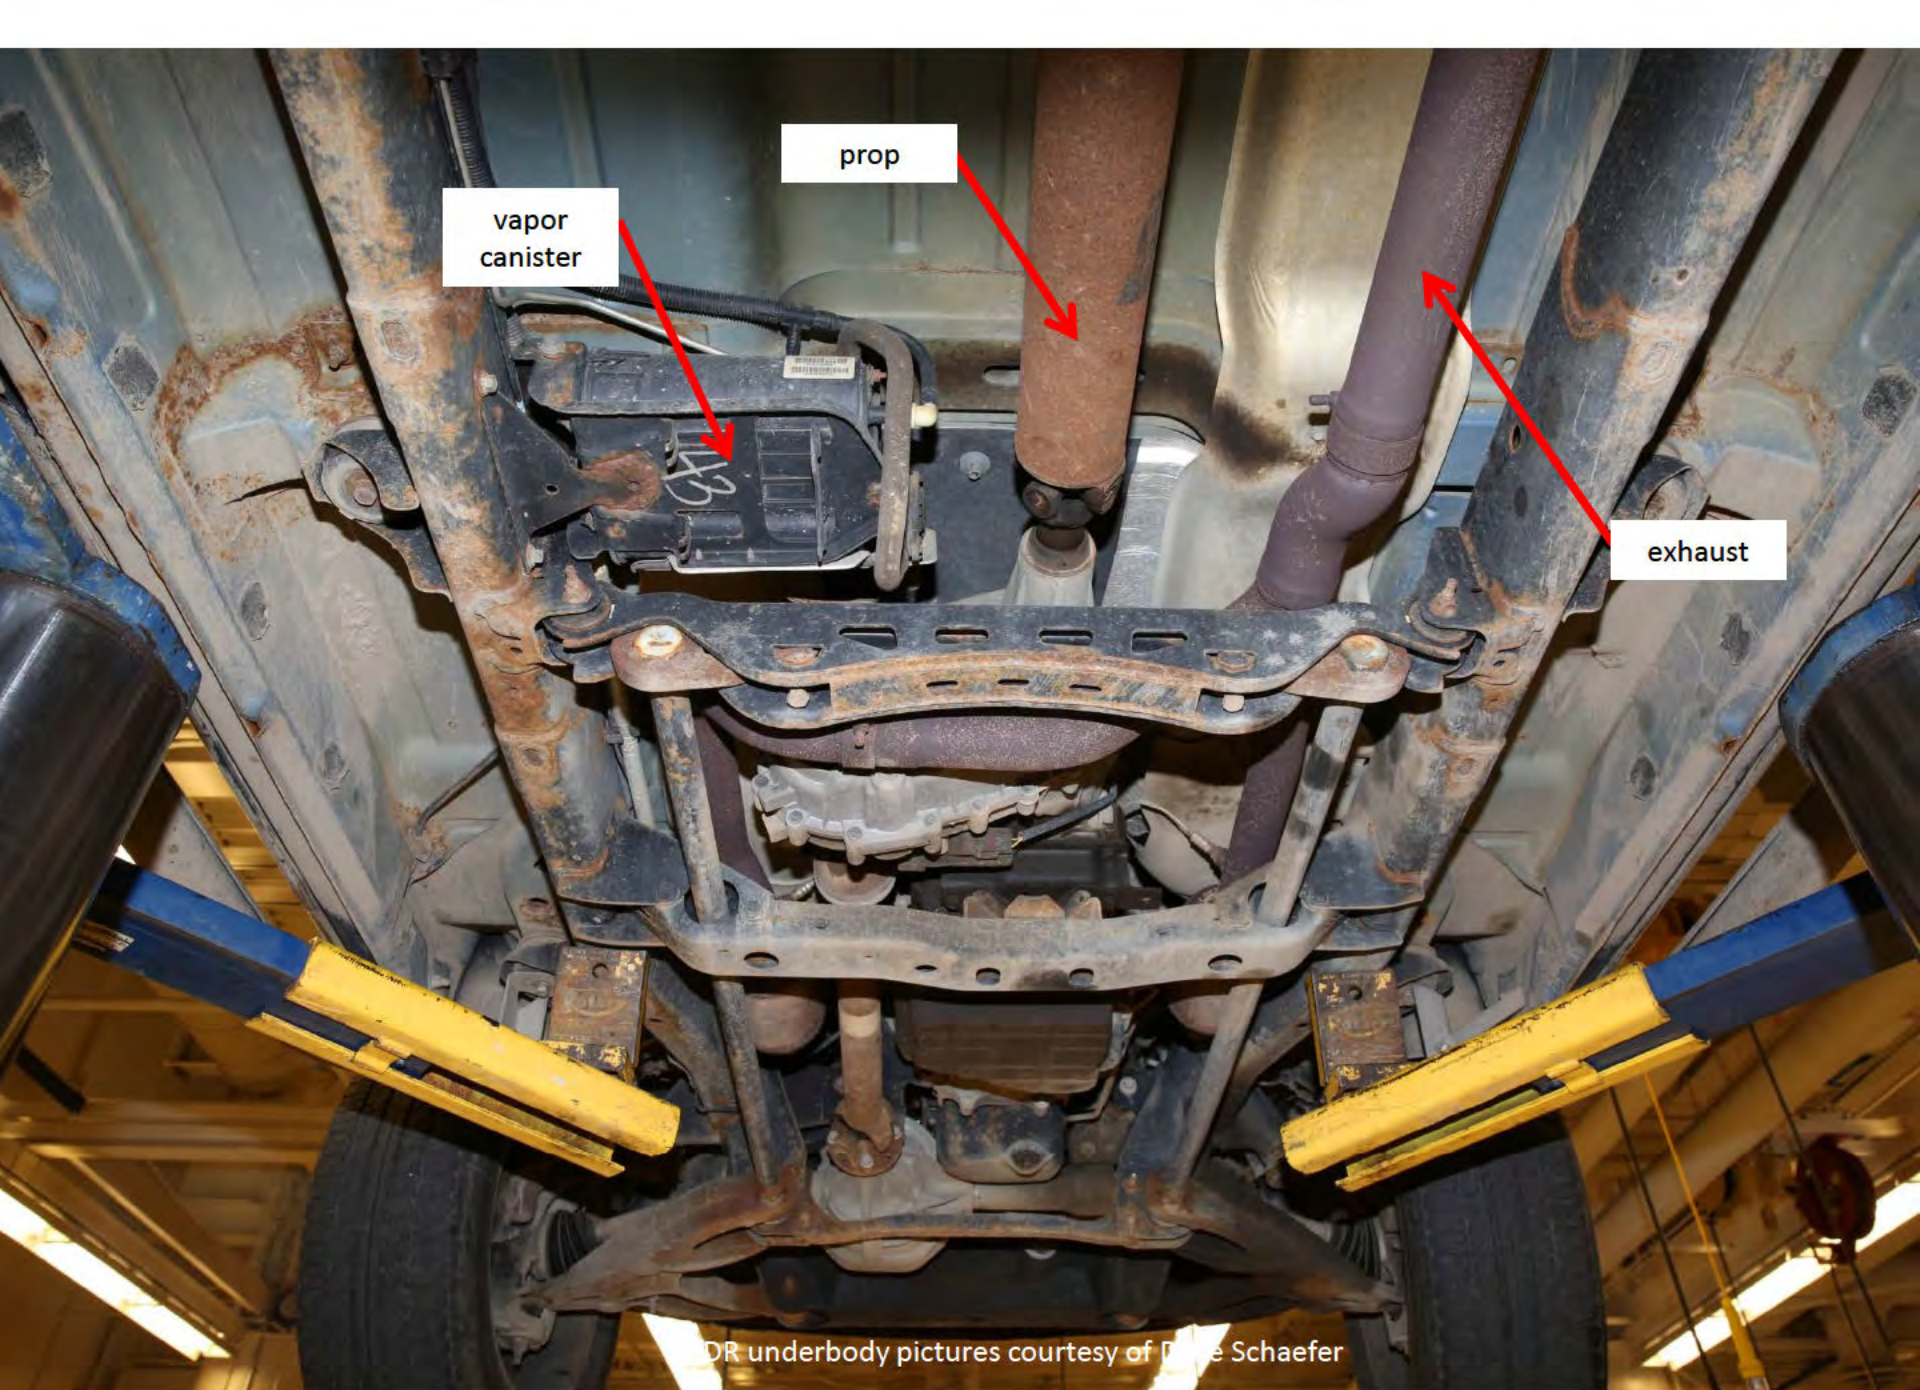
DR underbody pictures courtesy of Dave Schaefer

vapor
canister

prop

exhaust
