PE14-020

Request No. 5 Data Files

**INDIANA UNIVERSITY**  
**TRANSPORTATION RESEARCH CENTER**  
**ON-SITE COMPRESSED NATURAL GAS**  
**VEHICLE EXPLOSION INVESTIGATION**  
FOR THE OFFICE OF DEFECTS INVESTIGATION (ODI)  
CASE NUMBER - [REDACTED]  
LOCATION - WISCONSIN  
VEHICLE - 2014 FREIGHTLINER M2 112  
CRASH DATE - April 2014

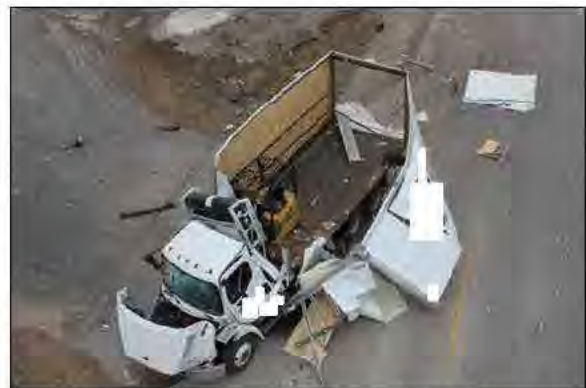
This on-site investigation focused on the Compressed Natural Gas (CNG) fuel system of a 2014 Freightliner M2 112 (**Figure 1**). One of the five CNG fuel cylinders was punctured by the left fork of an unsecured Yale Type E forklift located in the cargo box of the Freightliner resulting in an explosion of the fuel cylinder. There was no fire. This investigation was initiated by the National Highway Traffic Safety Administration (NHTSA) on April 15, 2014 through the Office of Defects Investigation (ODI), which was responding to an on-line news article. This investigation was assigned on April 17, 2014 when cooperation to inspect the Freightliner was finalized with the vehicle's owner. The incident involved the Freightliner and the Yale Type E forklift located within the cargo box of the vehicle. This incident occurred in April 2014 at 1335 hours, in Wisconsin and was investigated by a local police agency. The Freightliner and incident scene were inspected on April 22, 2014. Interviews with the front right passenger of the Freightliner, the owner of the Freightliner, and the city public safety director were also conducted on April 22, 2014.

**Figure 1:** On-scene police photograph of the damaged 2014 Freightliner M2 112

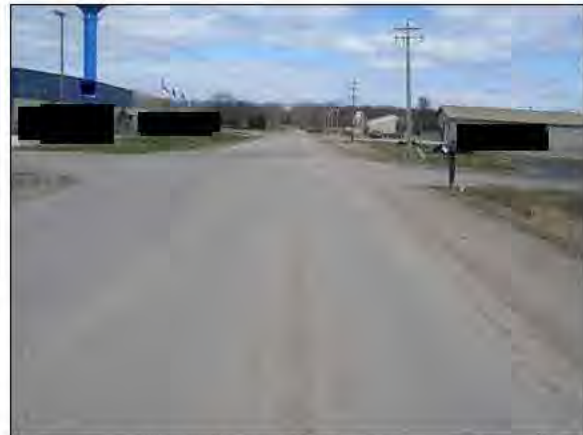
**Figure 2:** Freightliner's eastbound approach to the driveway (on right) and area of explosion

**Incident:** The unsecured forklift traveled forward in the cargo box as the driver braked. The front forks pierced the front panel of the cargo box and the left fork impacted the lowest of five CNG fuel cylinders that were oriented horizontally and stacked vertically within an aluminum cabinet located between the truck cab and cargo box. The impact site on the CNG cylinder was located 65 cm (25.6 in) left of the right cylinder end. This impact resulted in a rupture and explosion of the cylinder. There was no fire. The Freightliner's air lines were severed and the wheels locked, leaving police-reported skid marks that ranged from 4.3 - 7.44 m (14.1 - 24.4 ft) in length as the vehicle skidded to final rest, heading southeast. A speed to skid to a stop calculation based on the longest skid mark length and a deceleration value range<sup>1</sup> of 0.41 - 0.56 g yielded a speed range at the onset of the skid

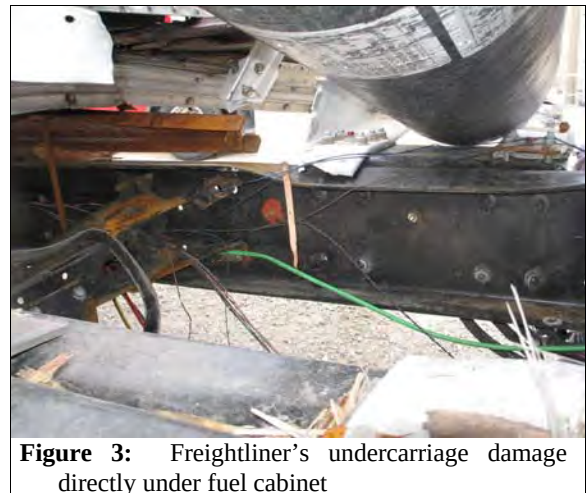
**Frame and Undercarriage:** The explosion deformed the truck frame directly below the fuel cylinder cabinet (**Figure 3**). Both frame rails were bent, as were the frame cross members fore and aft of the cylinder cabinet. The center section of the drive shaft was fractured and separated from the transmission. The air brake lines were severed and the air brake tank was also slightly displaced. The rear engine mounts were undamaged.

**Figure 3:** Freightliner’s undercarriage damage directly under fuel cabinet

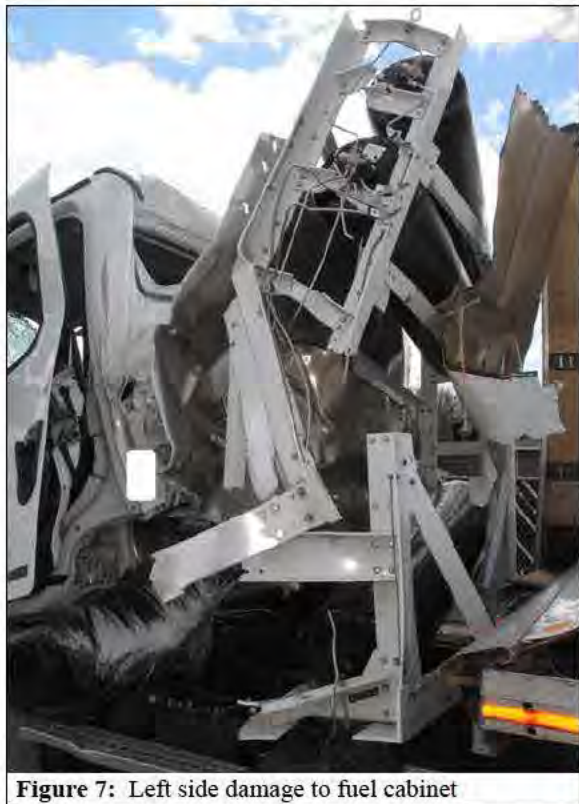
The cabinet for the CNG cylinders was manufactured by Agility Fuel Systems and was located between the cab and cargo box. The cabinet included an aluminum support structure that measured 217 cm (85.4 in) in height and 53 cm (20.9 in) in width, which was encased by aluminum sheeting. There was no protective barrier between the CNG cabinet and the cargo box. The rack allowed for five CNG cylinders to be mounted by the neck, horizontally onto cross members. The cylinders were stacked vertically in the cabinet. The cabinet sustained severe damage as a result of the explosion (**Figure 7**). The sheet metal encasing the cabinet was mostly displaced from the vehicle, with only the forward panel remaining attached. The left rear vertical frame member fractured and separated 88 cm (34.6 in) from the bottom support and the front vertical frame member

**Figure 7:** Left side damage to fuel cabinet

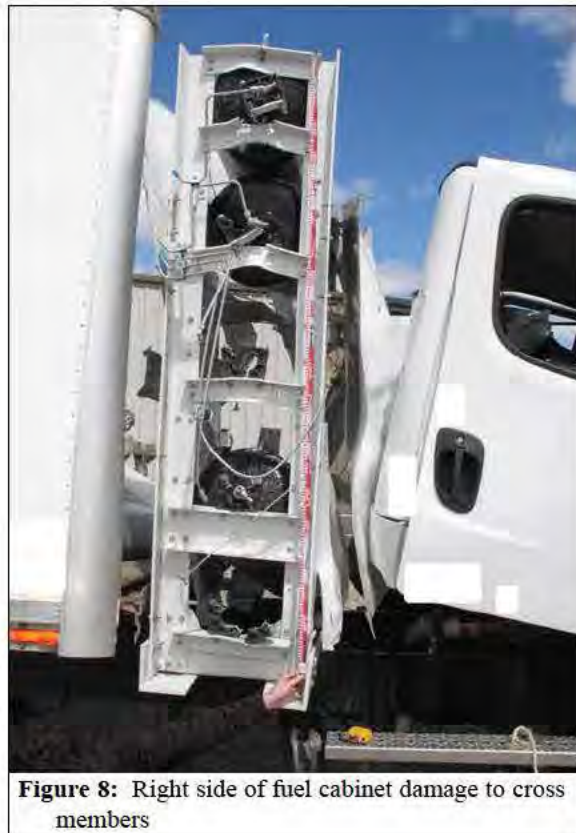
was rotated 90 degrees to the left. All cross members, on both sides, were either fractured, displaced, or bent (**Figure 8**).

**Figure 8:** Right side of fuel cabinet damage to cross members

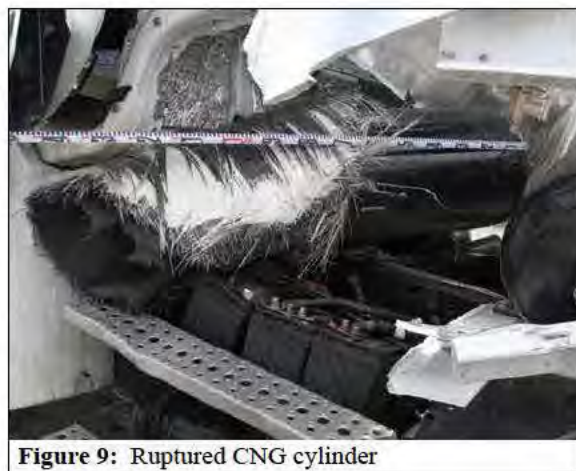
The five CNG cylinders were Type 4 design (polymer liner with carbon fiber and fiberglass overwrap), manufactured by Hexagon Lincoln, Model number RH36A16-07601. Each cylinder measured 205 cm (80.6 in) in length, 41 cm (16 in) in diameter, and were certified with ANSI NGV2 and FMVSS 304. Each cylinder was equipped with a Pressure Relief Device (PRD) at each end, which was designed to pipe discharge away to the top of the cabinet in the event of a breach of the system. Each cylinder had a manual valve without an excess flow device that was manufactured by OMB. The bottom cylinder (cylinder 1) was impacted by the left fork of the forklift and ruptured (**Figure 9**), with the damage starting 65 cm (25.6 in) left of the right end of the cylinder. A 66 cm (26 in) section of the left end of the cylinder (**Figure 10**) separated and was displaced into the street (**Figure 11**). Both valves separated from the bottom cylinder. Cylinder 2 remained intact, but the left side dropped from its mount. The left side valve was detached and part of the right side valve remained in place. Cylinder 3 was propelled out of the cabinet and landed in the street, according

**Figure 9:** Ruptured CNG cylinder

4. The composite fracture apparently progressed approximately in a longitudinal direction and then turned and ran circumferentially, separating one of the cylinder ends and ejecting it from the driver's side of the truck.

8. The shape of the fork tip probably produced a cut perpendicular to the critical hoop direction reinforcing fibers. These fibers carry the greatest load in a pressure vessel and the orientation of the fork tip was such to maximize the number of hoop fibers that were damaged.

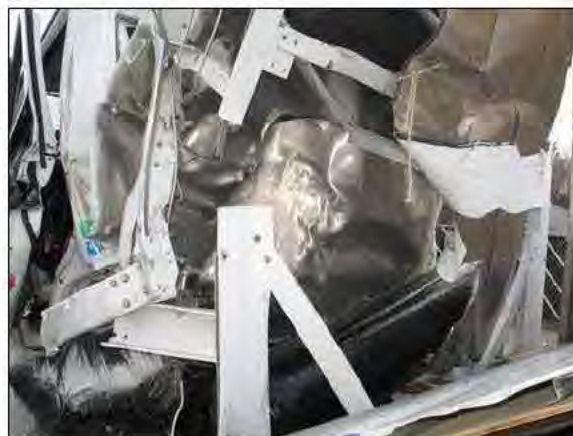
The interior of the Freightliner sustained severe damage from the CNG cylinder explosion. There were a total of twelve intrusions to the passenger compartment. The most severe intrusions occurred in the driver's space and were to the back wall of the cab and the backlight header (**Figures 12 and 13**), which intruded longitudinally approximately 80 cm (31 in), and 30 cm (12 in), respectively, and the floor, which intruded vertically approximately 40 cm (16 in). The driver was projected forward by the explosion and he loaded the steering assembly (**Figure 13**), displacing it forward approximately 25 cm (10 in). Scuff marks were noted on the roof above the driver's seat, possibly from contact by the driver's head. The rearview mirror was also displaced from possible contact by the driver's right hand. Fragments of fiber glass from the ruptured CNG tank were also deposited throughout the cab. Some of the fragments cut the ceiling upholstery in the front right passenger's space, and fragments were embedded in the roof and damaged a plastic storage compartment in this area. Both doors were jammed shut and the left door was mechanically pried open by rescue personnel. The windshield was in place and holed due to explosion forces. The right and left glazings as well as the backlight all disintegrated due to the explosion. The only undamaged glazings were the small windows on each door.

**Figure 12:** Exterior view of intrusion of back wall of Freightliner's cab

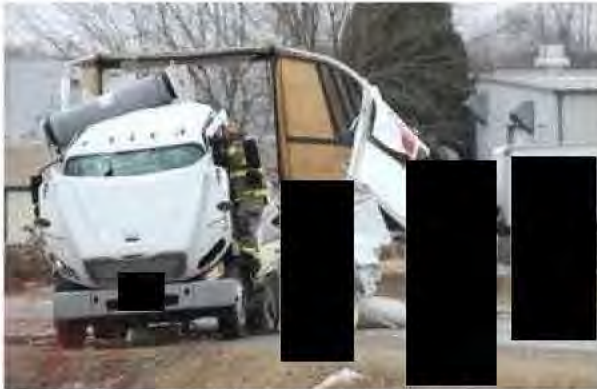
**One person was killed after the truck he was driving exploded Thursday on Pamperin Road in Howard. / H. Marc Larson/Press-Gazette Media**
