PE14-020

DATA TO ODI

This on-site investigation focused on the Compressed Natural Gas (CNG) fuel system of a 2014 Freightliner M2 112 (**Figure 1**). One of the five CNG fuel cylinders was punctured by the left fork of an unsecured Yale Type E forklift located in the cargo box of the Freightliner resulting in an explosion of the fuel cylinder. There was no fire. This investigation was initiated by the National Highway Traffic Safety Administration (NHTSA) on April 15, 2014 through the Office of Defects Investigation (ODI), which was responding to an on-line news article. This investigation was assigned on April 17, 2014 when cooperation to inspect the Freightliner was finalized with the vehicle's owner. The incident involved the Freightliner and the Yale Type E forklift located within the cargo box of the vehicle. This incident occurred in April 2014 at 1335 hours, in Wisconsin and was investigated by a local police agency. The Freightliner and incident scene were inspected on April 22, 2014. Interviews with the front right passenger of the Freightliner, the owner of the Freightliner, and the city public safety director were also conducted on April 22, 2014.

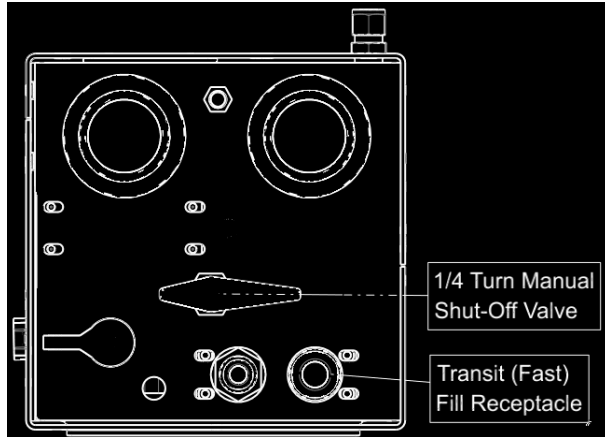
Transit (fast) fill receptacles are prone to freezing during rapid filling procedures due to "wet" compressed natural gas conditions.

Figure 32 Transit (Fast) Fill Freeze-Up

To remedy the issue, keep the 1/4-turn main shutoff valve in the “OFF/CLOSED” position until ice is no longer visible and the internal poppet assembly achieves a seal. Once sealed, the internal check valve will resume normal operation and gas will cease to escape from the receptacle.

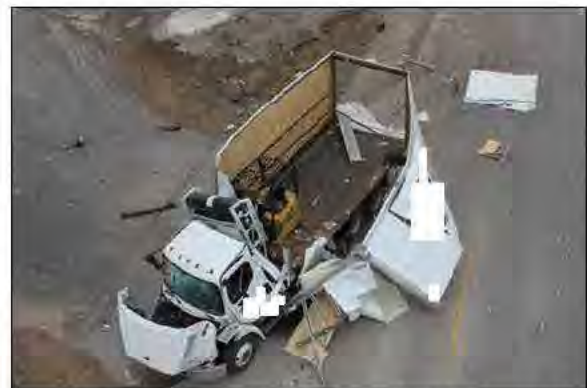
**Figure 1:** On-scene police photograph of the damaged 2014 Freightliner M2 112

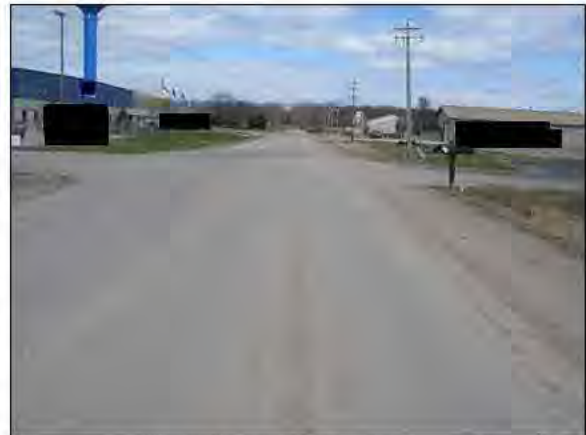
**Figure 2:** Freightliner's eastbound approach to the driveway (on right) and area of explosion

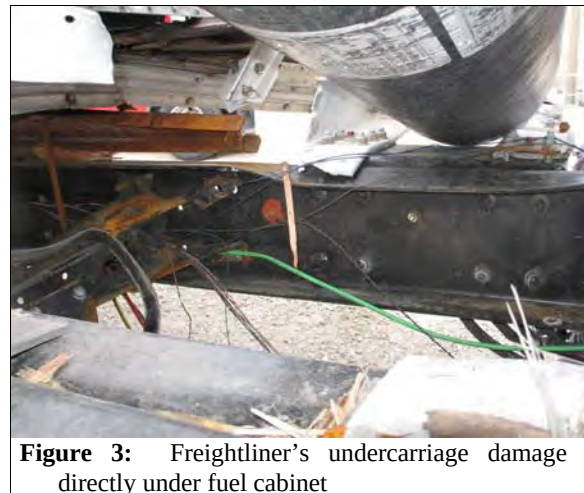
**Figure 3:** Freightliner’s undercarriage damage directly under fuel cabinet

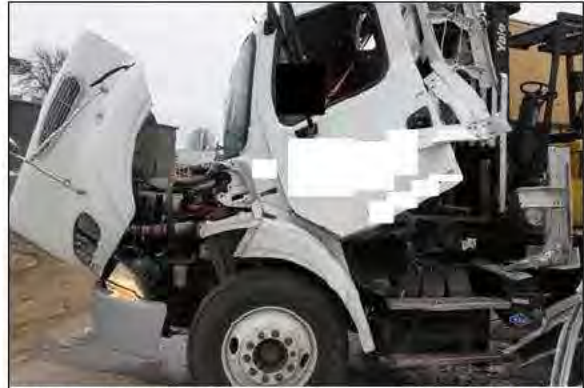
**Passenger Cab:** The cab of the truck was heavily damaged from the explosion (**Figure 4**). The most

**Figure 4:** Police on-scene photograph of damage to cab of the Freightliner

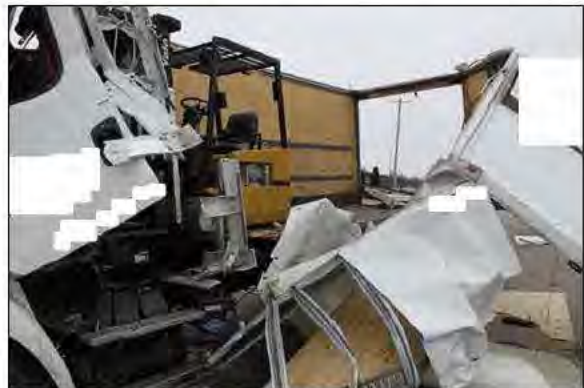
**Figure 5:** Police on-scene photograph of damage to the Freightliner's cargo box

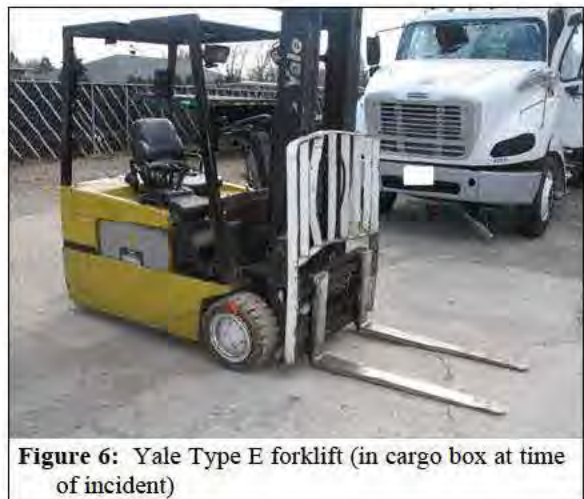
**Figure 6:** Yale Type E forklift (in cargo box at time of incident)

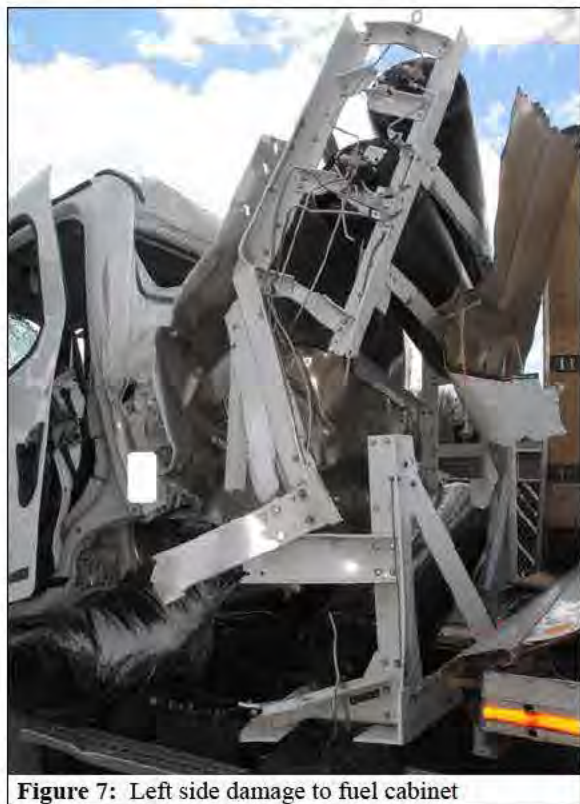
**Figure 7:** Left side damage to fuel cabinet

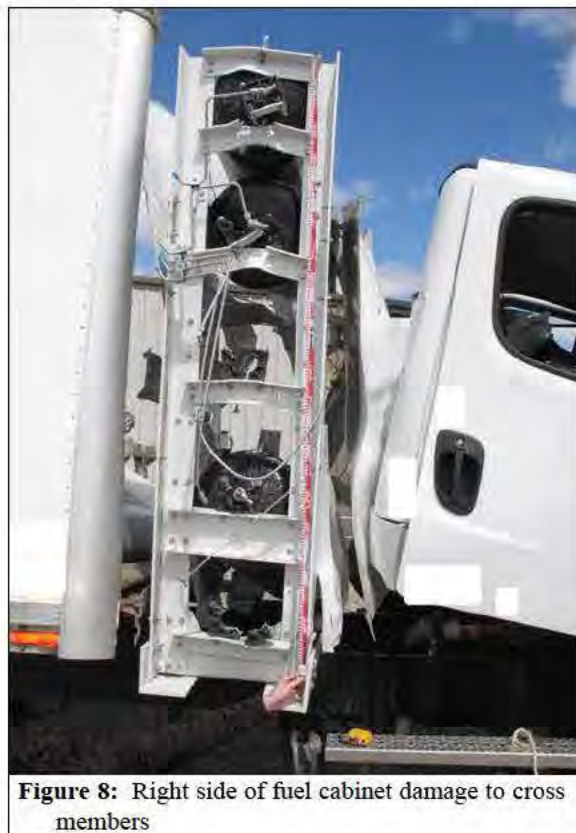
was rotated 90 degrees to the left. All cross members, on both sides, were either fractured, displaced, or bent (**Figure 8**).

**Figure 8:** Right side of fuel cabinet damage to cross members

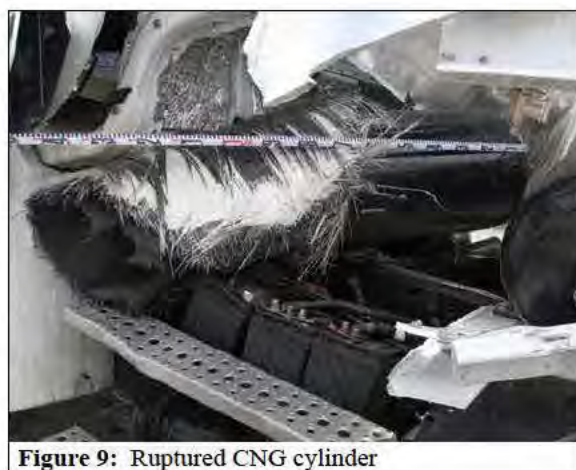
The five CNG cylinders were Type 4 design (polymer liner with carbon fiber and fiberglass overwrap), manufactured by Hexagon Lincoln, Model number RH36A16-07601. Each cylinder measured 205 cm (80.6 in) in length, 41 cm (16 in) in diameter, and were certified with ANSI NGV2 and FMVSS 304. Each cylinder was equipped with a Pressure Relief Device (PRD) at each end, which was designed to pipe discharge away to the top of the cabinet in the event of a breach of the system. Each cylinder had a manual valve without an excess flow device that was manufactured by OMB. The bottom cylinder (cylinder 1) was impacted by the left fork of the forklift and ruptured (**Figure 9**), with the damage starting 65 cm (25.6 in) left of the right end of the cylinder. A 66 cm (26 in) section of the left end of the cylinder (**Figure 10**) separated and was displaced into the street (**Figure 11**). Both valves separated from the bottom cylinder. Cylinder 2 remained intact, but the left side dropped from its mount. The left side valve was detached and part of the right side valve remained in place. Cylinder 3 was propelled out of the cabinet and landed in the street, according

**Figure 9:** Ruptured CNG cylinder

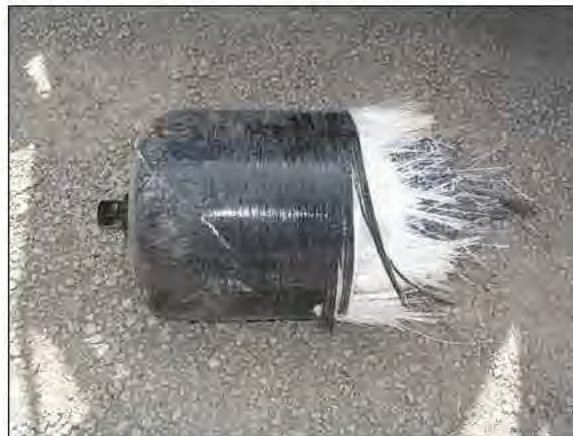
**Figure 10:** Displaced section of ruptured CNG cylinder

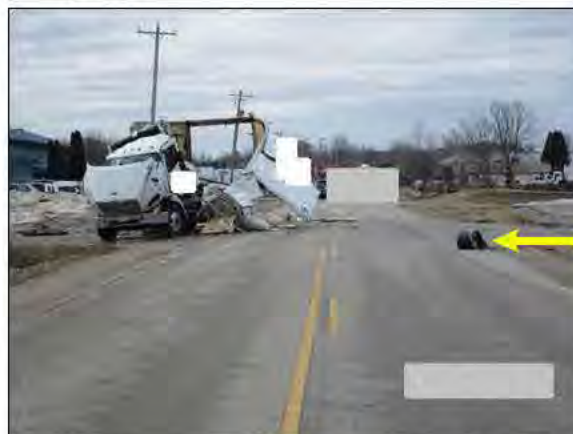
**Figure 11:** Police on-scene photograph showing location of displaced section of bottom CNG cylinder (arrow)

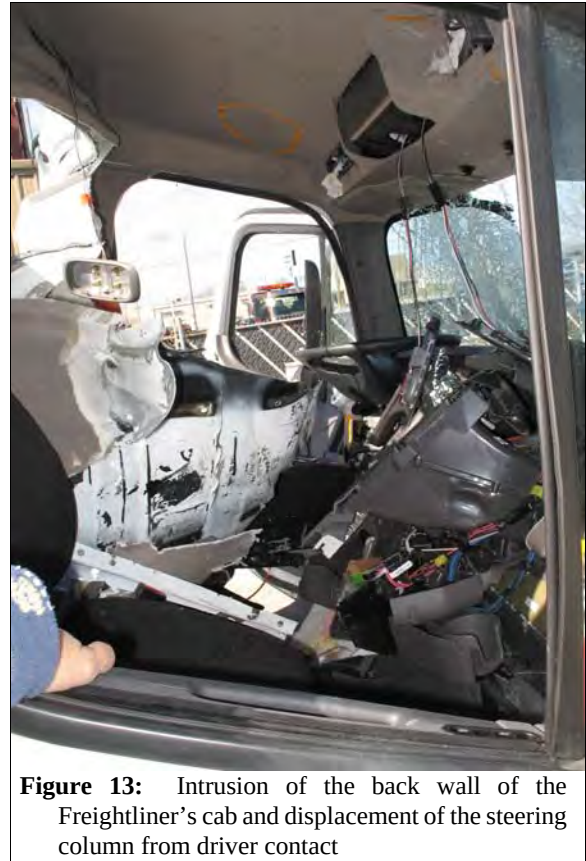
**Figure 13:** Intrusion of the back wall of the Freightliner's cab and displacement of the steering column from driver contact
