PE14-028

FORD

APPENDIX G

Engineering Review

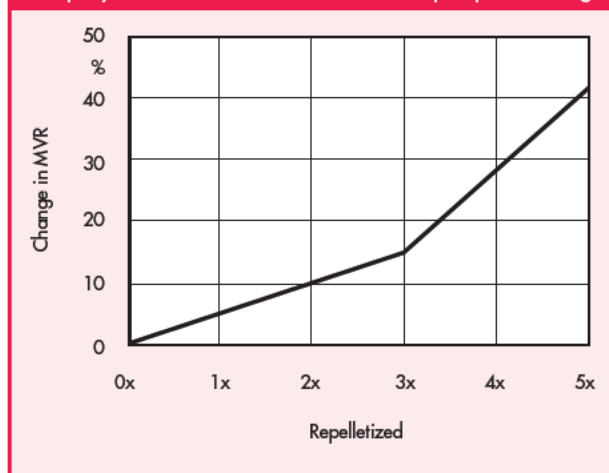
**Fig. 92** · Change in the volume flow rate (MVR) of polyacetals as a function of multiple processing

Multiple processing can lead to material degradation. This is shown by an increase in the volume flow rate MVR which is an index for reduction in molecular weight, fig. 92. An increase in MVR is accompanied by a loss in thermal stability and frequently in toughness as well.

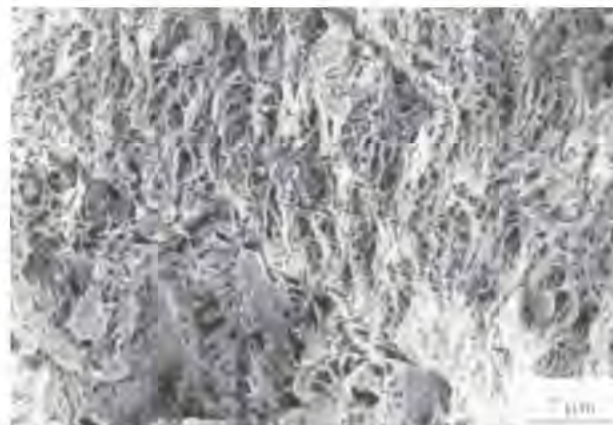
Fig. 13. SEM micrograph of a detail of the damage zone from a tensile fracture surface.

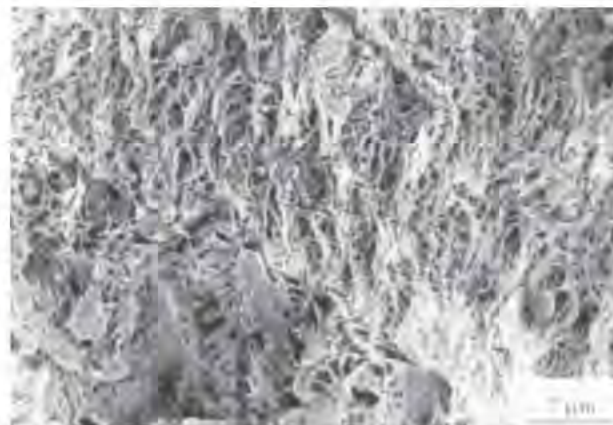
Fig. 13. SEM micrograph of a detail of the damage zone from a tensile fracture surface.
