PE14-030

FORD

12/19/2014

**2010 thru 2012 Model Year Ford Fusion, Lincoln MKZ,
2010 thru 2011 Model Year Mercury Milan
Alleged EPAS failure while driving, resulting in increased steering effort**

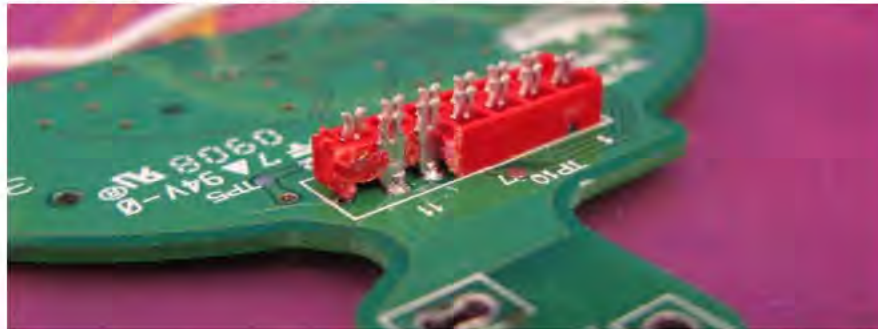
Motor PCB connect pin with sectioned to show pins

Centred Pin

- PCB track for connecting to pin
- Ground Plane
- Clearance around pin

Misaligned pin could short circuit to the ground plane. Resulting in a motor position fault.

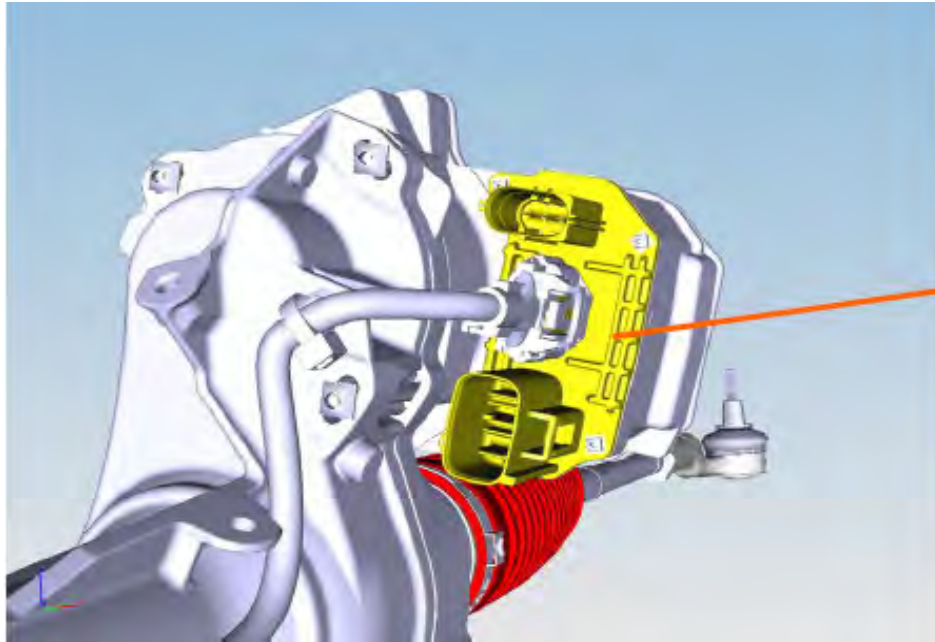
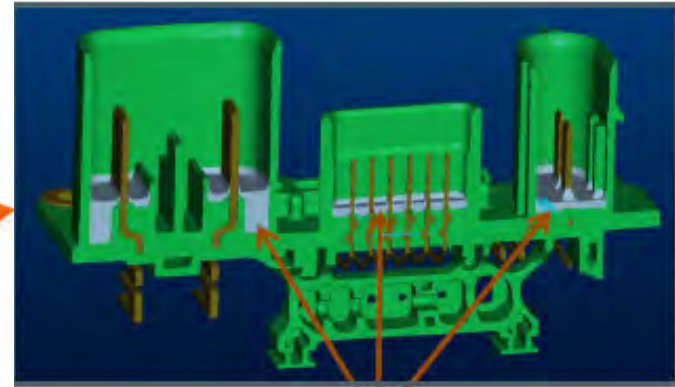
Photos for change 6

EPP Header

Potting material added around terminals

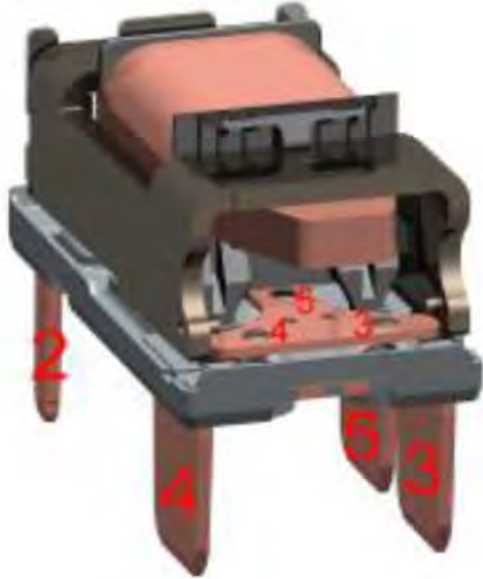
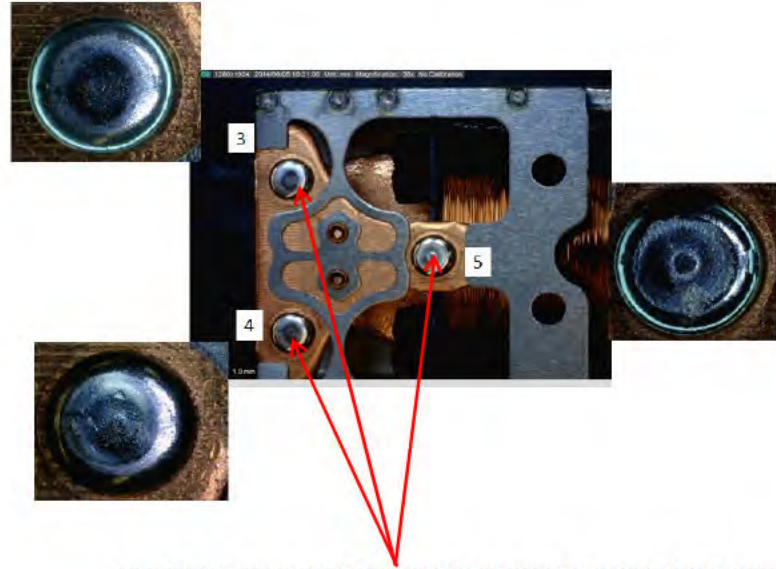
Photos for changes 1, 2, and 3

Relay

Ice can be generated on contacts prevent contacts from closing at start up.
