PE14-030

FORD

APPENDIX I

Engineering Review

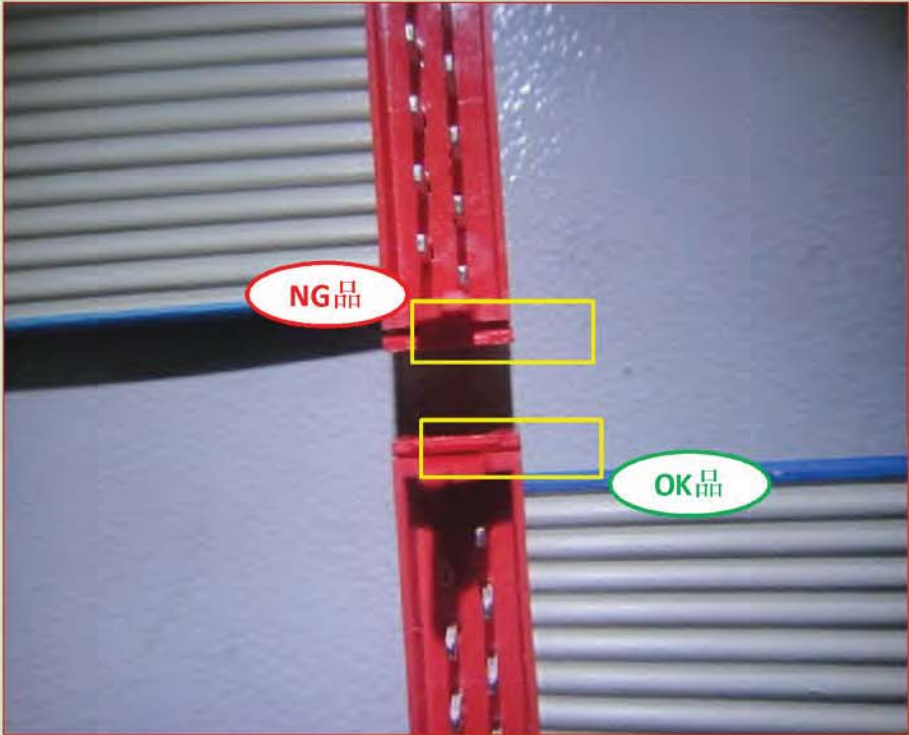
A	B	C	D	E	F	G	H	I	J	K	L	M
1	<div>导线端子卡销间隙大</div>

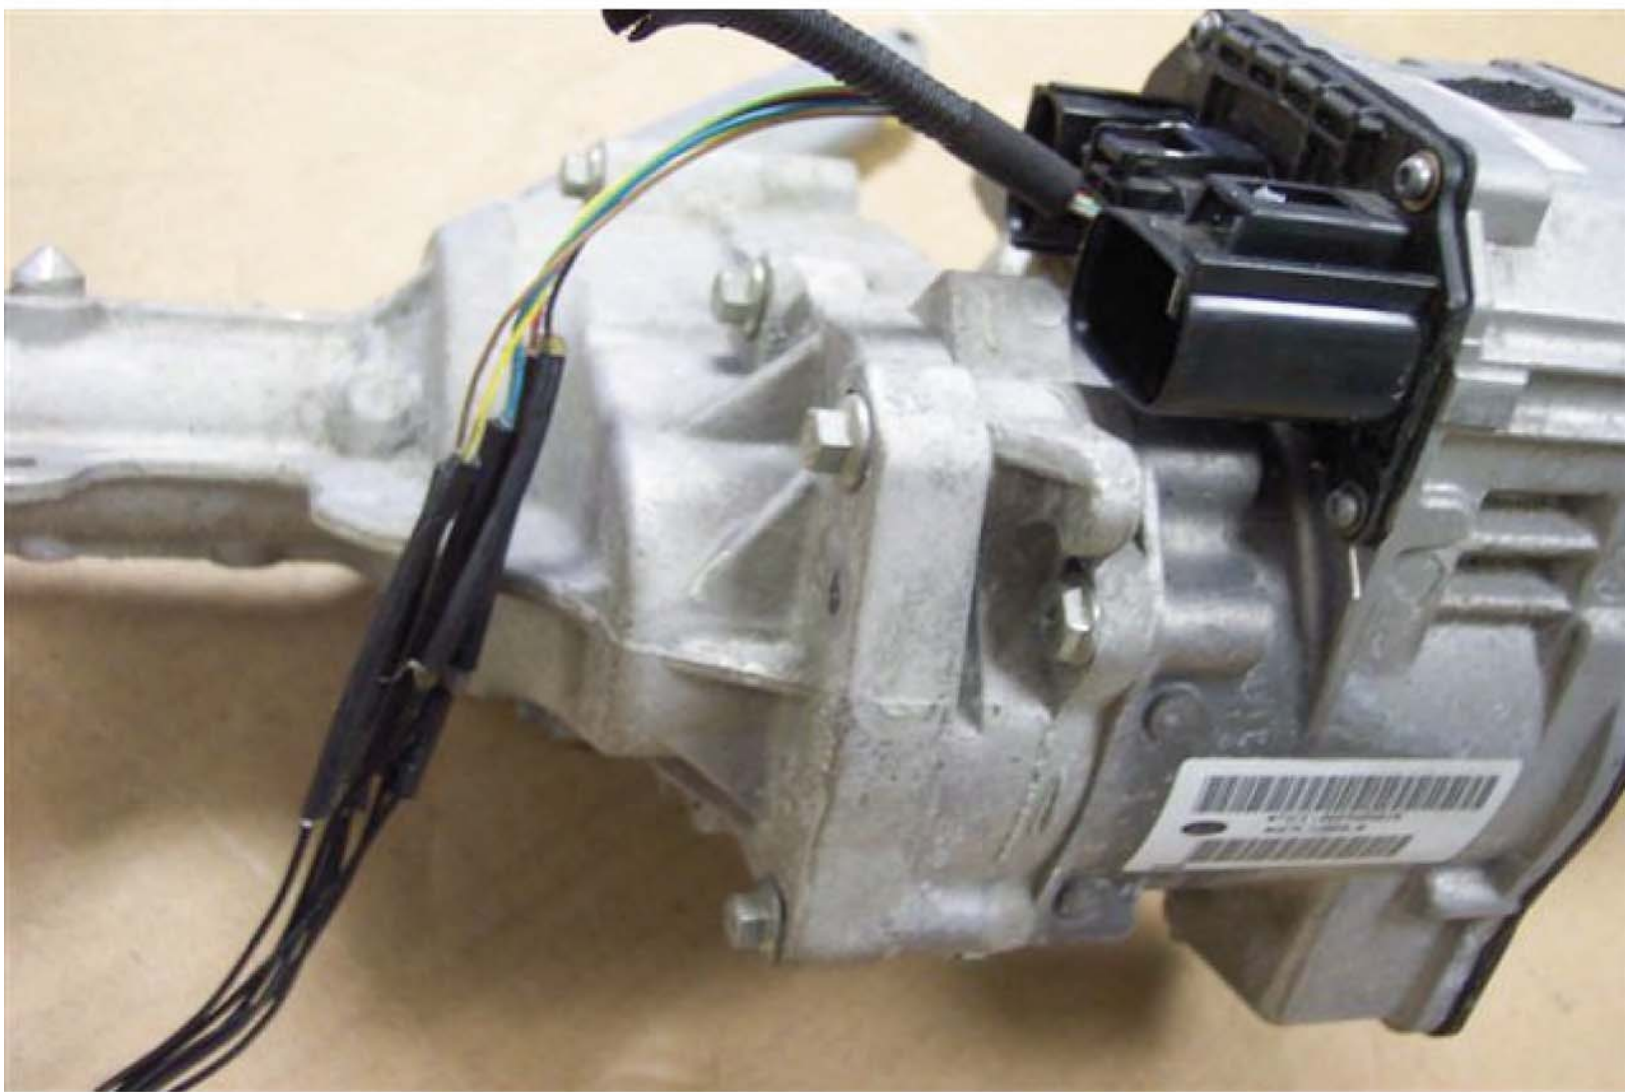
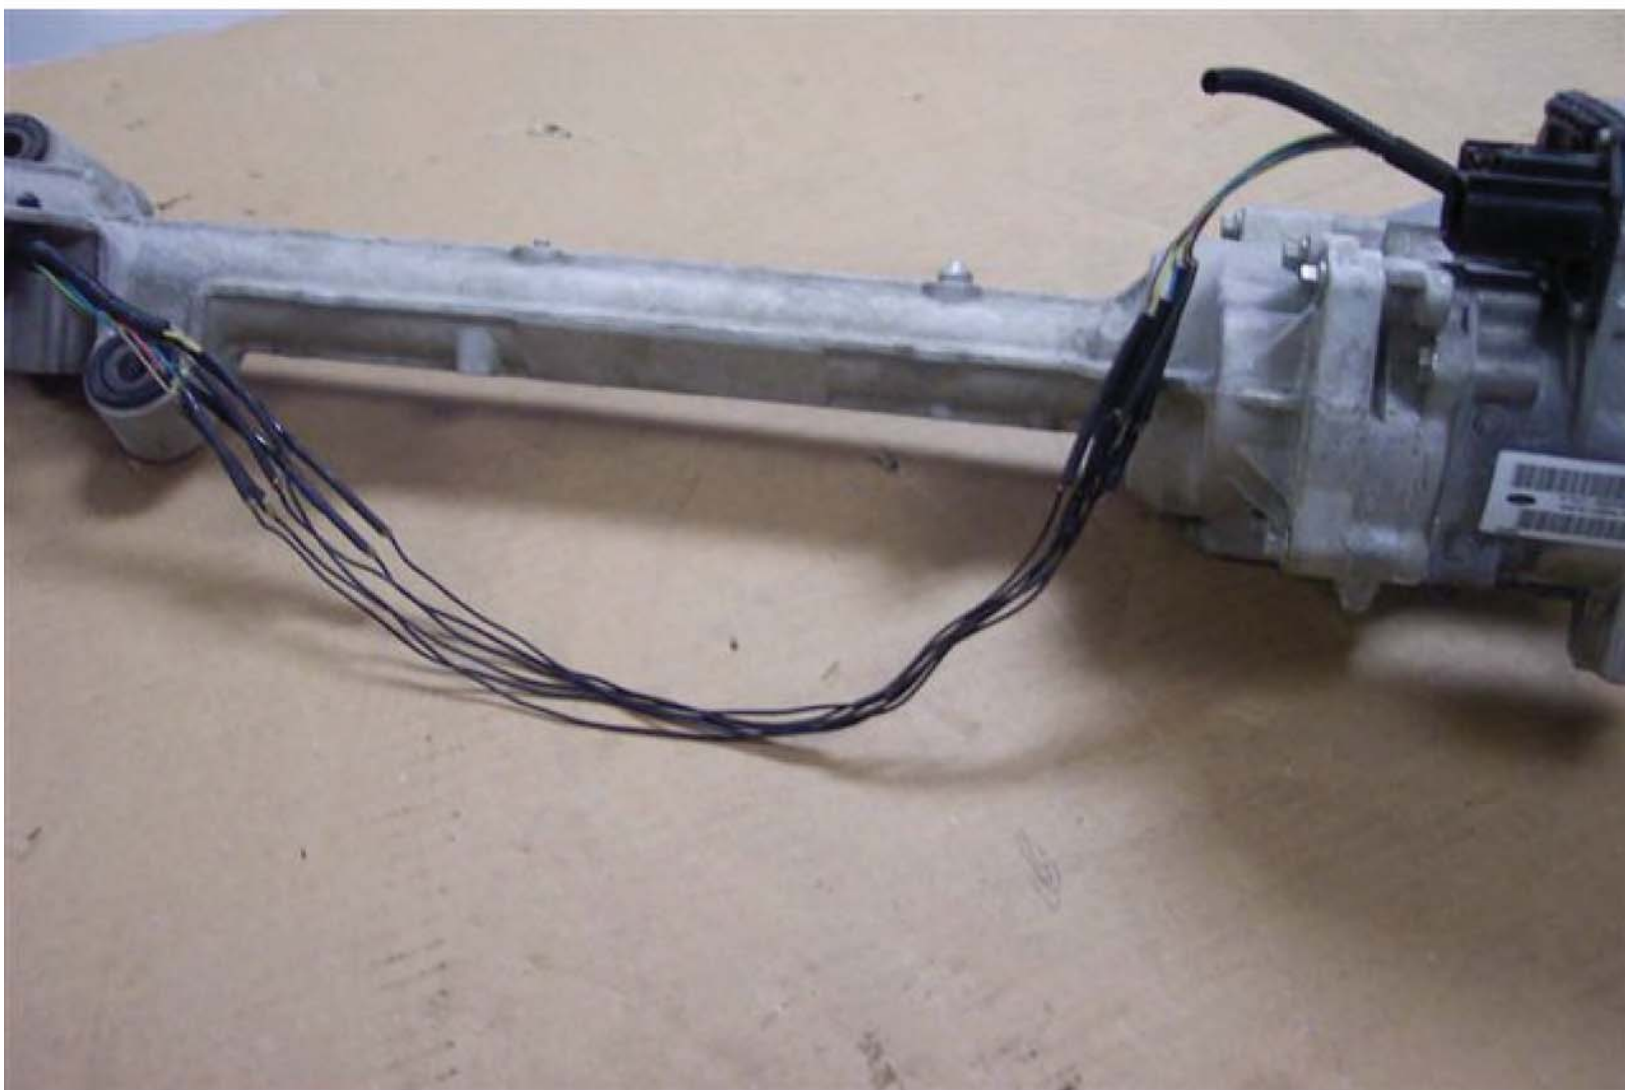
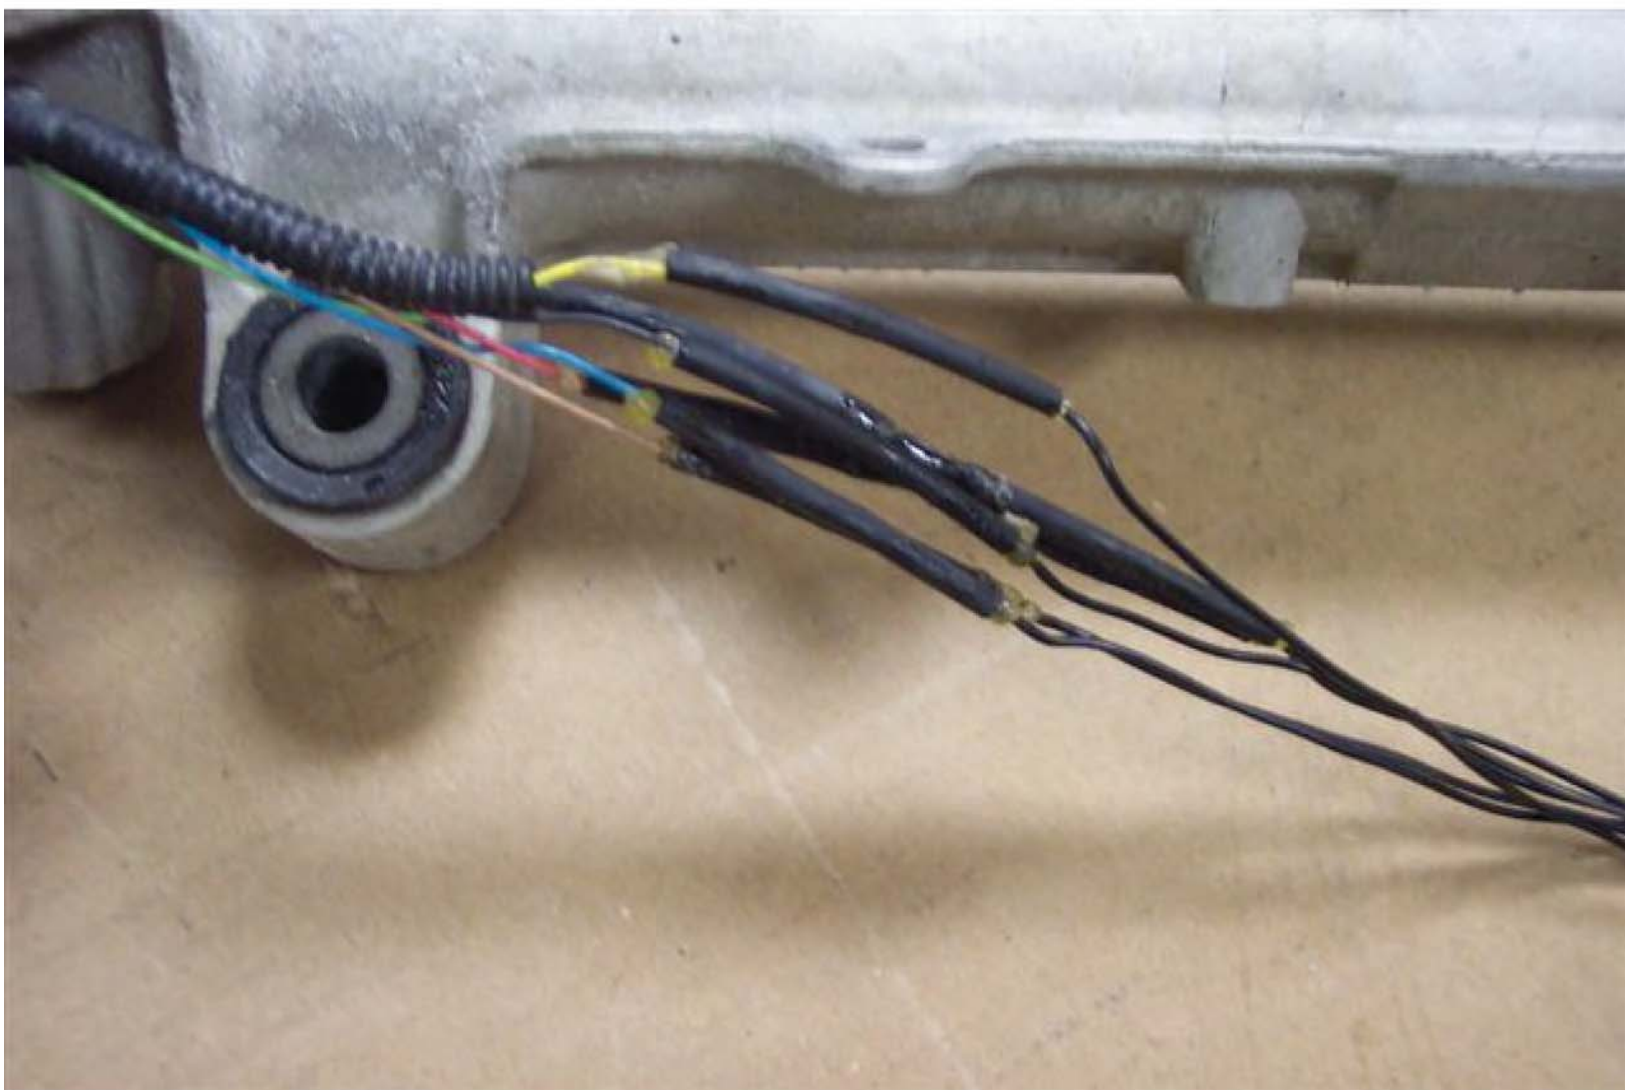
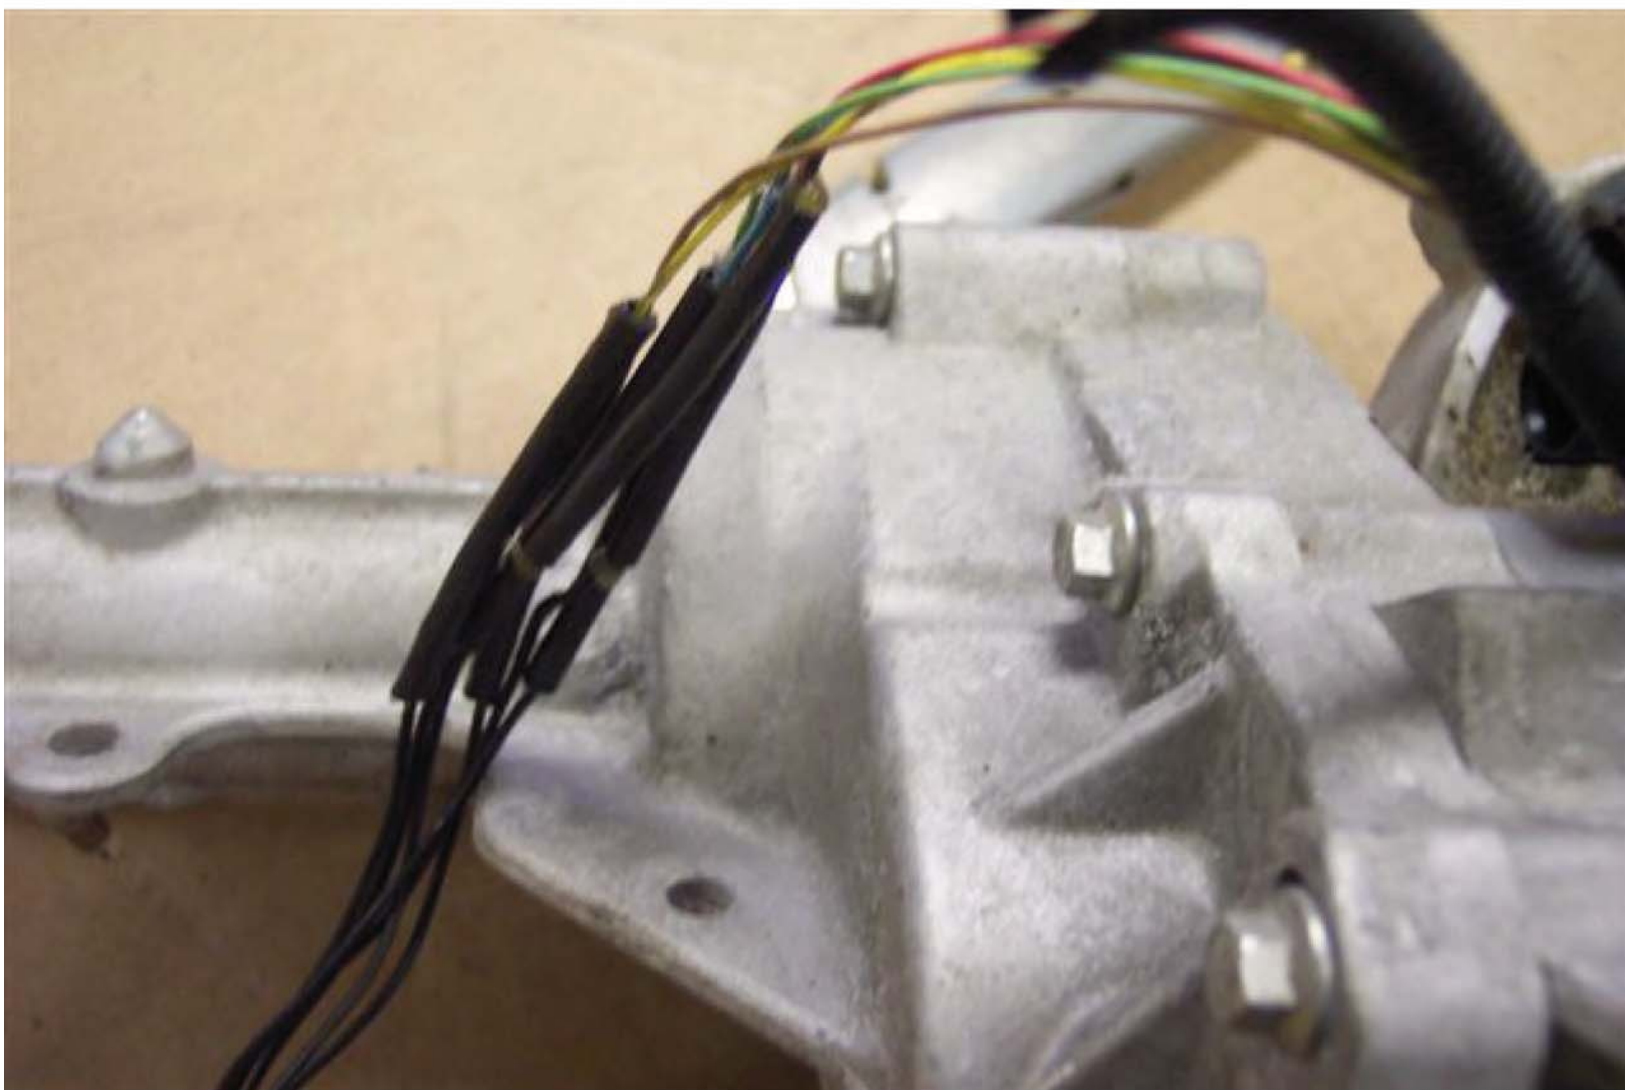
EPAS Gear 001.jpg
EPAS Gear 002.jpg
EPAS Gear 003.jpg
EPAS Gear 004.jpg
EPAS Gear 005.jpg
EPAS Gear 006.jpg

This is one we did not have time for in yesterday's TS meeting but not sure if we can close this out since the dealer cut-out the evidence of a damaged TS harness. See attachments for pics & the interactive diagnosis. Vehicle was not in a wreck or had other repairs only came in for this complaint and the vehicle has 22k miles so unsure how this TS harness was damaged.
