PE14-030

FORD

APPENDIX I

Engineering Review

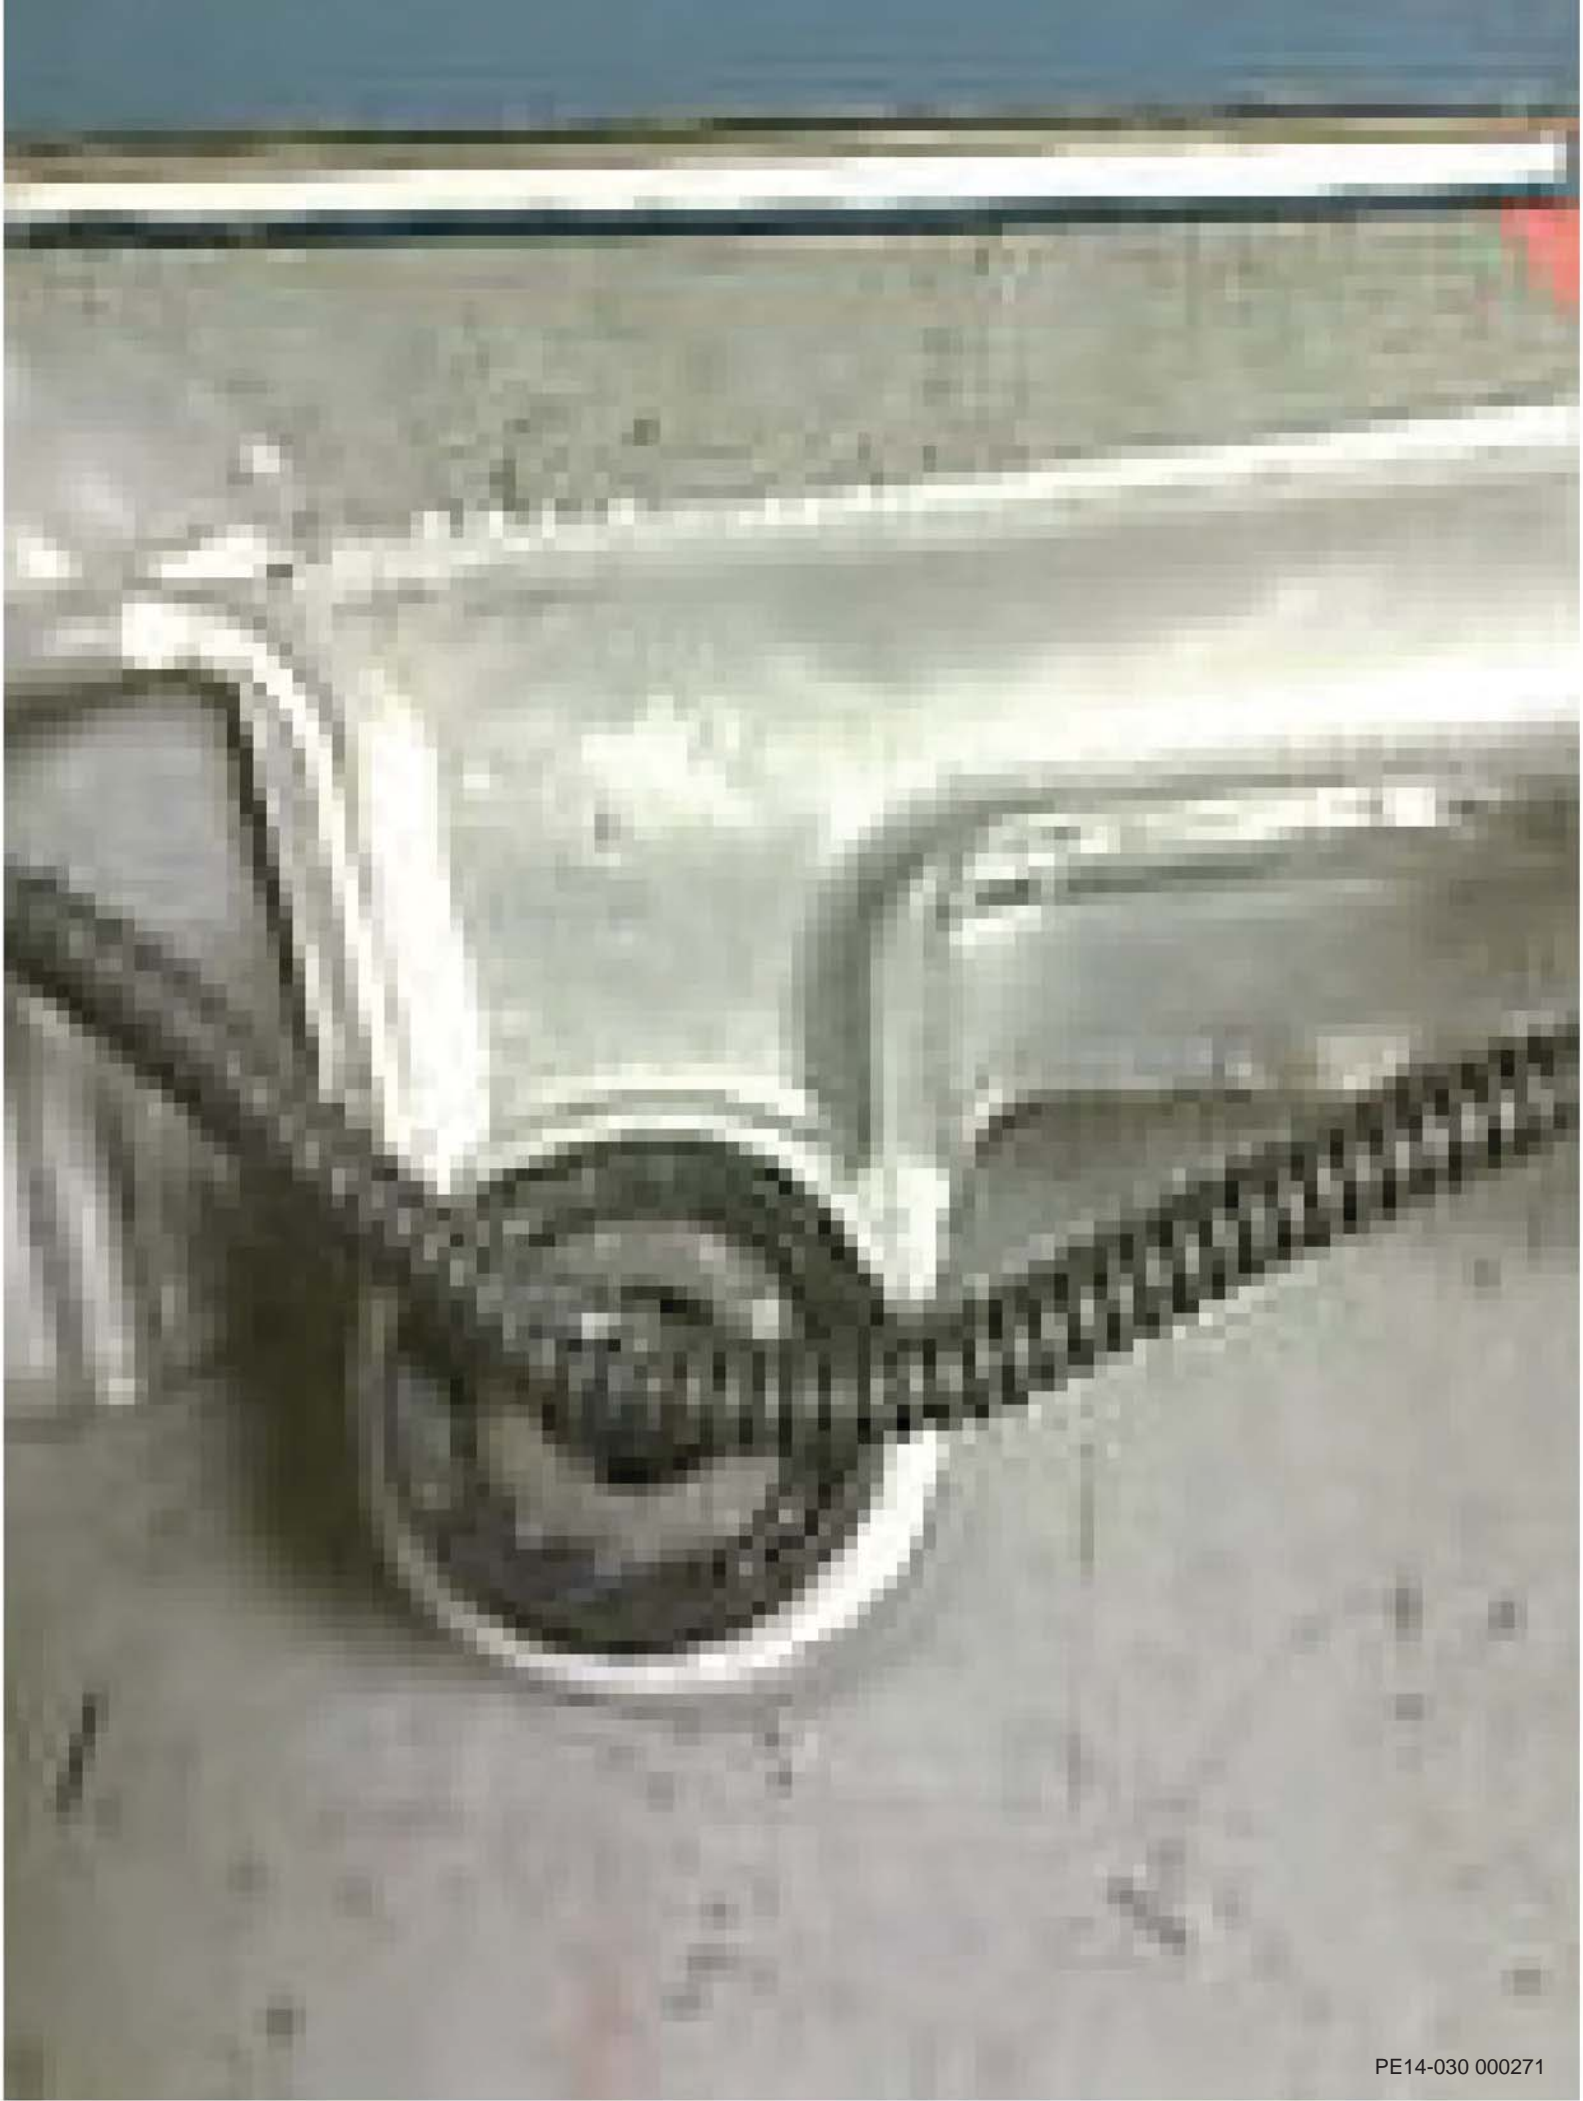
Pete,
TRW was looking at expensive clip options but Benteler said they would just move the wire before driving the bolt so we made no design changes.

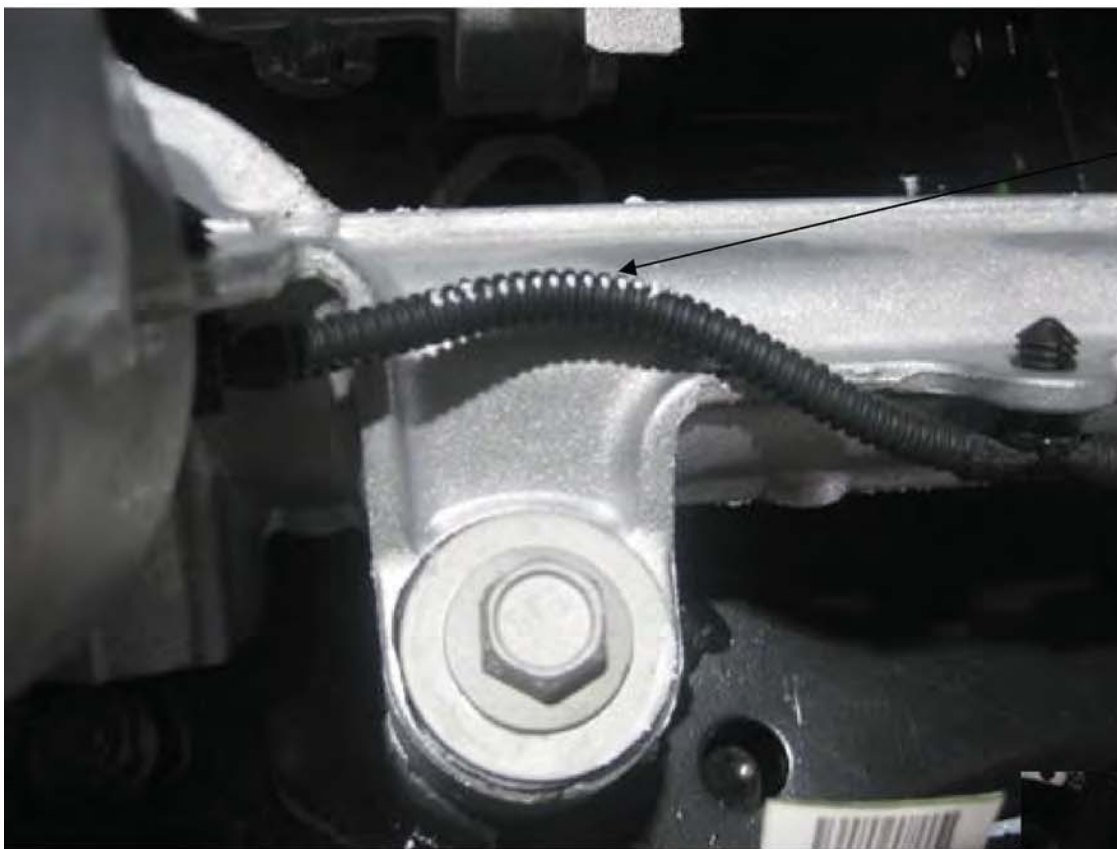
Today during the build we saw an interference between the EPAS harness and the bolt that attach the gear to the frame, see pics. I remember this issue in VP's but I do not remember what was the last word on it, Do you remember if the length of the harness would be reduce to prevent this??? Or what was the last word????

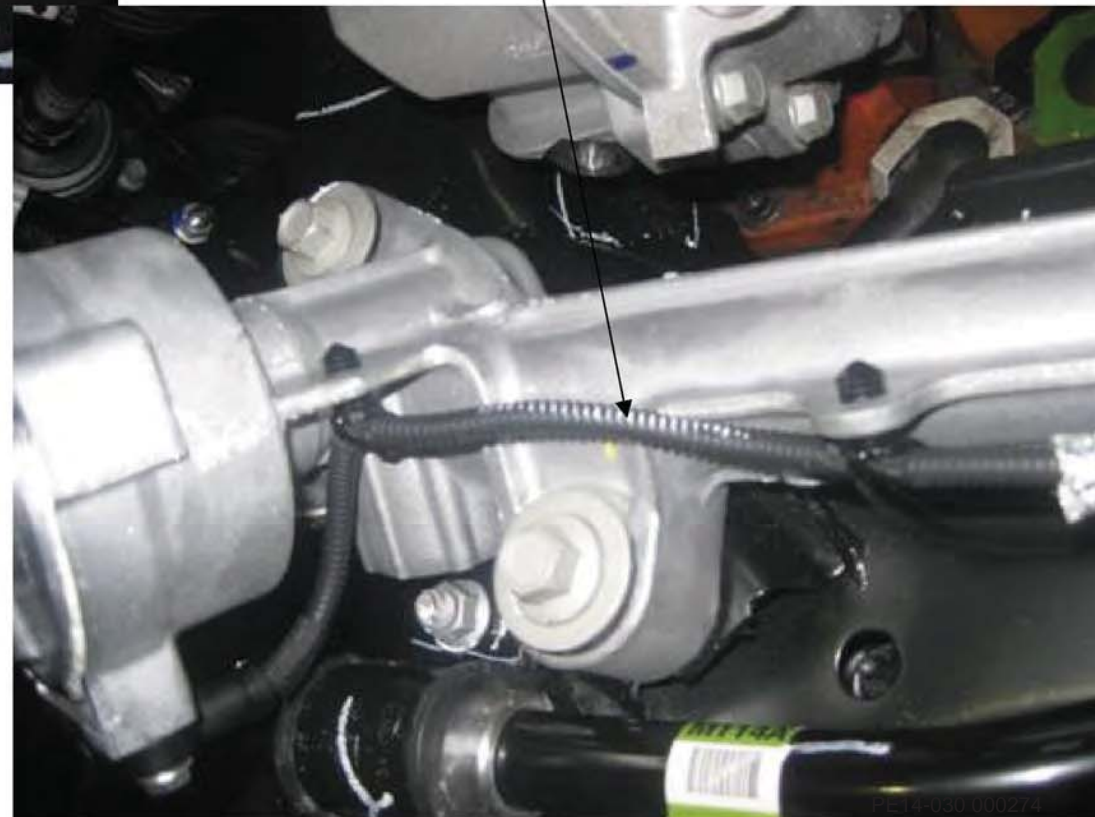
After apply the torque the operator mark the harness as an evidence that the cable was not crashed
