PE14-032

HNDA

12-19-2014

Title: CBR250 Insufficient valve clearance causes engine to cut out with clutch disengaged
(Valve clearance adjust NG)

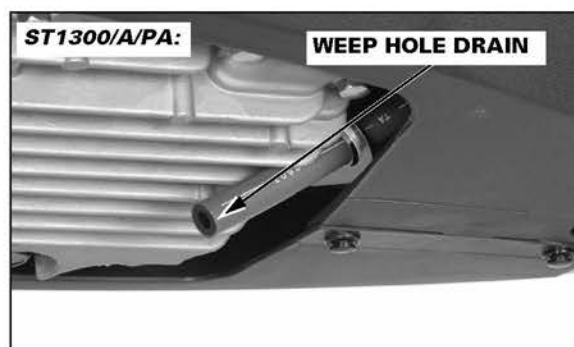
Some dealers have reported small coolant stains underneath water cooled vehicles on their showroom floors. A small amount of coolant leaking from the water pump inspection/weep hole on new vehicles, when the engine is stopped, is normal.

Remember that a brand-new vehicle has very little run-time on the engine. As a result, the mechanical water pump seal has not broken in and fully sealed yet. Running the engine will promote break-in of the water pump seal. There should be no continuous leakage from the weep hole when the engine is running.

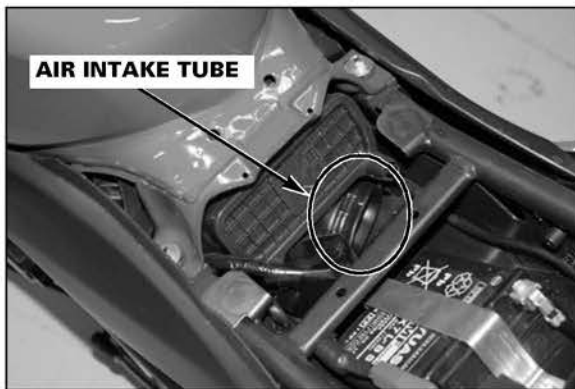
TechLine has received a few reports from dealers of blocked air cleaner intake tubes. The typical customer complaint is that the engine won't run or starts but won't accelerate. Upon examination, the technicians have found maps or other items blocking the air intake tube, which is located under the rider seat. Apparently, customers have been tempted to use this area for storage. Advise customers to use only the tray beneath the passenger seat for storage.

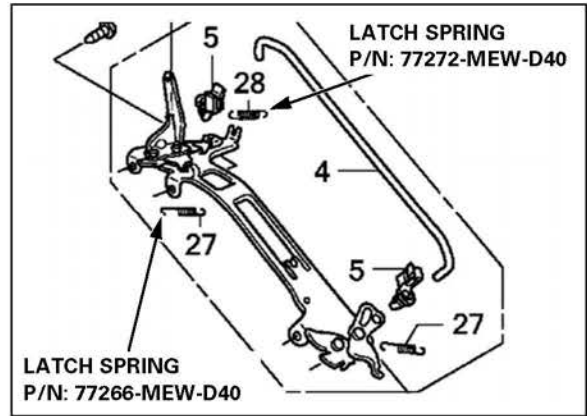
If you encounter a saddlebag that won't stay latched, chances are that one of the three springs in the saddlebag catch assembly is either broken or has become dislodged from the mechanism; often by small items being improperly stored under the seat. There is no need to replace the entire saddlebag catch assembly as the springs are easily replaced using long needle-nose pliers. Once the latch is repaired, advise the customer not to store under seat items outside the frame rails, as they may interfere with saddlebag latch operation. See the illustration at the top of the next column for a detailed parts catalog view and part numbers.

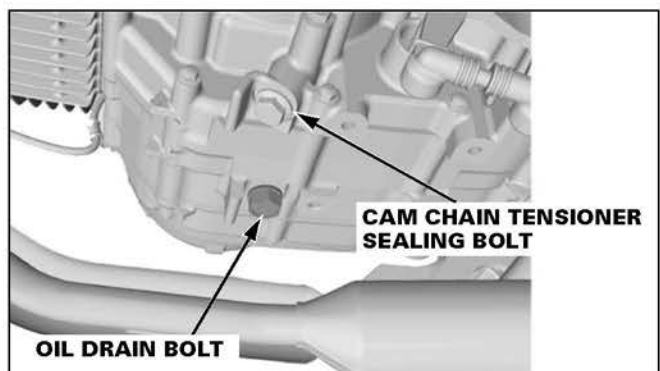
Recently, TechLine has fielded some calls from dealer technicians who were alarmed when a spring jumped out of the oil drain bolt hole... Turns out these techs had actually removed the cam chain tensioner sealing bolt rather than the oil drain bolt. As it happens on the horizontal cylinder engine layout, the oil drain bolt and the cam chain tensioner sealing bolt both face down and they both have 17 mm hex heads. However, the bolts are easily differentiated as the oil drain bolt has a dull grey finish and the cam chain tensioner sealing bolt has a bright, shiny finish.

So be careful and refer to the Service Manual when changing oil on the Grom for the first time to be certain you're removing the oil drain bolt. If you remove the wrong bolt, refer to page 9-15 of the Service Manual for the proper installation of the cam chain tensioner spring and sealing bolt.

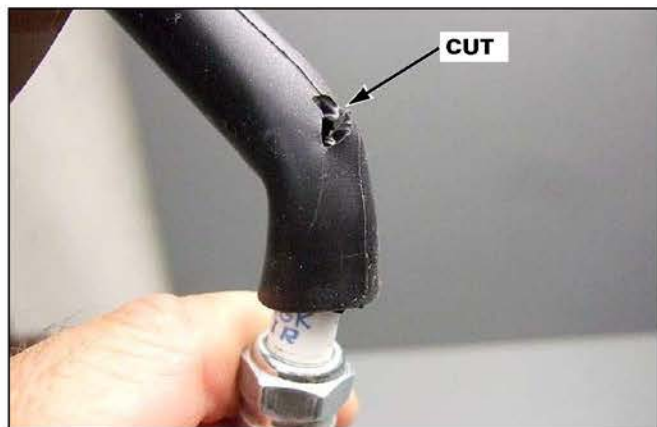
If you encounter a CBR250R/RA that won't start, has poor idle, a clicking noise coming from the cylinder head, and/or poor throttle response, the

problem may be a damaged spark plug boot. The silicone rubber spark plug boot can be easily cut by the threaded spark plug terminal if the boot is not carefully positioned over the spark plug when it is installed. Even a small cut in the plug boot can allow voltage to short circuit from the spark plug terminal to the cylinder head, causing the driveability/starting problems.

To inspect the plug boot for cuts or cracks, squeeze it between your fingers near the terminal area. To help ease the installation of the plug boot and therefore prevent the spark plug terminal from tearing plug boot, dab some dielectric grease around the inside of the boot opening before slipping the boot over the spark plug.

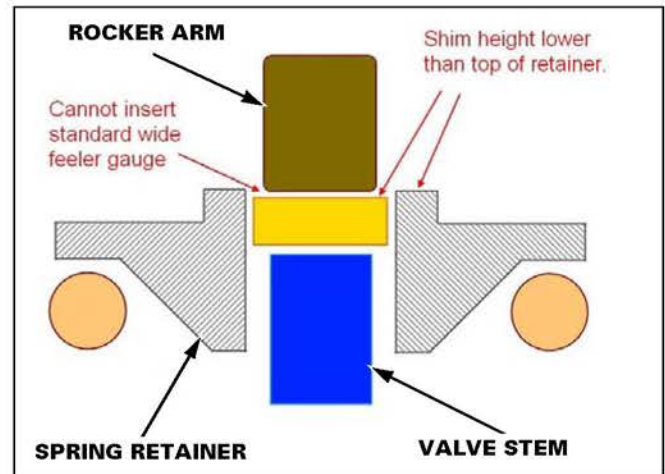
In some cases (where thin shims are installed), the valve shim may sit below the edge of the spring retainer shim cavity as shown. As a result, standard width feeler gauges will not provide accurate readings. Narrow feeler gauges (less

than 6.2 mm wide) will be necessary to fit into the recess of the valve spring retainer.

Tapered, and tapered-angled feeler gauges are now available from AHM that allow very accurate valve clearance measurements on this model. See the *Tool Chest* section for part numbers.

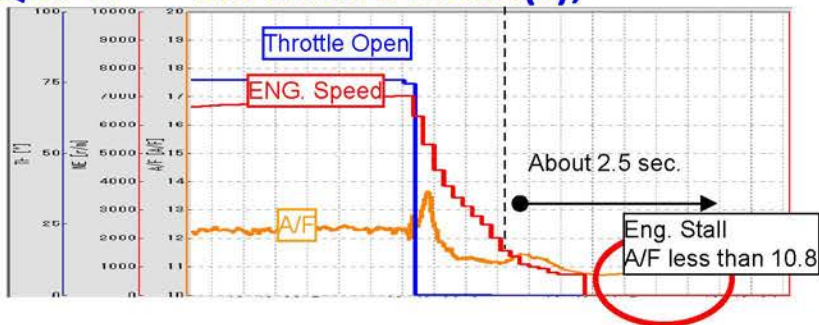
- The tightening torque of the cylinder Head ($51 \pm 3\text{Nm}$) had no margin for limit axial force before leak occurs (38.6kN). Thus, depending on manufacturing variation in tightening the cylinder head at the manufacturing plant, there are instances in which axial force may exceed the leak limit (38.6kN).

- The failure may happen intermittently within 10 minutes of engine start-up while riding between 3000-8000rpm and the clutch is disengaged for an extended period of time.

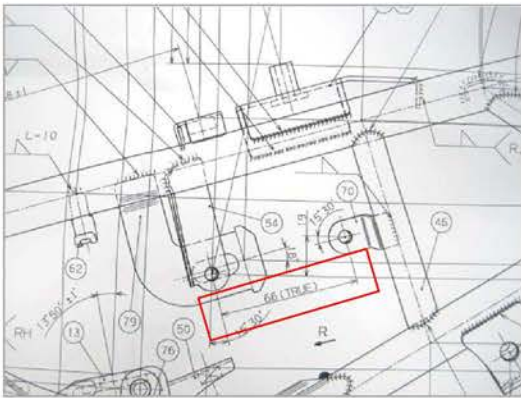
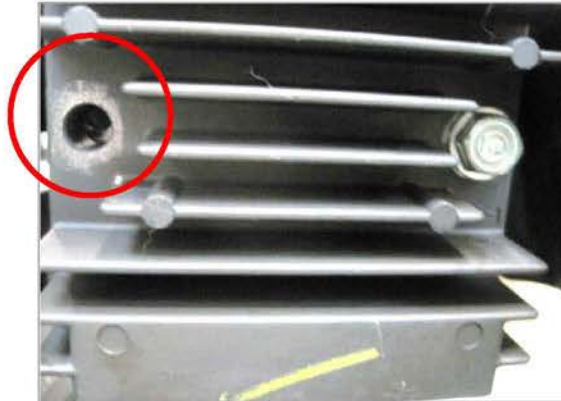
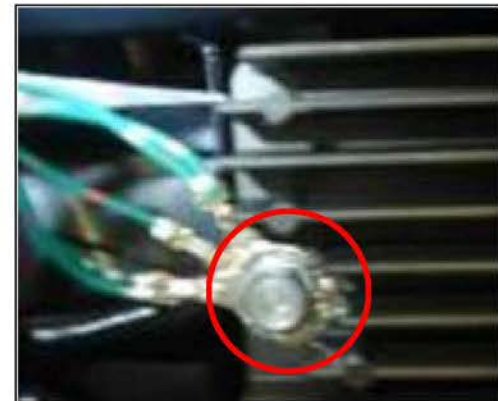
• The regulator/rectifier and frame were not in alignment for installation. The wire harness ground terminal and regulator/rectifier are jointly fastened to the frame and, due to the misalignment the mounting bolt was installed at an angle causing the threads to strip. The stripped threads created a loose ground connection. Also, a post-tightening check was not performed.

• Because of a loose ground connection, riding and engine vibrations cause poor electrical contact resulting in electrical component malfunctions (vehicle lights and indicator lights on the instrument panel flicker, or sometimes will not illuminate), rough idle, or engine stalling.

- Most failures occur very early and are detected at pre-delivery inspection or not long after purchase. Prior to an engine stall, the engine speed will become unstable. At that time, there will be no sudden change in deceleration feeling, and irregular vehicle behavior will not occur.

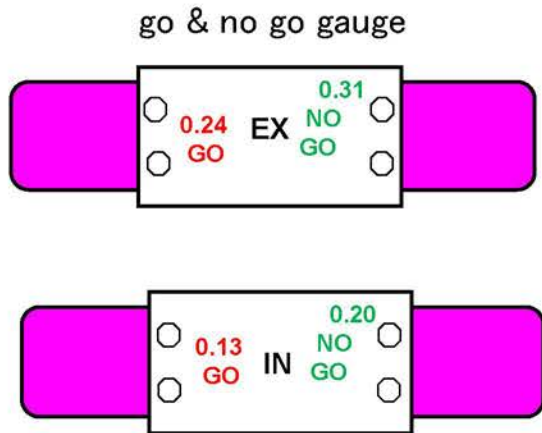
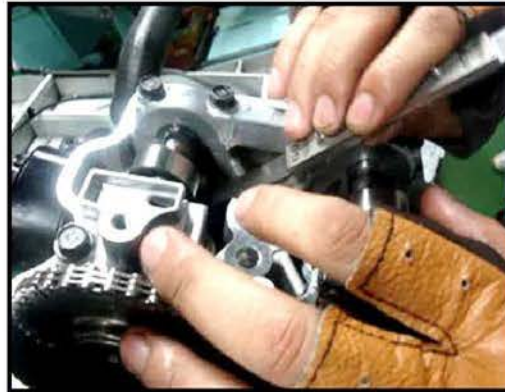
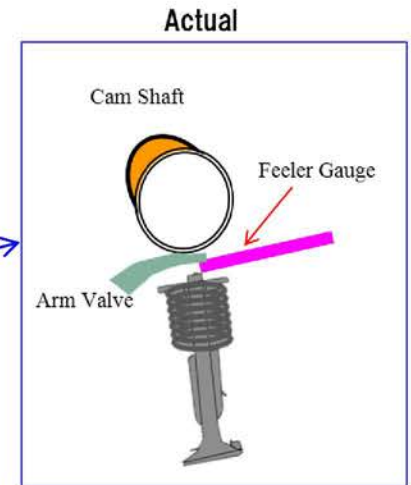
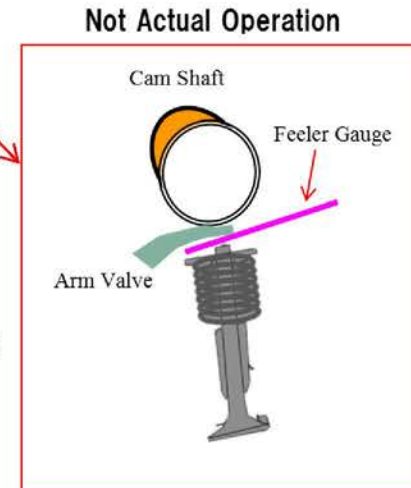
- The GO side of the GO & NO GO gauge was not checked during the valve adjustment of the engine assembly process.
- Units with insufficient valve clearances were released.

- With intake and exhaust valve clearances below specification, idle speed becomes unstable, or the engine stalls while it is hot.

- The failure is unstable idle speed. Engine stalling occurs while coasting with the clutch disengaged or at idle, and the engine can be started by operating the starter switch. Therefore, rapid deceleration or irregular vehicle behavior will not occur while riding.
