PE14-032

HNDA

ACTUAL PLACE VISIT
REPORT REDACTED PG 38

GQM REDQACTED PAGE 58

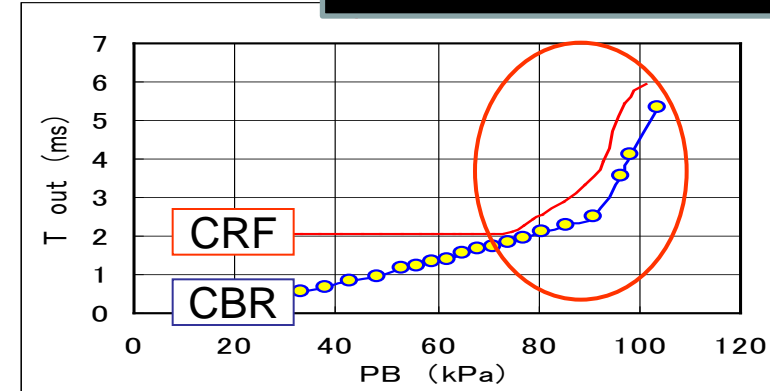
CBR250R Changing Head tightening torque (Right side)

Stall	No	No	Yes	Unconfirmed (Plan)	Yes
Eng. Speed after dropping	900r/min	1,050r/min	980r/min		970r/min
A/F	11.1	11.2	11.2		11.2
Leakage Volume cm ³ /min (@20kPa)	236	79(New HEAD)	434	1,564	1,700
Head tightening torque	40N·m Ref.	48N·m Upper Tolerance	51N·m Setting	35KN (Axial Force Buy Back) ⇒56N·m	60.5N·m (Ave.) EX 58.7 61.1 69.3 52.8

- There is specifications difference (fuel pressure, bore diameter, the intake and exhaust System), it is not possible numerical comparison.
- CRF, the engine stall does not occur when Lean fuel setting under Idle Speed
- Amount of leakage is changed by the Head Tightening Torque, CBR Stall becomes not occur.

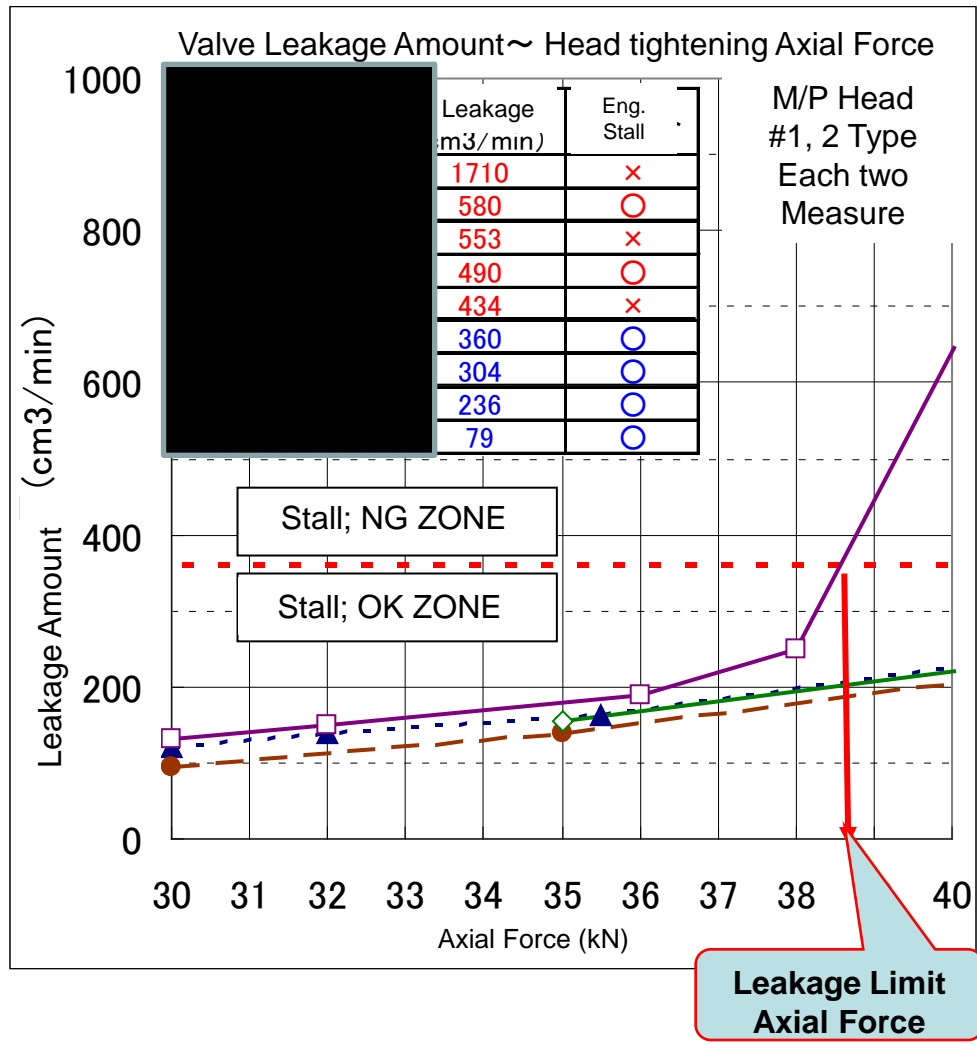
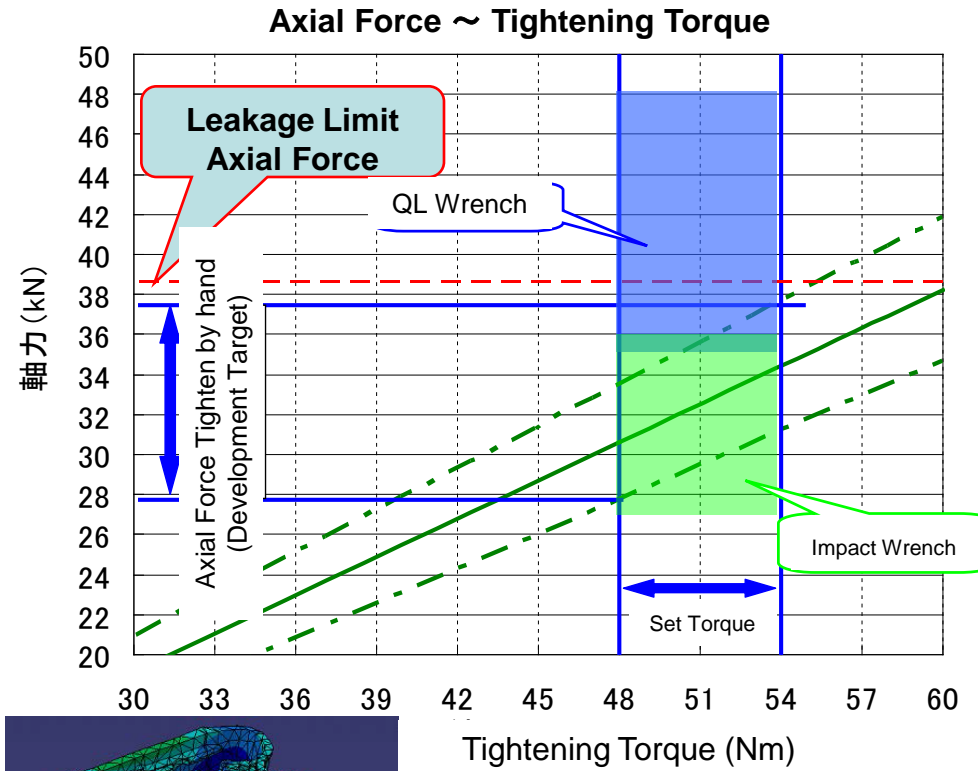
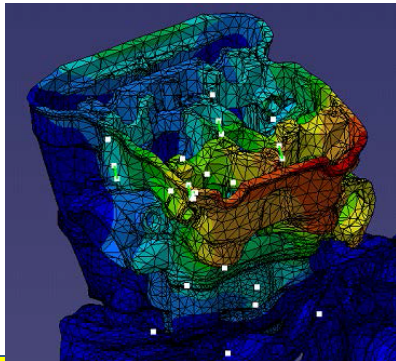
4. Analysis Result Valve Leakage amount ~ Head tightening Axial Force

CAE analysis results
Valve Seat Leakage occurs deformed by with Head Tightening Axial Force

CAE Conditions: Axial Force 37.7kN

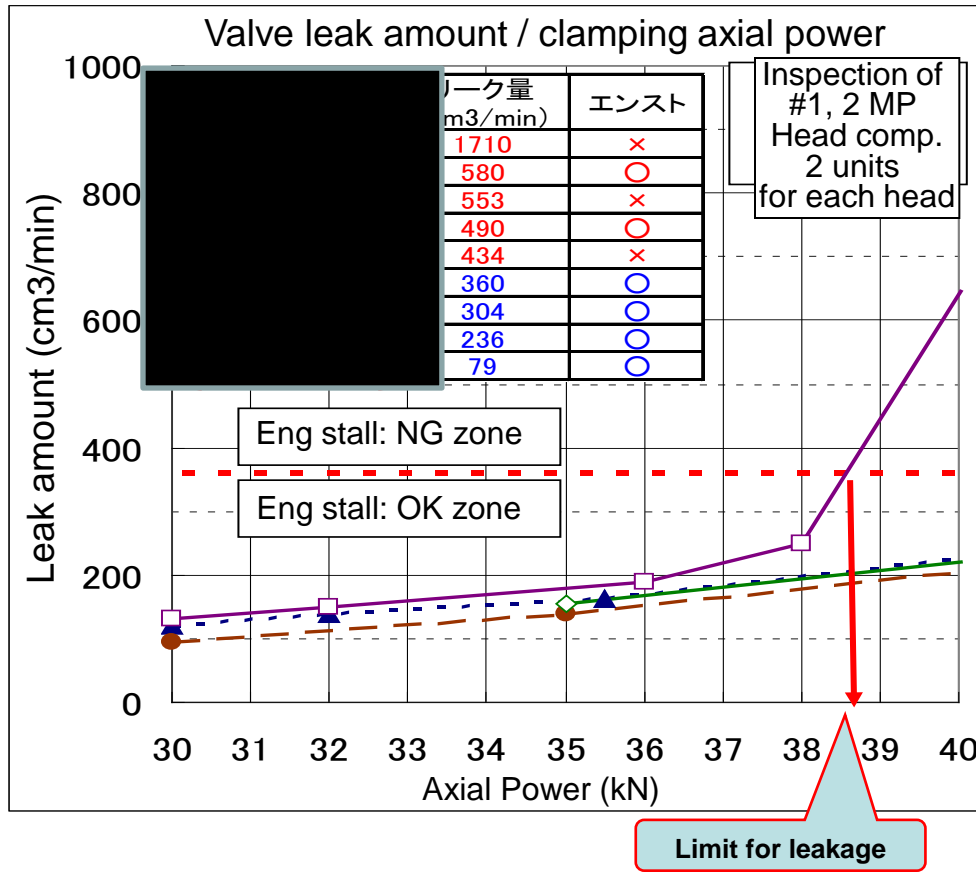
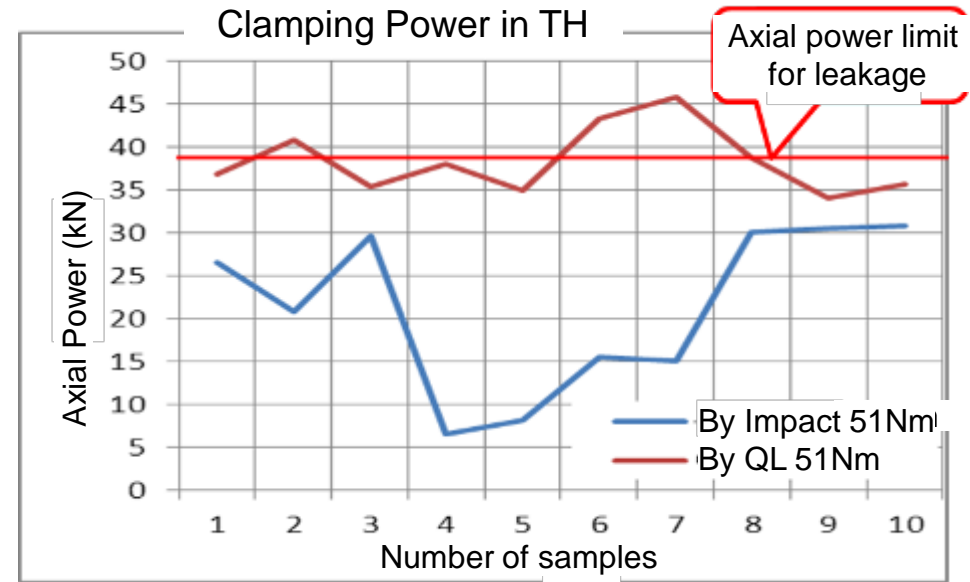
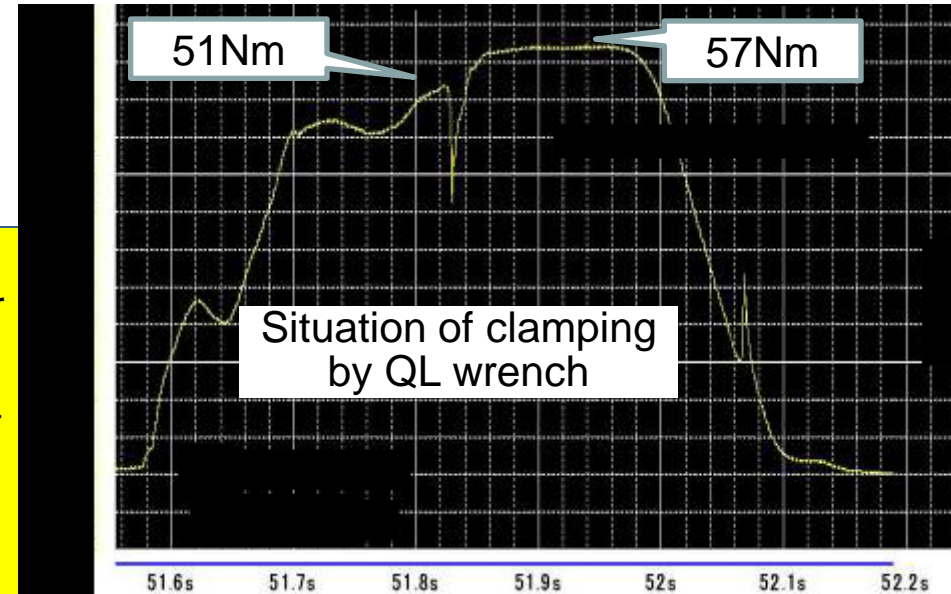
Correlation between valve air leakage, head clamping axial power

- The axial power which does not cause engine stall is under 38.6 kN.
- Clamping of TH(Impact & QL) may surpass axial power limit for leakage.
 - Variation of axial power by impact wrench clamping.
 - Overstroke by QL wrench clamping

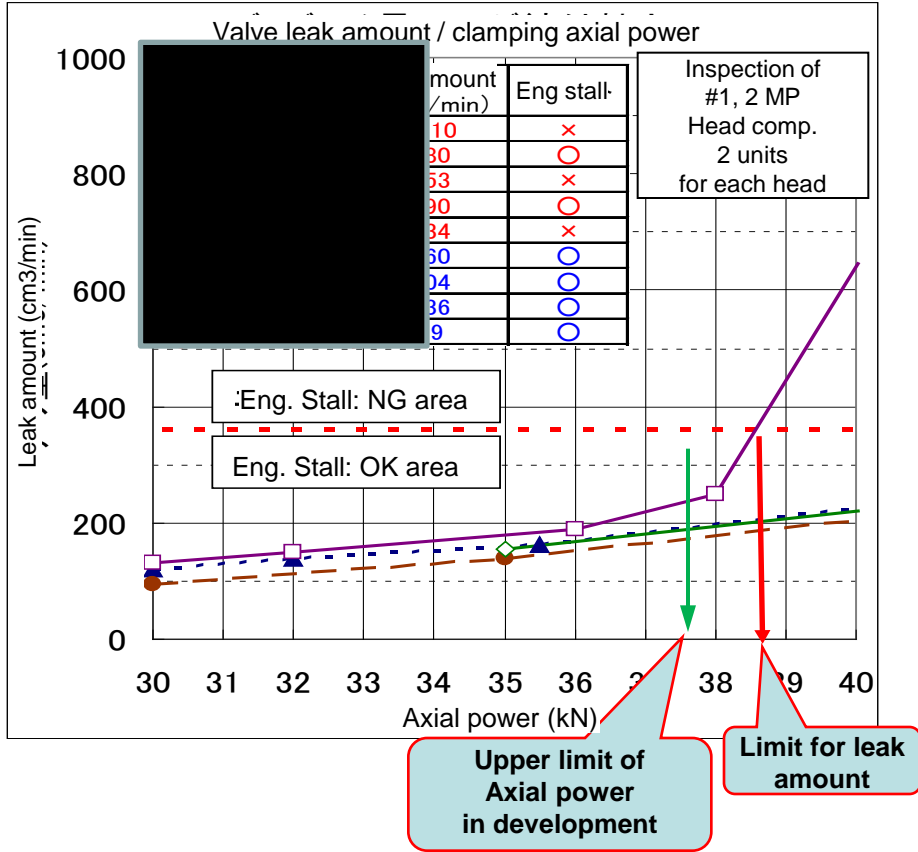
Valve leak amount / clamping axial power

- The axial power which does not cause engine stall is under 38.6 kN.
- Compared to the axial power upper limit set in development, margins of axial power limit for leakage was small.
- Compared to the axial power set in development, MP clamping axial power has a big unevenness in the high axial power side.

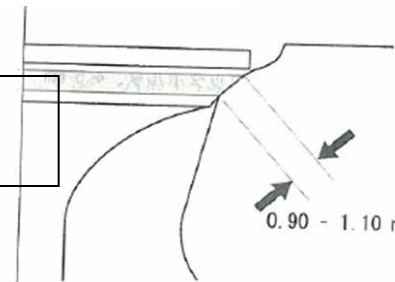
~ 2. Effectiveness verification for seat cutter

According to service manual, grinding was done until the contact is confirmed. Uniform contact state was made and leakage as a comp. became smaller than $50\text{cm}^3/\text{min}$. Verification results with real vehicle test showed no engine stall. OK.

Using Seat cutter (32° , 60°), correct sitting surface into the standard range. Valve sheet contact width: $0.9-1.1\text{mm}$. After that, perform valve grinding and verify contact state with red lead. Considering the status of contact, change valves.
