PE14-032

HNDA

CBR250R (US) : Visiting an actual place Result : Customer feedback information

10. Engine stall when riding CBR250R(KYJA)

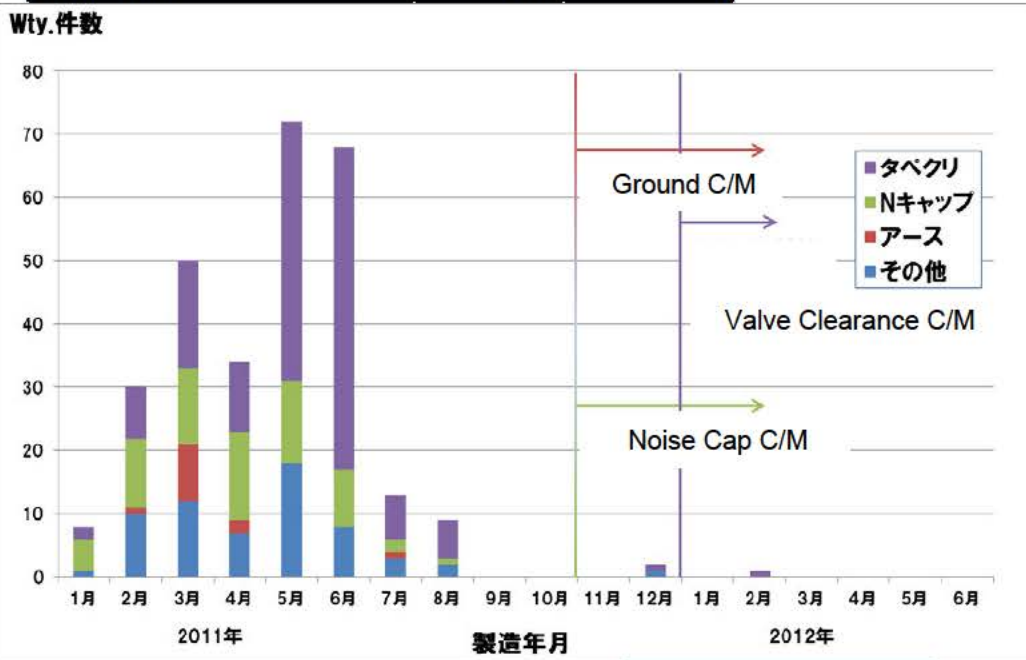
What led to the stall for reasons other than Grand Failure, Noise Cap Broken, Valve Clearance Failure is 11 units / QIC 3 items.

After 3 items Countermeasure, 1 unit occurred Eng. Stall in Japan.

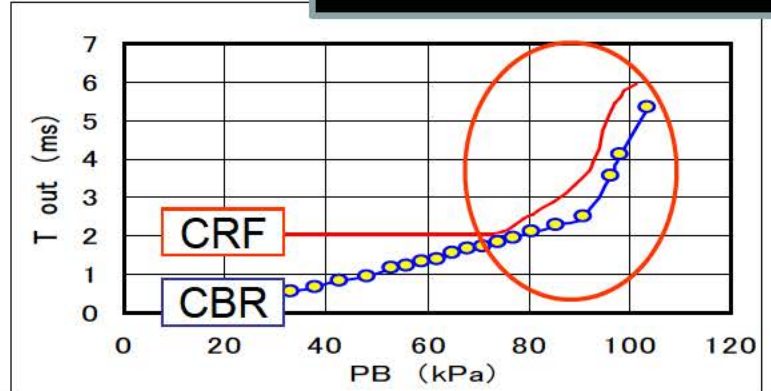
CBR250R Changing Head tightening torque (Right side)

Stall	No ○	No ○	Yes ×	Unconfirmed (Plan)	Yes ×
Eng. Speed after dropping	900r/min	1,050r/min	980r/min		970r/min
A/F	11.1	11.2	11.2		11.2
Leakage Volume cm3/min (@20kPa)	236	79(New HEAD)	434	1,564	1,700
Head tightening torque	40N·m Ref.	48N·m Upper Tolerance	51N·m Setting	35KN (Axial Force Buy Back) ⇒56N·m	60.5N·m (Ave.) EX 58.7 61.1 69.3 52.8

- There is specifications difference (fuel pressure, bore diameter, the intake and exhaust System), it is not possible numerical comparison
- CRF, the engine stall does not occur when Lean fuel setting under Idle Speed
- Amount of leakage is changed by the Head Tightening Torque, CBR Stall becomes not occur.

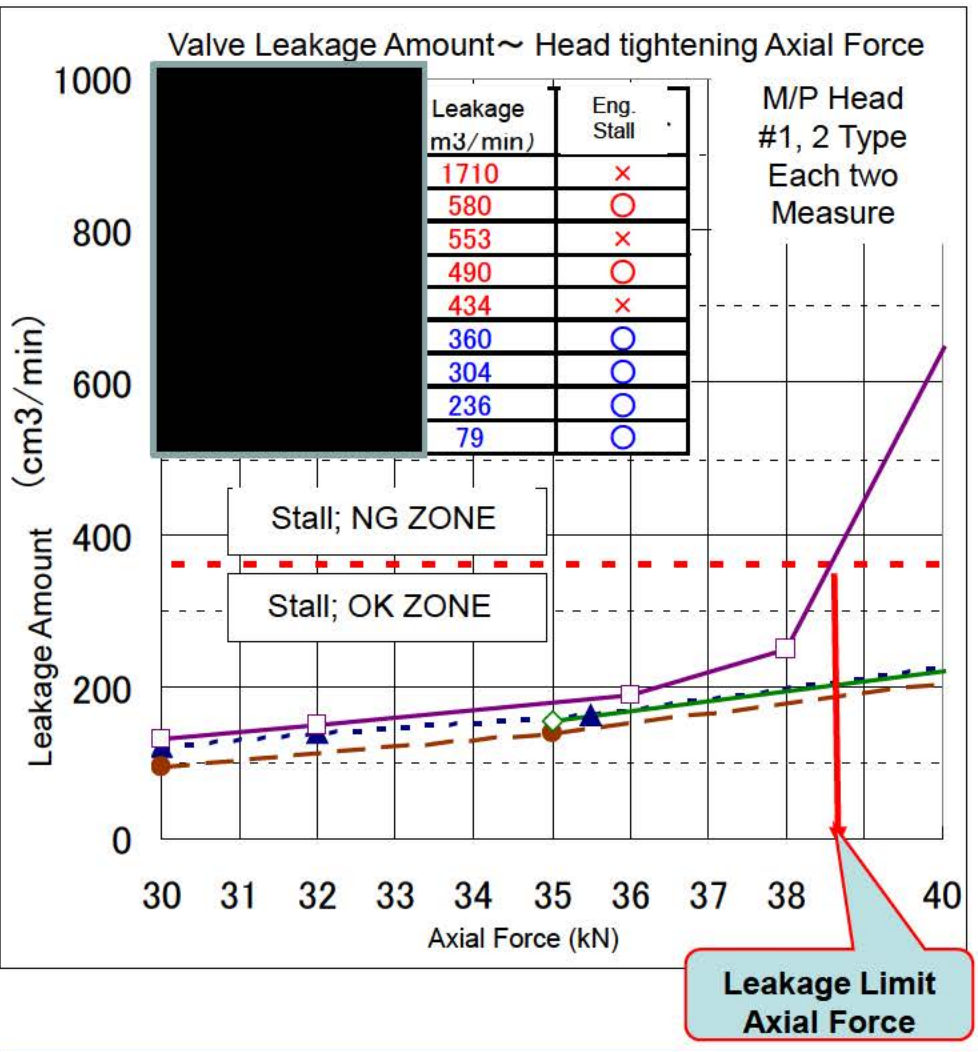
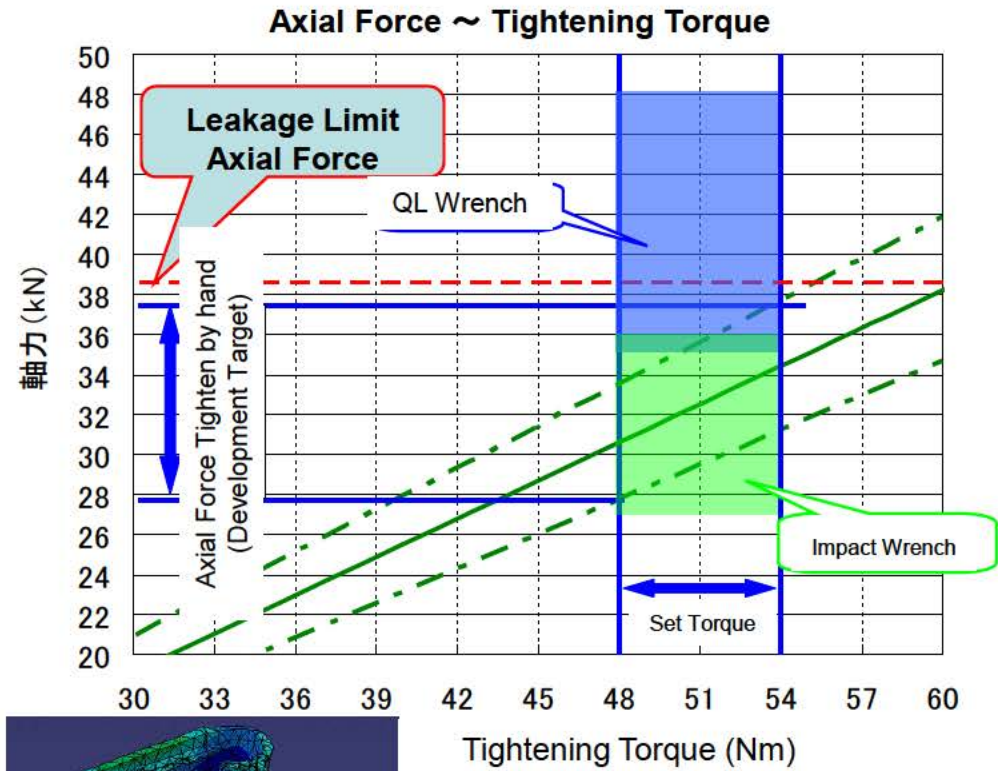
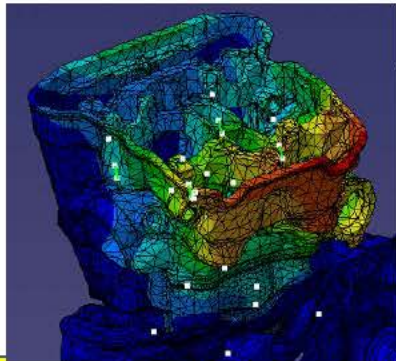
4. Analysis Result Valve Leakage amount ~ Head tightening Axial Force

CAE analysis results
Valve Seat Leakage occurs deformed by with Head Tightening Axial Force

CAE Conditions: Axial Force 37.7kN

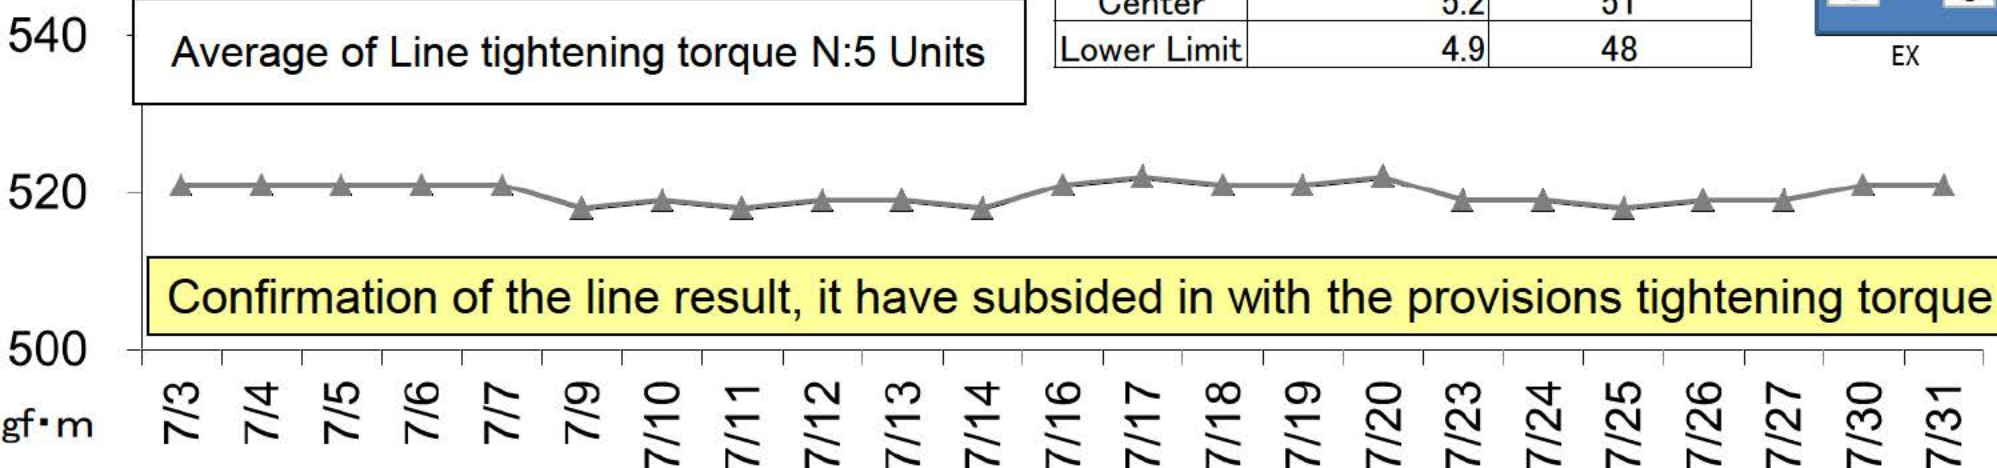
Average of Line tightening torque N:5 Units

Confirmation of the line result, it have subsided in with the provisions tightening torque.

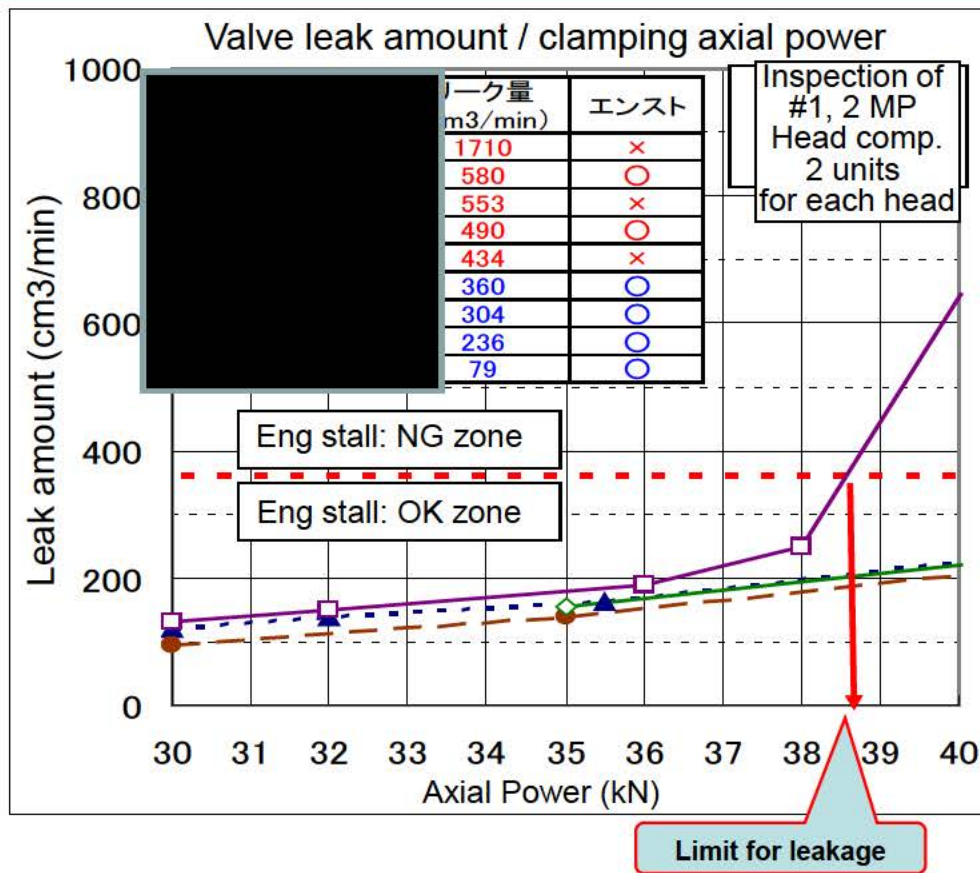
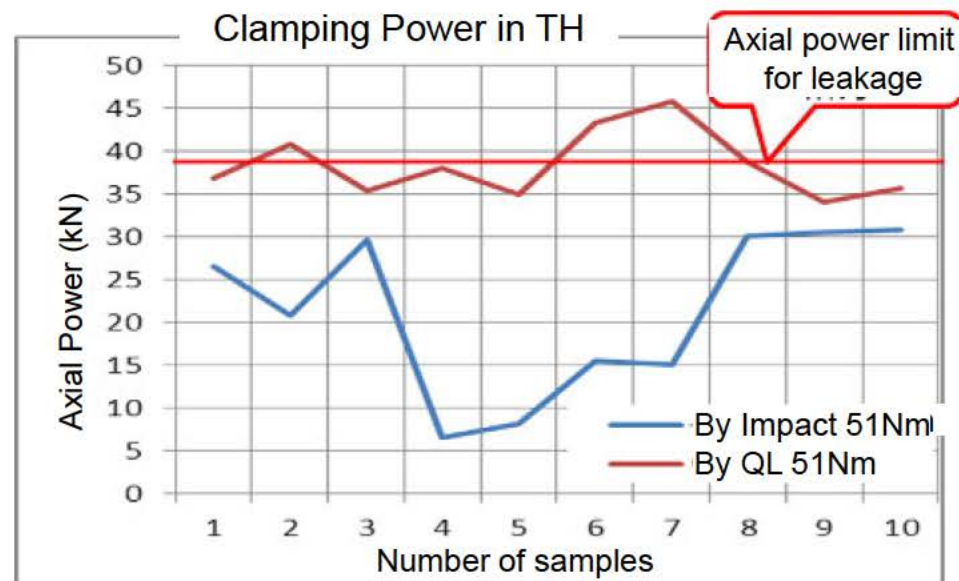
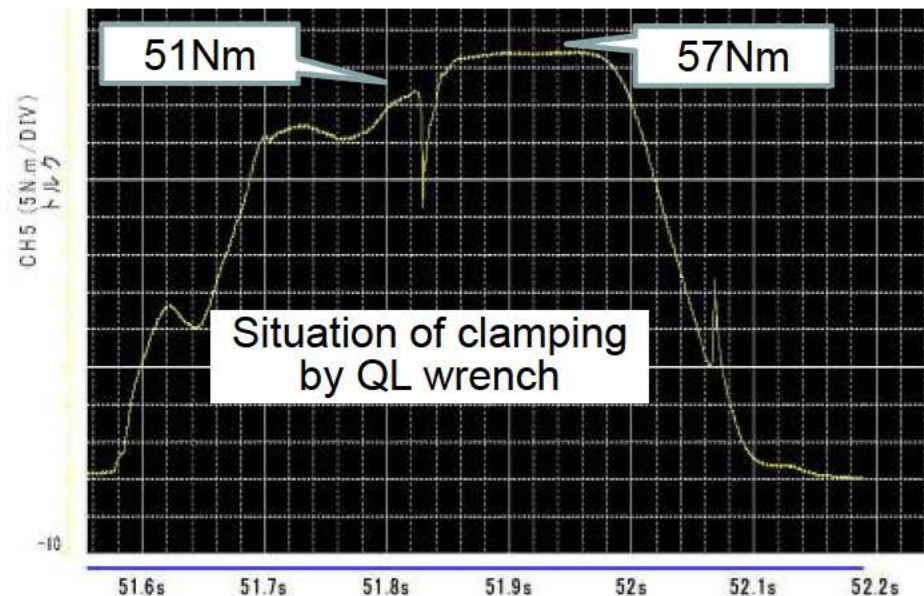
Correlation between valve air leakage, head clamping axial power

- The axial power which does not cause engine stall is under 38.6 kN.
- Clamping of TH(Impact & QL) may surpass axial power limit for leakage.
 - Variation of axial power by impact wrench clamping.
 - Overstroke by QL wrench clamping

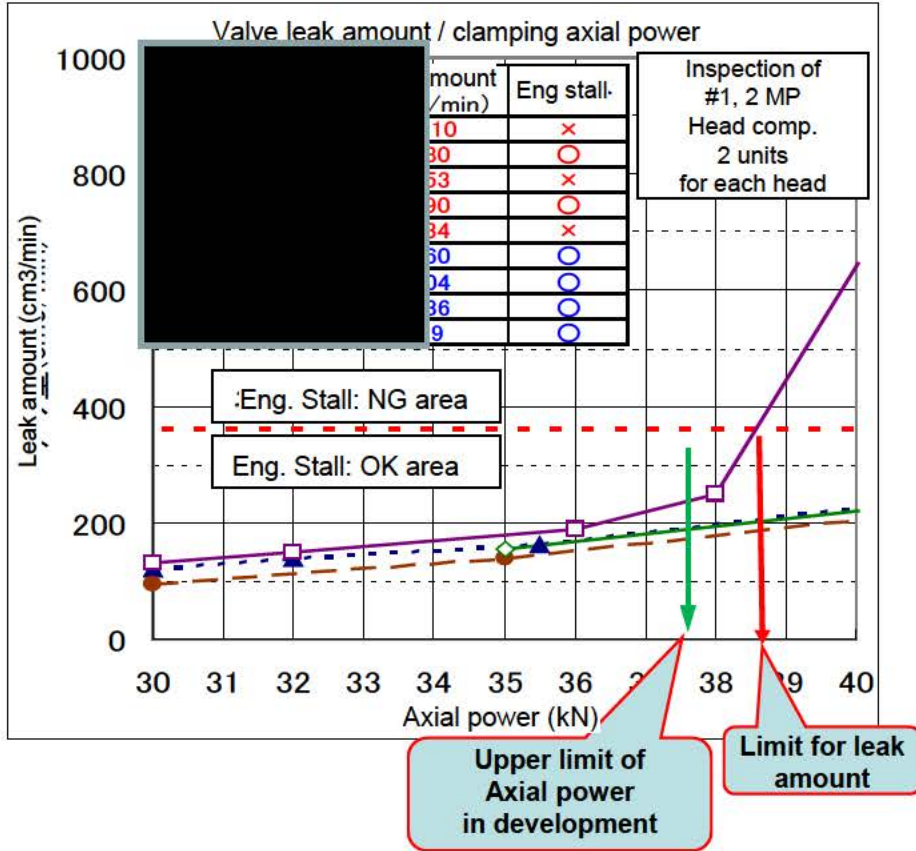
Valve leak amount / clamping axial power

- The axial power which does not cause engine stall is under 38.6 kN.
- Compared to the axial power upper limit set in development, margins of axial power limit for leakage was small.
- Compared to the axial power set in development, MP clamping axial power has a big unevenness in the high axial power side.

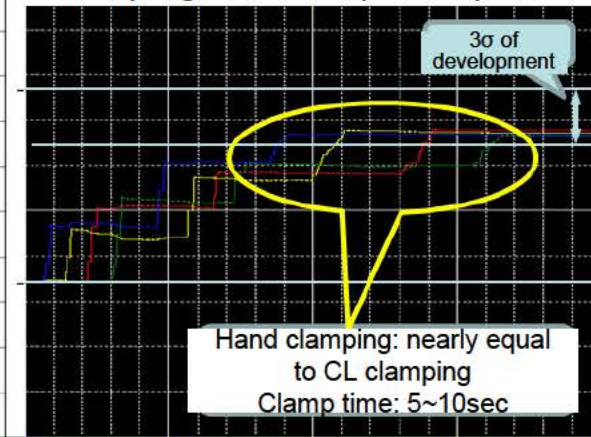
Clamping of development process

- By the method of MP clamping (impact and QL) in TH, it may sometimes exceed the marginal axial power for leakage.
- Instability of clamping by QL wrench and overstroke, caused by unevenness of clamping time at the time of impact clamping.
- Decrease of coefficient of friction, caused by the clamping speed.

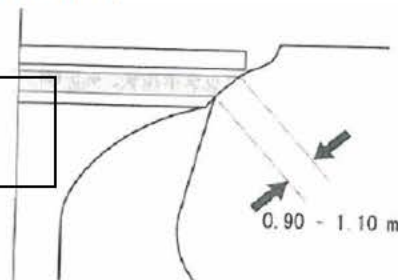
According to service manual, grinding was done until the contact is confirmed. Uniform contact state was made and leakage as a comp. became smaller than $50\text{cm}^3/\text{min}$. Verification results with real vehicle test showed no engine stall. OK.

Using Seat cutter (32° , 60°), correct sitting surface into the standard range. Valve sheet contact width: $0.9-1.1\text{mm}$. After that, perform valve grinding and verify contact state with red lead. Considering the status of contact, change valves.
