RQ14-005

Appendix H

Field Communications

## 6.4L DIESEL—LACKS POWER, MIL ON WITH DTCS P20E2, P20E3, P20E4, P2080, P2084, P242A, P242B, P0544 OR P2031

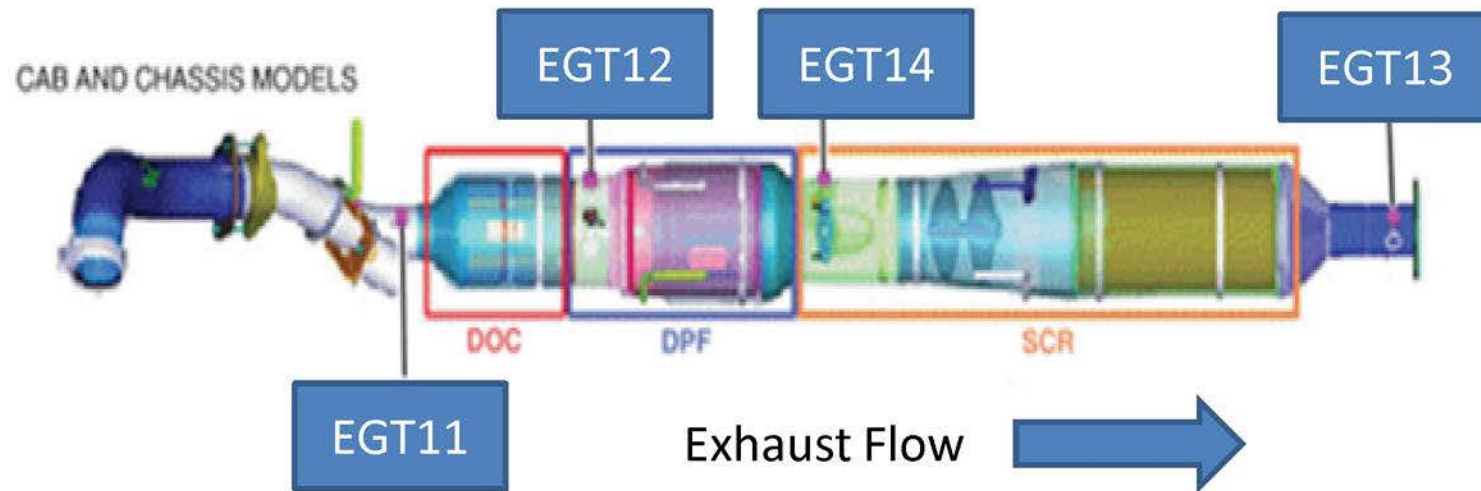
## 2011MY and 2012MY P473 6.7L Dyno Cert – Exhaust Gas Temperature (EGT) Layout

**2011-2012 F350-550 Super-Duty Chassis Cab (Narrow Frame) vehicles built after 11/5/12 and equipped with 6.7L diesel engines set the following DTCs:**

Disconnect EGT14 (Pin T-39), confirm that PID EGT14\_V sensor voltage is reading 5V.  
 If 5V then replace EGT14 sensor (3rd EGT in order of exhaust flow)

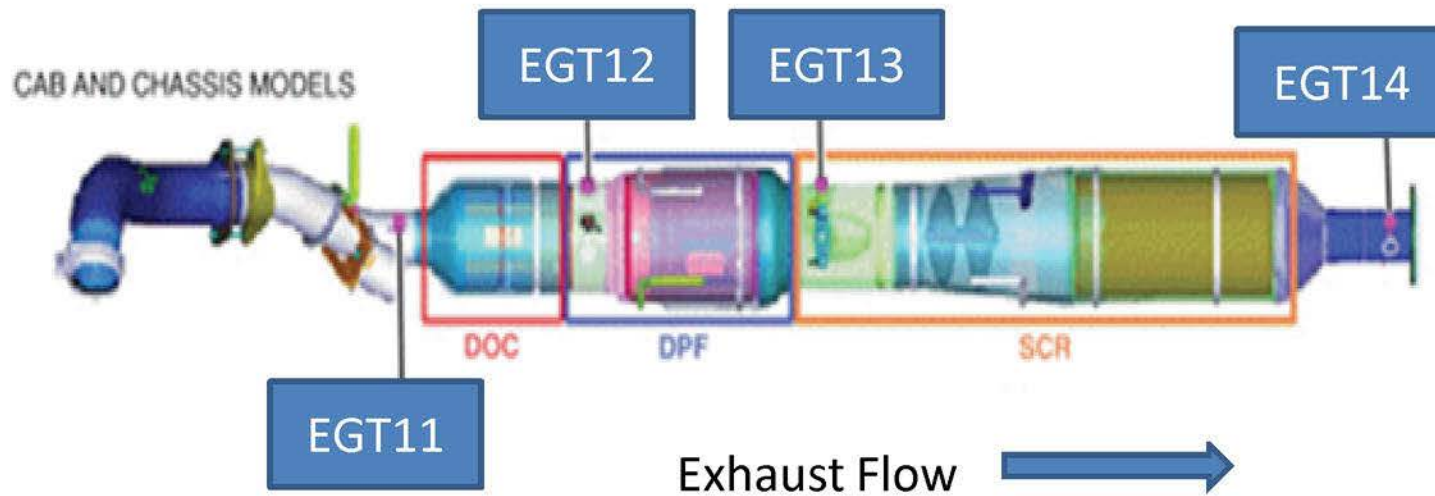
## 2013 MY P473 6.7L (R10) Dyno Cert – Exhaust Gas Temperature (EGT) Layout

**2013/ F350-550 Super-Duty Chassis Cab (Narrow Frame) vehicles built after dd/mm/12 and equipped with 6.7L diesel engines set the following DTCs:**

Disconnect EGT13 (Pin T-37), confirm that PID EGT13\_V sensor voltage is reading 5V.  
 If 5V then replace EGT13 sensor (3rd EGT in order of exhaust flow)

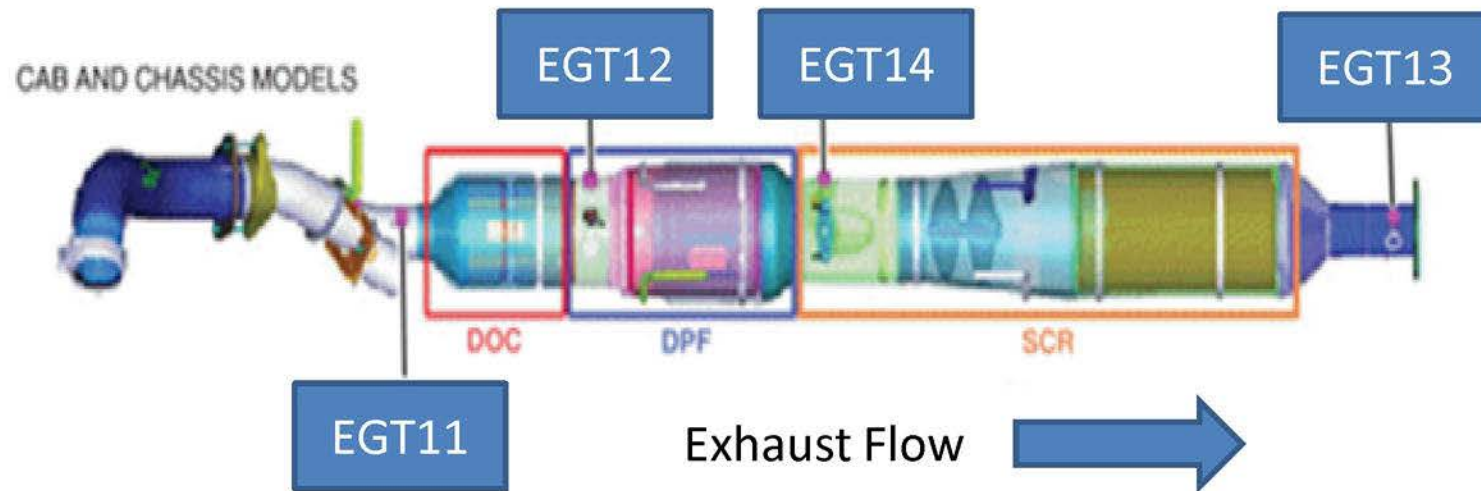
## 2011MY and 2012MY P473 6.7L Dyno Cert – Exhaust Gas Temperature (EGT) Layout

**2011-2012 F350-550 Super-Duty Chassis Cab (Narrow Frame) vehicles built after 11/5/12 and equipped with 6.7L diesel engines set the following DTCs:**

Disconnect EGT13 (4th EGT in order of exhaust flow), confirm that PID EGT14\_V sensor voltage is reading 5V.  
 If 5V then replace EGT13 sensor (4th EGT in order of exhaust flow)

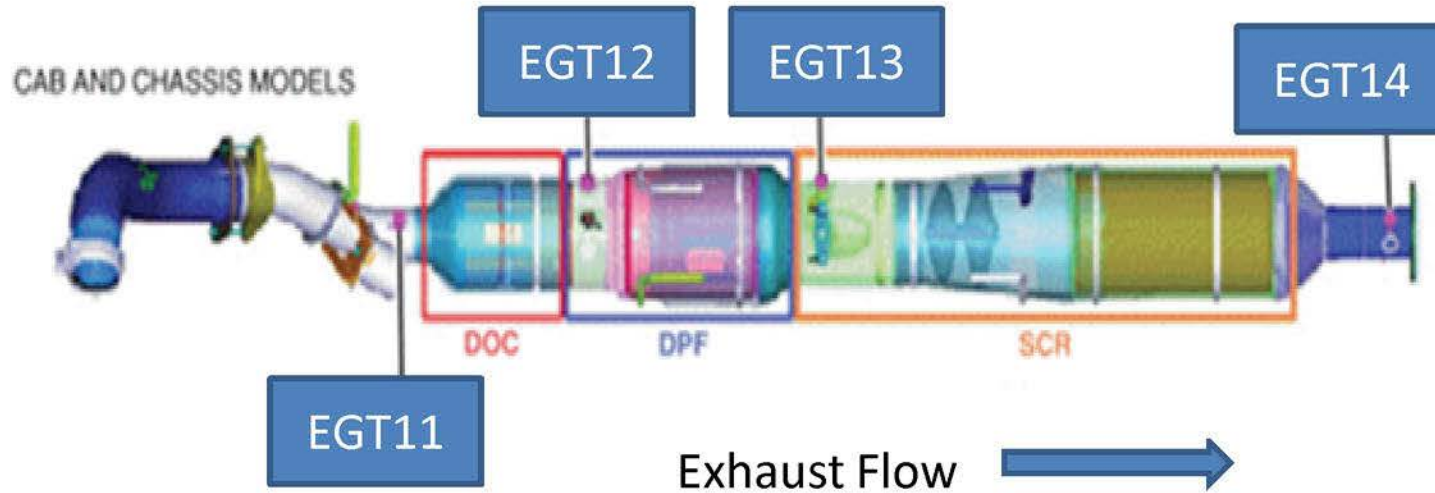
## 2013 MY P473 6.7L (J1) Dyno Cert – Exhaust Gas Temperature (EGT) Layout

**2013/ F350-550 Super-Duty Chassis Cab (Narrow Frame) vehicles built after dd/mm/12 and equipped with 6.7L diesel engines set the following DTCs:**

Disconnect EGT13 (3rd EGT in order of exhaust flow), confirm that PID EGT14\_V sensor voltage is reading 5V.  
 If 5V then replace EGT13 sensor (3rd EGT in order of exhaust flow)

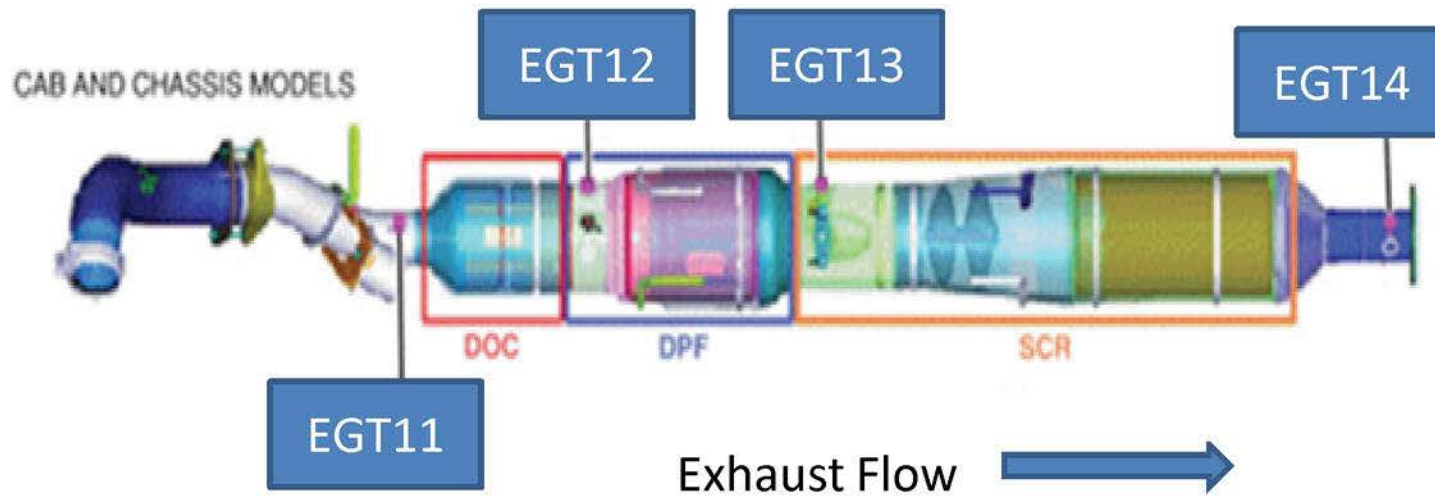
## 2013 MY P473 6.7L (Post J1) Dyno Cert – Exhaust Gas Temperature (EGT) Layout

| 2013/ F350-550 Super-Duty Chassis Cab (Narrow Frame) vehicles built after 11/10/12 and equipped with 6.7L diesel engines set the following DTCs: | Repair Procedure (proposed) |

| 2013/ F350-550 Super-Duty Chassis Cab (Narrow Frame) vehicles built after 11/10/12 and equipped with 6.7L diesel engines set the following DTCs: | Repair Procedure (proposed) |
|---|---|
| <p>P246E - Exhaust Gas Temperature Sensor Circuit (Bank 1 Sensor 4)</p> <p>P246F - Exhaust Gas Temperature Sensor Circuit Range/Performance (Bank 1 Sensor 4)</p> <p>P2470 - Exhaust Gas Temperature Sensor Circuit Low (Bank 1 Sensor 4)</p> <p>P2471 - Exhaust Gas Temperature Sensor Circuit High (Bank 1 Sensor 4)</p> <p>P200C - Particulate Filter Over Temperature (Bank 1)</p> <p>P200E - Catalyst System Over Temperature (Bank 1)</p> | <p>Disconnect EGT14, confirm that PID EGT14_V sensor voltage is reading 5V.</p> <p>If 5V then replace EGT14 sensor (4th EGT in order of exhaust flow)</p> |
| <p>P242A - Exhaust Gas Temperature Sensor Circuit (Bank 1 Sensor 3)</p> <p>P242B - Exhaust Gas Temperature Sensor Circuit Range/Performance (Bank 1 Sensor 3)</p> <p>P242C - Exhaust Gas Temperature Sensor Circuit Low (Bank 1 Sensor 3)</p> <p>P242D - Exhaust Gas Temperature Sensor Circuit High (Bank 1 Sensor 3)</p> | <p>Disconnect EGT13 , confirm that PID EGT13_V sensor voltage is reading 5V.</p> <p>If 5V then replace EGT13 sensor (3rd EGT in order of exhaust flow)</p> |

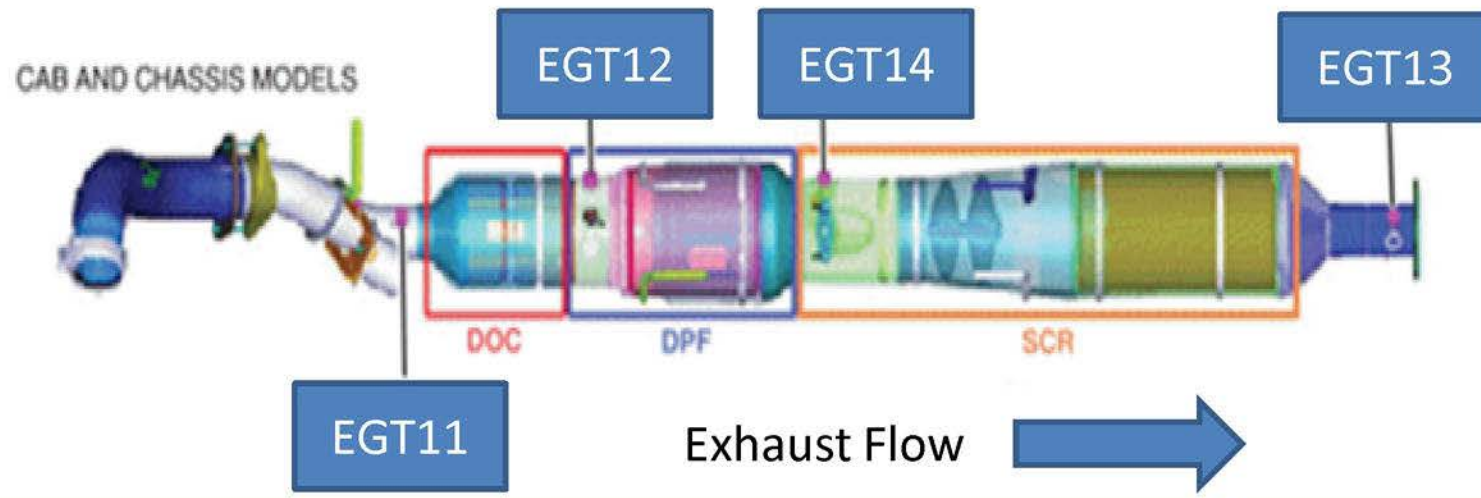
## 2011MY and 2012MY P473 6.7L Dyno Cert – Exhaust Gas Temperature (EGT) Layout

**2011-2012 F350-550 Super-Duty Chassis Cab (Narrow Frame) vehicles built after 11/5/12 and equipped with 6.7L diesel engines set the following DTCs:**

Disconnect EGT13 (4th EGT in order of exhaust flow), confirm that PID EGT14\_V sensor voltage is reading 5V.  
 If 5V then replace EGT13 sensor (4th EGT in order of exhaust flow)

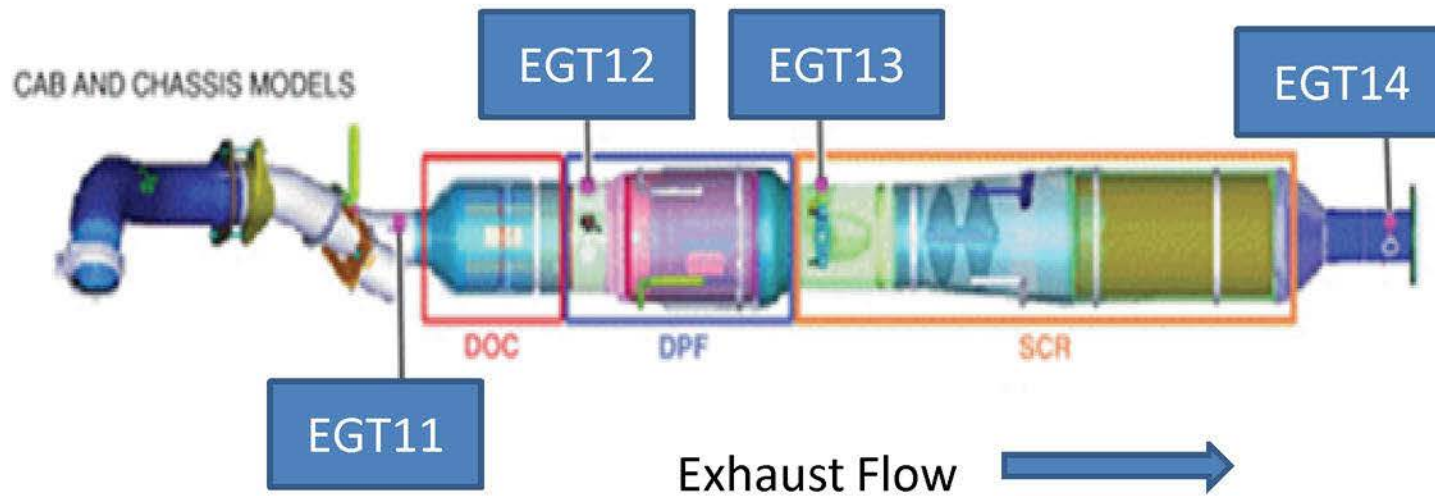
## 2013 MY P473 6.7L (J1) Dyno Cert – Exhaust Gas Temperature (EGT) Layout

**2013/ F350-550 Super-Duty Chassis Cab (Narrow Frame) vehicles built after dd/mm/12 and equipped with 6.7L diesel engines set the following DTCs:**

Disconnect EGT13 (3rd EGT in order of exhaust flow), confirm that PID EGT14\_V sensor voltage is reading 5V.  
 If 5V then replace EGT13 sensor (3rd EGT in order of exhaust flow)
