Reference: TIPM Design Review

This voluntary submission contains FCA US LLC's ("FCA US") responses to the various informal information requests related to Totally Integrated Power Module-7 ("TIPM-7"). These requests were in response to various design reviews and meetings between the Office of Defect Investigations ("ODI") and FCA US Safety Office.

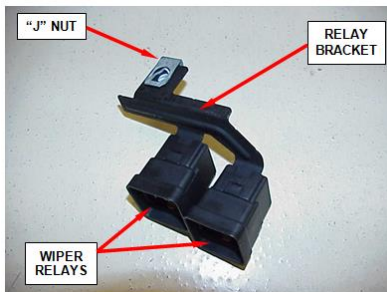
- CBL3J280AA Wiring Harness Overlay Package

A6. The relay used for the J28 remedy is shown below.
