Mr. Jeffrey L. Quandt, Chief Vehicle Controls Division (VCD), NVS-213 U.S. Department of Transportation

Reference: NVS-213swm; PE14-013

Subject Vehicle Identification

Alleged Defect Definition

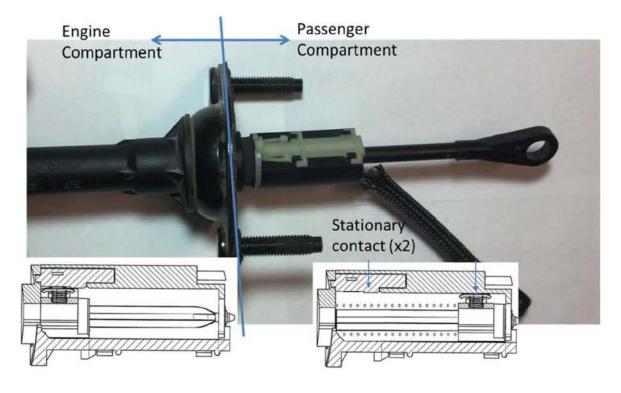
Figure 1 - Clutch Interlock Switch Mounted on Clutch Master Cylinder

The clutch interlock switch has two springs, located on each side of the collar that push the collar off the contacts to open the circuit as the clutch pedal is released. The purpose of the springs is to return the assembly to the free state when the clutch pedal is moved from the depressed position to the up position. Figure 2 shows the clutch interlock switch with one of the two return springs visible.

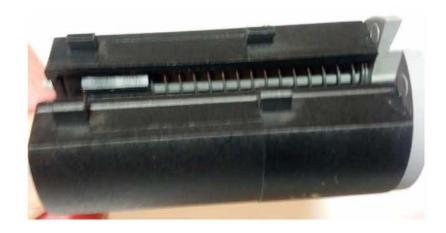
Figure 2 – Clutch Interlock Switch and View of a Return Spring

A second potential failure mode Chrysler identified is the fatigue fracture of both return springs in the clutch interlock switch. If both return springs should fracture, the potential exists for the circuit contacts to remain closed when the clutch pedal returns to the up position. This could permit the starter motor to crank the engine without the clutch pedal being depressed. If the vehicle's parking brakes were not set and the manual transmission shifter was not placed in the Neutral position at the time the ignition switch was actuated to "START" mode, the vehicle could move.

Fractured return springs were discovered in four of 61 clutch interlock switch assemblies that were obtained from subject and peer vehicles. As discussed more fully in A10, Assessments 1, 3 and 4, these four clutch interlock switches exhibited fractures in both of the return springs. Metallurgical analysis of the return springs in one of the four switches indicated the fractures were due to fatigue (see lab test report LTR 147349). The remaining three returned clutch interlock switches with fractured springs are being submitted to NHTSA in response to Q12. None of the four returned clutch interlock switches with fractured springs showed signs of foreign substance contamination, suggesting that contamination did not contribute to the return spring fractures or otherwise cause the switch to malfunction.
