Reference: NVS-213swmc; PE14-019

The subject vehicle is the 2005 model year ("MY") Dodge Ram 1500 Pick-up ("DR") ("subject vehicles"). In its information request, NHTSA has defined the peer vehicles as any 2002 to 2008 model year vehicle equipped with a 9.25 inch rear axle assembly. Chrysler has identified the following vehicle families that meet the peer vehicle criteria:

Chrysler's investigation of rear axle lock-up or driveshaft detachment from the rear differential caused by loose pinion nuts (the "alleged defect") in the 2005 Dodge Ram 1500 ("subject vehicles") may be attributed to one or more of the following causal effects: 1) a change of the pinion nut and washer to a single piece flanged nut introduced in the 2005 model year; 2) a service action of the rear differential where the original nut was reused or a non-specified nut was installed; 3) a service action of the rear differential where a service nut without a torque prevailing crimp or adhesive patch was installed (NHTSA 12V-474; 4) a customer's negligence to have the rear differential serviced at the recommended service interval; 5) an undersized pinion shaft spline (NHTSA 13V-038); 6) customer vehicle usage or dut

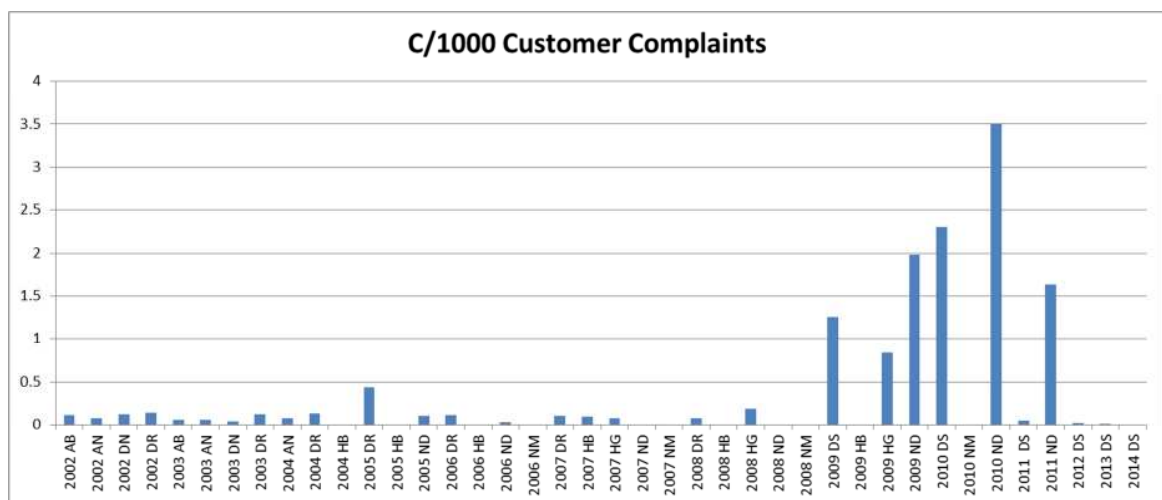
Despite the frequency of undersized pinion splines potentially in the field for subject and peer vehicles, there is a low rate of loose pinion nuts in field complaint and warranty repair data. Out of a population of 257,227, there were 113 unique VINs with customer complaints (CAIRs) or legal claims received by Chrysler that reported the alleged defect on the subject vehicles (a rate of 0.44 C/1,000). Out of a population of 2,108,503, there were 232 unique VINs with customer complaints (CAIRs) or legal claims received by Chrysler that reported the alleged defect on the peer vehicles (a rate of 0.11 C/1,000). The chart below reflects an analysis of the customer complaints and field reports by make, model and model year.

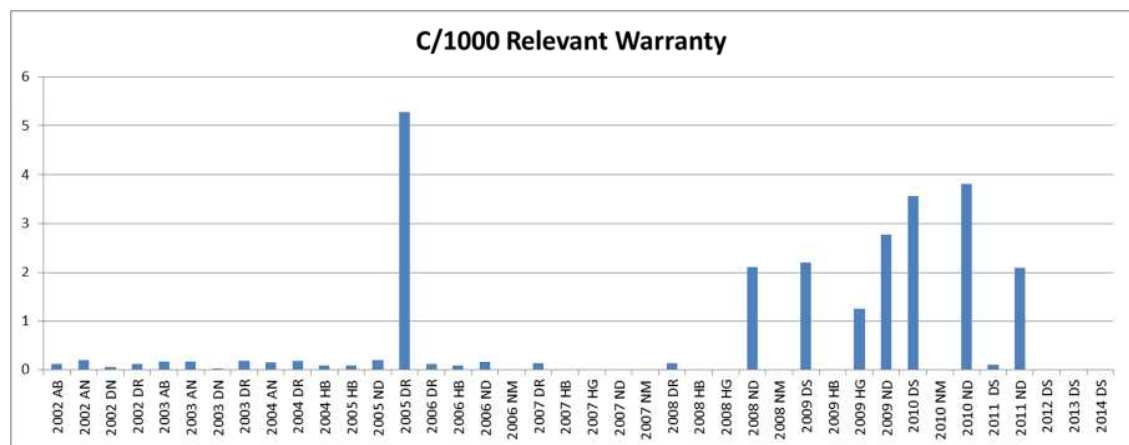
Out of a population of 257,227, there were 2,443 warranty claims received by Chrysler that relate to, or may relate to, the alleged defect on the subject vehicles (a rate of 9.5 C/1,000). Out of a population of 2,108,503, there were 19,688 warranty claims received by Chrysler that relate to, or may relate to, the alleged defect on the peer vehicles (a rate of 9.34 C/1,000). Not all warranty claims

necessarily relate to the alleged defect, as these components can be replaced for leaking seals, noise and/or gear set damage. An analysis of the available vehicle warranty narratives for the subject vehicles indicates that about 55% may relate to a missing or loose missing pinion or related condition. A similar analysis of the available peer vehicles warranty narratives indicates less than 2% may relate to a missing or loose pinion nut or related condition. The chart below reflects an analysis of these warranty narratives by make, model and model year.
