| Title: | National Highway Traffic Safety Administration Toyota Unintended Acceleration Investigation | Page #: 1 of 177 |

Technical Support to the National Highway Traffic Safety Administration (NHTSA) on the Reported Toyota Motor Corporation (TMC) Unintended Acceleration (UA) Investigation

January 18, 2011

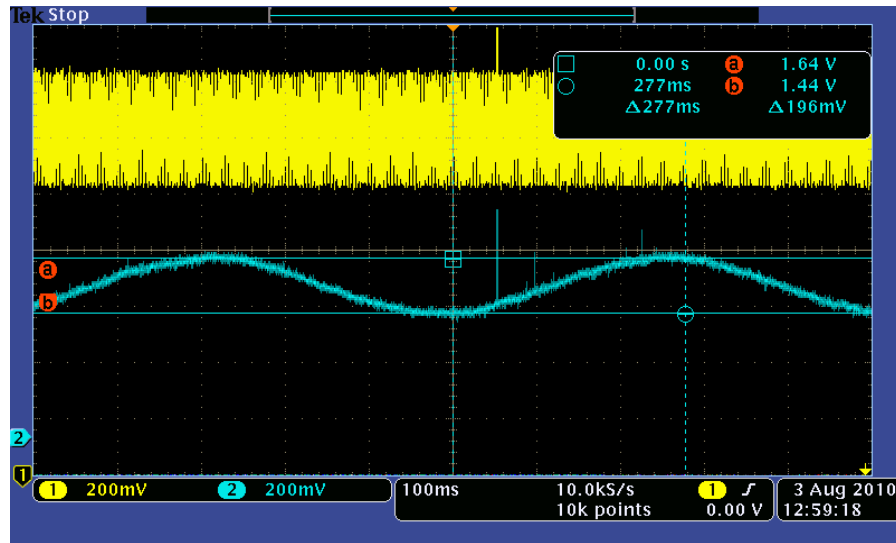
Figure 6.6.1.2-2 indicates the postulated EMI faults as identified from the fishbone analysis. Three different tests uncovered a 500 Hz sensitivity; the noise injection common to both VPA signals, noise injection on VTA1 signal, and the vehicle level conductive EMC testing.

Figure 6.6.1.2-3. 500Hz injected common to both VPA signals (top Yellow trace) results in driving the motor and roughly 2 Hz aliasing sensed on VTA (bottom Blue trace)

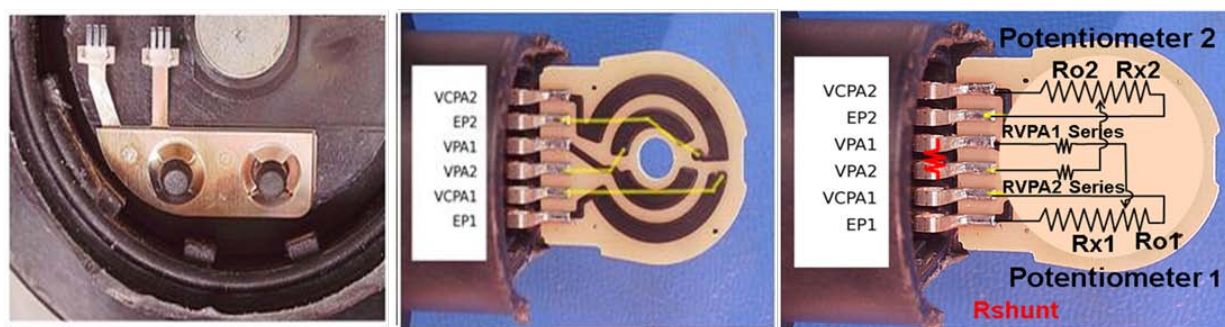
Vehicle testing using a defective potentiometer accelerator pedal assembly from a VOQ vehicle with a resistive short, within a narrow range of values between the sensors outputs, identified a vulnerability that may compromise nominal limp home mode fail-safe operation on subsequent ignition key cycles and affect the malfunction indicator lamp (MIL) display and/or DTC generation under certain specific conditions.

Figure 6.6.2.3-1. One of two rotating contact assemblies (left), resistive elements (center), and electrical diagram (right) for the potentiometer pedal sensors showing defective accelerator pedal assembly fault region

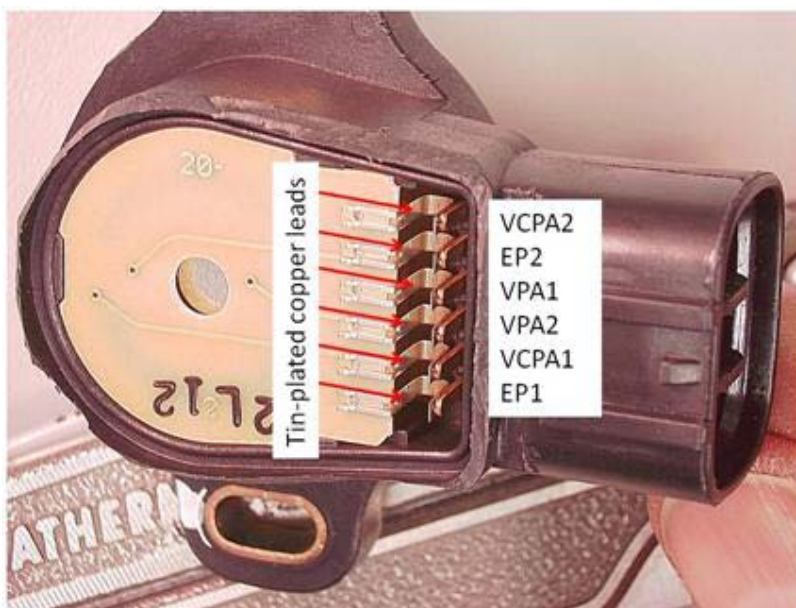
Figure 6.6.2.3-5. Disassembled Accelerator Pedal Assembly Potentiometer

Destructive physical analysis of this pedal assembly found tin whiskers², one of which had formed the resistive partial short circuit between the pedal signal outputs. A second tin whisker of similar length was also found in this pedal assembly that had not caused an electrical short. If a resistive short between the potentiometer accelerator pedal signal outputs exists, the system may be vulnerable to a specific second fault condition that could theoretically lead to UA. However, if resistive faults were occurring during normal use, DTCs would be expected from at least the first ignition key cycle and the following cycles that did not meet the specific criteria. Subsequent review of the warranty data does not support an observable failure signature of pedal-induced DTCs. Electrical measurements on six VOQ vehicles found no indication of the resistive paths necessary for this failure scenario.

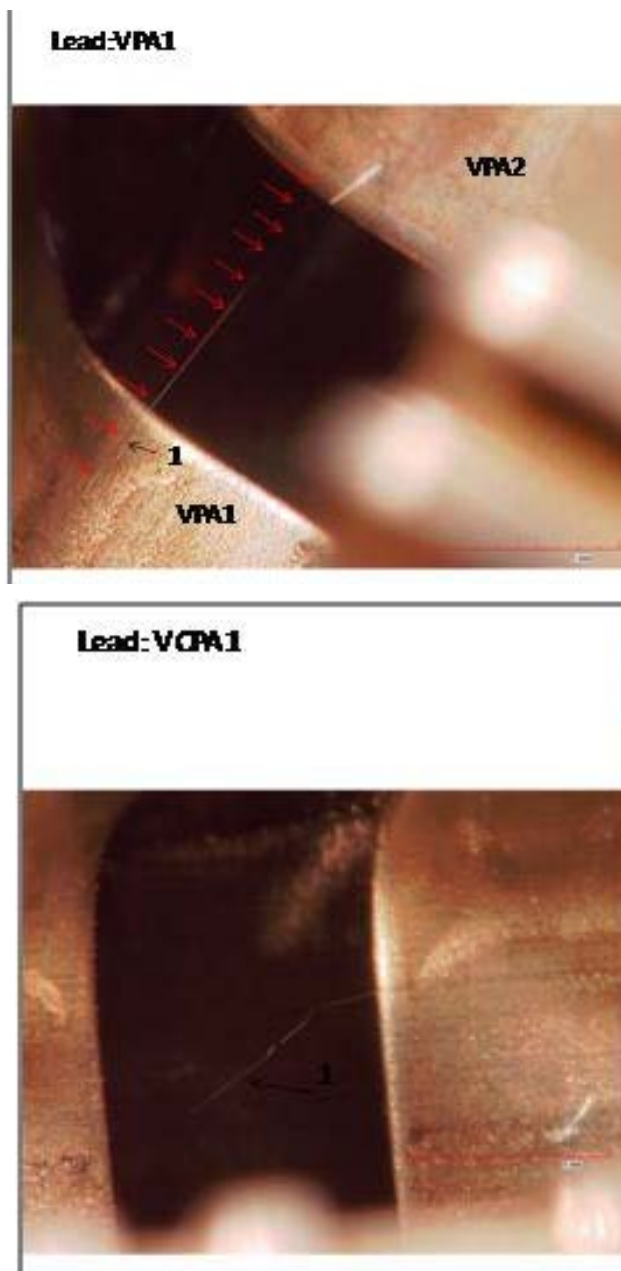
Figure 6.6.2.3-6. Shorting whisker VPA1 to VPA2 (top) and long whisker on VCPA1 (bottom)

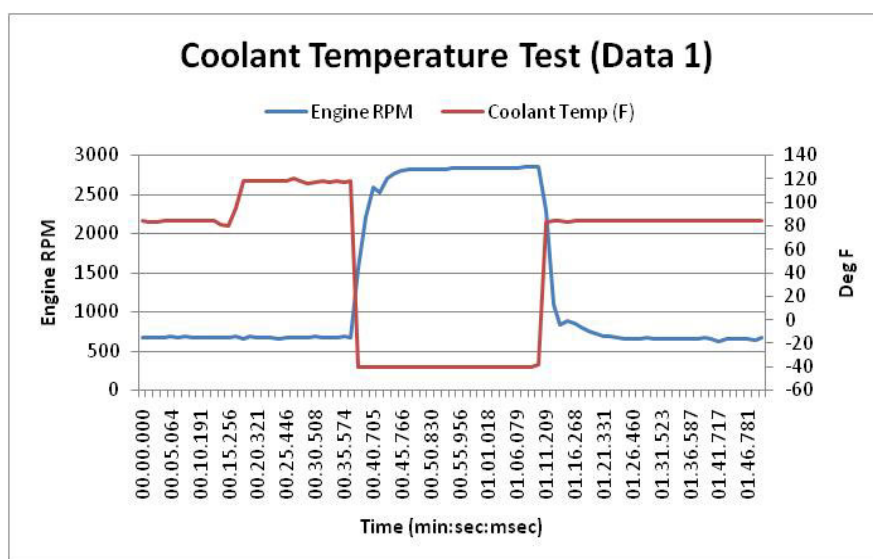
Figure 6.6.3.7-1. Test results with coolant temperature sensor failed to 150 Kohms resulting 2000 RPM increase with vehicle in neutral
