**Rear-End Collision and Subsequent Vehicle Intrusion
Into Pedestrian Space at Certified Farmers' Market
Santa Monica, California
July 16, 2003**

Highway Accident Report

NTSB/HAR-04/04

**NTSB/HAR-04/04
PB2004-916204
Notation 7649B
Adopted August 3, 2004**

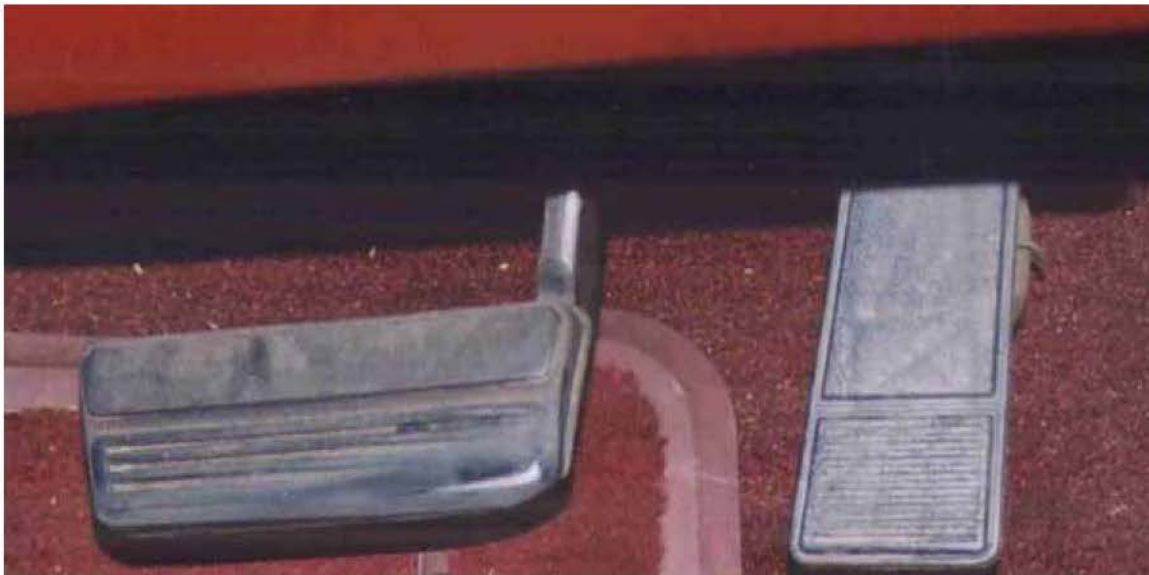
Figure 3. Accident vehicle's brake pedal.

The Buick was equipped with a power-assisted, dual-circuit hydraulic brake system configured with front disc brakes and rear drum brakes. The master cylinder was adequately filled with fluid and the power booster supply check valve functioned properly. All wheel hubs rotated freely and without indications of drag or out-of-round conditions. Examination of each brake assembly and associated hydraulic lines revealed no leaks, restrictions, or operational defects. The brake pedal was intact and functional, offering consistent resistance and approximately 2 1/2 inches of nonpower-assisted travel. The rubber cover on the brake pedal was worn on the lower right edge, revealing the metal beneath (see figure 3). Separation between the brake pedal and the accelerator at the closest point was 2 inches.

The primary concern about pedal placement is dual activation, that is, the driver depressing both the accelerator and the brake when he or she only intends to depress one or the other. The pedal separation in the accident vehicle was at the recommended minimum,³² and two factors suggest that dual activation did not occur in this accident. First, witnesses reported they did not see the vehicle's brake lights illuminate, which would have occurred if the brake pedal had been depressed, even in conjunction with the accelerator. Second, witness descriptions of the vehicle's motion and the physical evidence indicated significant increases in acceleration and speed during the accident sequence and did not indicate a retarding force, which would be expected if the brake pedal had been depressed.

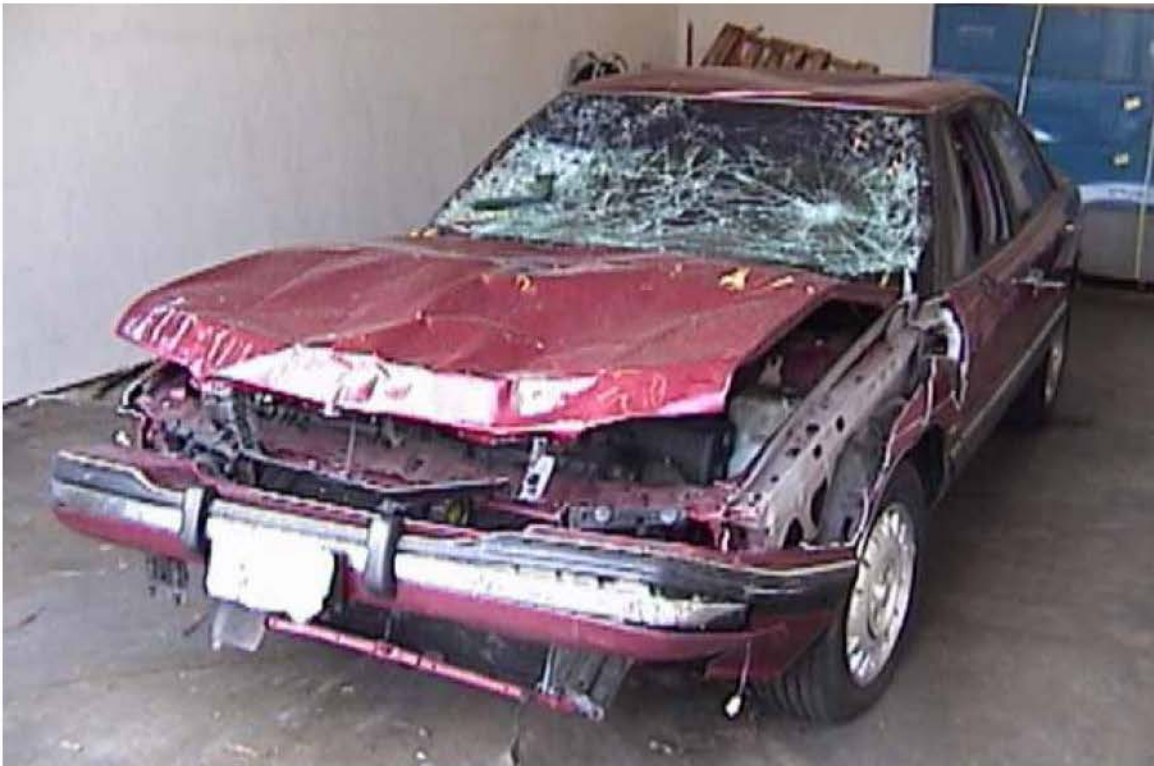
Figure 4. Postaccident damage to 1992 Buick LeSabre.

The Buick sustained frontal damage encompassing the front bumper, forward light fixtures, radiator grill, radiator and support, left front quarter panel, windshield, roof, both side mirrors, and rear antenna. (See figure 4.) The two side-view mirrors were missing, and the shattered windshield had two distinct impact or indentation locations; remnants and debris from items struck were found embedded in the windshield. The right side of the front bumper had light blue paint transfer, and the rubber portion of the right rear bumper had white paint transfer. The left bumper quarter panel was missing and exhibited exposed, jagged edges. The bumper was angled upward from the frame, consistent with accident damage. The Buick's airbag had deployed.

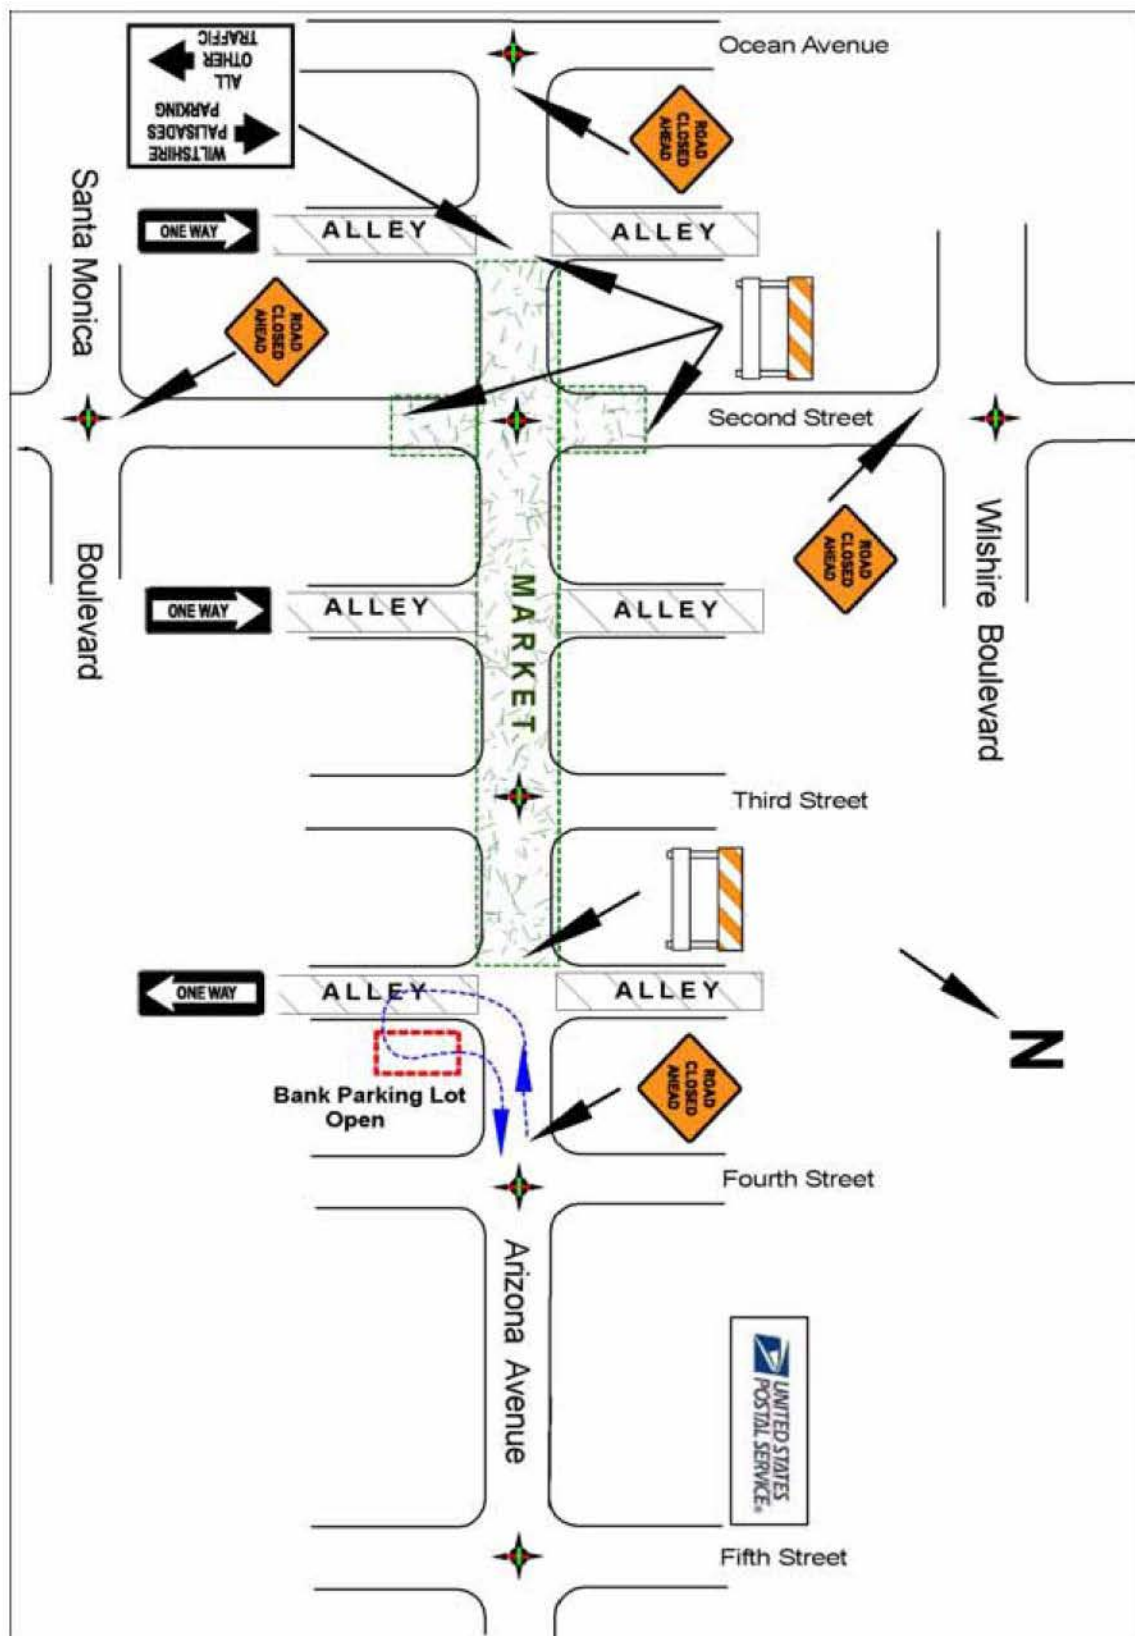
Figure 5. Road closures in place for SMCFM.

At the time of the accident, Arizona Avenue was closed to vehicular traffic between the alley east of Ocean Avenue and the alley west of Fourth Street (see figure 5), and the roadway was being used as an outdoor farmers' market from 9:00 a.m. to 2:00 p.m. Prior to the beginning of the market area, westbound traffic was allowed to use Arizona Avenue between Fourth Street and an alley, located between Third and Fourth Streets, to access a bank parking lot on the southwest corner. A full closure was located at the west side of the intersection of Arizona Avenue and the alley between Third and Fourth Streets. Past the closure points on Arizona Avenue, fruit and vegetable vendor canopy tents occupied the outer edges of the roadway from the alley midway between Third and Fourth Streets to the alley midway between Second Street and Ocean Avenue.

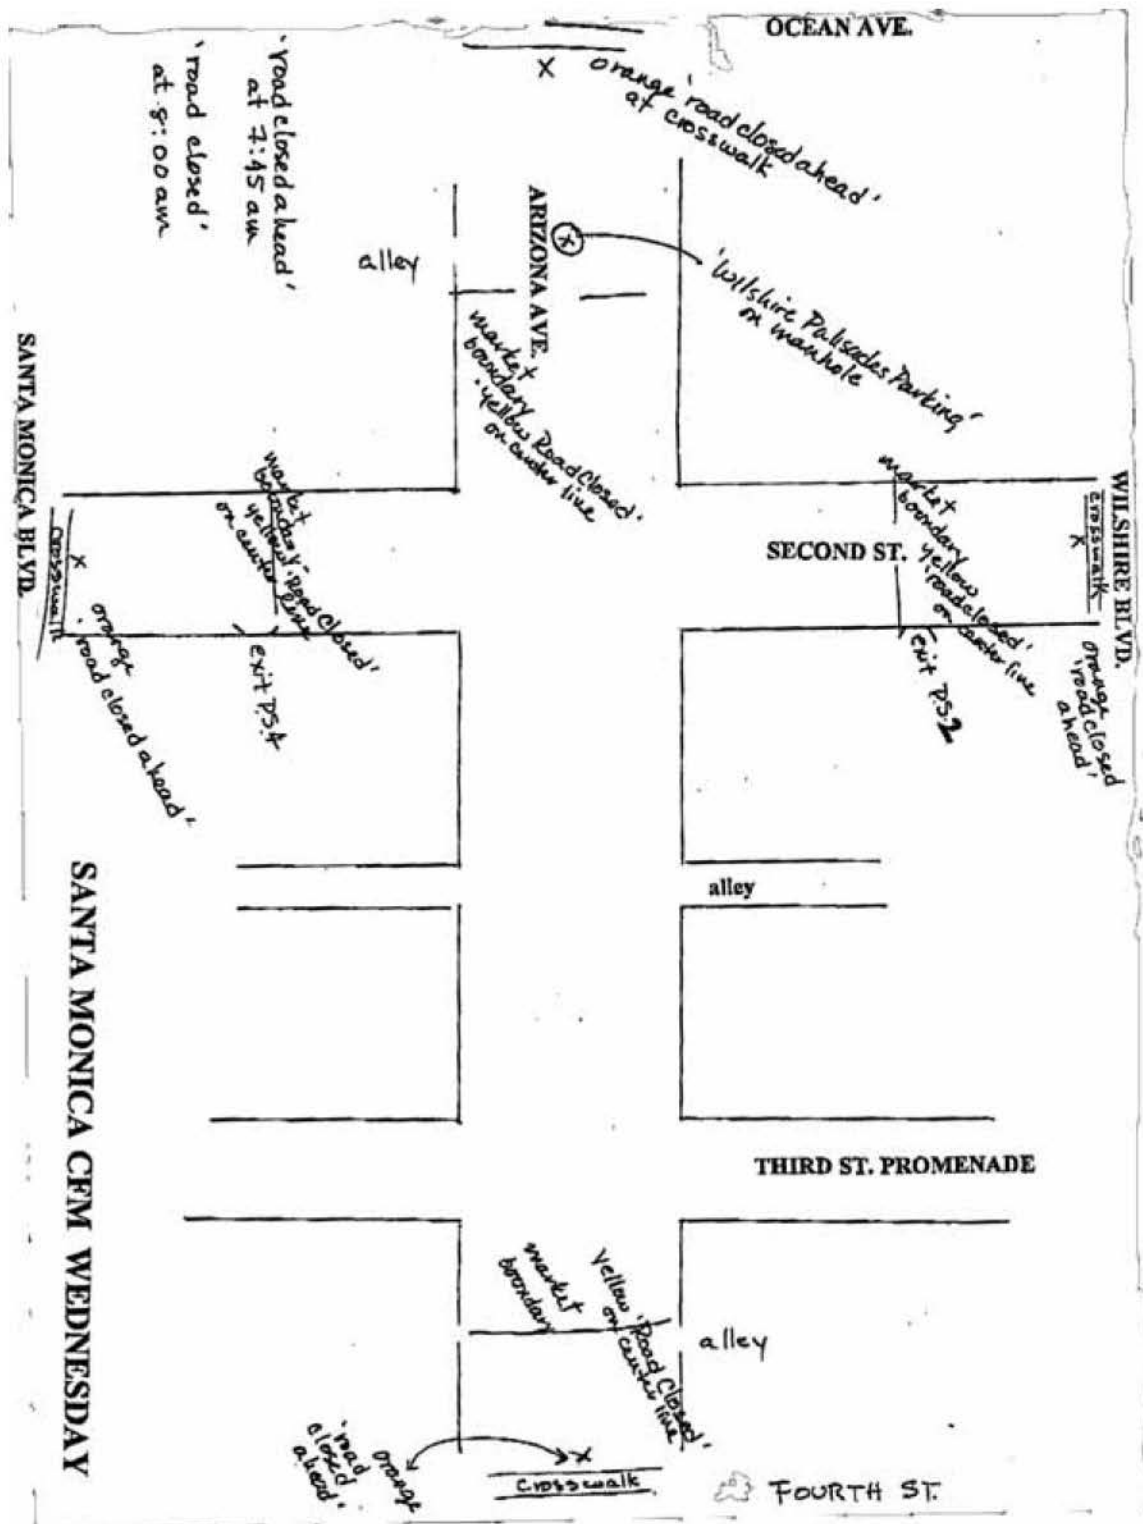
Figure 6. Temporary traffic plan (1986 version).

Santa Monica provided a temporary traffic plan for the SMC FM to Safety Board investigators. The undated and unsigned temporary traffic plan consisted of a single sheet of paper (8 1/2 x 11 inches) on which a roadway diagram was hand-drawn (see figure 6); the diagram indicated where barricades should be placed in the roadway. The plan did not cite any specific *Manual on Uniform Traffic Control Devices* (MUTCD) or *Caltrans* [California Department of Transportation] *Traffic Manual* (CTM) barricade types or traffic channelization devices⁸ to be used. According to the director of the SMC FM, the traffic plan had been developed in 1981 when the market opened and revised in 1986 when the market expanded onto Second Street. It had not been revised, reevaluated, or updated since then.

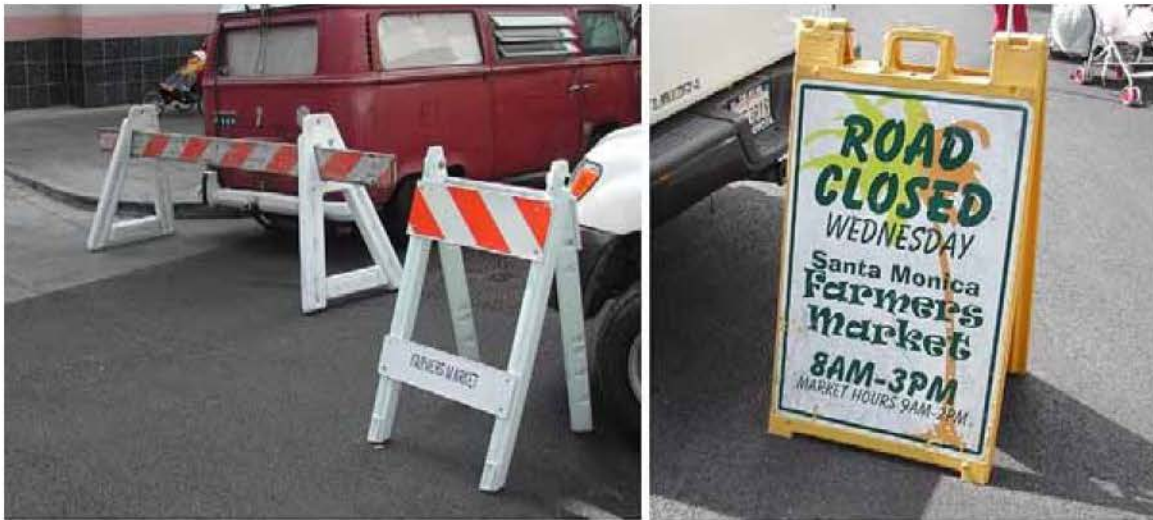
Figure 7. Market barricades.

According to the SMCFM director, Arizona Avenue was blocked at the entrances to the market by two MUTCD type I barricades,⁹ supplemented by two A-frame plastic barricades (see figure 7). The barricades were placed in the roadway about 7:00 a.m. every Wednesday, remained in place during the event, and removed about 3:00 p.m. Orange, diamond-shaped ROAD CLOSED AHEAD warning signs (designated “W-20” signs in the MUTCD and “C-19” in the CTM), attached to temporary fixtures, were placed on the centerlines of Arizona Avenue and Second Street (see figure 8),¹⁰ about 1/2 block before the road closure. No other advance warning signs were used. When Safety Board investigators observed the SMCFM in operation on July 23, 2003, barricades were in place at those locations indicated in the temporary traffic plan. Contract personnel, hired by the city’s Office of Economic Development, placed and removed the barricades and warning signs.

⁹ The CTM, Chapter 5, Section 5-05.6, “Channelizing Devices, F. Barricade Application,” recommends the use of type III barricades for full road closures, as shown in Typical Application 5-8 on page 5-99, “Road Closed with Off-Site Detour.”

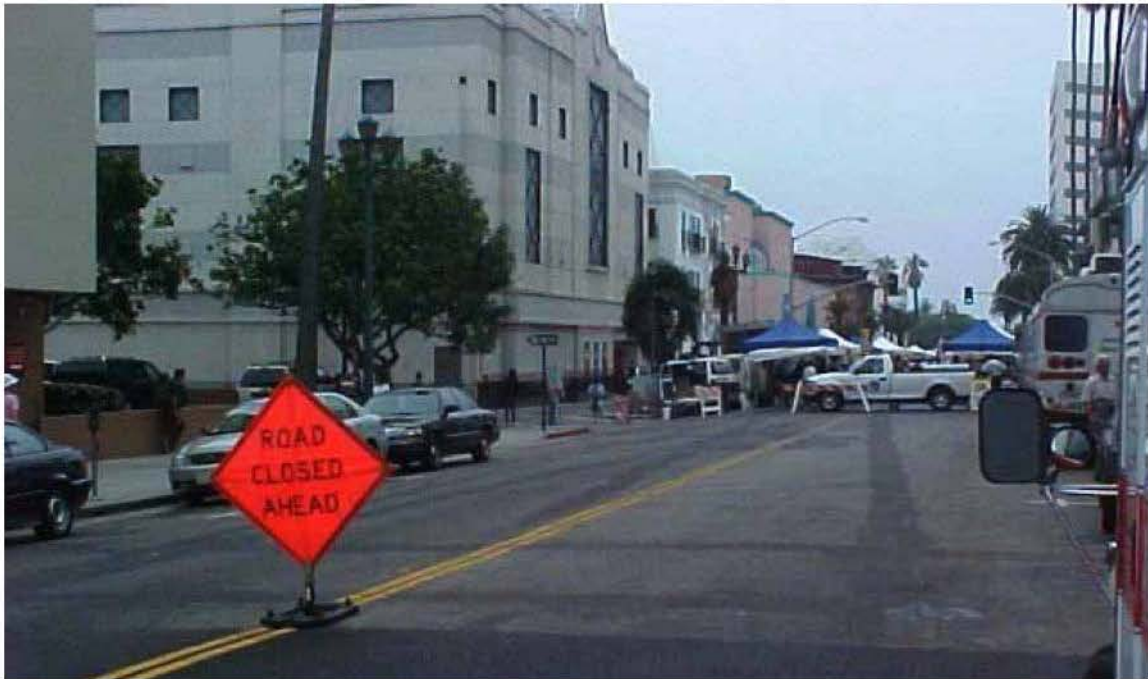
Figure 8. Advance warning sign on Arizona Avenue, just west of Fourth Street (postaccident).

¹⁰ In this photograph, taken a week after the accident, a small pickup truck is parked in the middle of the street. No vehicles were parked in the middle of the street on the day of the accident.

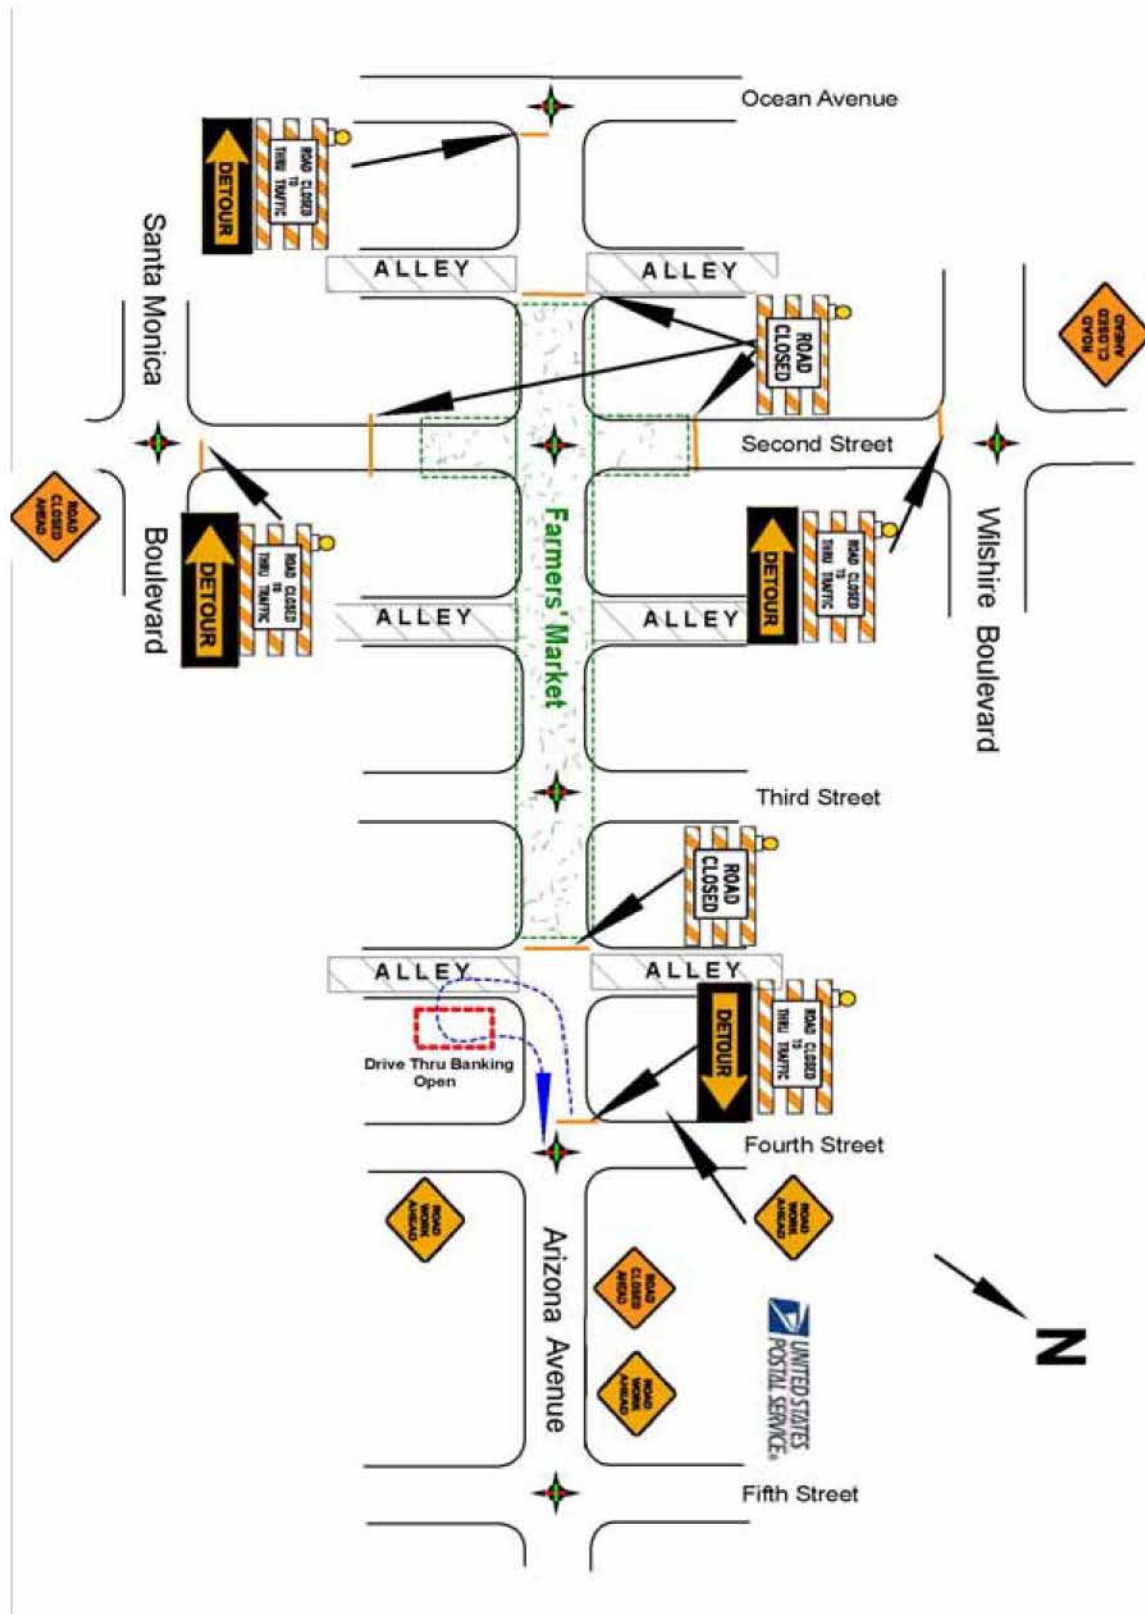
Thus, Santa Monica failed to comply not only with its own guidance, but also with State and Federal guidelines regarding temporary road closures for the SMC FM. As a result, the temporary traffic control devices erected along Arizona Avenue at the time of the accident did not provide the more robust barricades recommended in city, State, and Federal manuals and sent conflicting messages to motorists by, for example, allowing traffic signals at Second and Third Streets to function, even though the road was not open to through traffic. While the signage is unlikely to have affected the accident driver's actions, it could be critical in another situation in which a driver is impaired or distracted and does not understand that Arizona Avenue is closed to vehicular traffic.

Figure 13. SMCFM traffic control measures that comply with city guidelines.

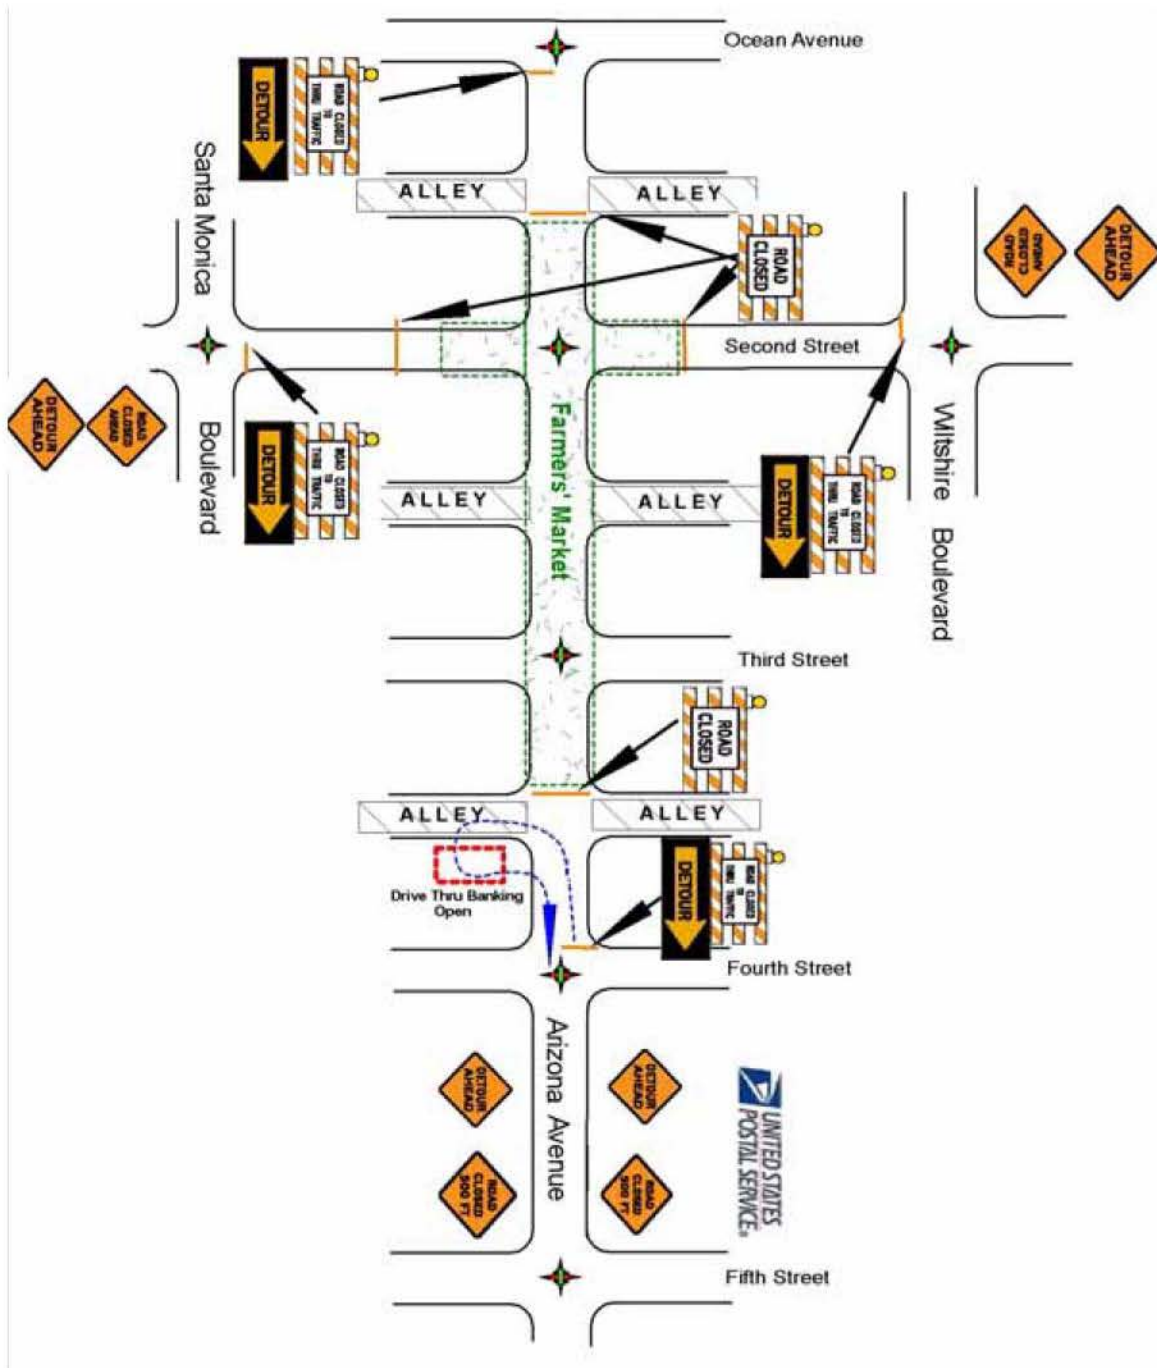
Figure 14. SMC FM traffic control measures that comply with CTM and MUTCD guidelines.

The Safety Board therefore concludes that the city's temporary traffic plan for closure of Arizona Avenue to accommodate the SMC FM was not consistent with established local, State, or national guidelines and was inadequate to ensure the safe flow of vehicular and pedestrian traffic in the area. The temporary traffic control plan for the market had been developed more than 2 decades ago and revised only once 5 years later. Since the 1986 revision, both the CTM and the MUTCD were updated several times.
