U.S. Department
Of Transportation

National Highway
Traffic Safety
Administration

Technical Assessment of Toyota Electronic Throttle Control (ETC) Systems

February 2011

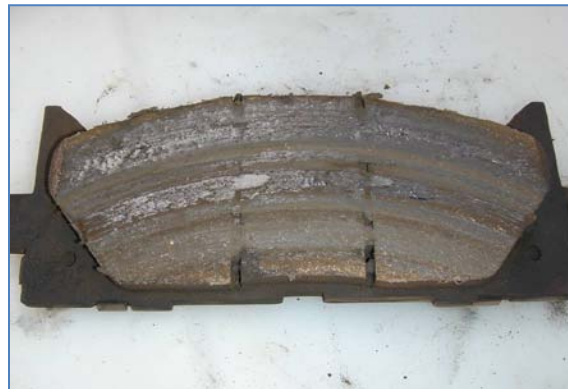
Brake fade is a reduction in braking effectiveness or stopping power that occurs due to friction-related thermal effects of repeated and/or sustained brake application, especially in high-speed conditions. Post-incident inspections of brake components removed from vehicles involved in high-speed, long-duration incidents have revealed evidence of this type of thermal degradation of friction materials indicative of prolonged braking at speed (Figures 4 and 5). This type of damage has only been observed in incidents that originated at highway speeds and involved prolonged open-throttle braking.⁴⁵ These types of events were first observed by NHTSA in 2006 in MY 2007 Lexus ES 350 vehicles⁴⁶ and, to date, such brake system overheating in UA incidents has only been observed in events involving throttles stuck wide-open due to pedal entrapment.

Figure 4: Left-front inboard brake pad; 2007 Lexus ES350 (ODI 10182245)

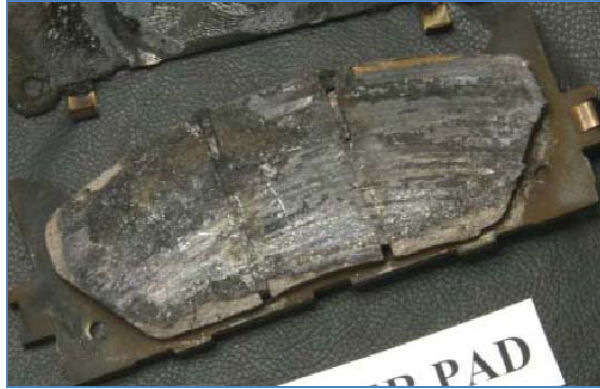
Figure 5: Left-front inboard brake pad; 2009 Lexus ES350 (ODI 10284881)
