The Use of Event Data Recorders in the Analysis of Unintended Acceleration Incidents

**Trevor Lehouillier
William Holmes
Transport Canada**

ABSTRACT

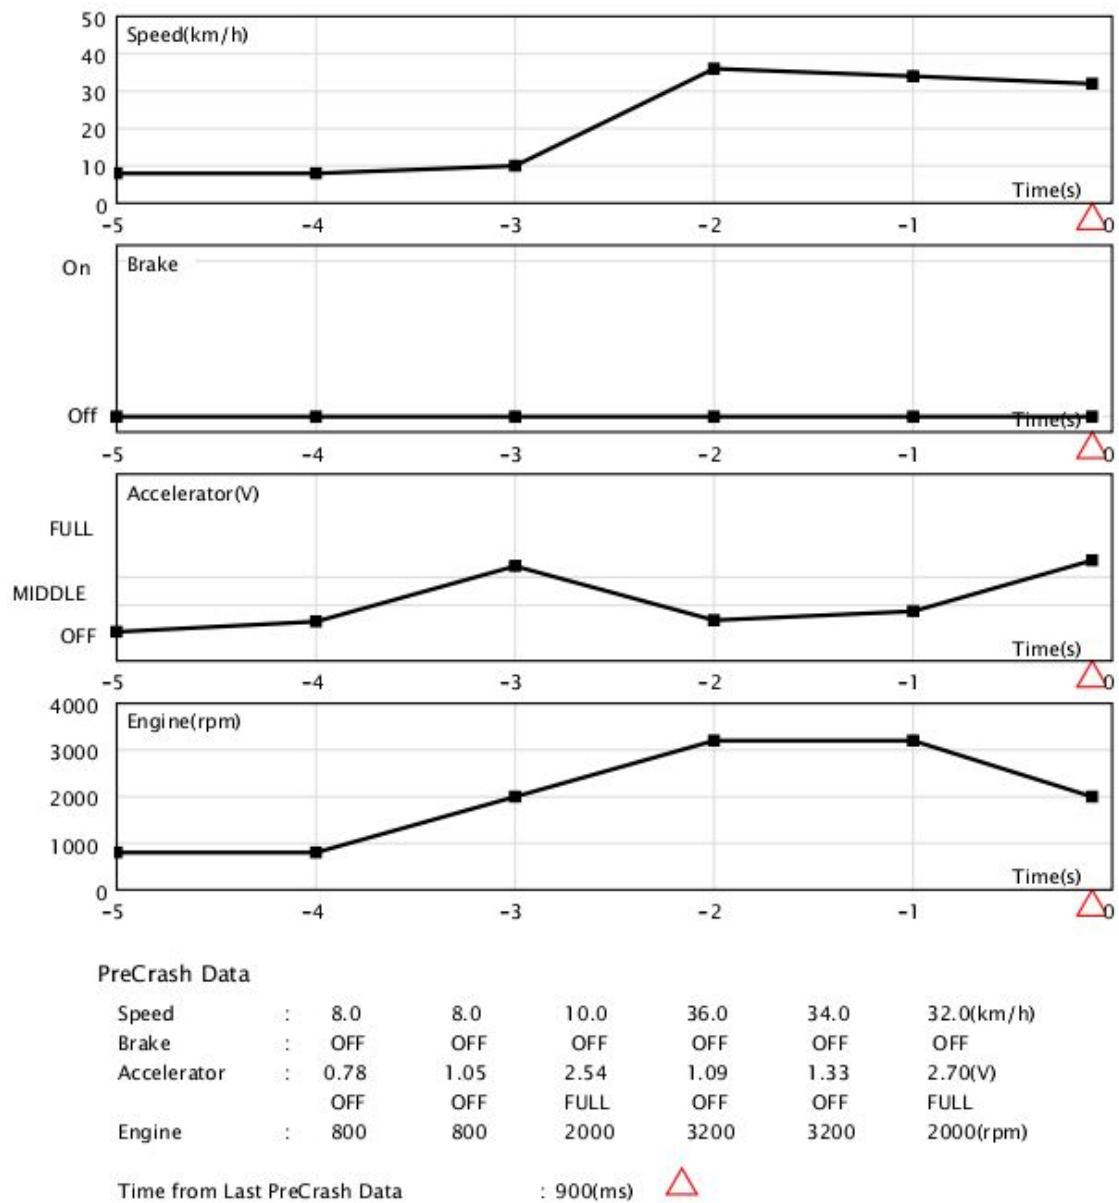
Figure 4. Pre-Crash Data for Case No. 1

A post-impact inspection of the vehicle did not identify any faults with either the brakes or the throttle system. A brake-hold test confirmed that the brakes would overpower the engine. The vehicle's EDR was downloaded and provided the pre-crash data shown in Figure 4.

Note that, despite the driver's assertions that she pressed on the brake pedal, the brake light switch remains in the off position throughout the recorded incident. Furthermore, there are various levels of effort applied to the accelerator. In particular, note that at $t = -3s$, the accelerator voltage rises to 2.54 volts, and then drops down in the next two time intervals. However, at the trigger point for the EDR recording (approximately $t = 0s$), the accelerator voltage is once again relatively high at 2.70 volts. These two accelerator applications may well correspond to the driver's belief that she initially pressed the brake pedal and subsequently pressed harder.

It can also be noted in the pre-crash data that the various levels of accelerator application are accompanied by expected increases in engine speed (RPM) and vehicle speed, subject to time lags between pedal actuation and engine response.

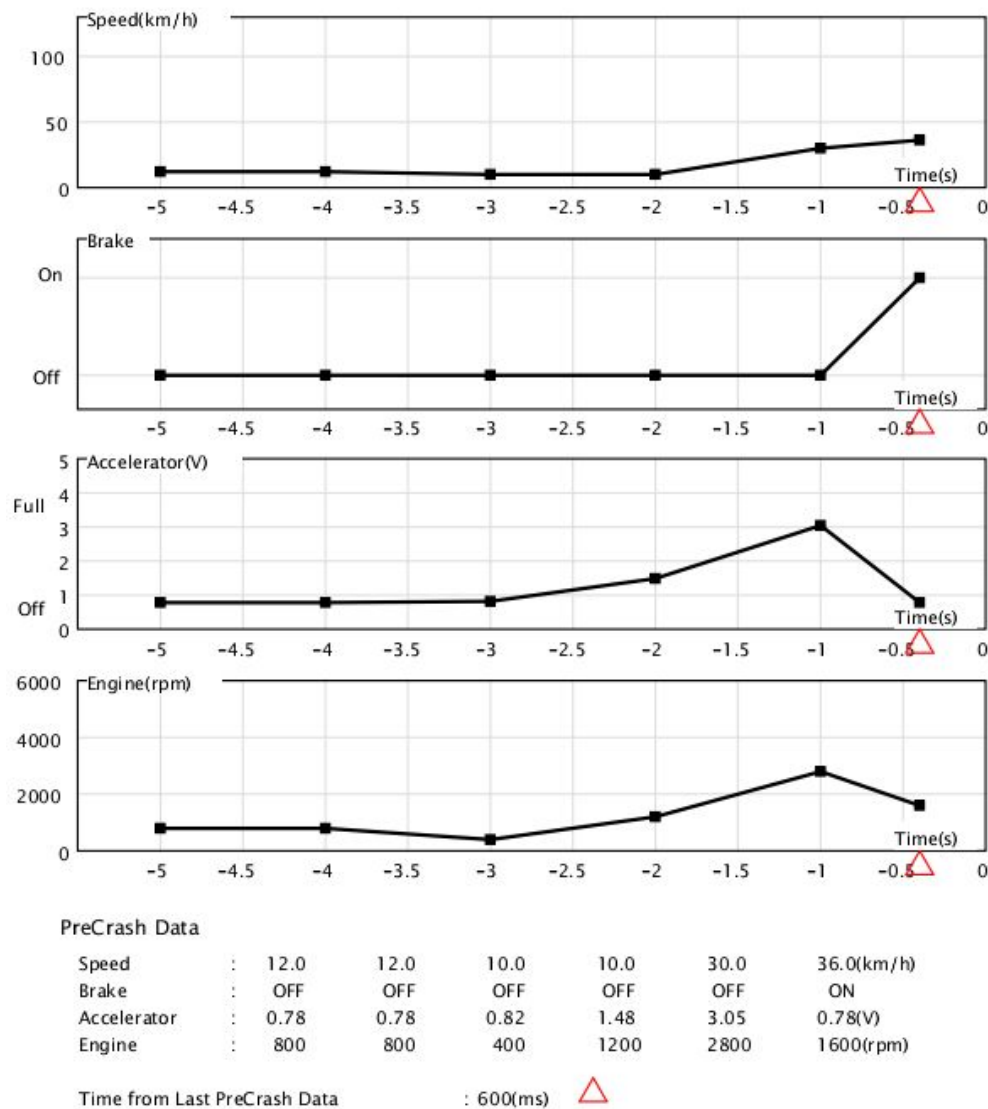
Figure 5. Pre-Crash Data for Case No. 9

Transport Canada personnel subsequently inspected the vehicle's brake and throttle system and did not identify any problems. An On-Board Diagnostics (OBD) scan did not reveal any fault codes. A brake-hold test confirmed that the brakes were capable of holding the vehicle under a wide-open throttle. The vehicle's EDR was downloaded. The stored pre-crash data are shown in Figure 5.

These data show that the vehicle was initially travelling at approximately 12 km/h ($t = -5s$), with no brake application, and no accelerator application. At $t = -3s$, the accelerator voltage rises from 0.78 volts to 0.82 volts, and subsequently to 1.48 and 3.05 volts, indicating rapidly increasing pedal application. As a result, both the engine RPM and the vehicle speed can be seen to increase, with the vehicle's speed reaching 36 km/h at the trigger point for the EDR recording. In the final data interval, the accelerator pedal is shown to have been released and the brakes applied.

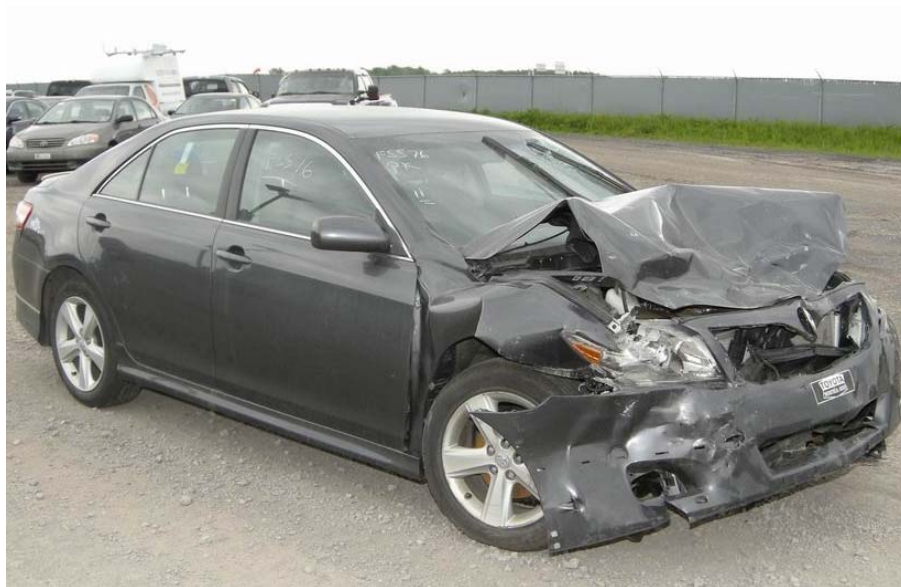
Figure 6. Damage to the 2011 Toyota Camry

The case vehicle, a 2011 Toyota Camry was being operated as a taxi. The male driver arrived at a restricted marshaling area and stopped at a gate controlling access. After obtaining access through the gate, the driver alleges that the vehicle abruptly and very rapidly accelerated. The vehicle continued forward, travelling at high speed, until it impacted a line of parked vehicles and contacted an individual standing next to the struck vehicles. The progress of the fast-moving vehicle just prior to the collision was captured by a security camera.
