### ON-SITE COMPRESSED NATURAL GAS VEHICLE EXPLOSION INVESTIGATION

FOR THE OFFICE OF DEFECTS INVESTIGATION (ODI)

CASE NUMBER - IN14016

VEHICLE - 2014 FREIGHTLINER M2 112

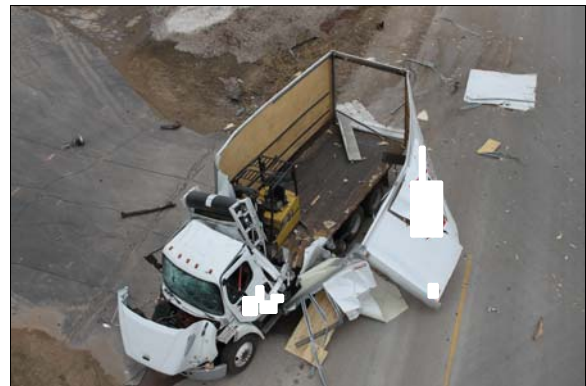
This on-site investigation focused on the Compressed Natural Gas (CNG) fuel system of a 2014 Freightliner M2 112 (**Figure 1**). One of the five CNG fuel cylinders was punctured by the left fork of an unsecured Yale Type E forklift located in the cargo box of the Freightliner resulting in an explosion of the fuel cylinder. There was no fire. This investigation was initiated by the National Highway Traffic Safety Administration (NHTSA) on April 15, 2014 through the Office of Defects Investigation (ODI), which was responding to an on-line news article. This investigation was assigned on April 17, 2014 when cooperation to inspect the Freightliner was finalized with the vehicle's owner. The incident involved the Freightliner and the Yale Type E forklift located within the cargo box of the vehicle. This incident occurred in April 2014 at 1335 hours, in Wisconsin and was investigated by a local police agency. The Freightliner and incident scene were inspected on April 22, 2014. Interviews with the front right passenger of the Freightliner, the owner of the Freightliner, and the city public safety director were also conducted on April 22, 2014.

**Figure 1:** On-scene police photograph of the damaged 2014 Freightliner M2 112

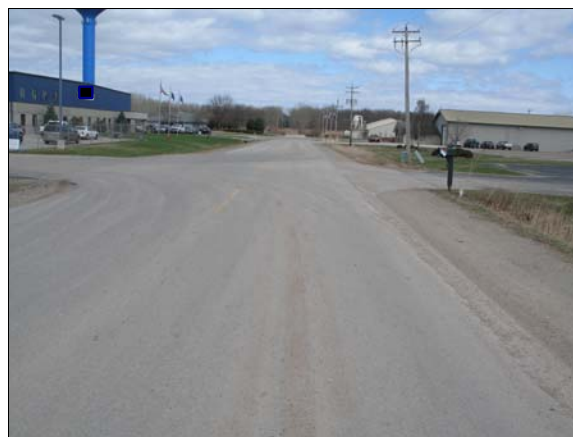
**Figure 2:** Freightliner's eastbound approach to the driveway (on right) and area of explosion

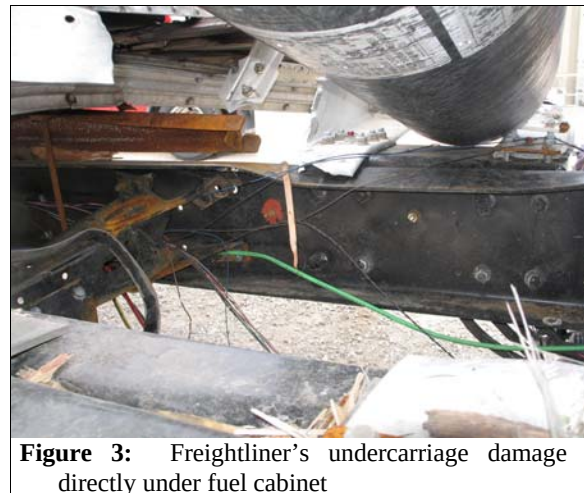
**Frame and Undercarriage:** The explosion deformed the truck frame directly below the fuel cylinder cabinet (**Figure 3**). Both frame rails were bent, as were the frame cross members fore and aft of the cylinder cabinet. The center section of the drive shaft was fractured and separated from the transmission. The air brake lines were severed and the air brake tank was also slightly displaced. The rear engine mounts were undamaged.

**Figure 3:** Freightliner’s undercarriage damage directly under fuel cabinet

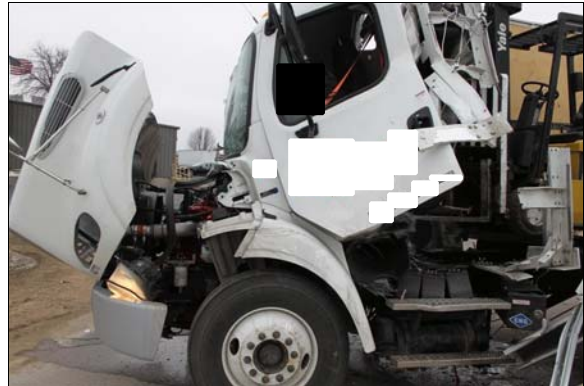
**Passenger Cab:** The cab of the truck was heavily damaged from the explosion (**Figure 4**). The most

severe damage occurred below and behind the driver's seat. The entire cab was displaced upward and forward approximately 40 cm (15.7 in) and the back panel of the cab was torn vertically, intruding into the passenger area. Shards of carbon fiber wrap and fiberglass from the ruptured cylinder were found throughout the inside of the cab and the windshield was holed from the force of the explosion.

**Figure 4:** Police on-scene photograph of damage to cab of the Freightliner

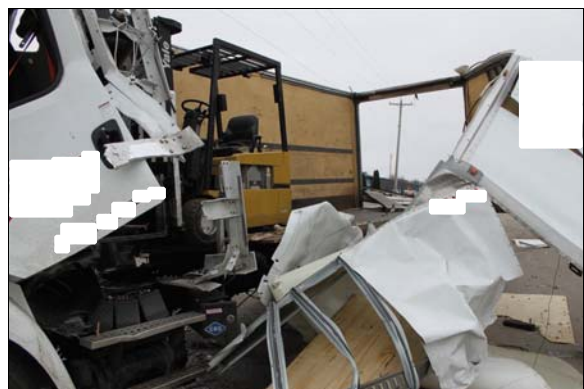
**Cargo Box:** The truck's cargo box (**Figure 5**) was also heavily damaged from the explosion. The front panel was largely displaced from the main structure. The roof and rear door panels completely detached and the left side panel was partially detached. There was slight damage to the floor and right side panel.

**Figure 5:** Police on-scene photograph of damage to the Freightliner's cargo box

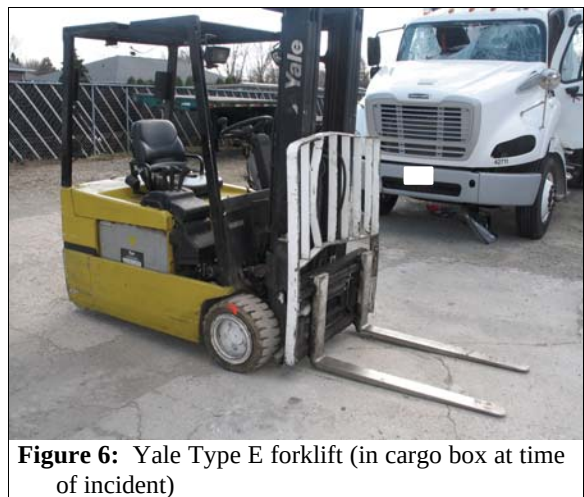
**Cargo:** The only cargo was a Yale Type E battery powered forklift, Model ERP040TFN03739W. The forklift (**Figure 6**) measured 306 cm (120.5 in) from back to fork tips and weighed 4,035 kg (8,896 lb). Each fork was 106 cm (41.7 in) in length and 10 cm (3.9 in) in width. The forks were 1.5 cm (0.5 in) thick at the tips and 4 cm (1.6 in) at the base and were set 49 cm (19.3 in) apart from each other. A parking brake was located on the left side of the instrument panel and was engaged at the time of the incident.

**Figure 6:** Yale Type E forklift (in cargo box at time of incident)

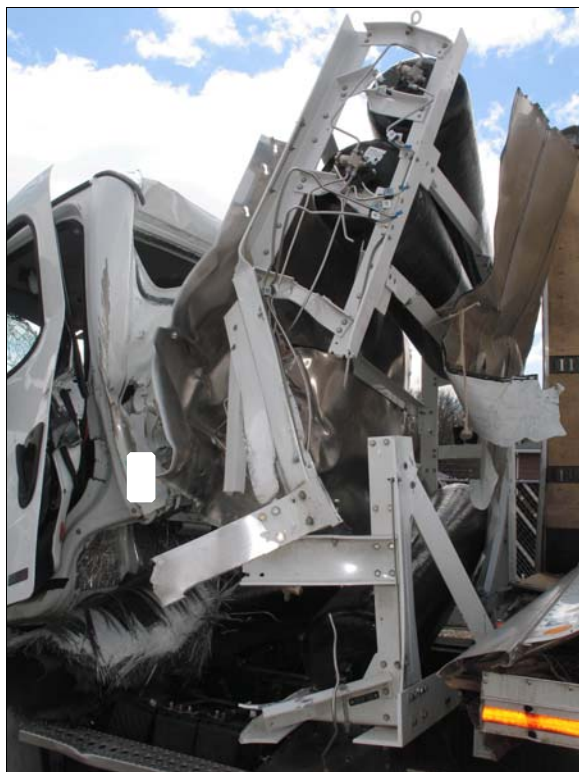
The cabinet for the CNG cylinders was manufactured by Agility Fuel Systems and was located between the cab and cargo box. The cabinet included an aluminum support structure that measured 217 cm (85.4 in) in height and 53 cm (20.9 in) in width, which was encased by aluminum sheeting. There was no protective barrier between the CNG cabinet and the cargo box. The rack allowed for five CNG cylinders to be mounted by the neck, horizontally onto cross members. The cylinders were stacked vertically in the cabinet. The cabinet sustained severe damage as a result of the explosion (**Figure 7**). The sheet metal encasing the cabinet was mostly displaced from the vehicle, with only the forward panel remaining attached. The left rear vertical frame member fractured and separated 88 cm (34.6 in) from the bottom support and the front vertical frame member

**Figure 7:** Left side damage to fuel cabinet

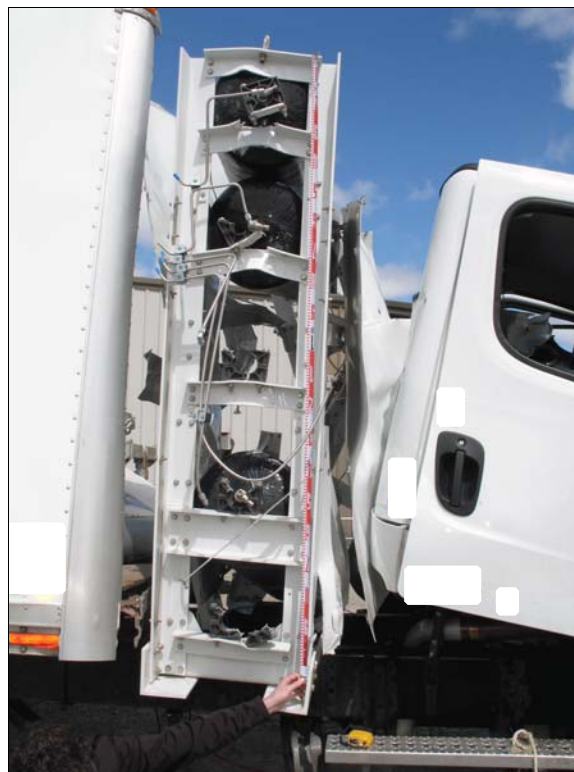
was rotated 90 degrees to the left. All cross members, on both sides, were either fractured, displaced, or bent (**Figure 8**).

**Figure 8:** Right side of fuel cabinet damage to cross members

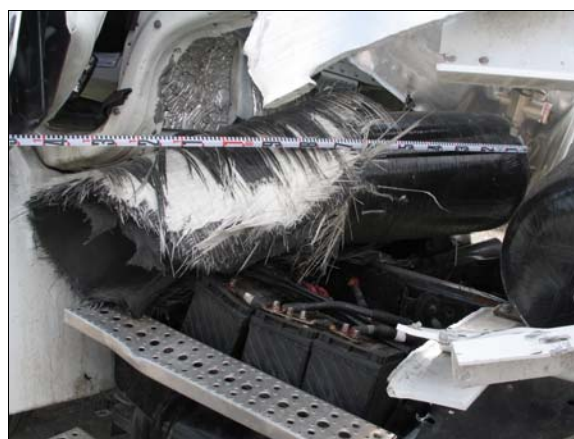
The five CNG cylinders were Type 4 design (polymer liner with carbon fiber and fiberglass overwrap), manufactured by Hexagon Lincoln, Model number RH36A16-07601. Each cylinder measured 205 cm (80.6 in) in length, 41 cm (16 in) in diameter, and were certified with ANSI NGV2 and FMVSS 304. Each cylinder was equipped with a Pressure Relief Device (PRD) at each end, which was designed to pipe discharge away to the top of the cabinet in the event of a breach of the system. Each cylinder had a manual valve without an excess flow device that was manufactured by OMB. The bottom cylinder (cylinder 1) was impacted by the left fork of the forklift and ruptured (**Figure 9**), with the damage starting 65 cm (25.6 in) left of the right end of the cylinder. A 66 cm (26 in) section of the left end of the cylinder (**Figure 10**) separated and was displaced into the street (**Figure 11**). Both valves separated from the bottom cylinder. Cylinder 2 remained intact, but the left side dropped from its mount. The left side valve was detached and part of the right side valve remained in place. Cylinder 3 was propelled out of the cabinet and landed in the street, according

**Figure 9:** Ruptured CNG cylinder

4. The composite fracture apparently progressed approximately in a longitudinal direction and then turned and ran circumferentially, separating one of the cylinder ends and ejecting it from the driver's side of the truck.

8. The shape of the fork tip probably produced a cut perpendicular to the critical hoop direction reinforcing fibers. These fibers carry the greatest load in a pressure vessel and the orientation of the fork tip was such to maximize the number of hoop fibers that were damaged.

9. If the fork tip penetrated the sidewall of the cylinder it would have wedged the break open because the long taper of the fork. This could have inflicted greater damage than a simple penetration by a 2 mm x 60 mm point.

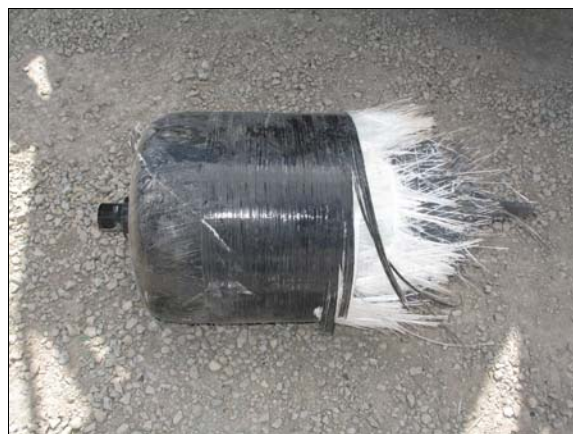
**Figure 10:** Displaced section of ruptured CNG cylinder

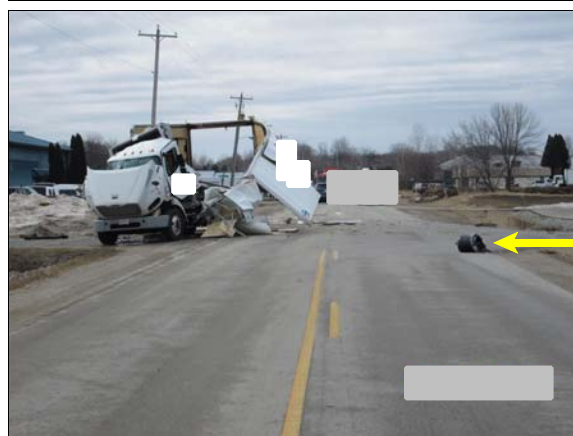
**Figure 11:** Police on-scene photograph showing location of displaced section of bottom CNG cylinder (arrow)

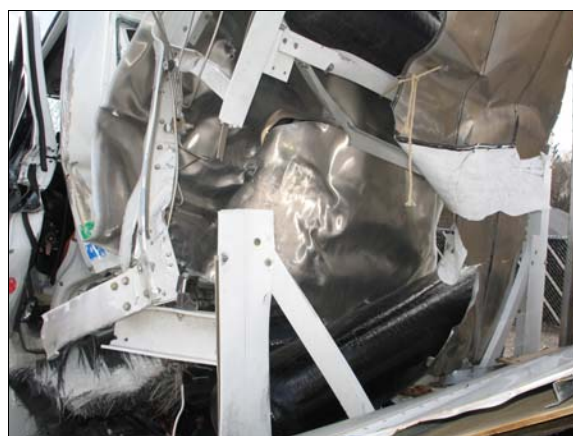
The interior of the Freightliner sustained severe damage from the CNG cylinder explosion. There were a total of twelve intrusions to the passenger compartment. The most severe intrusions occurred in the driver's space and were to the back wall of the cab and the backlight header (**Figures 12 and 13**), which intruded longitudinally approximately 80 cm (31 in), and 30 cm (12 in), respectively, and the floor, which intruded vertically approximately 40 cm (16 in). The driver was projected forward by the explosion and he loaded the steering assembly (**Figure 13**), displacing it forward approximately 25 cm (10 in). Scuff marks were noted on the roof above the driver's seat, possibly from contact by the driver's head. The rearview mirror was also displaced from possible contact by the driver's right hand. Fragments of fiber glass from the ruptured CNG tank were also deposited throughout the cab. Some of the fragments cut the ceiling upholstery in the front right passenger's space, and fragments were embedded in the roof and damaged a plastic storage compartment in this area. Both doors were jammed shut and the left door was mechanically pried open by rescue personnel. The windshield was in place and holed due to explosion forces. The right and left glazings as well as the backlight all disintegrated due to the explosion. The only undamaged glazings were the small windows on each door.

**Figure 12:** Exterior view of intrusion of back wall of Freightliner's cab

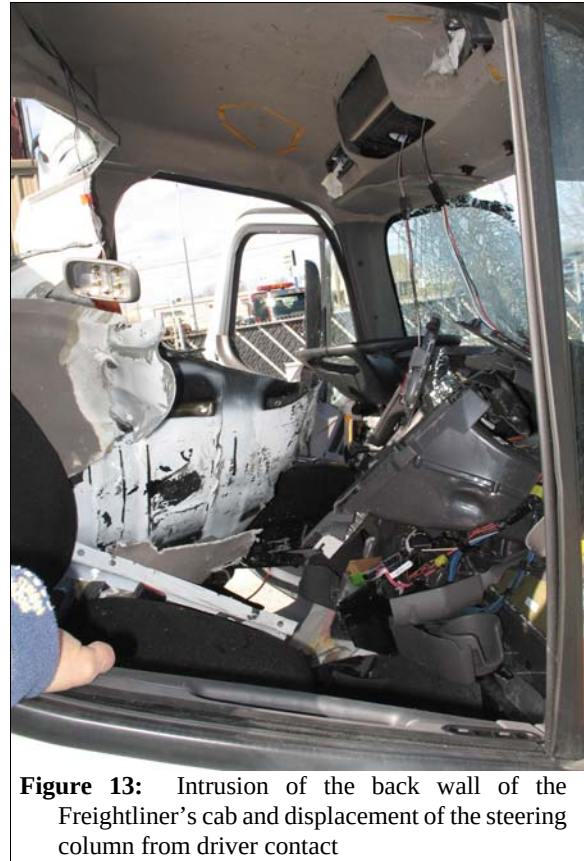
**Figure 13:** Intrusion of the back wall of the Freightliner's cab and displacement of the steering column from driver contact

The driver was restrained by the lap and shoulder safety belt. He was displaced forward and upward as a result of explosion forces and intrusion of the back wall of the cab. His face and chest loaded the steering assembly causing a subarachnoid hemorrhage, fracture of the right orbital plate and nose, lacerations of the pericardium, right and left atria, thoracic aorta, and diaphragm. He also sustained bilateral fractures of multiple ribs, contusions and lacerations of the lungs, and lacerations of the left kidney, liver, and spleen from contacting the steering assembly. Contact with the seat back caused a fracture of the right shoulder, and he sustained multiple lacerations and abrasions from flying glass from the disintegrated backlight. He also sustained multiple abrasions and contusions to the lower extremities from contacting the lower left instrument panel and steering wheel rim, and an open laceration of the left lower leg, also from contacting the lower left instrument panel. The driver injuries were fatal and he was officially pronounced deceased at 1640 hours.
