## ODI RESUME

**Investigation:** DP 15-006

**Subject:** Ride Quality

**Products:** 2013 - 2016 Volvo 780

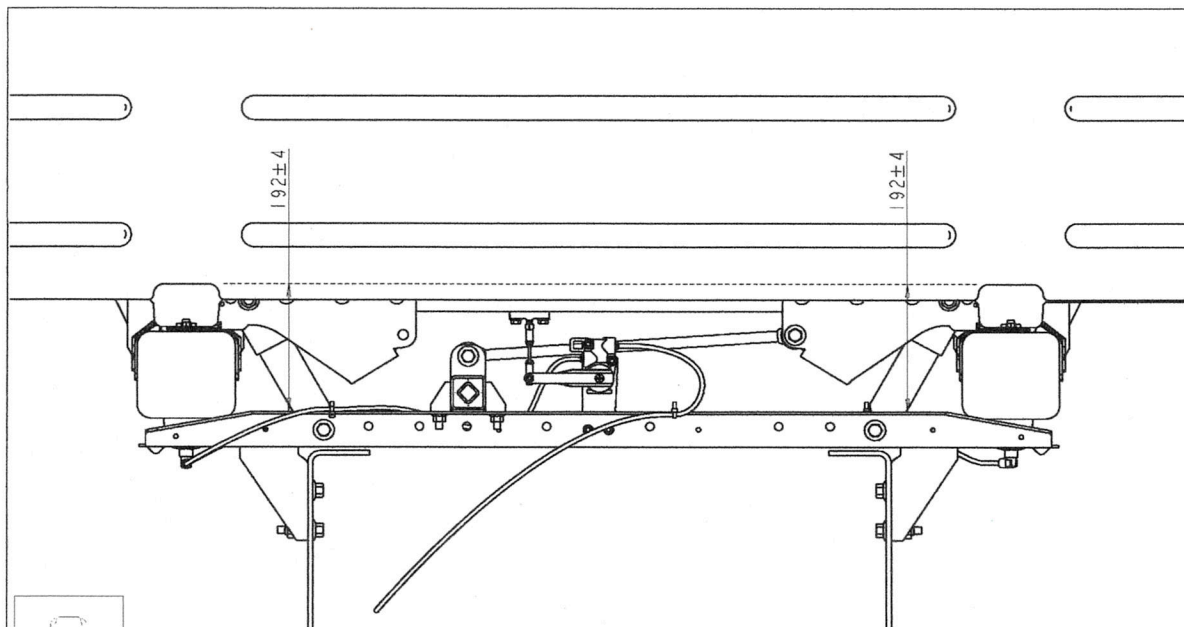
Figure 1 - Air Suspension Sleepers

**DESCRIPTION OF SYSTEM:** The cab suspension system installed on the petitioners' truck is an air ride configuration. The design has been used by Volvo since 2005 and consists of two (2) air bags, two (2) shock absorbers, an air leveling valve, and a torsion bar and block located at the rear of the sleeper cab. Two (2) mounting brackets are located at the front of the cab. Volvo uses shock absorbers that are mounted on an angle. Other OEMs such as Freightliner, Peterbilt and Kenworth were observed to use shock absorbers mounted in the vertical configuration. The front brackets are mounted such that the anchoring bolt and bushings are parallel to the frame. Again, this is unique when compared to Freightliner, Peterbilt and Kenworth.

The air bags are intended to support the load of the cab/sleeper. They are controlled by a single leveling valve. As more weight (occupants and personal gear) is added to the cab/sleeper more air is added to the air bags to support the additional load. When the load is reduced, air is exhausted from the air bags, maintaining the predetermined ride height of the cab/sleeper. The torsion bar and block are used to allow cab/sleeper movement, but maintain correct placement on the frame.

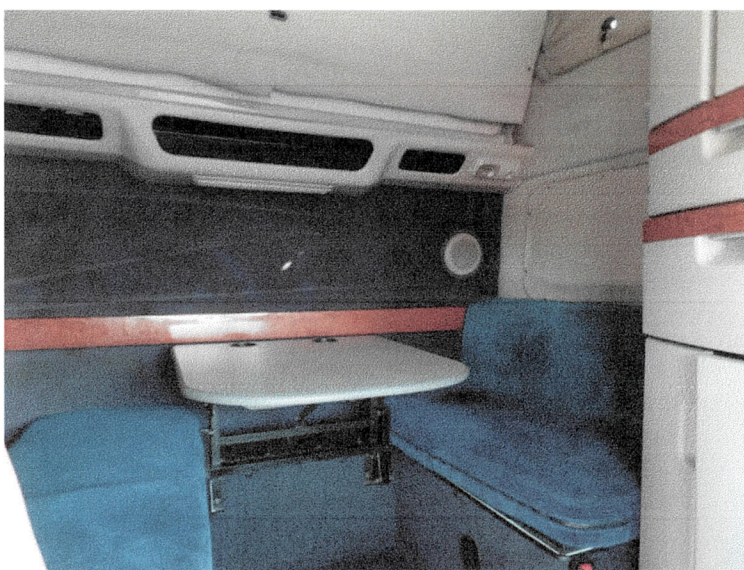
Figure 5: Volvo work station

One petitioner claims an injury was sustained when the cab bottomed out. ODI understands that the petitioner was seated at the work station (table) in the sleeper berth while the vehicle was in transit. Petitioners did not provide, in their petition or during their meeting with the investigator, enough details about the event for ODI to determine whether the injury was related to the alleged defect. Volvo has not designated this as a seating position. The seating area for the work station does not provide back support for a seated individual and is not equipped with seatbelts. Volvo does not intend for it to be used while the vehicle is in transit.

While ODI believes that it may be foreseeable that vehicle occupants may use the work station during transit, ODI does not believe that the alleged defect creates an unreasonable risk to motor vehicle safety. Volvo reported three (3) complaints and three (3) field reports for the cab bottoming out. One of the field reports described an incident in which a mounting bolt had punctured the air bag, which caused the failure. Volvo did not report any warranty claims related to bottoming out. Volvo also received three (3) reports of the cab hitting or striking the vehicle's aerodynamic flaring. Volvo has not received any reports of injury related to bottoming out.

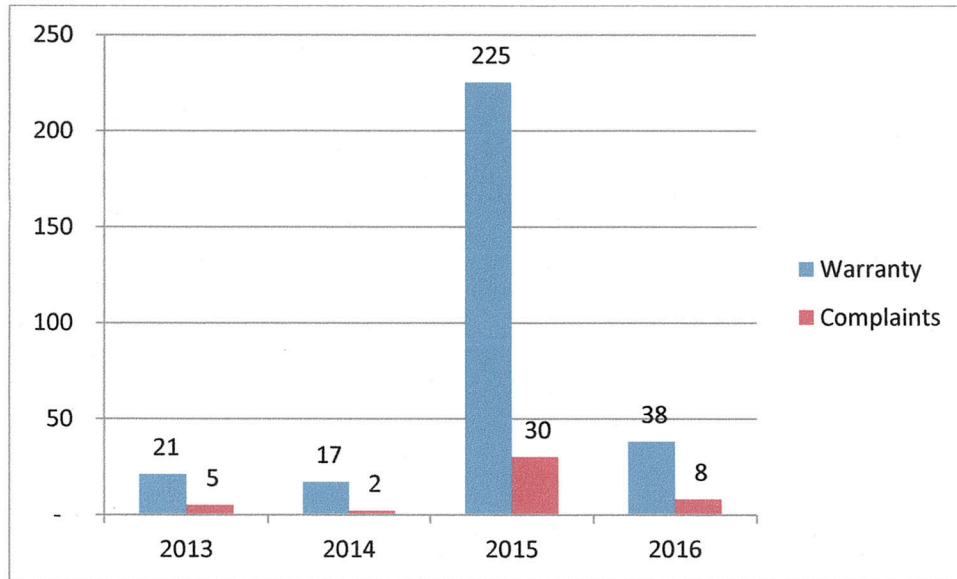
Figure 5 - Number of Volvo Reports by Vehicle Model Year

The final concern raised by the petitioners was cab misalignment/bottoming out. They stated that the cab has come out of alignment multiple times and it can then bottom out, forcefully striking the frame. Volvo reported forty-three (43) complaints and field reports and 292 warranty claims for cab misalignment. When sorted by MY, the 2015 MY stood out, with twenty-nine (29) complaints and field reports and 222 warranty claims. This equates to a 0.47%

warranty rate on the subject vehicles and a 1.24% warranty rate specifically for the 2015 MY. This significant shift indicated to ODI that there is a defect with the cab mounting components beginning in or about the 2015 MY; however a safety risk has not been identified because none of the complaints, field reports, or warranty claims received by Volvo report injuries.

It is ODI's contention—based on currently available information—that the incidence in the petition is isolated and is not related to a larger defect trend. There are several factors that could cause the sleeper cab to bottom out including traveling on a rough road surface, an incidence of heavy swaying, or an incident such as the one described in the field report. Furthermore, if the vehicle had a defect that caused the cab to bottom out ODI would expect to see more complaints, warranty claims, and field reports regarding the issue.
