**National Highway  
Traffic Safety  
Administration**

**Investigation:** EA 15-005

**Subject:** Front Brake Hose Failure

**Products:** 2013 - 2015 Ford Explorer Police Interceptor

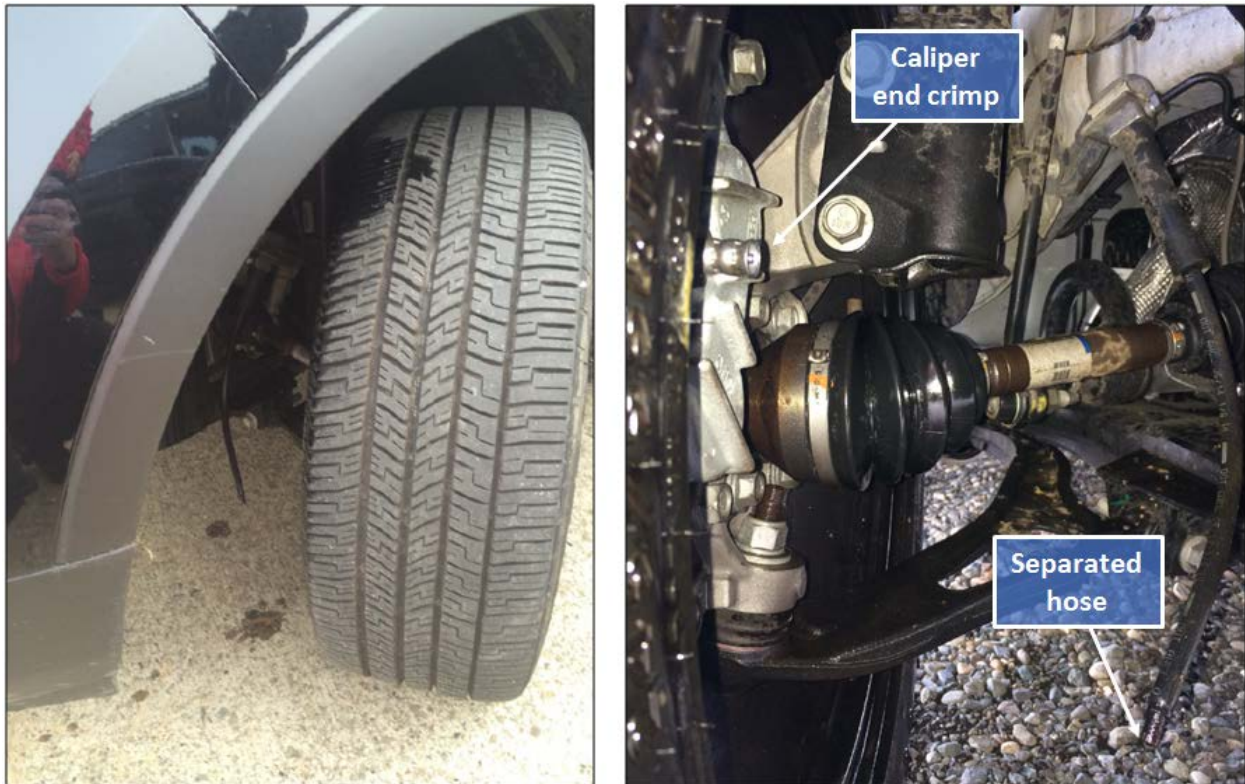
Most of the failures occurred within the first few miles of service on a closed course used for the EVOC program, which includes evasive accident avoidance and pursuit maneuver training. The hose assemblies either leaked at, or pulled completely free from, the caliper-end attachment where the hose is crimped to the steel end fitting (Figures 3 and 4). Most of the failures resulted in a sudden reduction of braking performance that caused the vehicle to run off the intended course. None of the failures resulted in any crashes, injuries or property damage.

**Figure 3. Sacramento EVOC training hose failures, left front brake hose (left) and right front brake hose (right).**

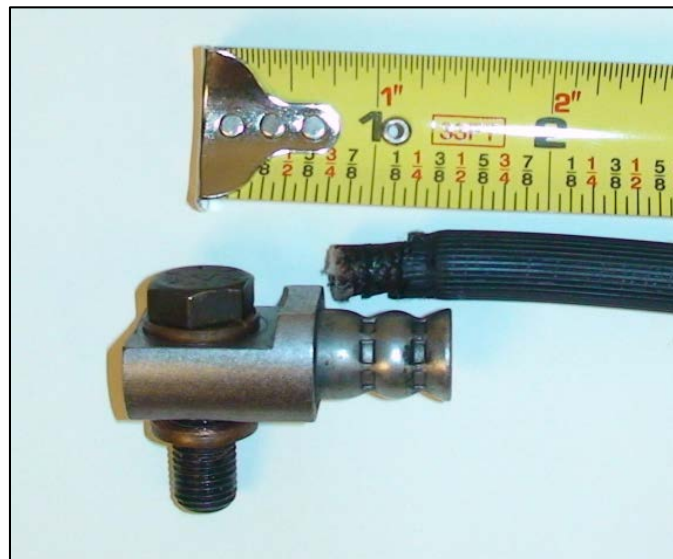
***Ford's analysis of the returned parts from the Sacramento Police Department identified the root cause of the failure as exposure to extreme heat at the jounce hose crimp joint on the caliper side, in combination with the added force of multiple electronic brake impulses resulting from their unique driver training course and procedures. In addition, all four reports related to the alleged defect from the Sacramento Police Department involved vehicles that were either currently or previously used for training purposes on this course. Ford is not aware of any other similar failures on any of the other subject or peer vehicles. Therefore, Ford believes this failure to be the result of an extreme usage and duty cycle unique to the Sacramento Police Department's pursuit training course and not a design or manufacturing defect.***

**Figure 4. Sacramento EVOQ crimp failure mode.**

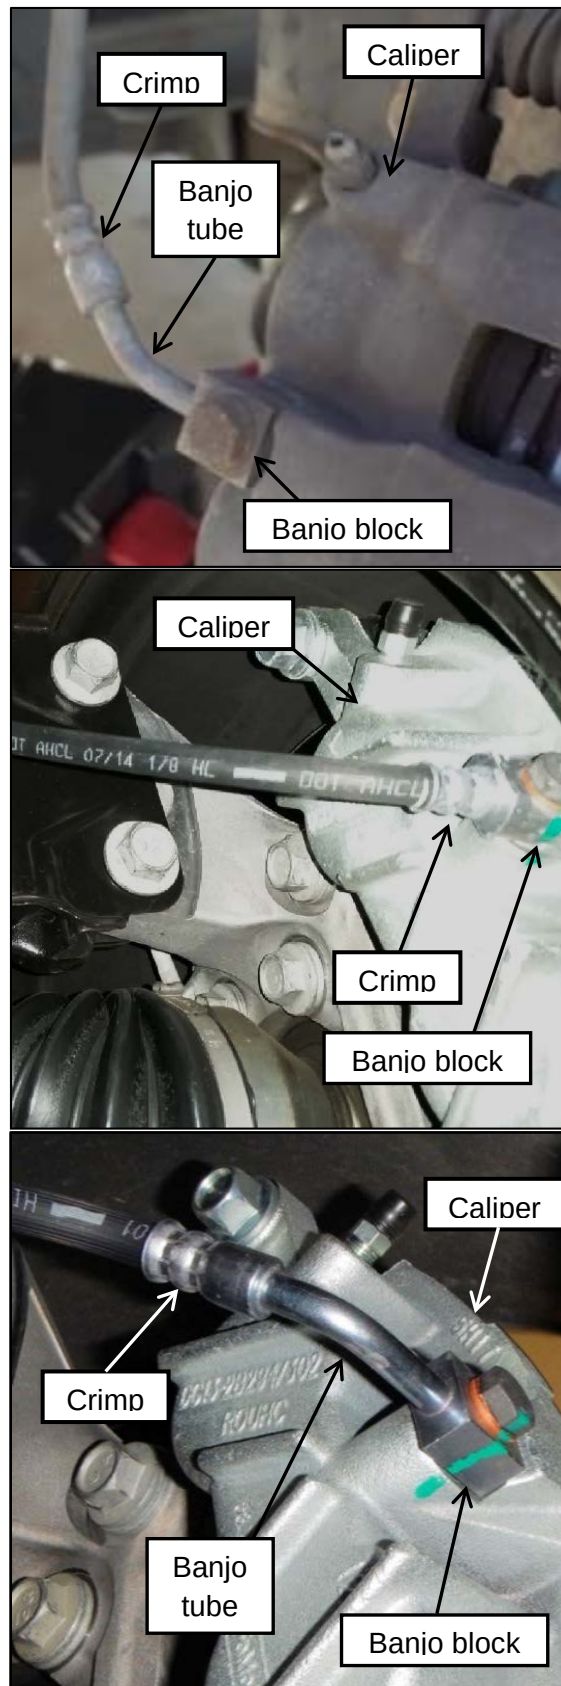
**Design history.** The front brake hose assemblies used in the subject vehicles are distinct from earlier and later production Explorer vehicles by the absence of steel tubes (“banjo tubes”) between the banjo block and caliper side crimp joint (Figures 5-7). Table 1 summarizes the changes that eliminated the banjo tubes near the beginning of MY 2013 Explorer vehicles in June 2012 and later added banjo tubes to accommodate the addition of a ride height sensor in late MY 2015 Explorer production.

Figure 5. MY 2011-12 hose assembly, with banjo tube (top); Subject MY 2013-15 hose assembly, no banjo tube (middle); and MY 2016-18 hose assembly, with banjo tube (bottom).

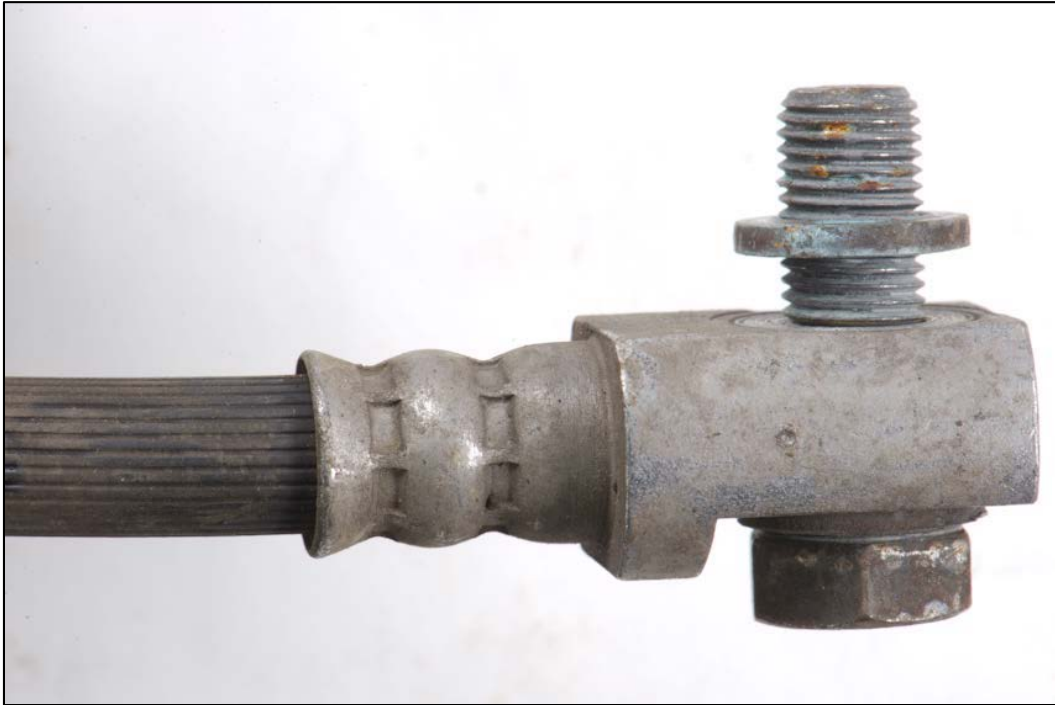
Figure 6. Caliper-side crimp, subject hose assembly (MY 2013-2015).

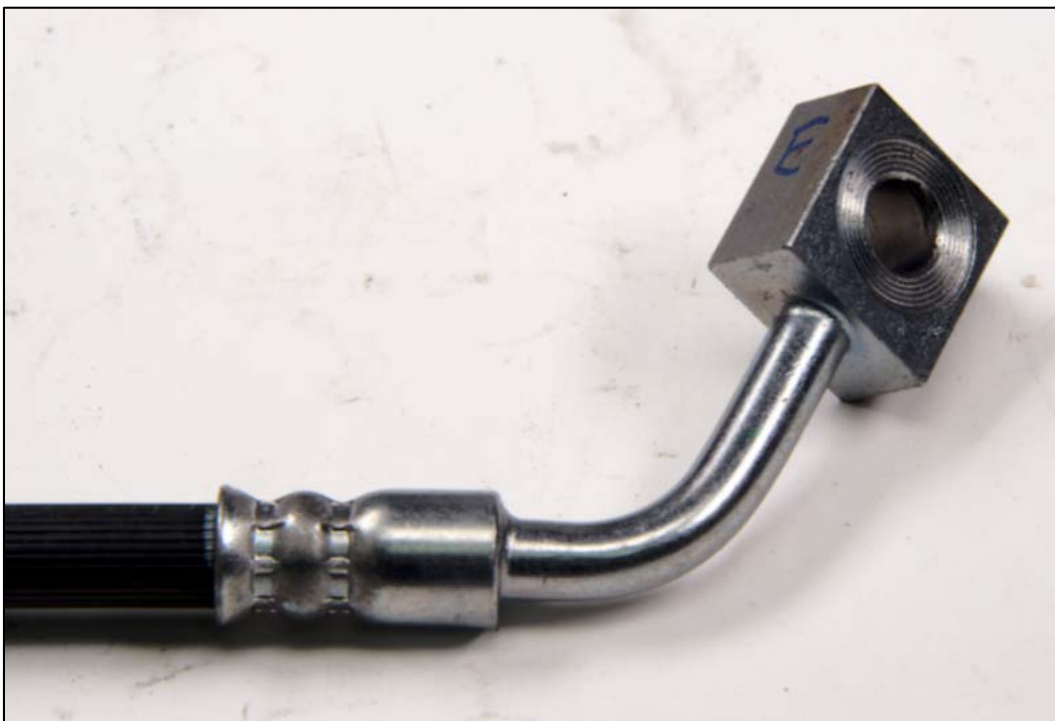
Figure 7. Caliper-side crimp, 2016 hose assembly.

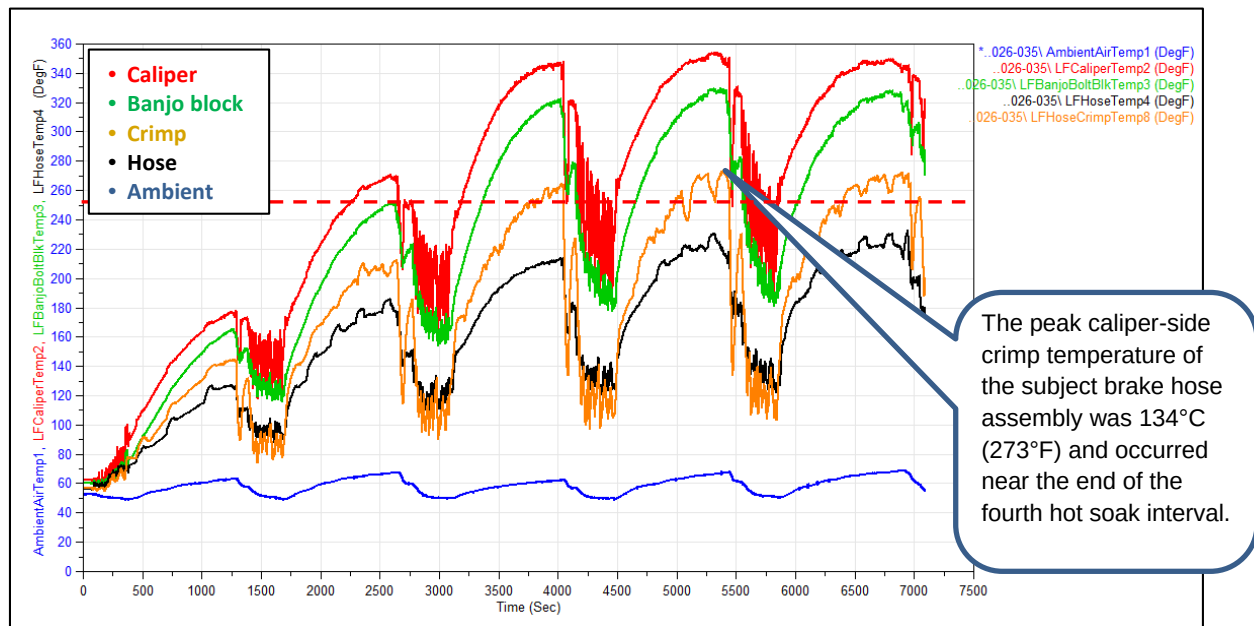
The VRTC testing demonstrated that most of the temperature increases observed in the subject caliper crimp joints occurred during the hot soak periods of the simulated EVOC training cycle, rising most rapidly at the beginning of each hot soak period and reaching progressively higher temperatures with each successive hot soak. Under the same test conditions, the same patterns were observed for the 2016 hose assemblies, but with significantly lower maximum crimp temperatures. When tested to intentionally overheat the brakes, with repeated 45 to 15 mph brake snubs until the brake fluid boiled, the crimp joint temperatures were marginally lower than the hose temperatures, indicating that the mechanism of heat transfer from this condition may have been from the inside-out through the brake fluid rather than by heat conducted from the banjo block to the crimp ferrule.

**Figure 10. Subject brake hose assembly component temperatures in EVOC training with simulated pursuit driving and hot soak intervals, left front.**

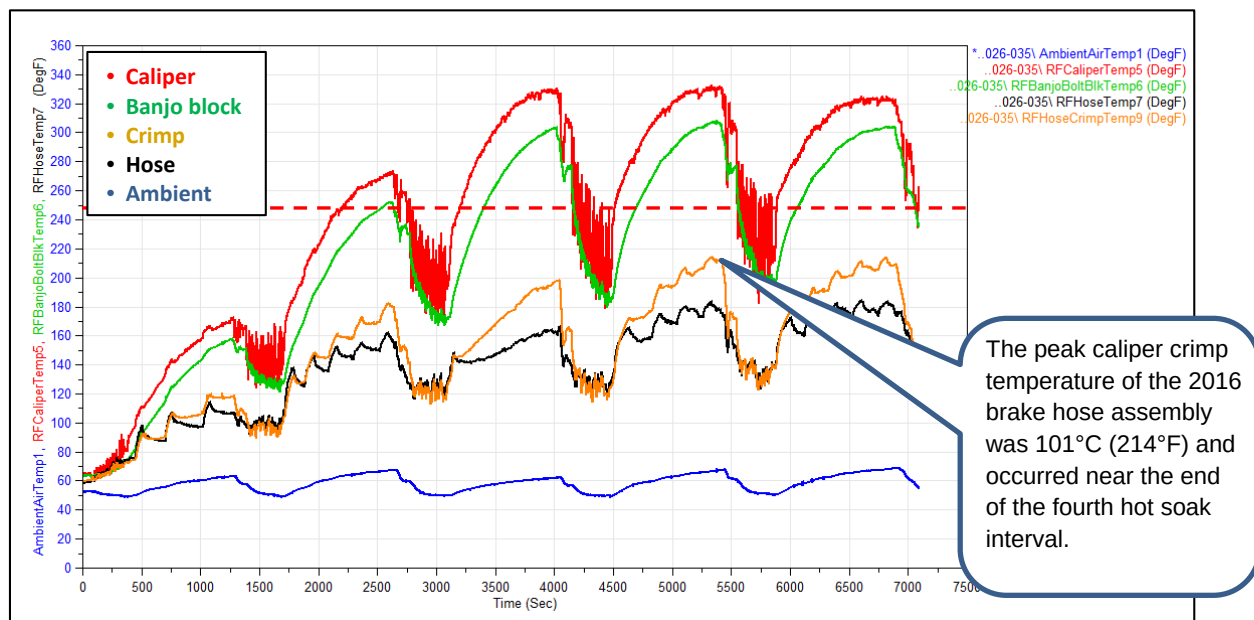
**Figure 11. 2016 brake hose assembly component temperatures in EVOC training with simulated pursuit driving and hot soak intervals, right front.**

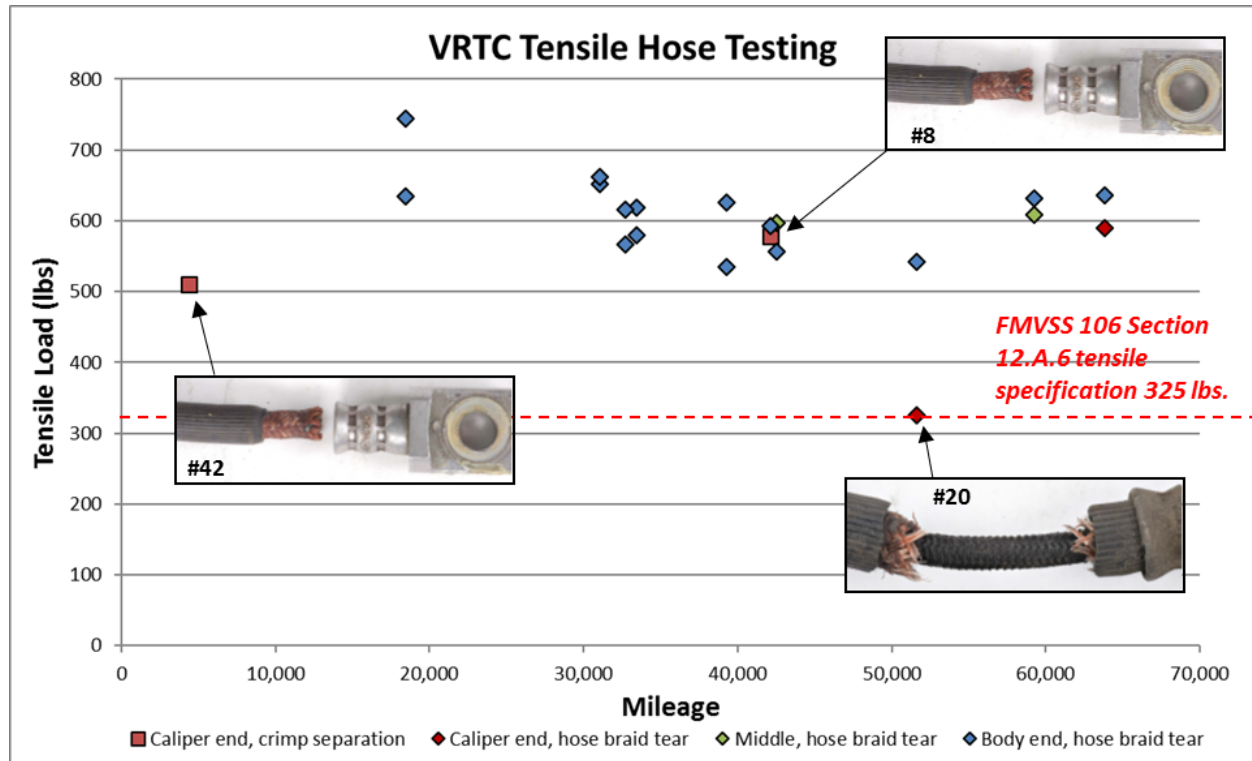
VRTC also conducted tensile tests on 21 subject hose assemblies from 10 police interceptor vehicles, including a hose assembly removed from the opposite side of a Sacramento EVOC incident vehicle and hoses used in the VRTC EVOC testing (Figure 14). This testing did not identify any concerns with thermal degradation or loss of strength of the subject crimp joints. All of the hoses met the tensile strength requirements of Federal Motor Vehicle Safety Standard (FMVSS) No. 106, Brake Hoses, with

failures occurring above 325 lb, although one hose failed at 326 lb<sup>2</sup>. Only two of the hoses failed in the alleged defect mode, crimp separation. One of these was the hose from the Sacramento EVOC incident vehicle (Hose #42, 4,400 miles, 510 lb) and the other was from the VRTC test vehicle (Hose #8, 42,138 miles, 578 lb).

<sup>2</sup> Hose #20 failed from tearing of the outer braid near the caliper crimp. This is not the same failure mode as the alleged defect, complete or partial separation from the crimp ferrule.

**Figure 14. VRTC Tensile Hose Testing Results.**
