# ODI RESUME

**Investigation:** EA 15-006  
**Prompted by:** IE15-038  
**Date Opened:** 10/16/2015  
**Investigator:** Kareem Habib  
**Approver:** Otto Matheke  
**Subject:** Brake Vacuum Pump Failure

**Manufacturer:** Ford Motor Company  
**Products:** 2011-2012 Ford F-150 equipped with 3.5L GTDI engines  
**Population:** 252,910

**Problem Description:** Moisture ingestion in the electric vacuum pump (EVP) may cause internal pump corrosion and failure resulting in excessive noise, vibration and increased brake pedal effort at cold start.

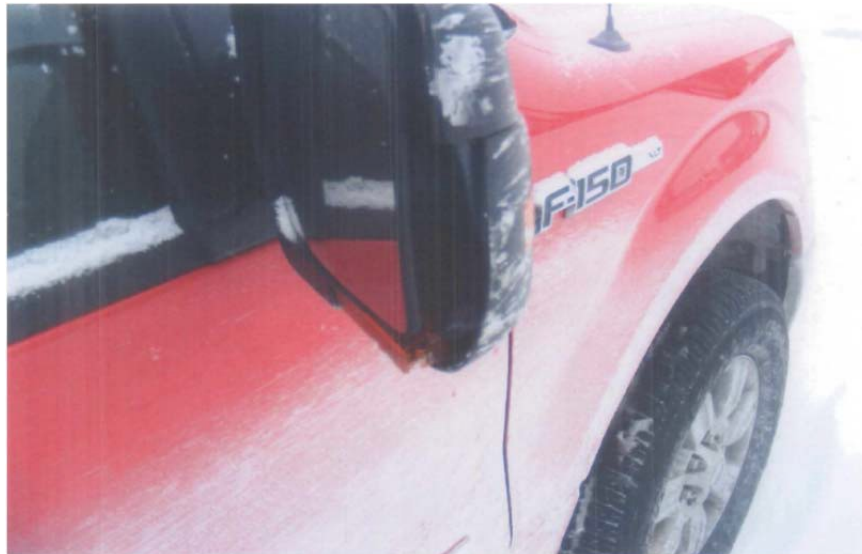
Figure 1

ODI identified a total of seven crash allegations that may be related to EVP failures in the subject vehicles. All seven incidents occurred in low-speed driveway maneuvers after a vehicle cold-start. One incident allegedly occurred after applying the accelerator a small amount. NHTSA's testing indicated that accelerator pedal application would result in normal engine manifold vacuum and negate the need for EVP supplemental vacuum, so this incident may not be related to the EVP. The complaints reported very minor exterior vehicle component damage with no loss of vehicle control. For example, one crash allegation reported damage to the side mirrors from contact with the garage door frame of his house (Figure 1). ODI observed that brake pedal forces required for cold start low-speed decelerations were increased from less than 10 lbs during normal operating conditions to over 20 lbs when the EVP is disabled and high accessory loads during cold-start result in relatively low engine manifold vacuum (e.g., 300 mbar). In the unlikely event that booster vacuum is completely depleted, the subject vehicles are equipped with an Optimized Hydraulic Braking (OHB) technology that will boost the brake hydraulic pressures for the driver by activating the ABS pump motor. The OHB technology is activated when booster vacuum drops below 100 mbar and begins providing boosted brake pressure at brake pedal forces of 30 lbs or greater.
