DEPARTMENT OF TRANSPORTATION
National Highway Traffic Safety Administration
Denial of Motor Vehicle Defect Petition

ACTION: Denial of a petition for a defect investigation.

Appendix - Petition Analysis - DP15-005

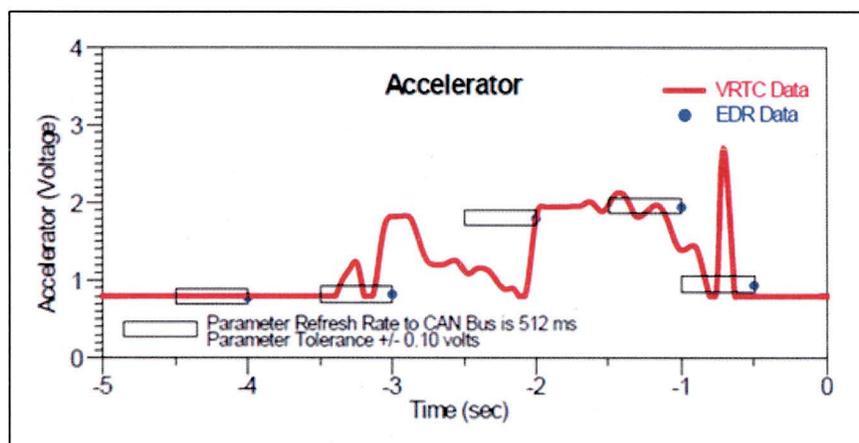
In 2010, NHTSA's Vehicle Research and Test Center (VRTC) conducted testing to validate the EDR pre-crash data used in NHTSA field investigations.⁴ Figure 1 shows accelerator pedal sensor voltage data from one test performed by VRTC in the validation testing.⁵ As the figure shows, the EDR does not necessarily capture all accelerator pedal applications during an event and the accelerator pedal voltage recorded at each EDR time interval may not be the actual accelerator pedal voltage at that interval.

Figure 1. VRTC validation testing of EDR accelerator pedal sensor voltage from simulated collisions in a 2007 Toyota Camry.
