ODI RESUME

Investigation: EA 15-003
Prompted by:
Date Opened: 04/01/2015
Investigator: Stephen Mchenry **Reviewer:** Jeff Quandt
Approver: Frank Borris
Subject: Pedal Operation Interference

Manufacturer: Nissan North America, Inc.
Products: Nissan Versa Sedan and Versa Note, MY 2013 - 2015
Population: 360,000 (Estimated)

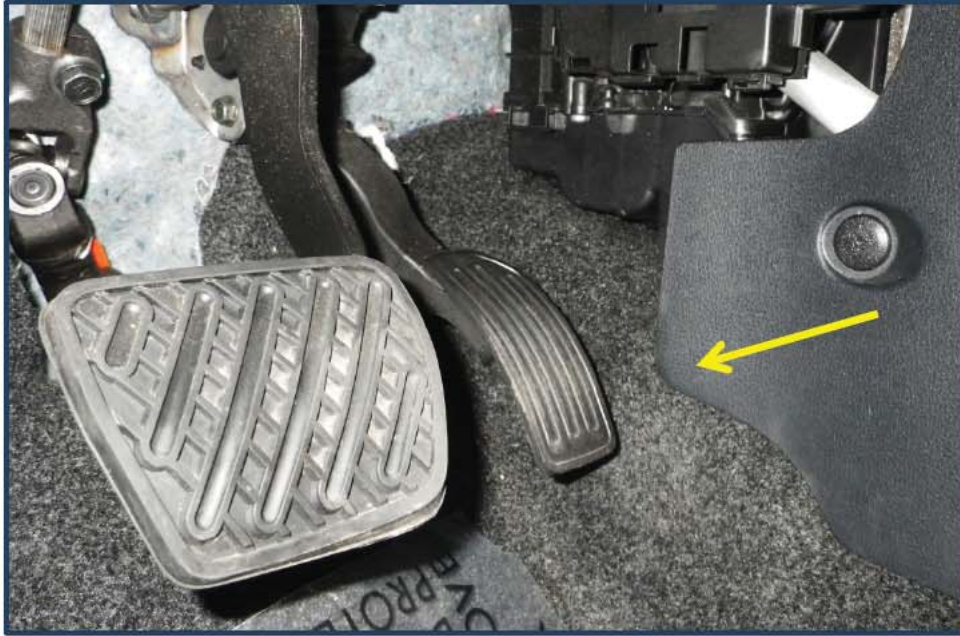
At the opening of PE14-018, ODI had identified one complaint, VOQ 10597004, alleging that the driver's foot became caught by the subject trim panel to the extent that the driver decided that it was necessary to pull on their leg to get the foot free of the interference, almost causing a crash. The trim panel in question (Figure 1) is located next to the accelerator pedal and the lower corner is positioned such that it is near the right outer edge of the driver's shoe. The complainant supplied a photograph (Figure 2) showing how the edge of the panel wedged itself in the driver's shoe. Complainant 10573057 alleged that when attempting to remove their foot from the accelerator pedal to apply the brake, their shoe was caught by the trim panel which delayed braking ability several times. During the investigation, ODI received a VOQ, 10614957, that alleged that the driver's foot was interfered with by the trim panel, delaying the driver's ability to apply the brakes, resulting in a crash and minor injuries to the driver.

Figure 1: Position of trim panel MY 2013 Versa
(Arrow indicates corner that interferes with driver's shoe)

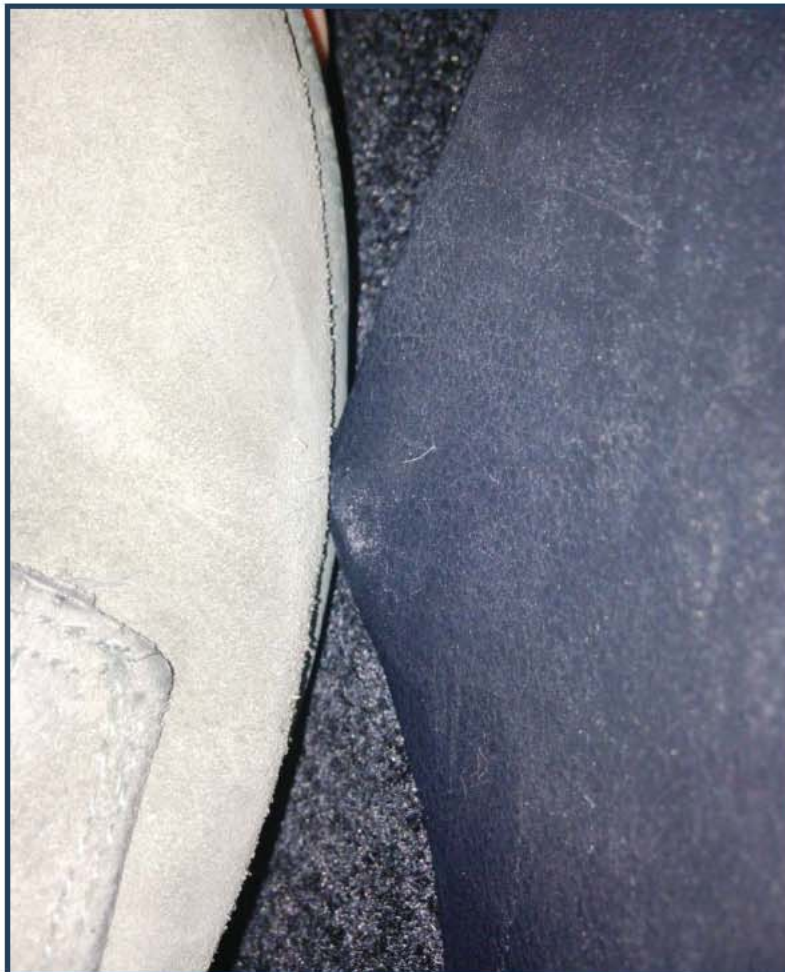
Figure 2: VOQ 10597004 demonstration of interference

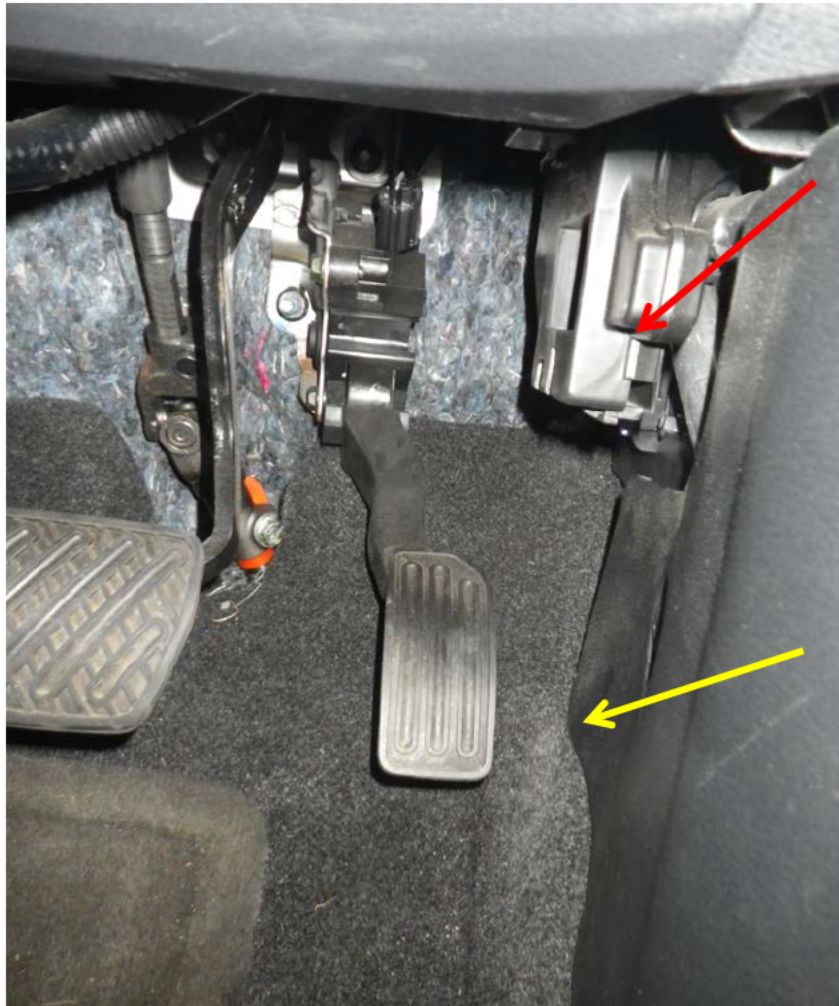
In addition, ODI has received VOQs alleging that the HVAC relay actuator, Figures 3 and 4, can also interfere with the driver's ability to react quickly to apply the brakes. MY 2015 Versa Sedan and Note vehicles have been added to the scope of the investigation as they are believed to have the same panel design and actuator placement as the subject vehicles.

Figure 3. Position of HVAC actuator, red arrow, and trim panel corner, yellow arrow.

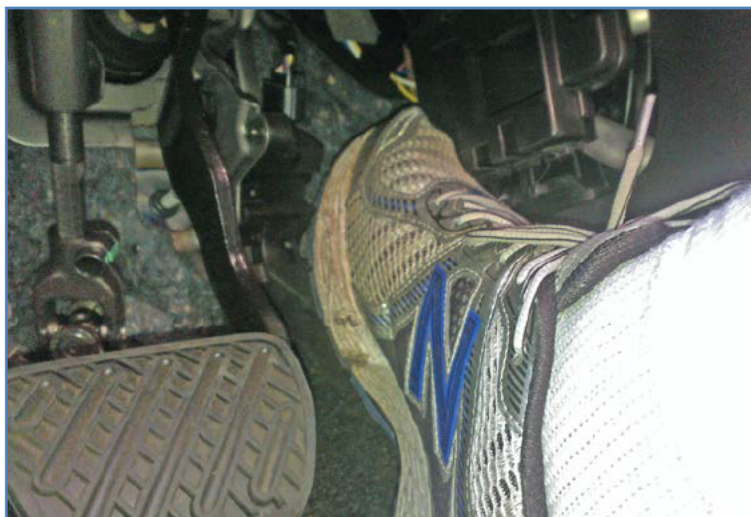
Figure 4. Photo supplied by VOQ 10640644 demonstrating interference by HVAC actuator.
