DP15-005

District Service Manager  
Information Letter

SUBJECT: Volvo Cab Leaning  
MODEL(S) VN  
ISSUED BY: Ron Duncan  
APPROVED: Elizabeth Jolin

Reliability is receiving reports of leaning cab suspension issues. Please reference the drawing below to ensure the cab is mounted correctly to the frame. The center-line of the frame is critical when placing the front cab mounts. The front two mounts should be placed as closely across from each other as possible. The rear cab mount cross-member comes into play to get a correct triangle measurement in order to properly correct suspect units. Any unit that has yet to exhibit this issue, but when inspected the dimensions required per the drawing below are not in spec, correct the unit and replace the stay rod torsion spring on the rear cab suspension, as it could possibly be compromised. Note: New fixture used in production – mid August 2014 to prevent occurrence

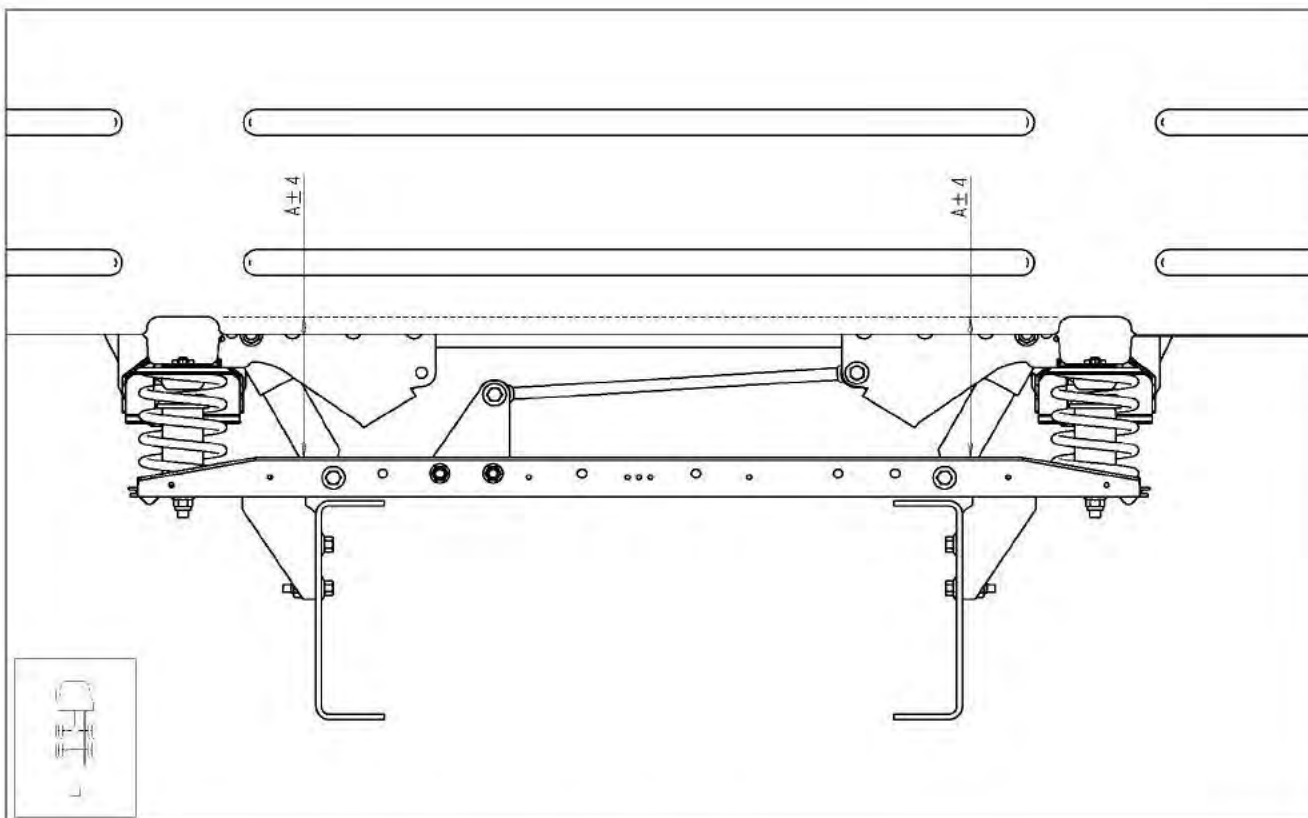
Figure 3 - Coil Spring Suspension

DIM A = 192 without roof deflector  
 197 with roof deflector  
 199 with roof deflector specified but not installed

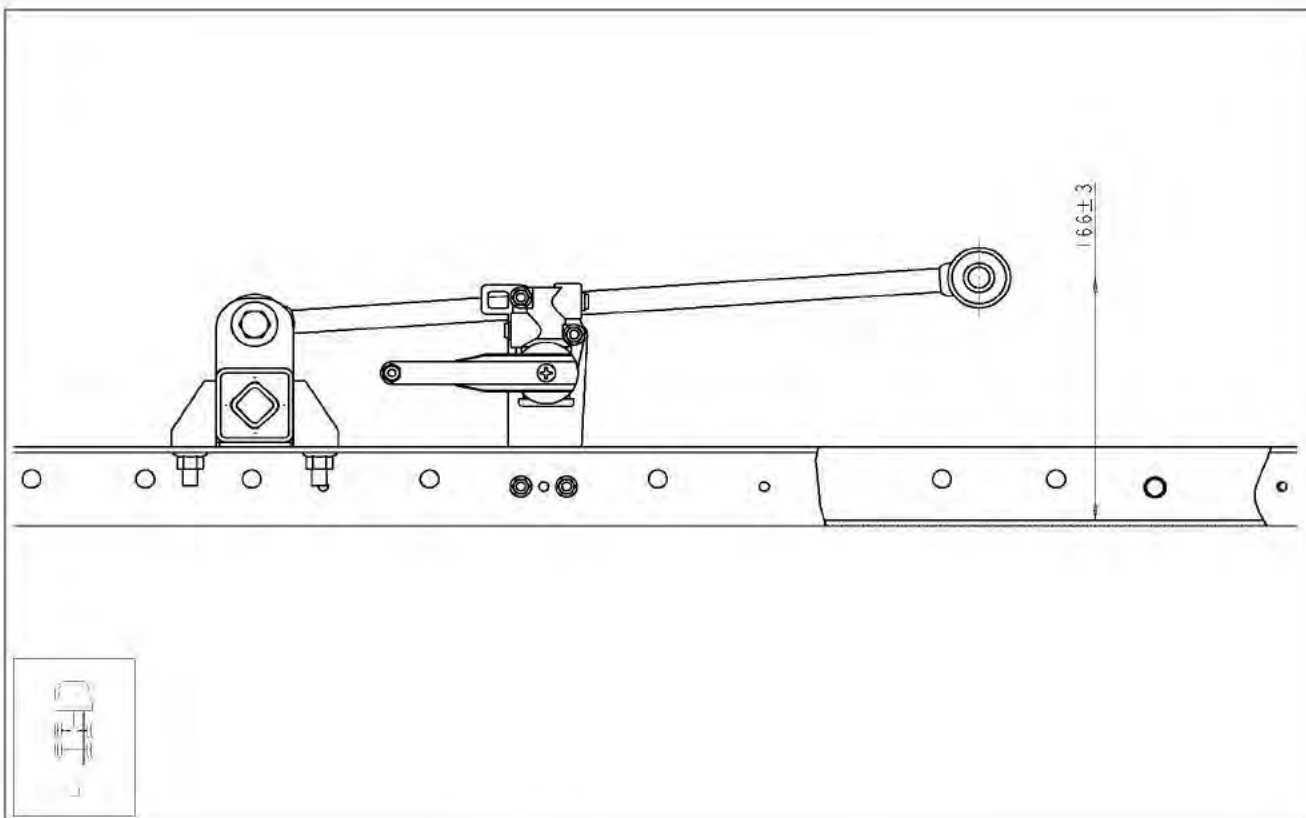
Figure 4 – Panhard Rod Height

For adjustments required after the cab has been assembled on the chassis, have both ends of the panhard rod connections loose, first set the ride height with the air valve adjustments (see section 5.1.1). After proper height has been set, tighten the end connections to the panhard rod to the proper torque.

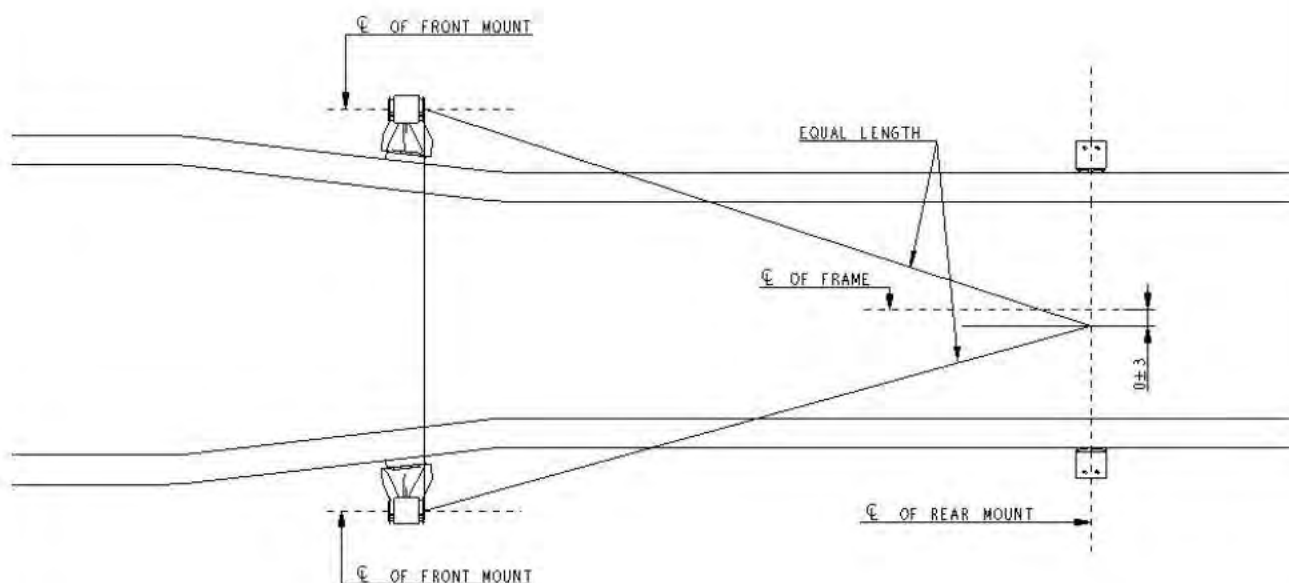
Figure 5 - Squaring Front Cab-Mounts

A fixture must be used to align the front cab mounts relative to each other and relative to the centerline of the frame. This can be established by using an isosceles triangle with the two equal sides of the triangle extending from the two target points on the front mounts to a point on the centerline between the rear cab mounts. The distance that this point may be off of the centerline is  $0 \pm 3$  mm.

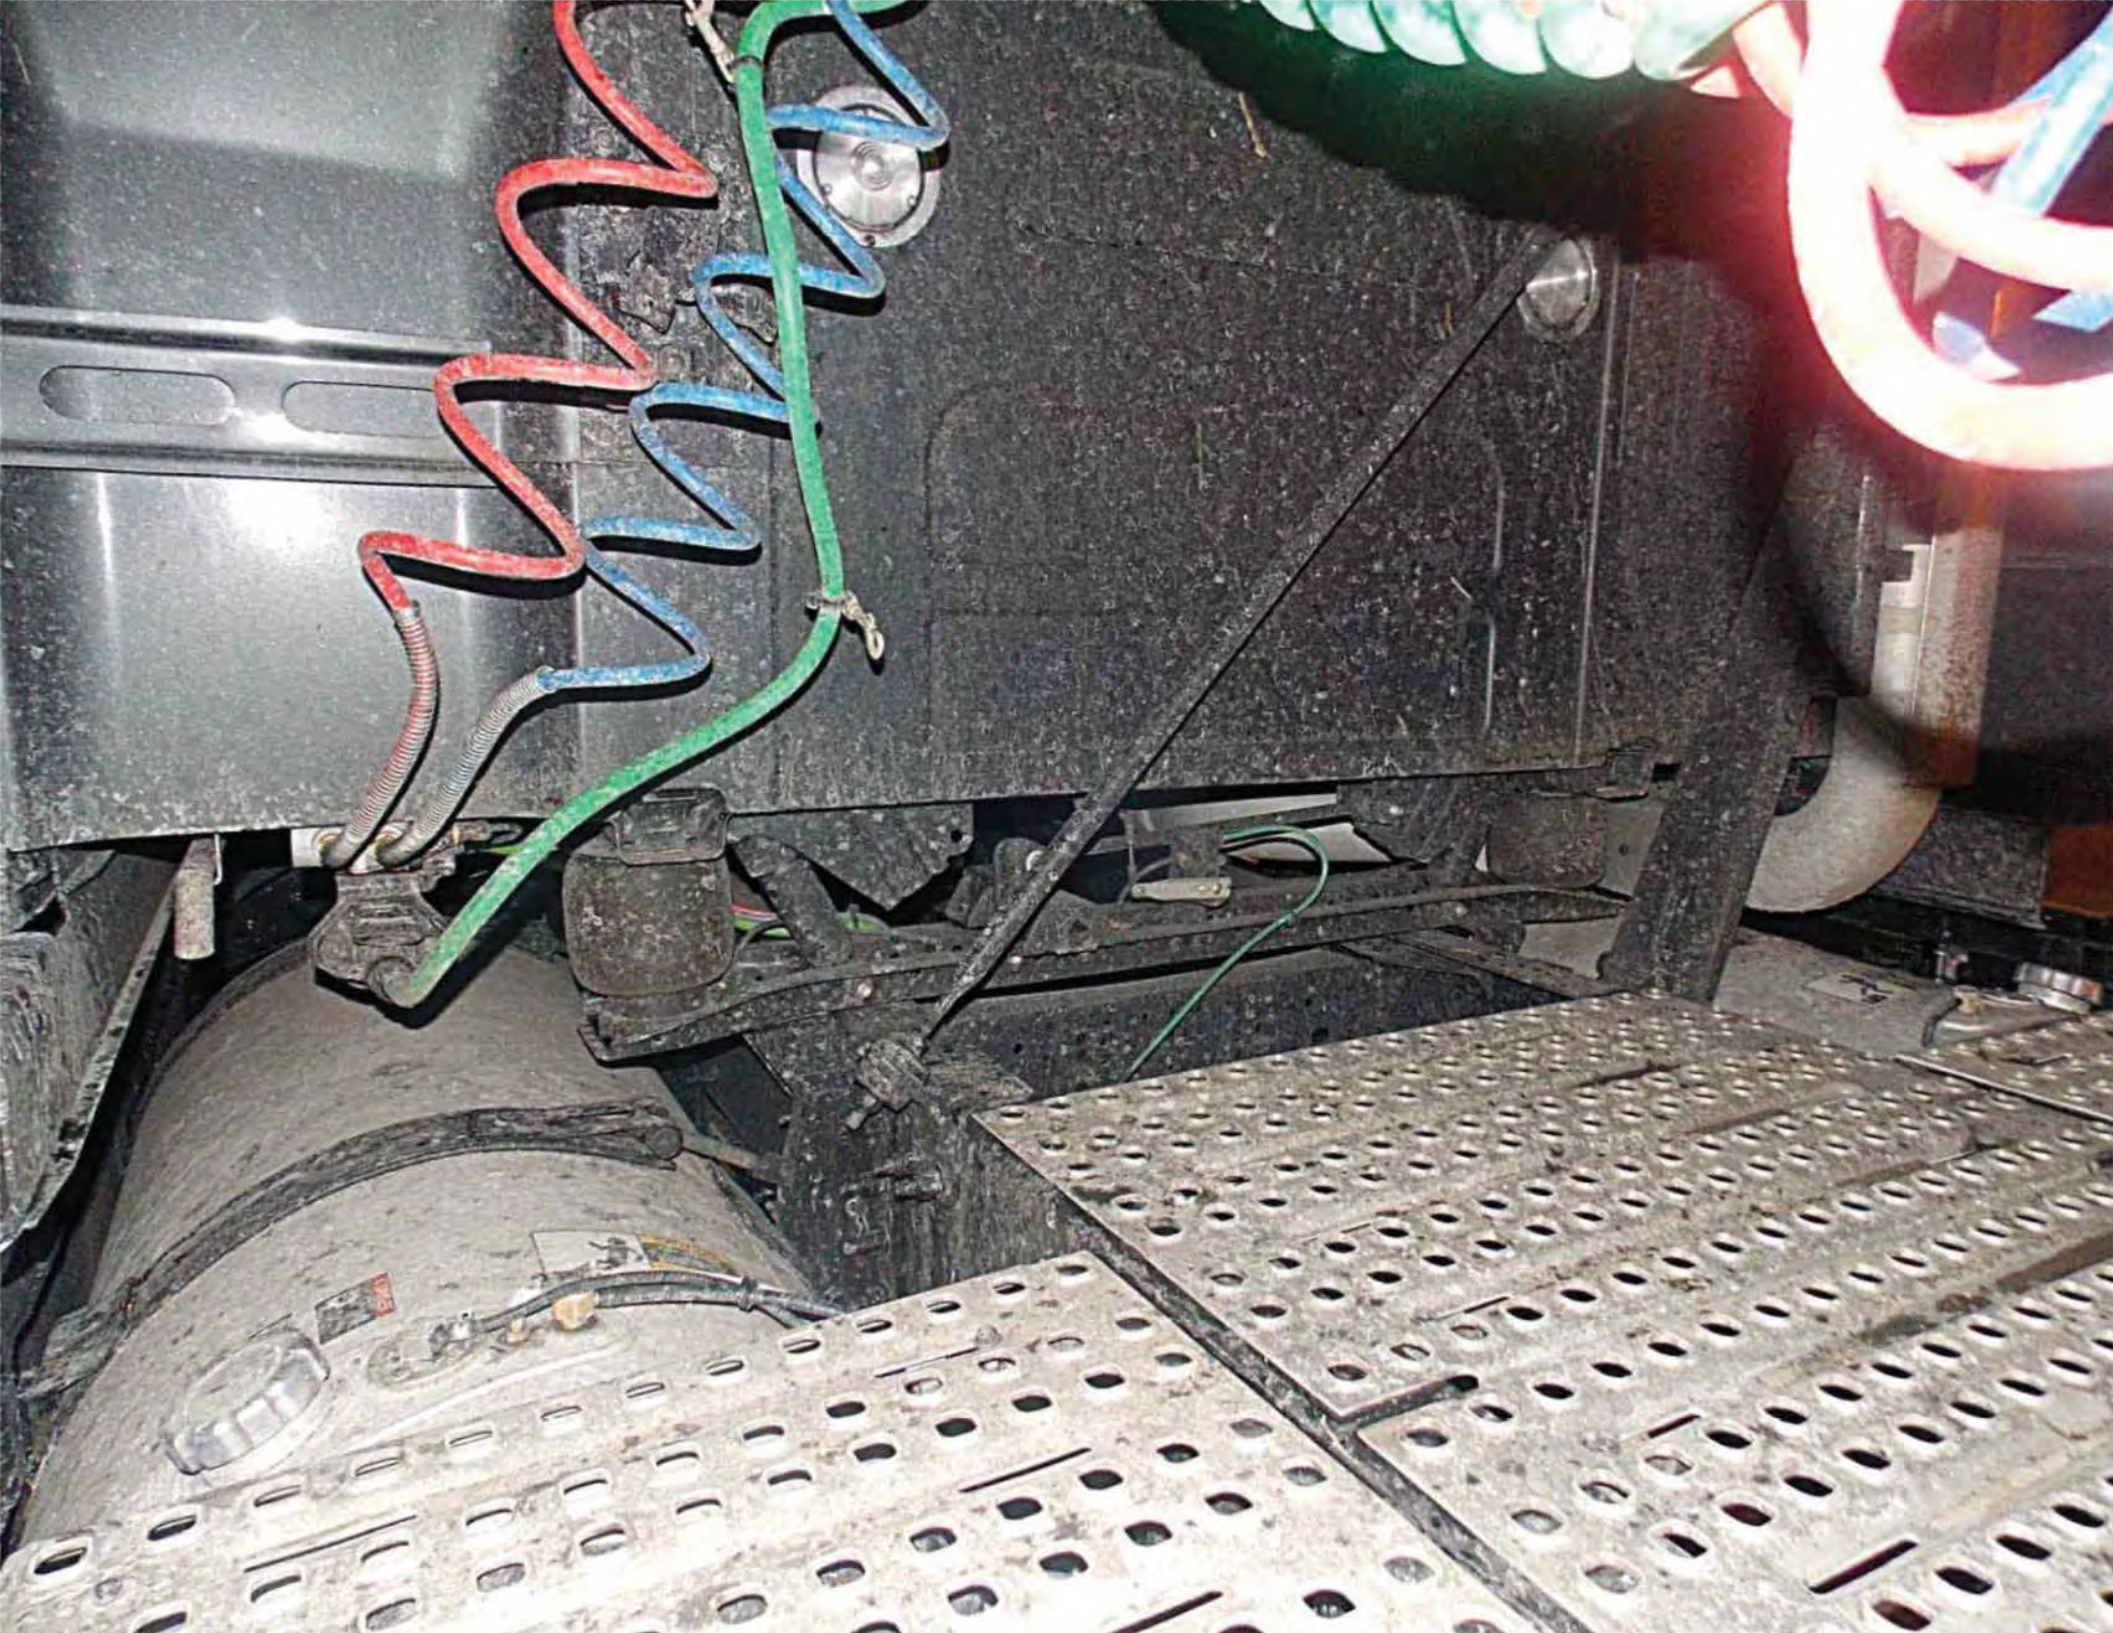
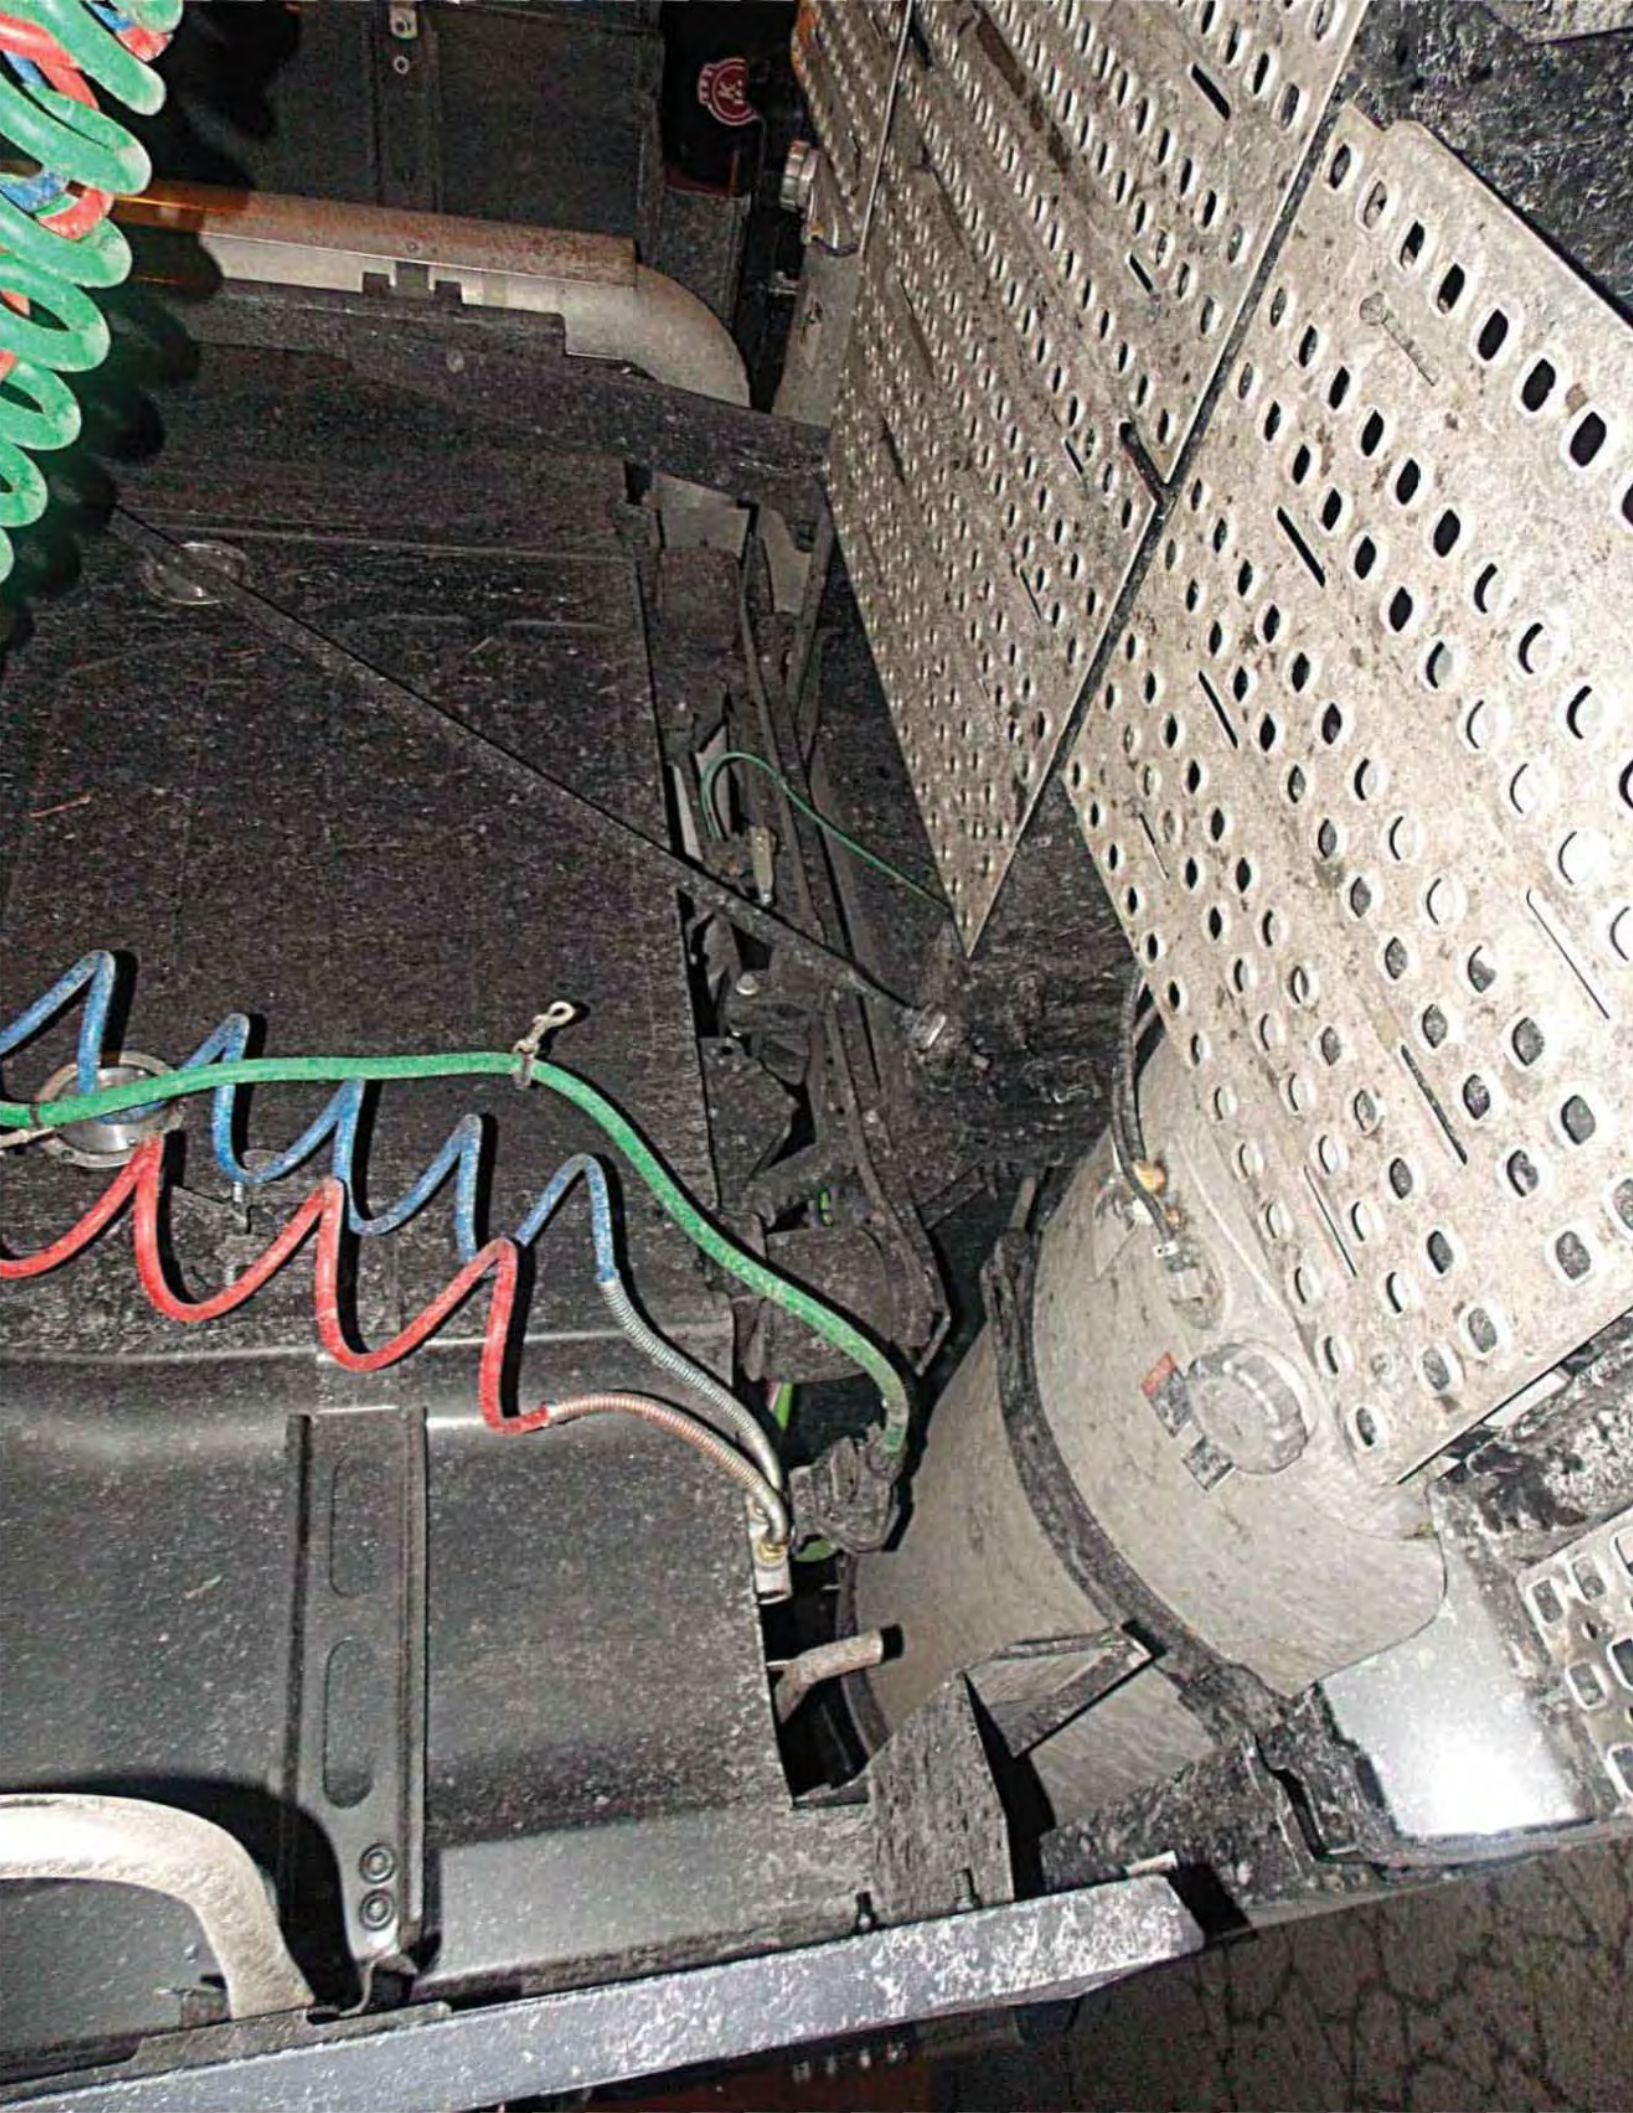
| Created | Created By | Audience | Activity Type | Comments |
|---|---|---|---|---|
| 11/29/2014<br>11:42:53 | DILLON<br>SCHOUWEILER | Public | Work Performed | we have a new truck and on customers first trip out he noticed the cab air ride uneven. we checked out the truck here and the left side of the sleeper sits half inch higher than the right side. the same air line supplies both air bags so in theory both air bags should have the same air pressure but it is visibly noticable that the left air bag is inflated more than the right air bag. we checked both inside the sleeper and in the side boxes and see no added weight on one side verses the other. weight looks evenly distributed from side to side. we visually inspected the air lines going from the leveling valve to the air bags and see no kinks in the air line. we unhooked the leveling valve, drained the air out of the sleeper air bags and then hooked up leveling valve and inflated air bags with no change in height. will attach pictures to view. Thanks. |
