DP15-005

District Service Manager  
Information Letter

SUBJECT: Volvo Cab Leaning  
MODEL(S) VN  
ISSUED BY: Ron Duncan  
APPROVED: Elizabeth Jolin

Reliability is receiving reports of leaning cab suspension issues. Please reference the drawing below to ensure the cab is mounted correctly to the frame. The center-line of the frame is critical when placing the front cab mounts. The front two mounts should be placed as closely across from each other as possible. The rear cab mount cross-member comes into play to get a correct triangle measurement in order to properly correct suspect units. Any unit that has yet to exhibit this issue, but when inspected the dimensions required per the drawing below are not in spec, correct the unit and replace the stay rod torsion spring on the rear cab suspension, as it could possibly be compromised. Note: New fixture used in production – mid August 2014 to prevent occurrence

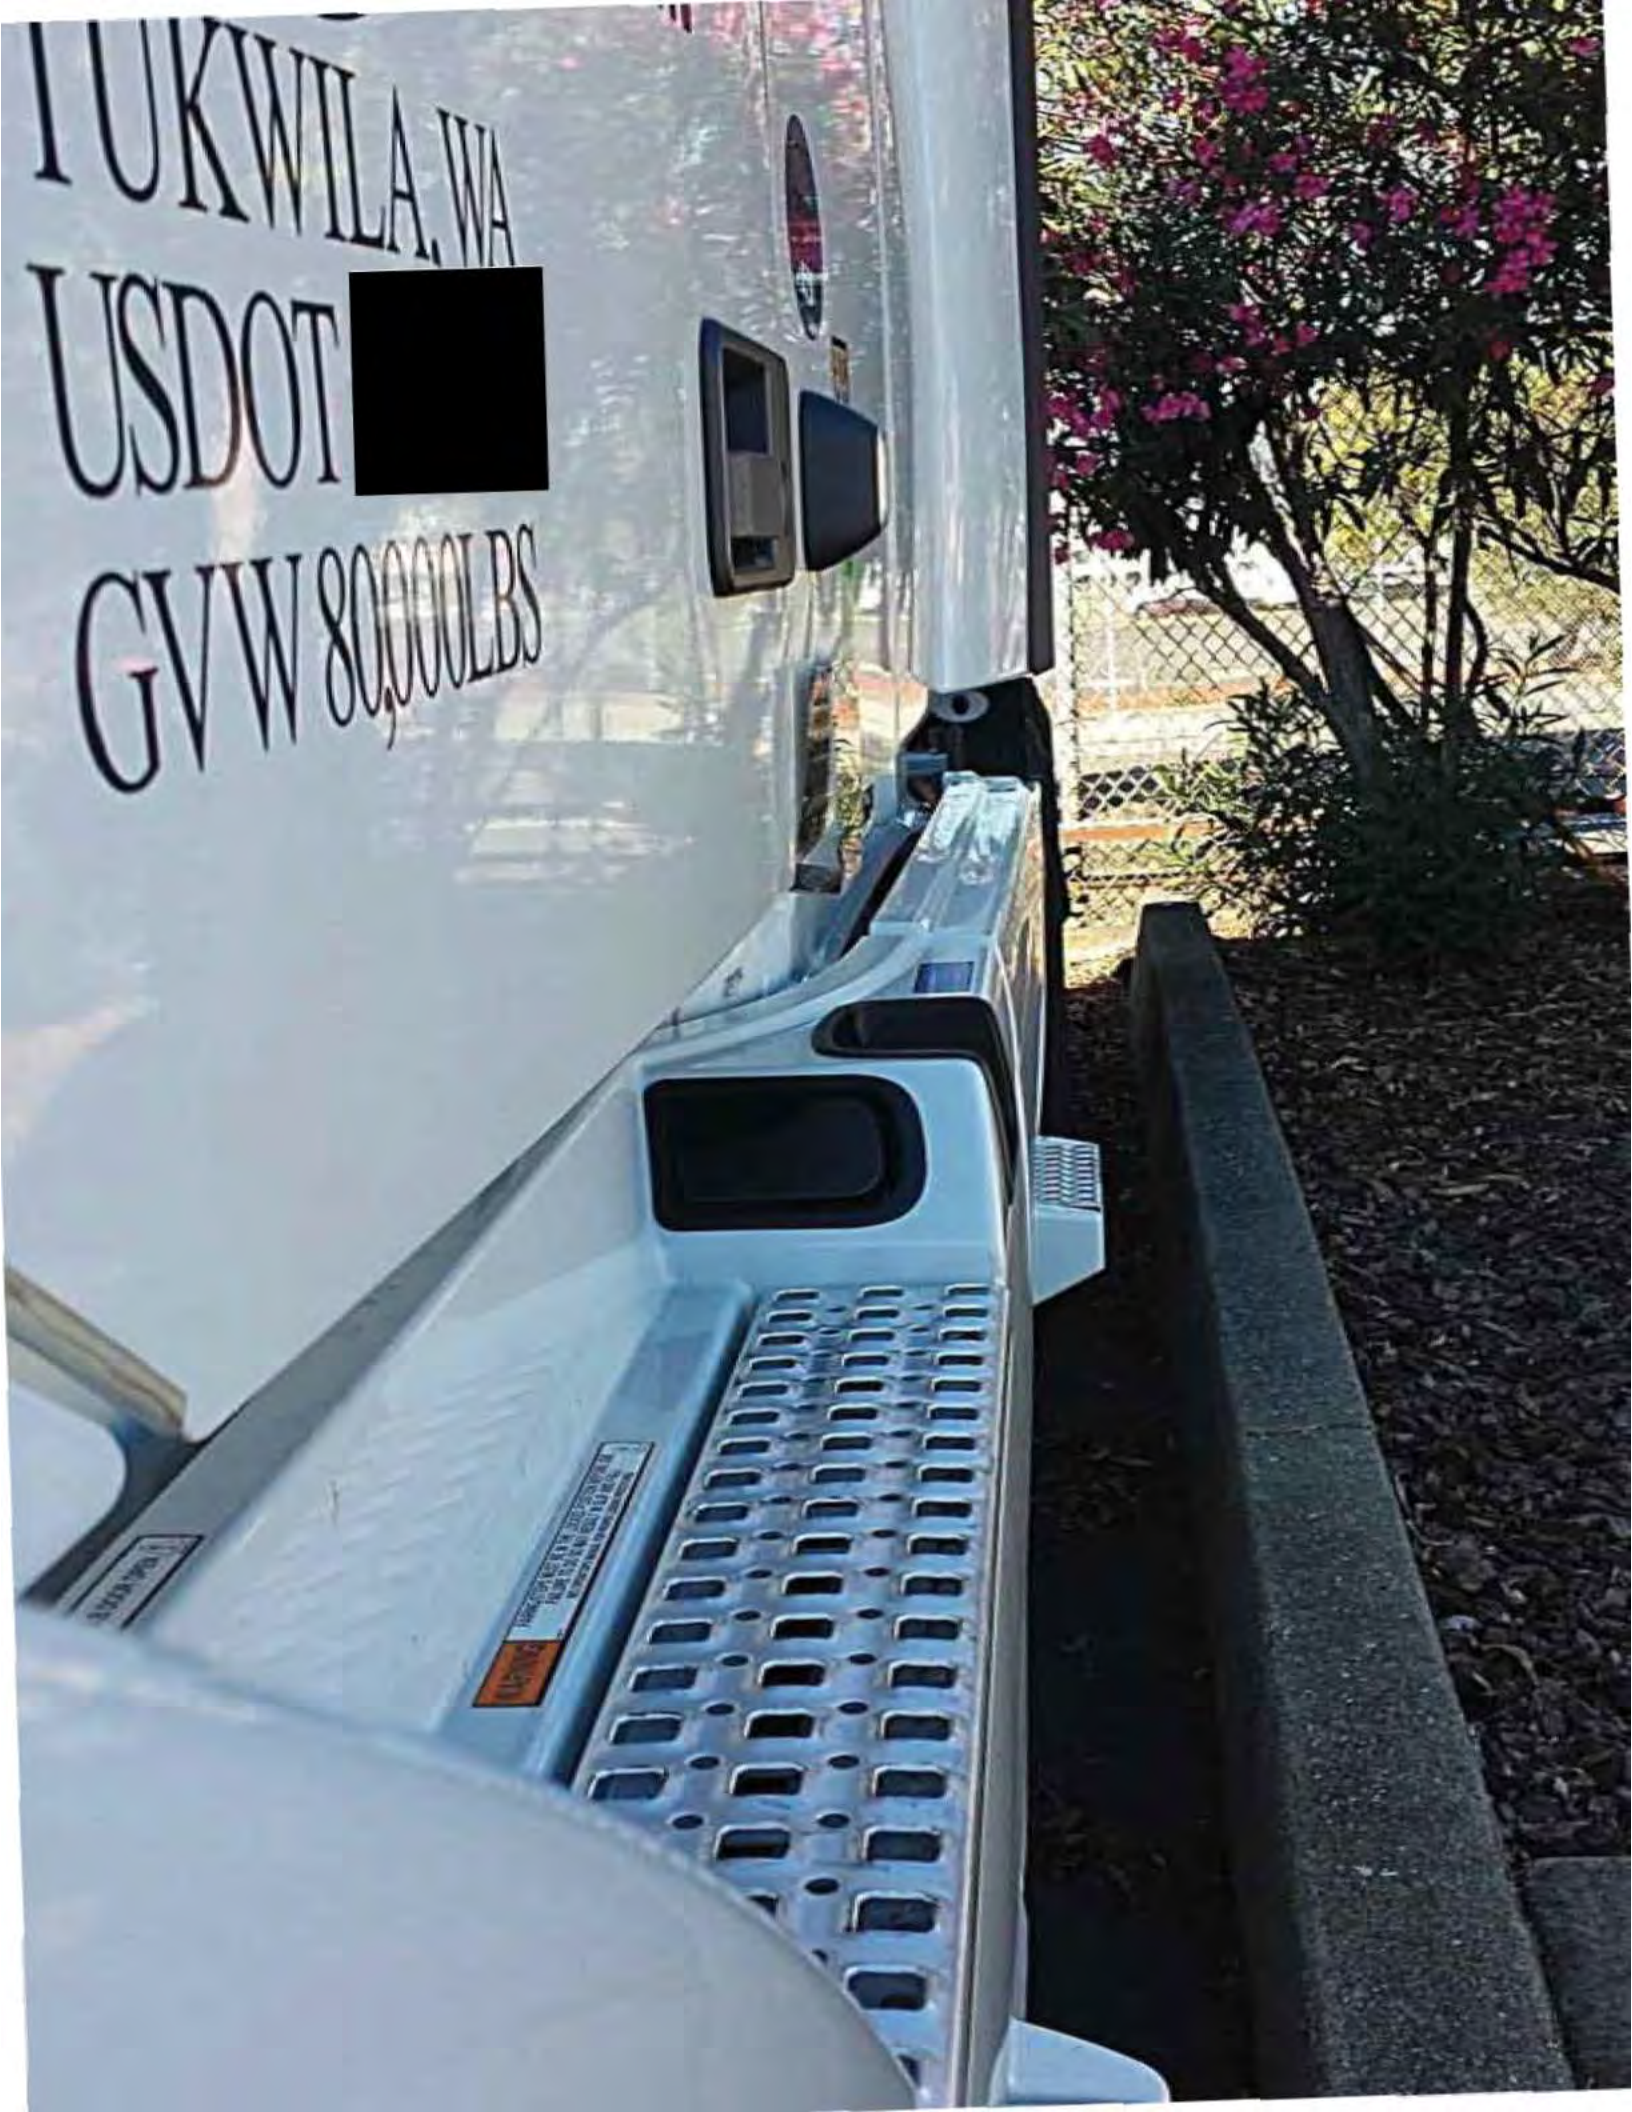
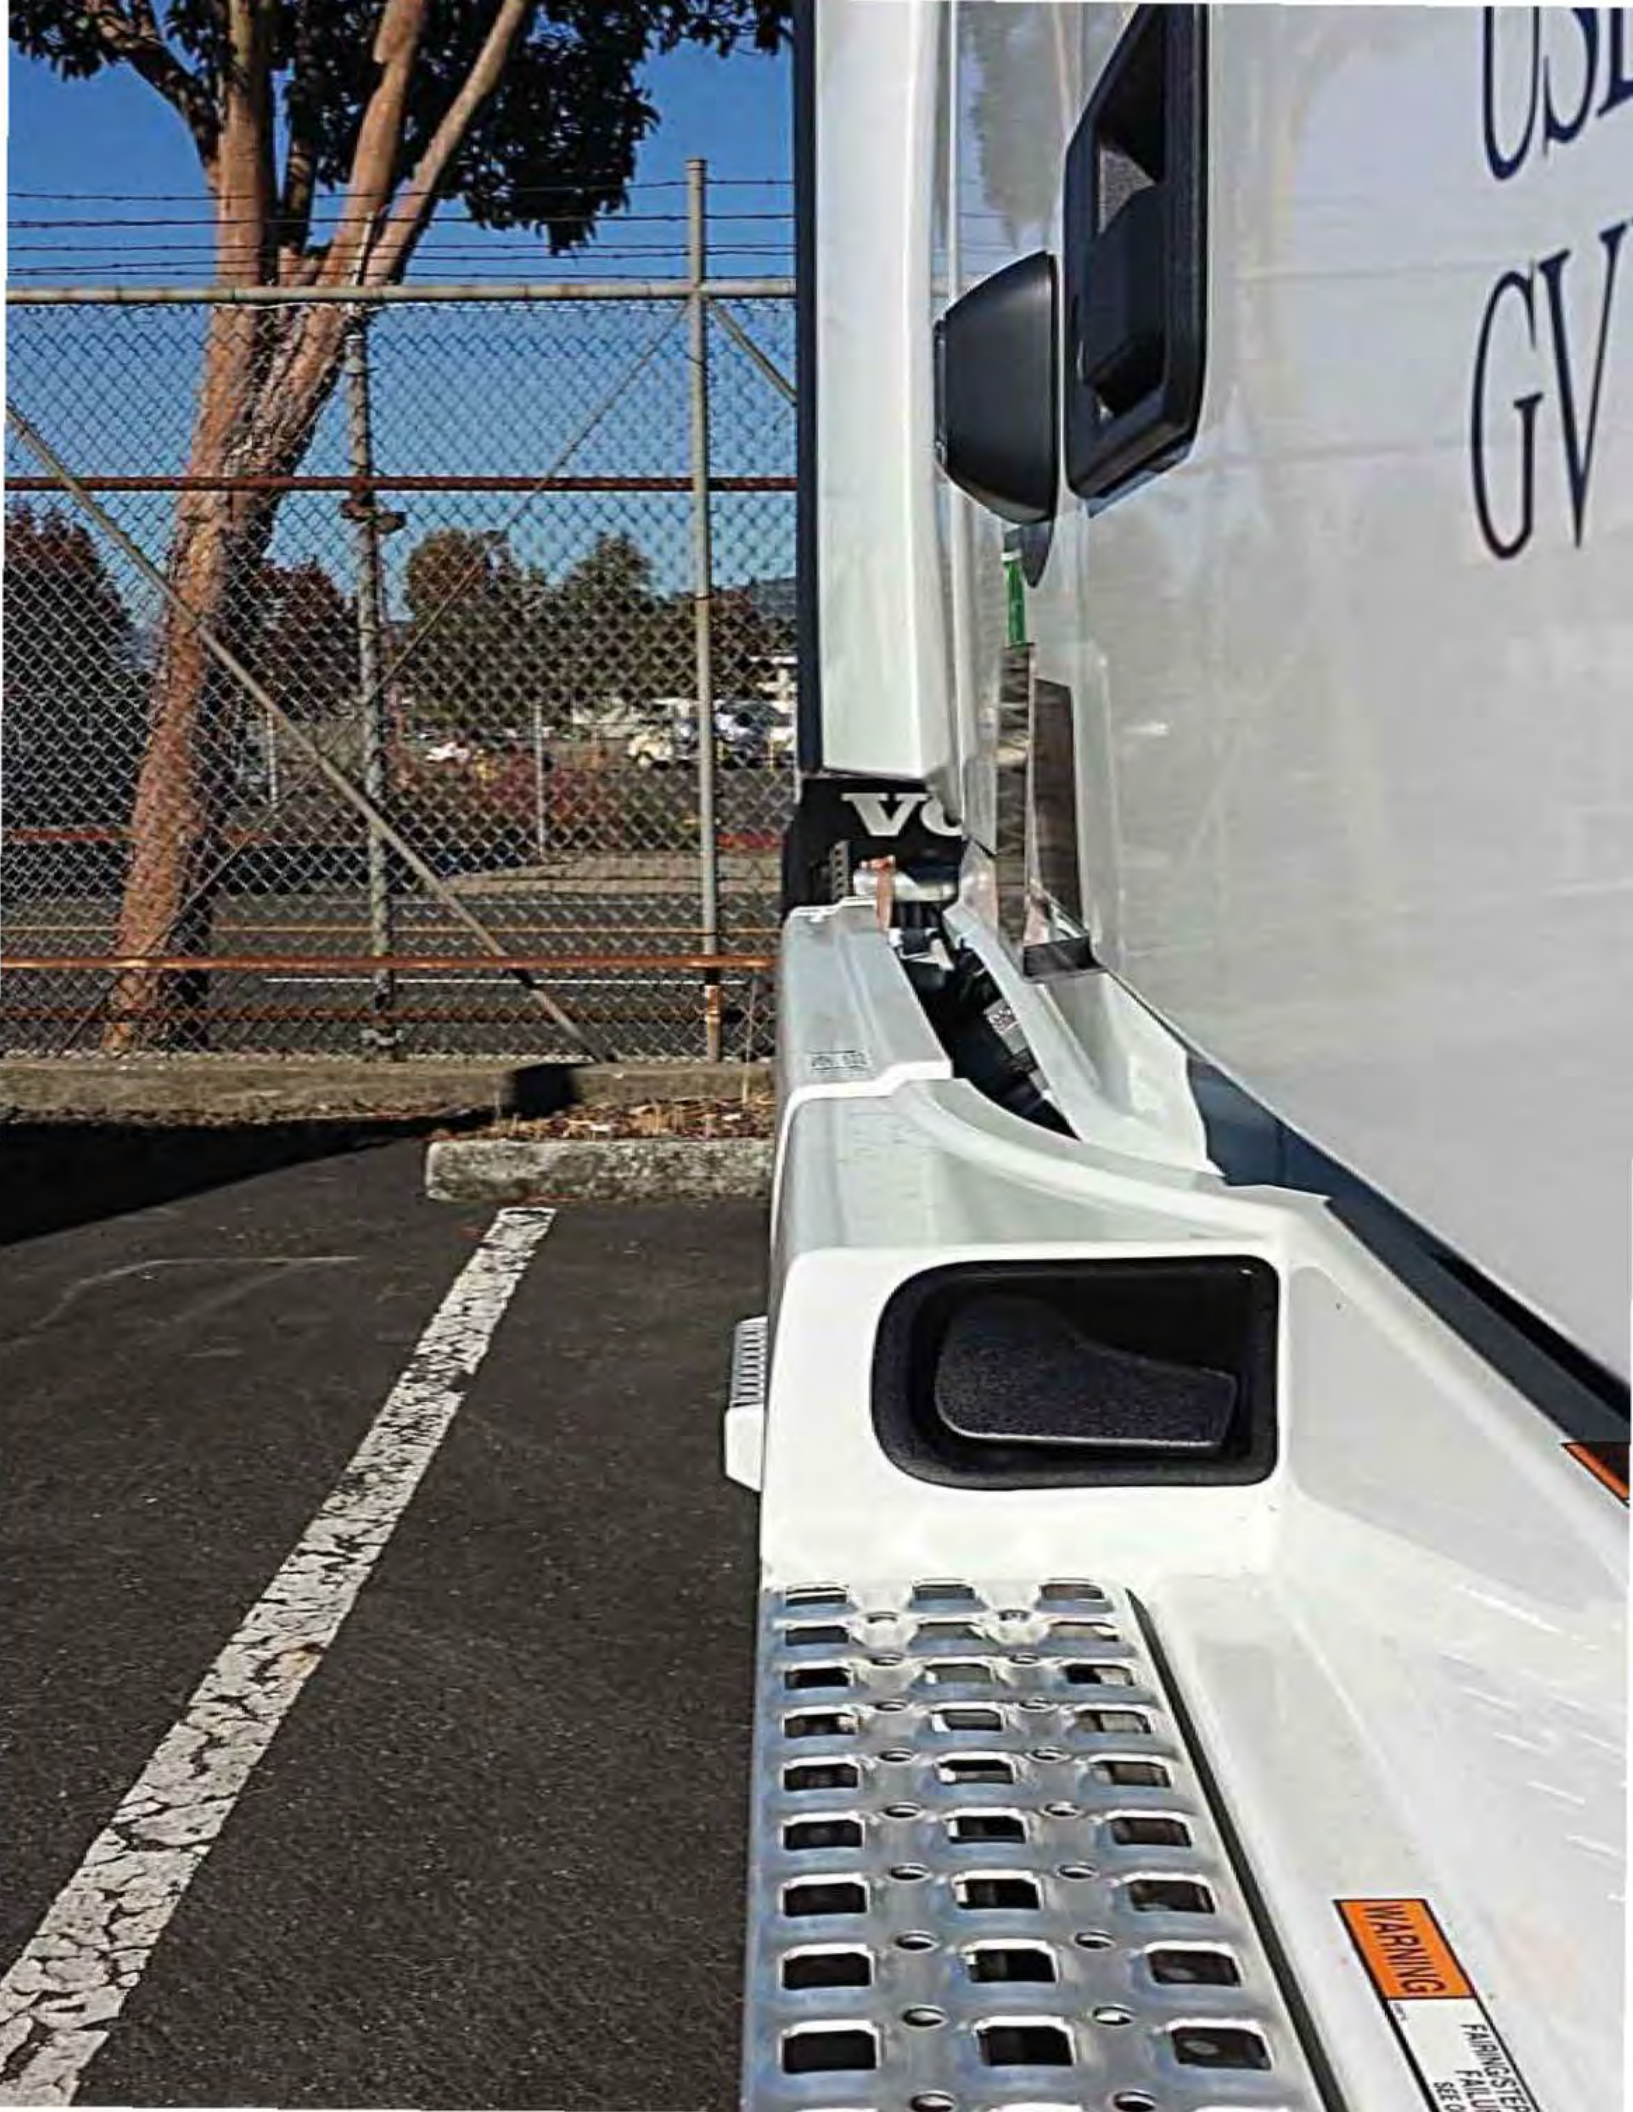
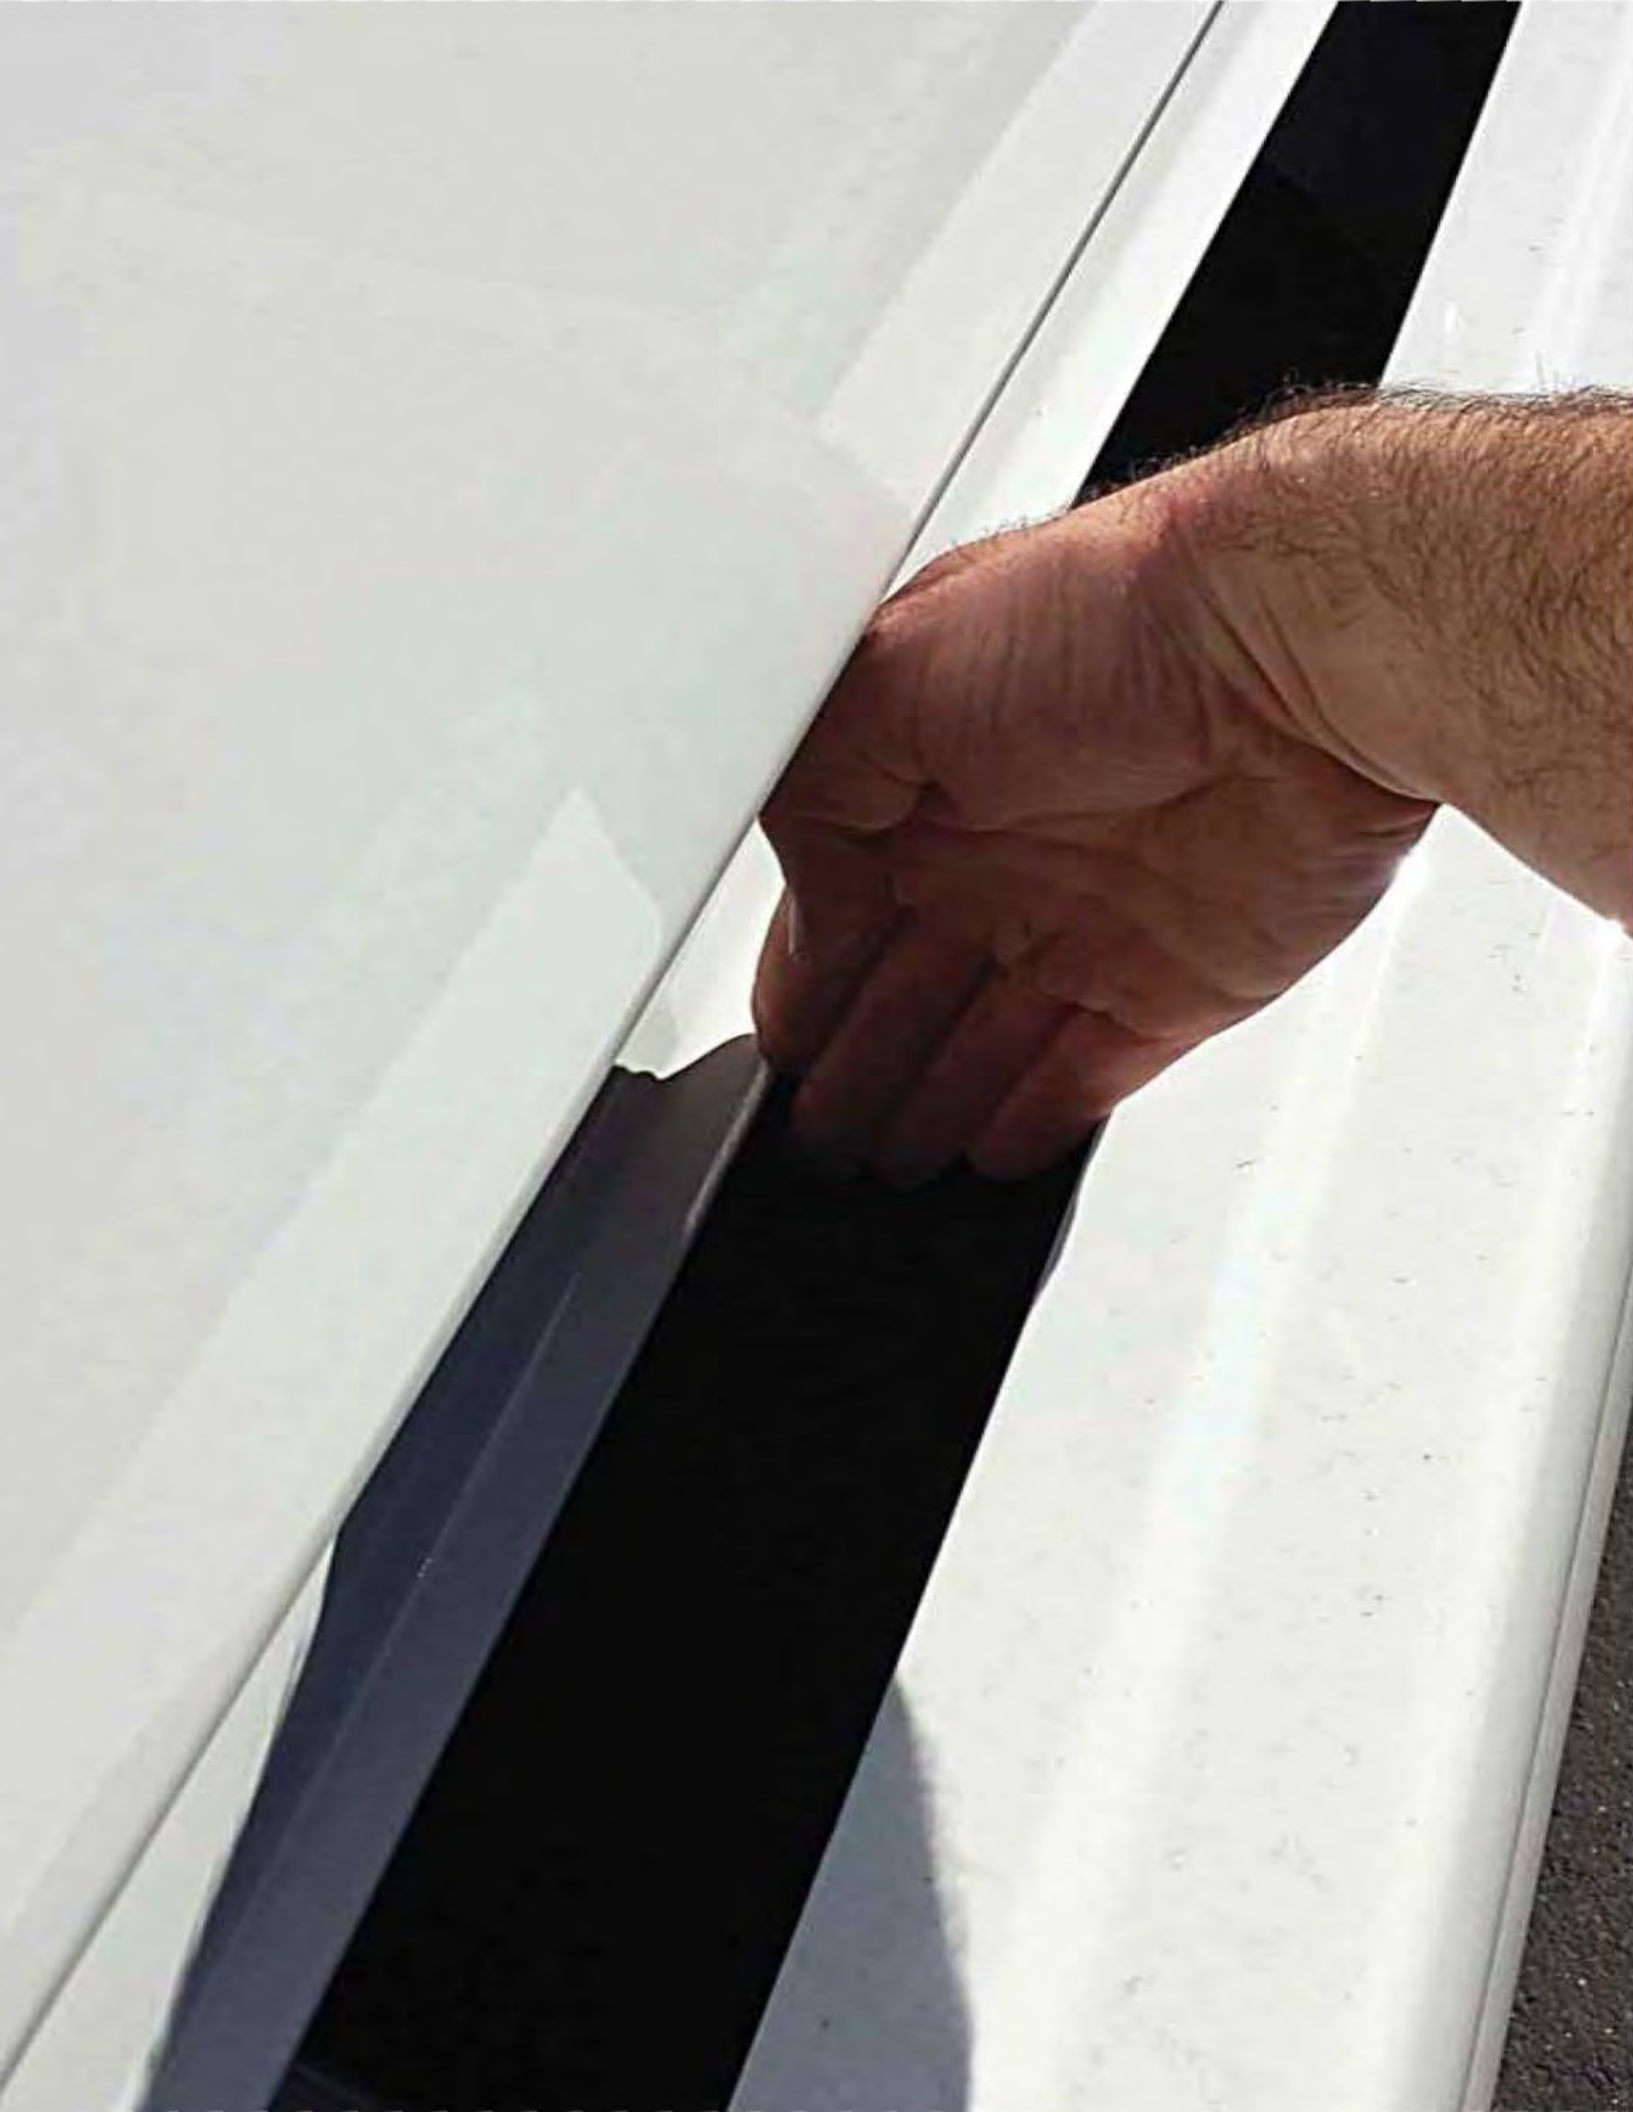
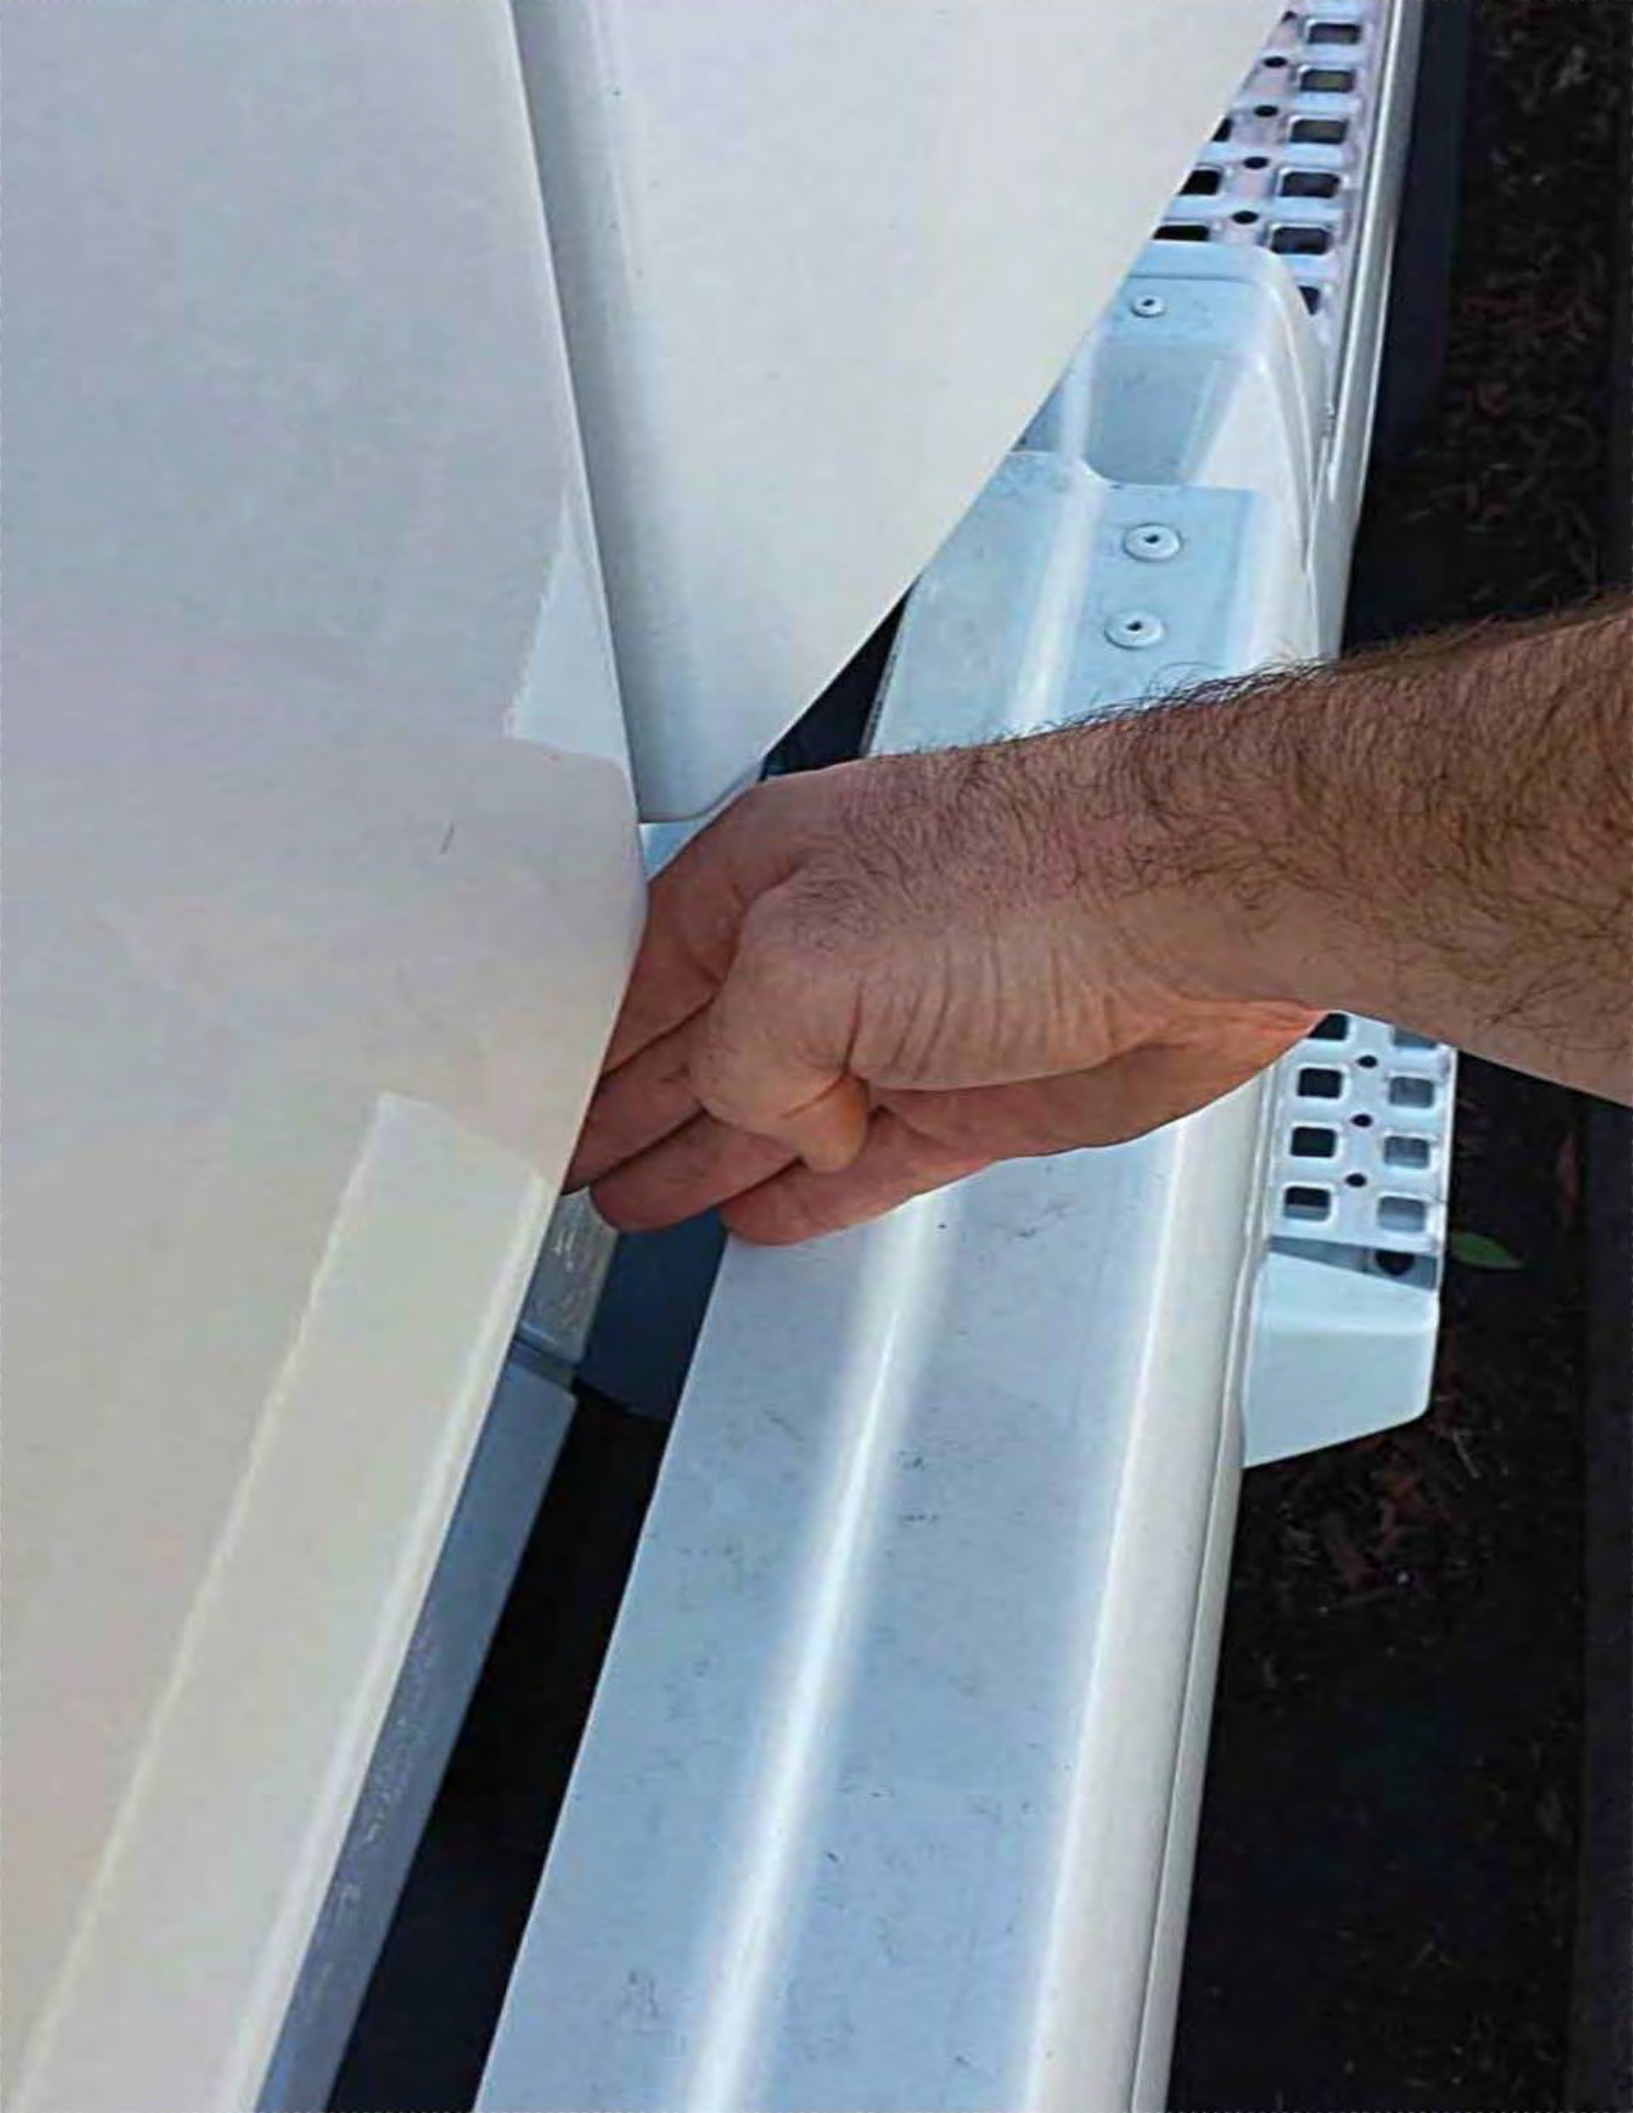
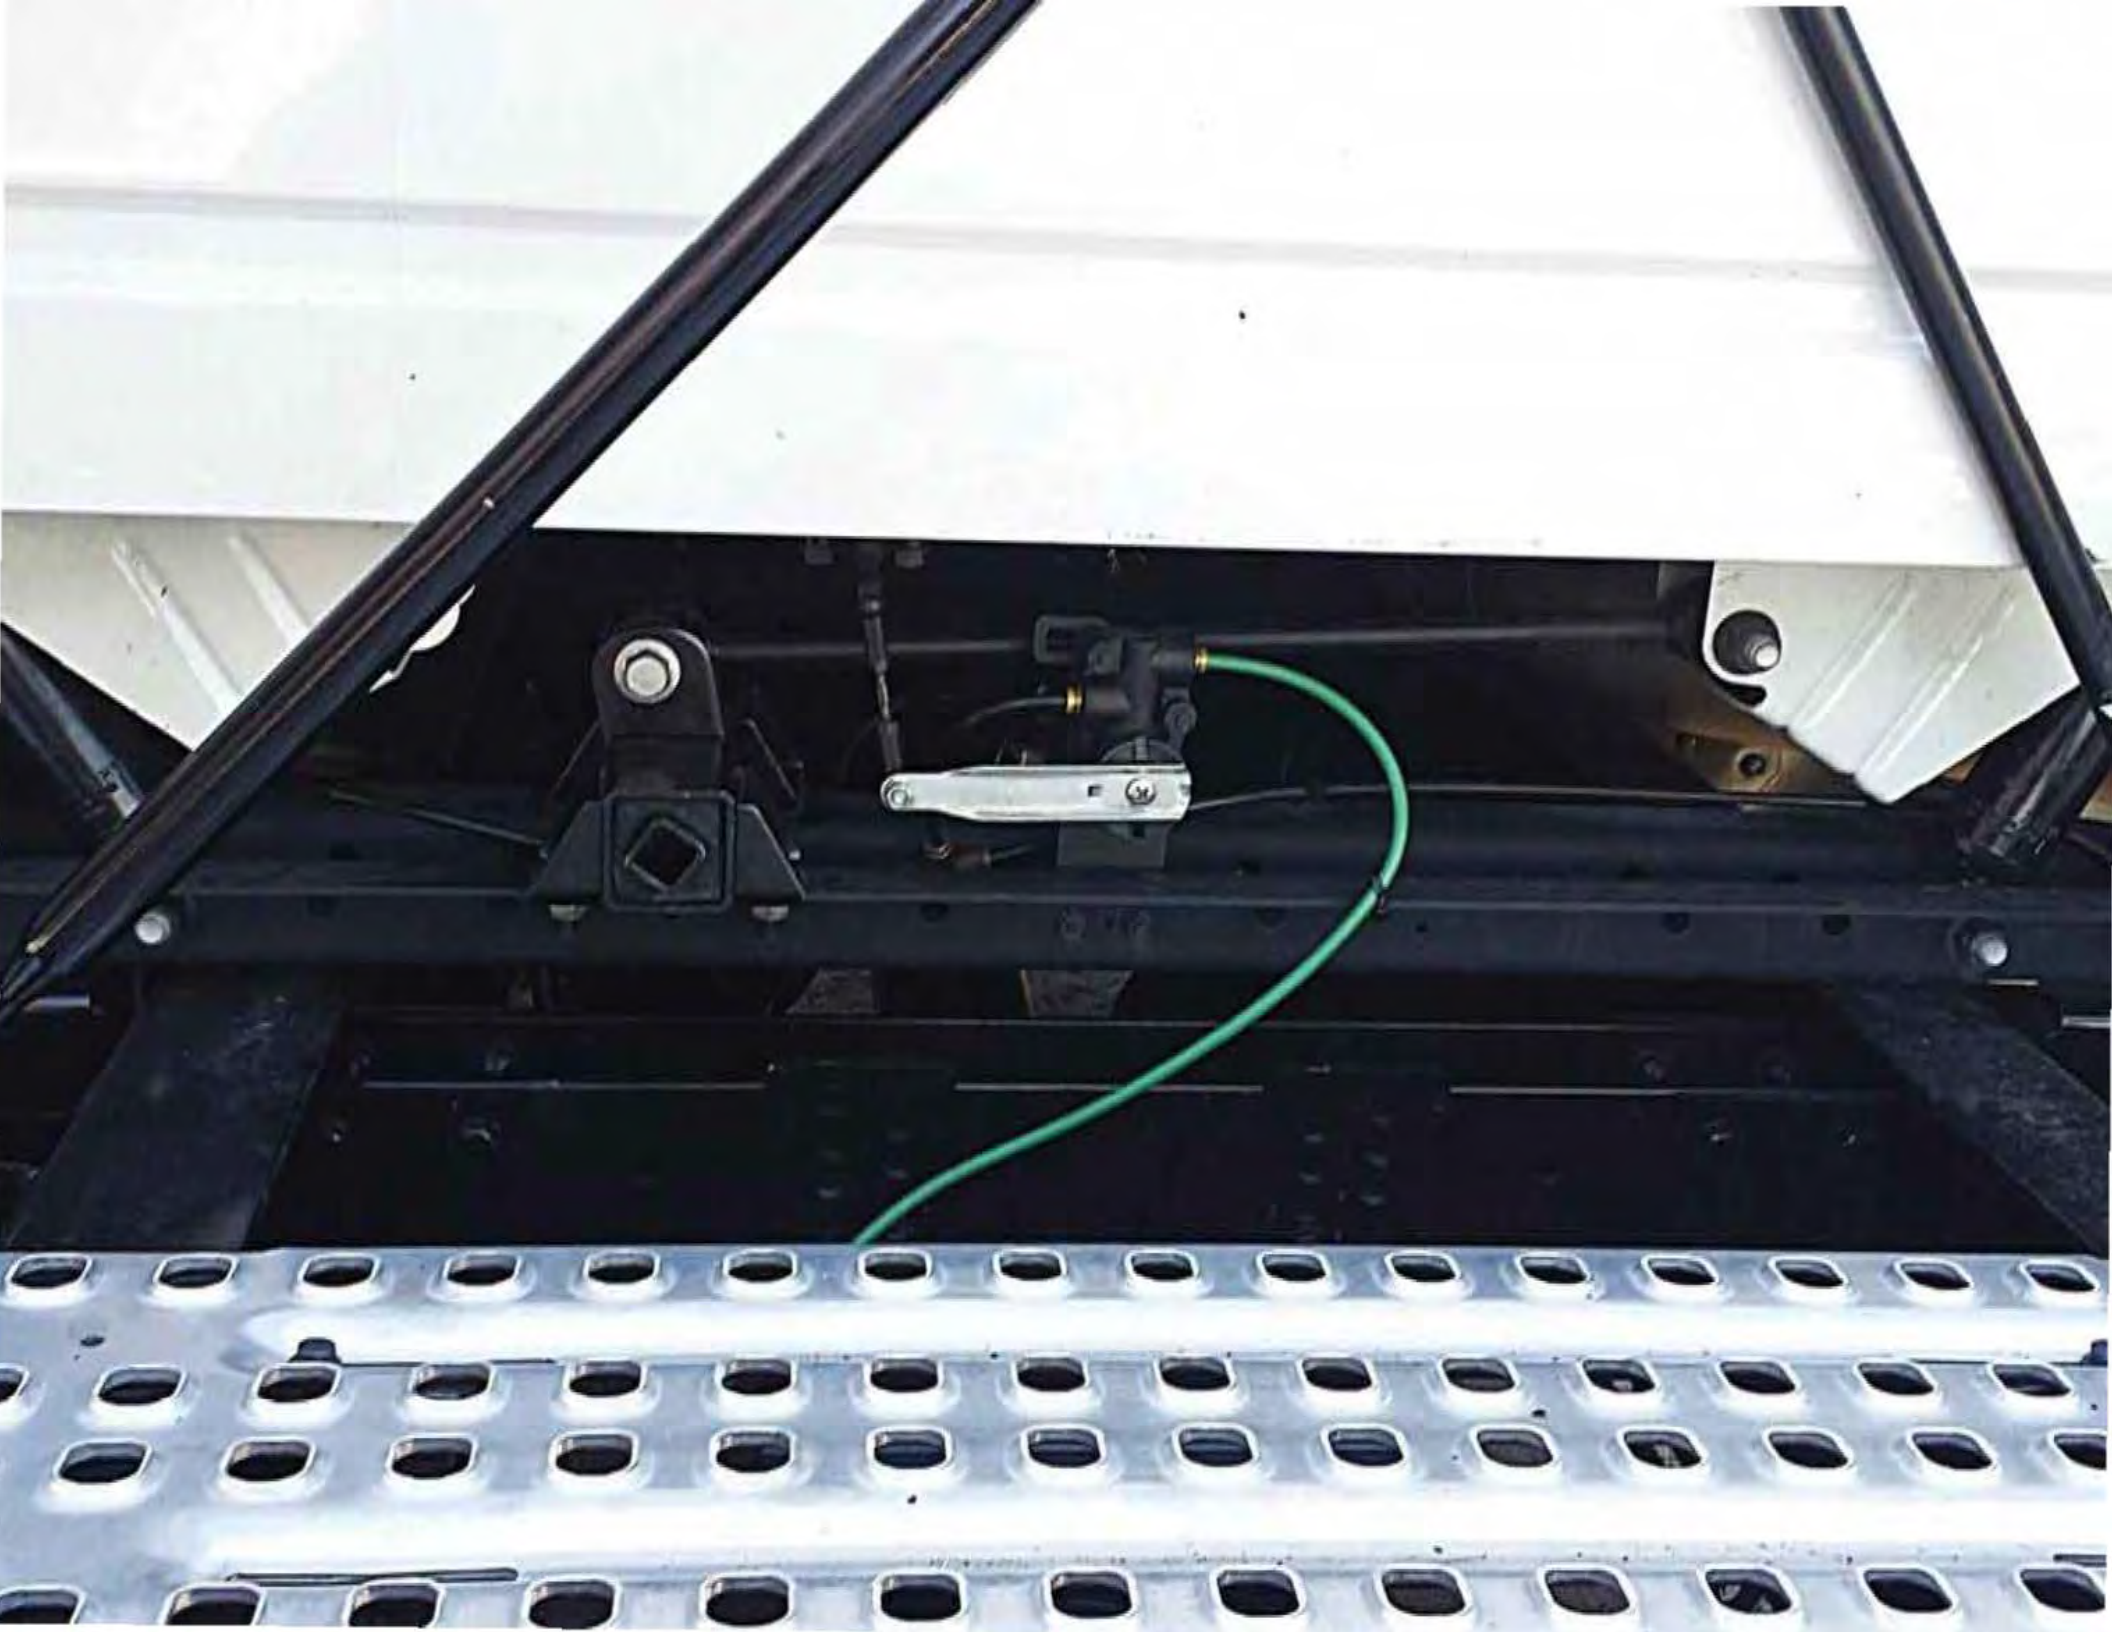
| Created | Created By | Audience | Activity Type | Comments |
|---|---|---|---|---|
| 10/29/2014 10:26:07 | | Public | Work Performed | We have changed the cab suspension torsion springs but the cab still goes to the left. we don't see anything else that would cause this. See attached pictures. How can we repair this? |
