DP15-005

District Service Manager  
Information Letter

SUBJECT: Volvo Cab Leaning  
MODEL(S) VN  
ISSUED BY: Ron Duncan  
APPROVED: Elizabeth Jolin

Reliability is receiving reports of leaning cab suspension issues. Please reference the drawing below to ensure the cab is mounted correctly to the frame. The center-line of the frame is critical when placing the front cab mounts. The front two mounts should be placed as closely across from each other as possible. The rear cab mount cross-member comes into play to get a correct triangle measurement in order to properly correct suspect units. Any unit that has yet to exhibit this issue, but when inspected the dimensions required per the drawing below are not in spec, correct the unit and replace the stay rod torsion spring on the rear cab suspension, as it could possibly be compromised. Note: New fixture used in production – mid August 2014 to prevent occurrence

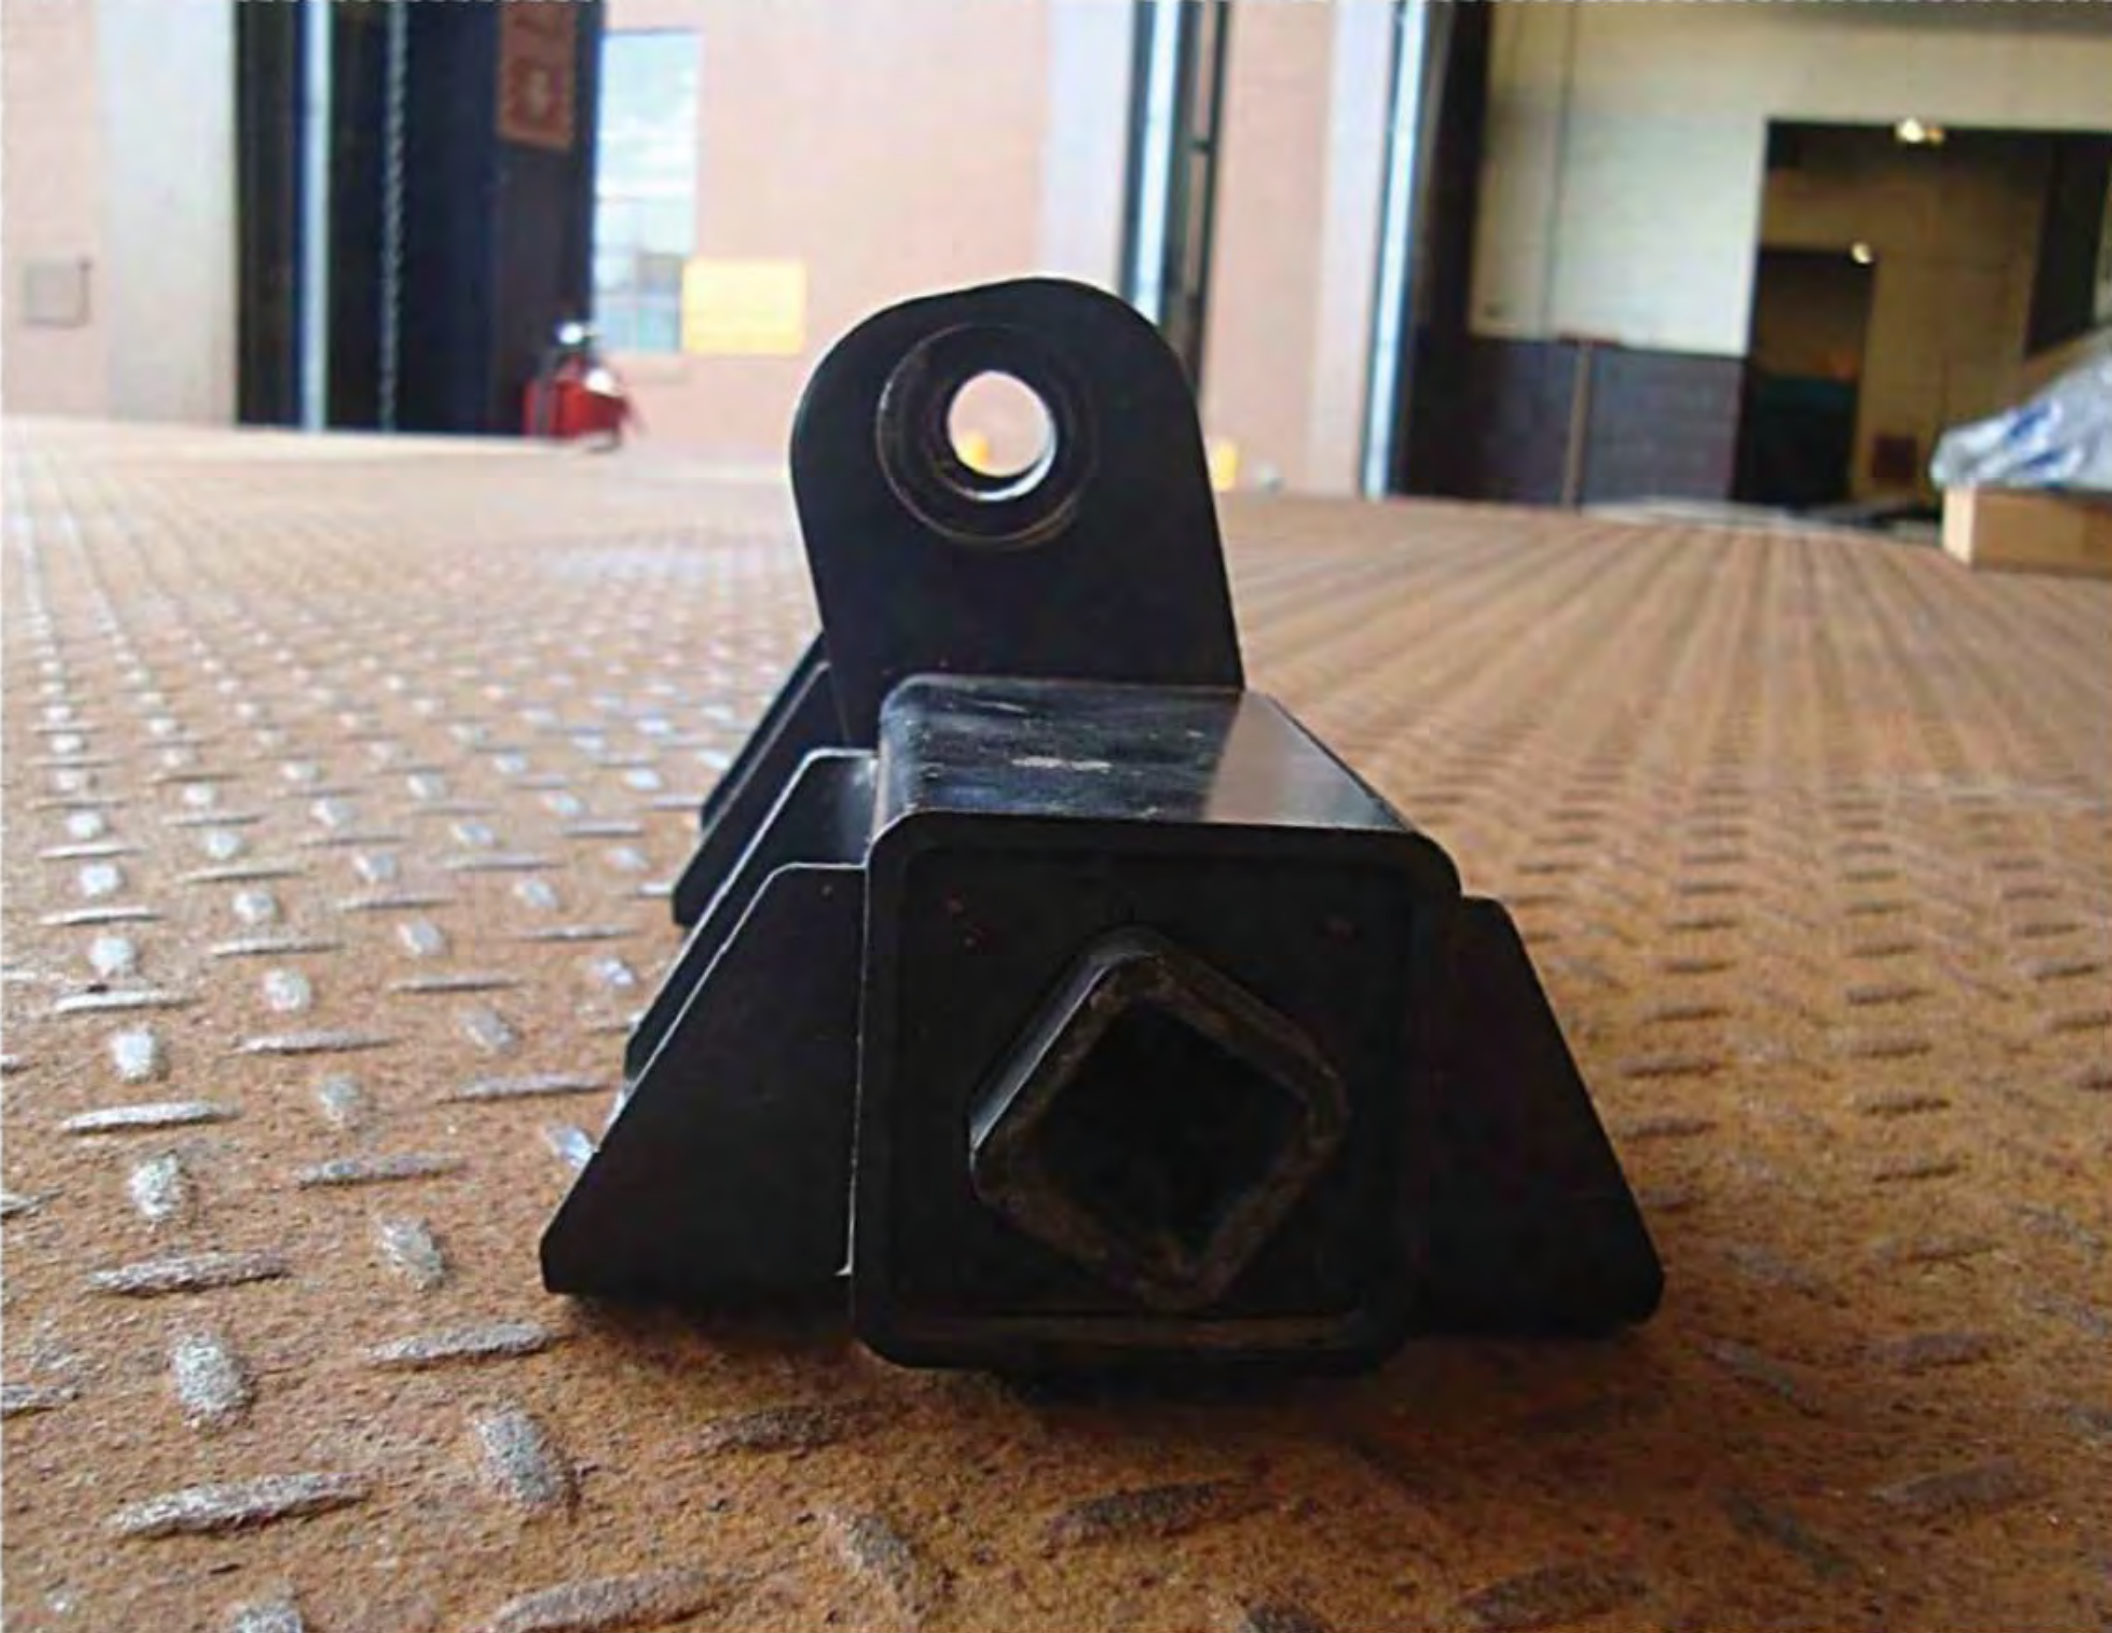
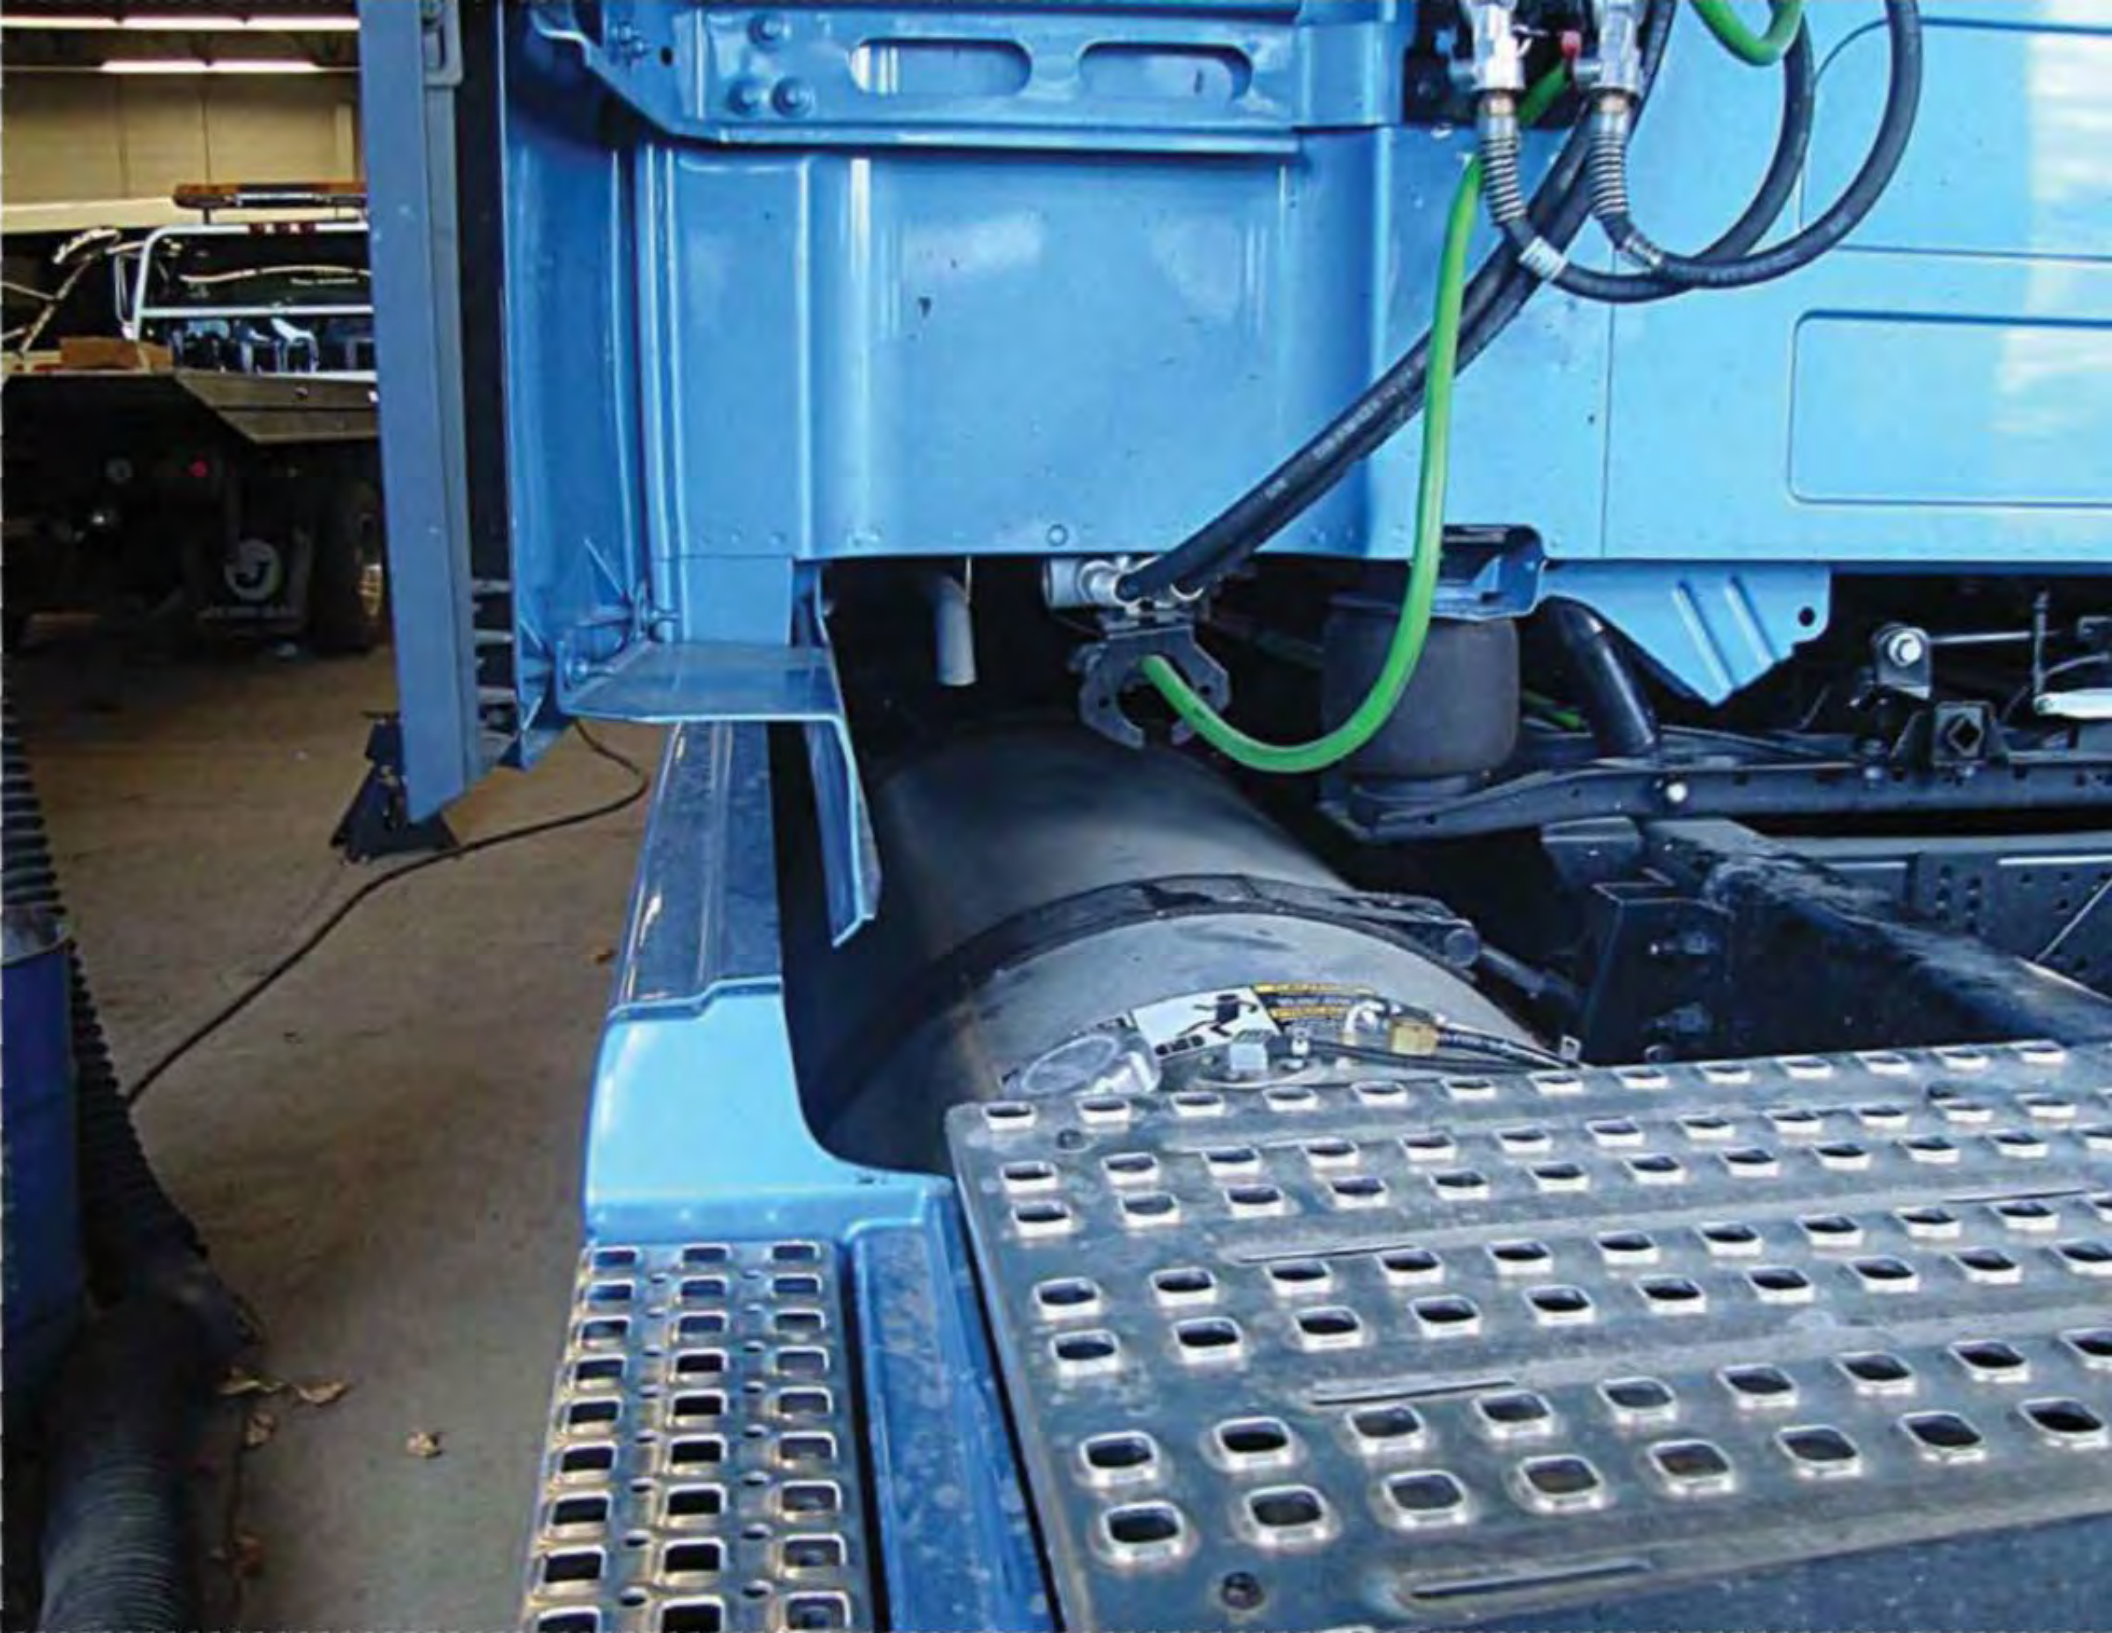
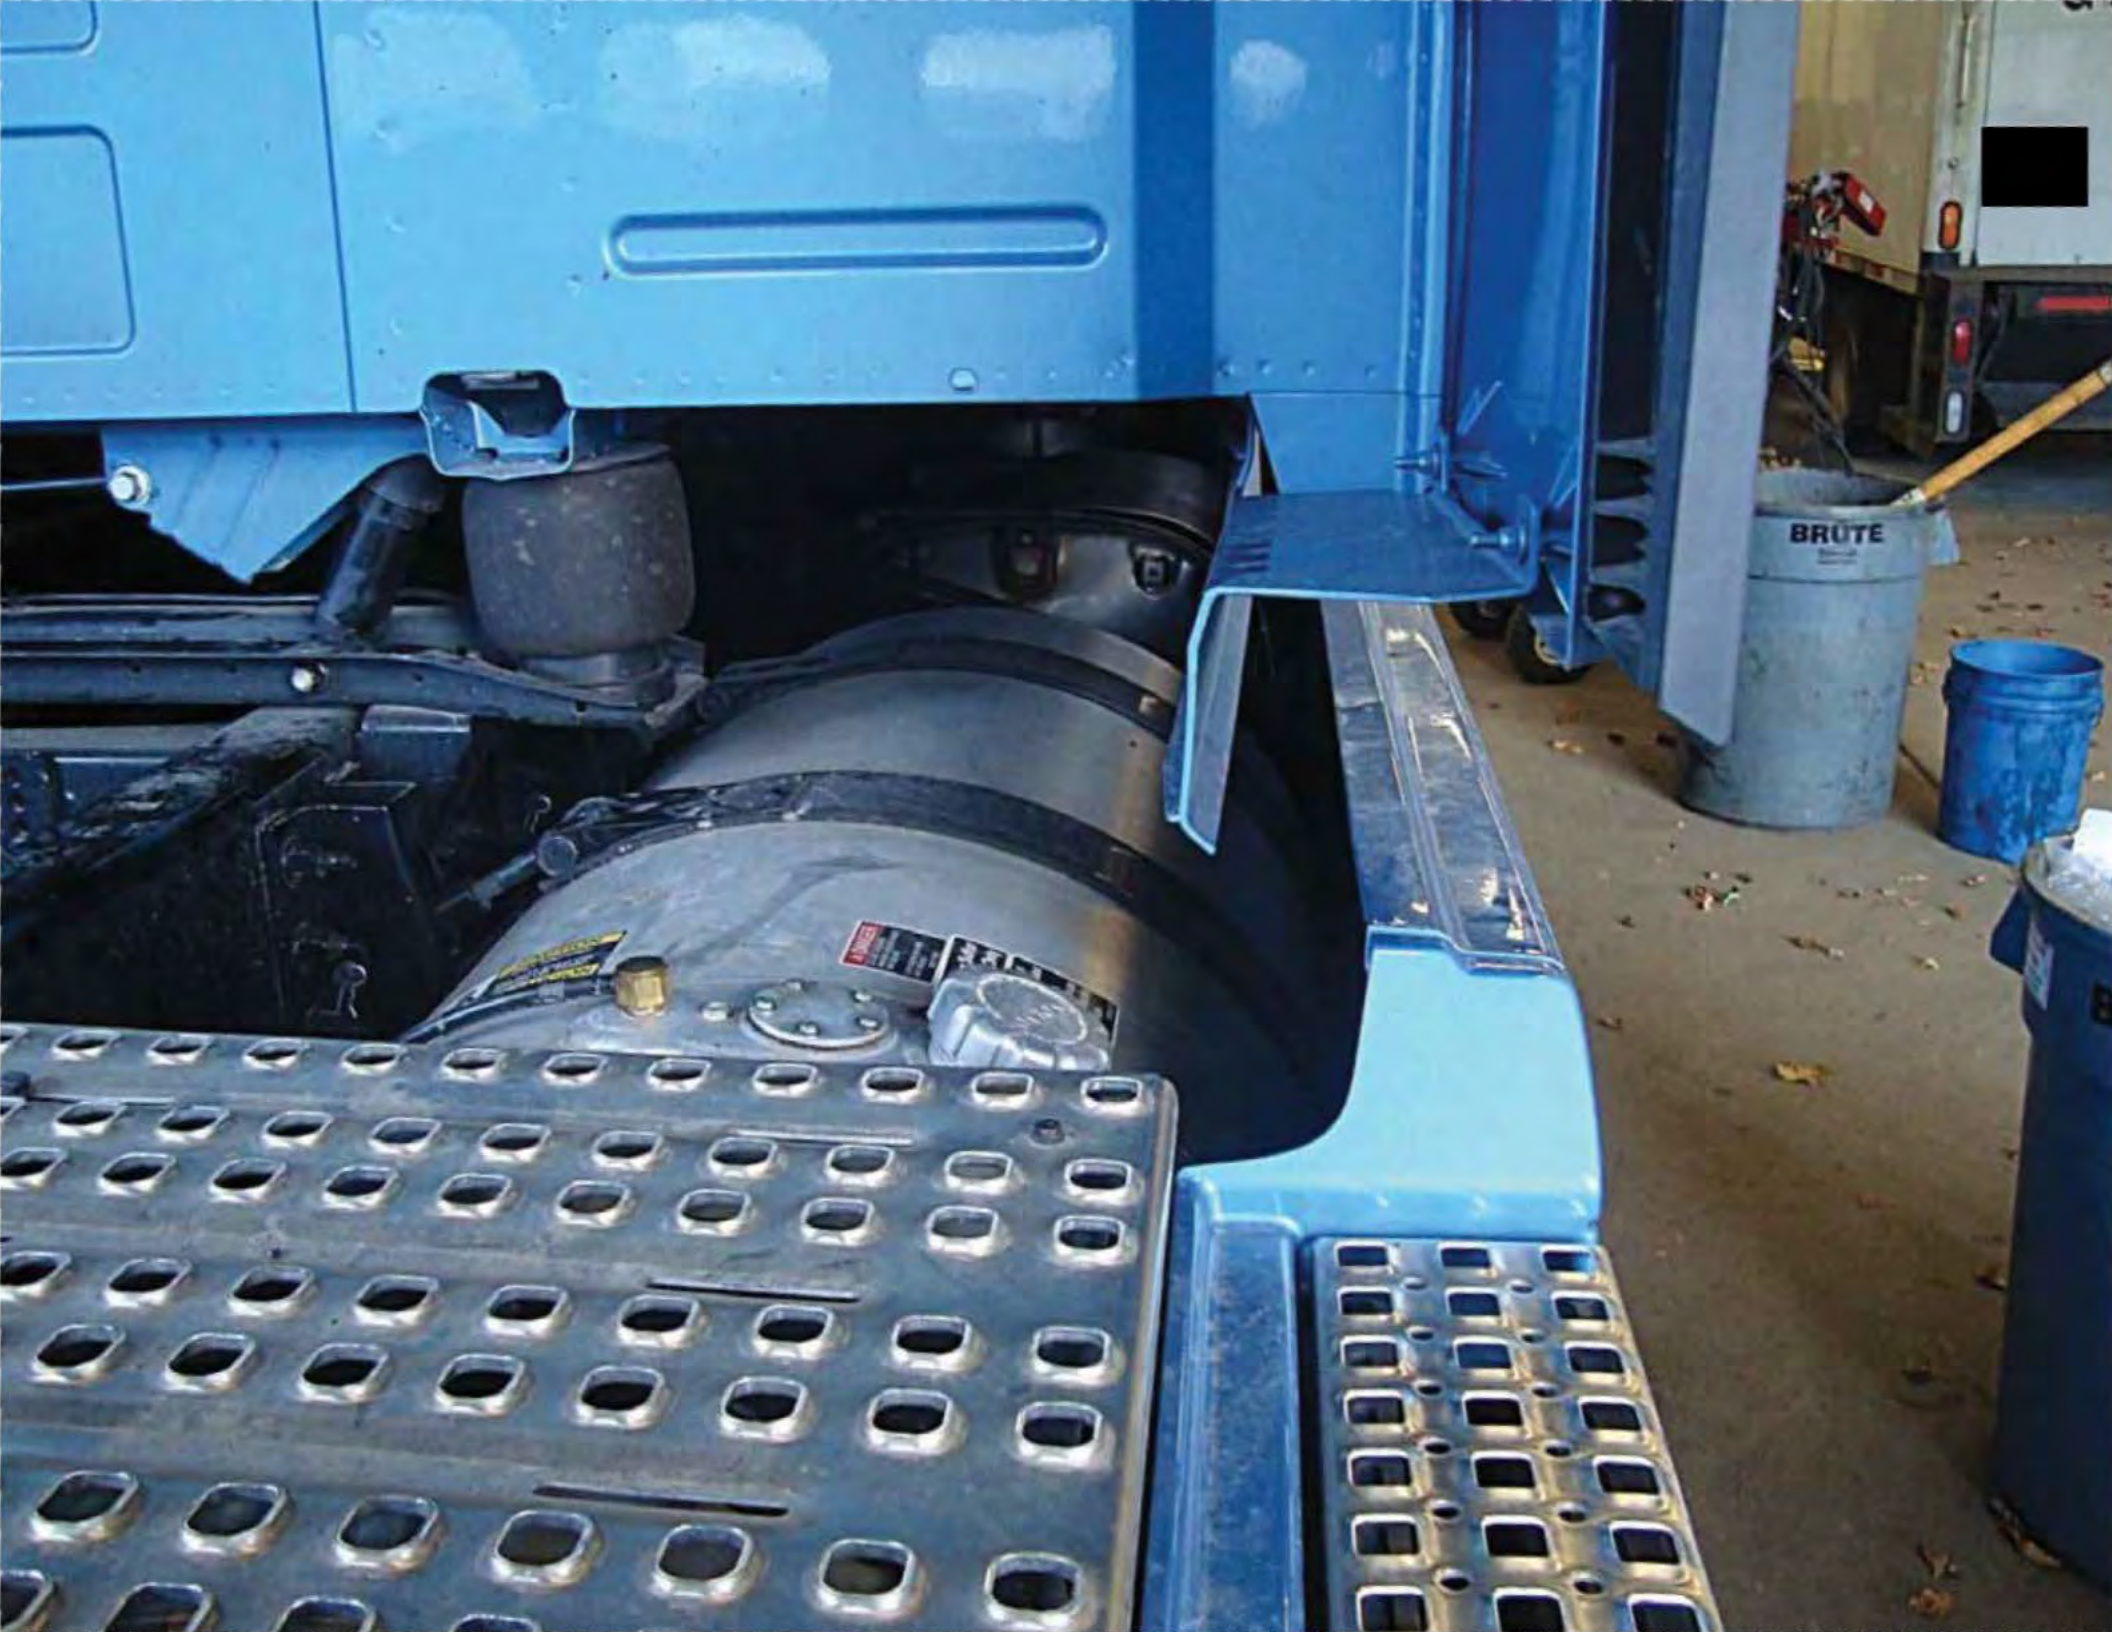
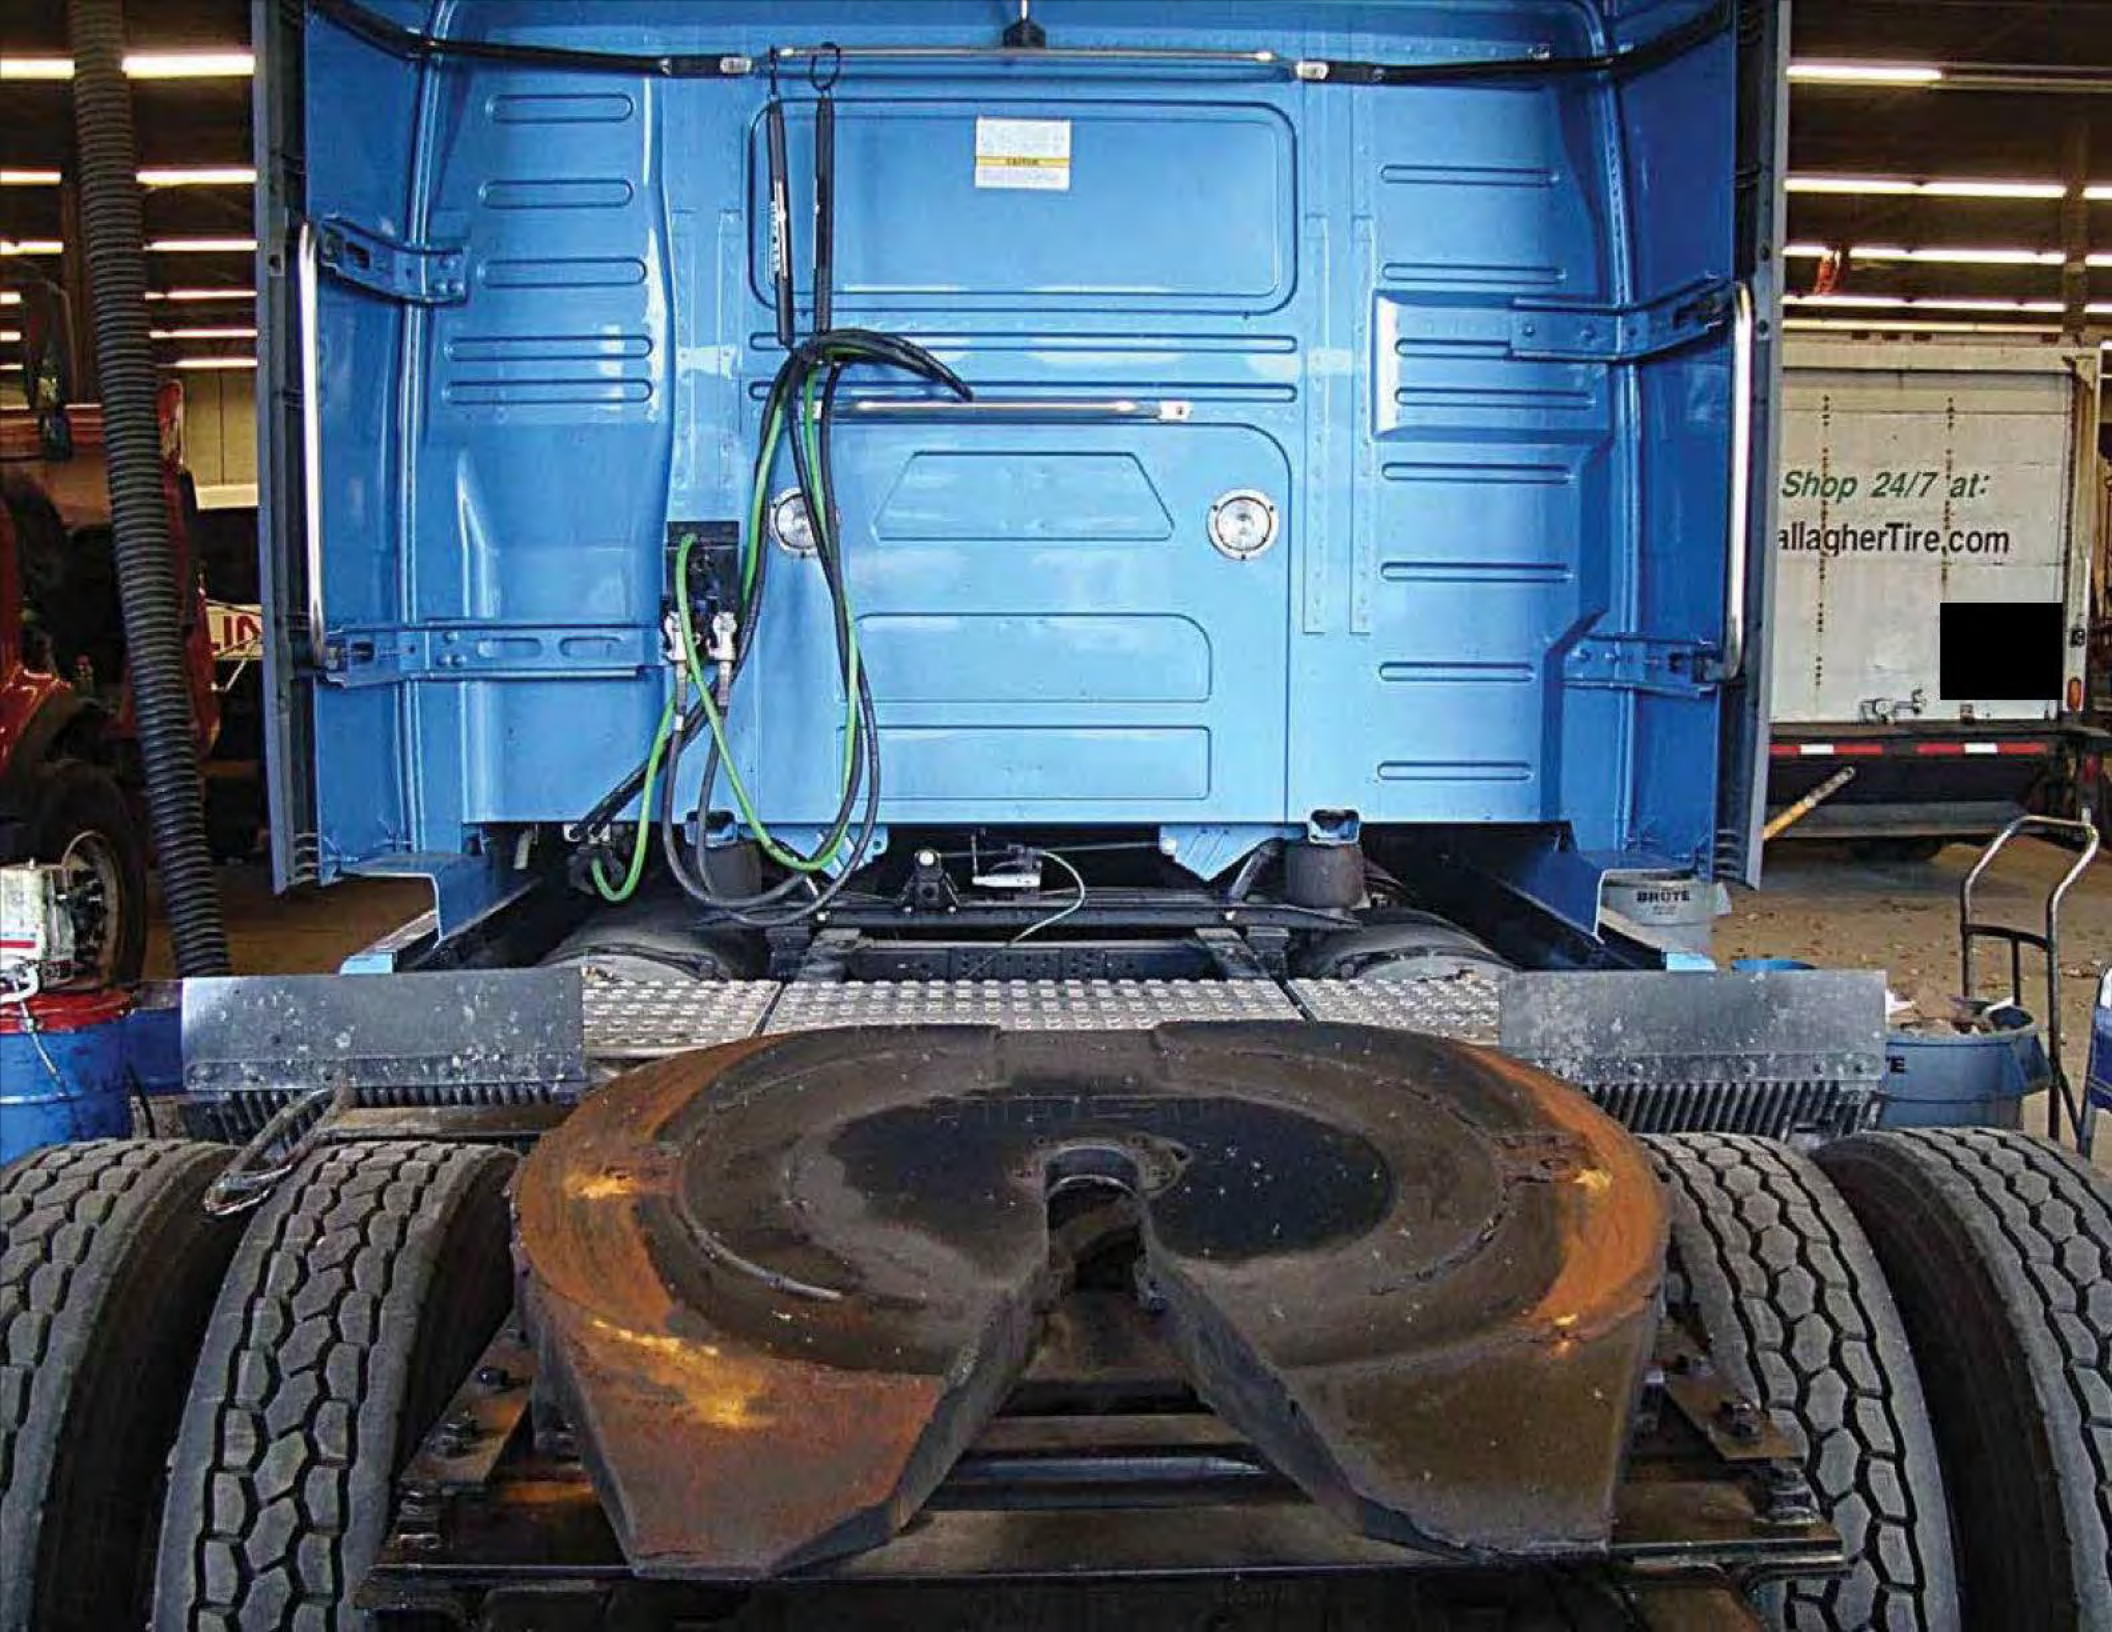
Checked cab hieght and adjusted to specs in 8181-06-03-01. Rear cab crossmember is offset to drivers side 10mm. Adjusted to center and Cab is still offset to drivers side approx 40mm. Cab suspension troubleshooting in Impact leads to front cab mounts being damaged or misaligned. Should we attempt to reallign front mounts or just replace them? Are there any better alignment instructions than the ones listed in Impact 8181-03-02-10? Are there any updated procedures for brake noise other than what's listed in Tech Support Tips?

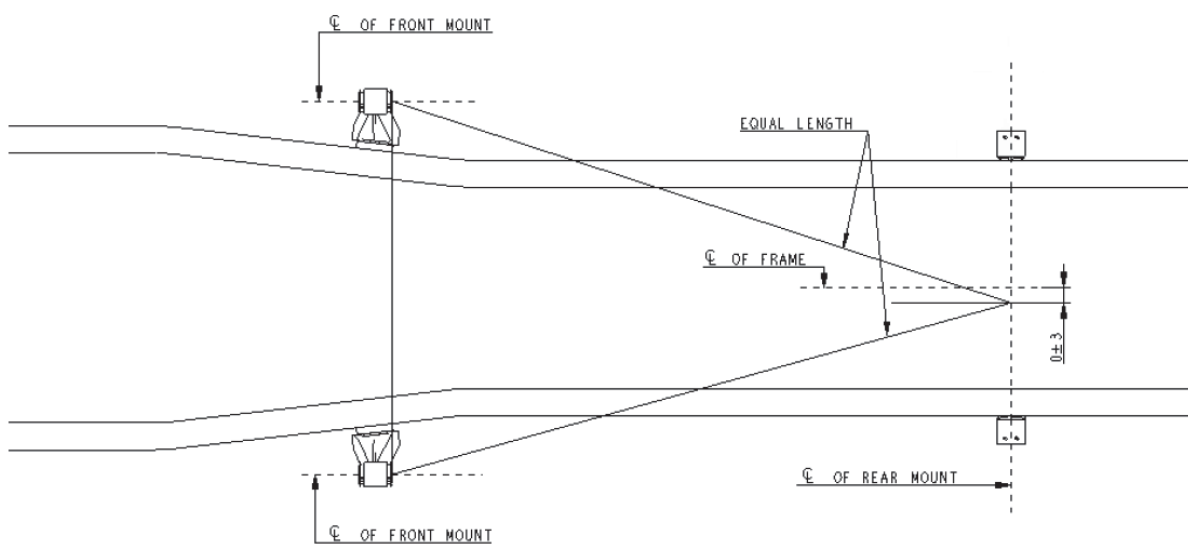
| Created | Created By | Audience | Activity Type | Comments |
|---|---|---|---|---|
| 09/09/2014 17:02:56 | RONALD DUNCAN | Public | Web Response | Please review attachment. The front mounts need to be as close as feasibly possible directly across from each other. Thank you... |

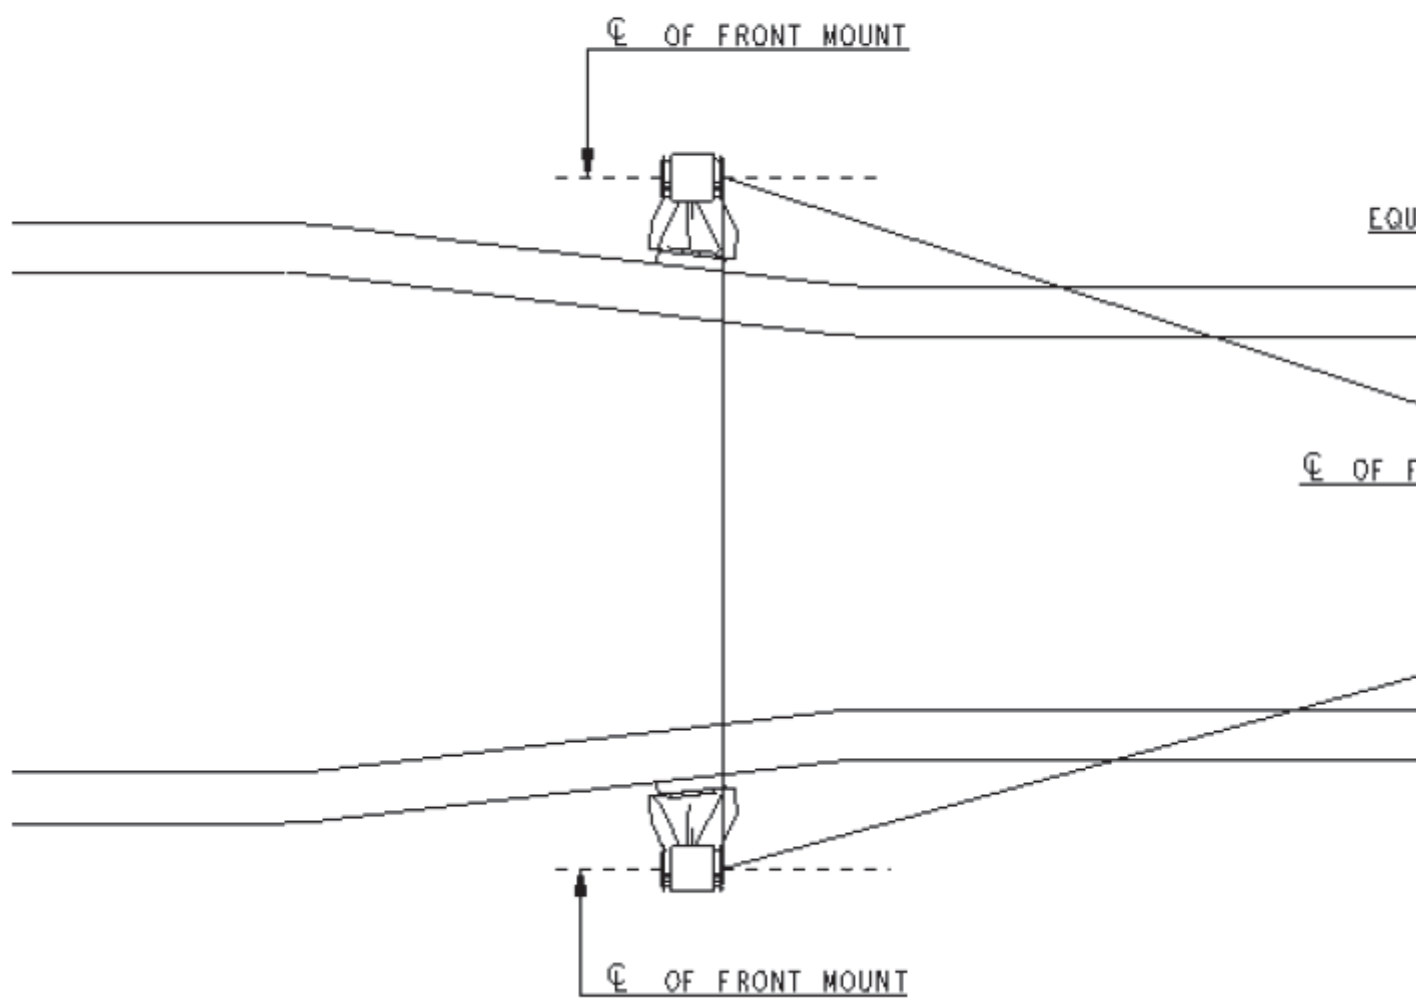
In light of the cab suspension issue that we are seeing in the field I have attached a drawing that will be required to ensure the cab is mounted correctly to the frame. As you can see the center-line of the frame is critical when placing the front mounts. The front two mounts should be mounted as closely across from each other as possible. The rear cab mount cross-member comes into play to get a correct triangle measurement in order to properly correct these units in the field. but when inspected the dimensions required per the attached are not in spec, the stay rod torsion spring should be replaced on the rear cab suspension. ...Thanks very much and let me know how I can further assist...
