DP15-005

District Service Manager  
Information Letter

SUBJECT: Volvo Cab Leaning  
MODEL(S) VN  
ISSUED BY: Ron Duncan  
APPROVED: Elizabeth Jolin

Reliability is receiving reports of leaning cab suspension issues. Please reference the drawing below to ensure the cab is mounted correctly to the frame. The center-line of the frame is critical when placing the front cab mounts. The front two mounts should be placed as closely across from each other as possible. The rear cab mount cross-member comes into play to get a correct triangle measurement in order to properly correct suspect units. Any unit that has yet to exhibit this issue, but when inspected the dimensions required per the drawing below are not in spec, correct the unit and replace the stay rod torsion spring on the rear cab suspension, as it could possibly be compromised. Note: New fixture used in production – mid August 2014 to prevent occurrence

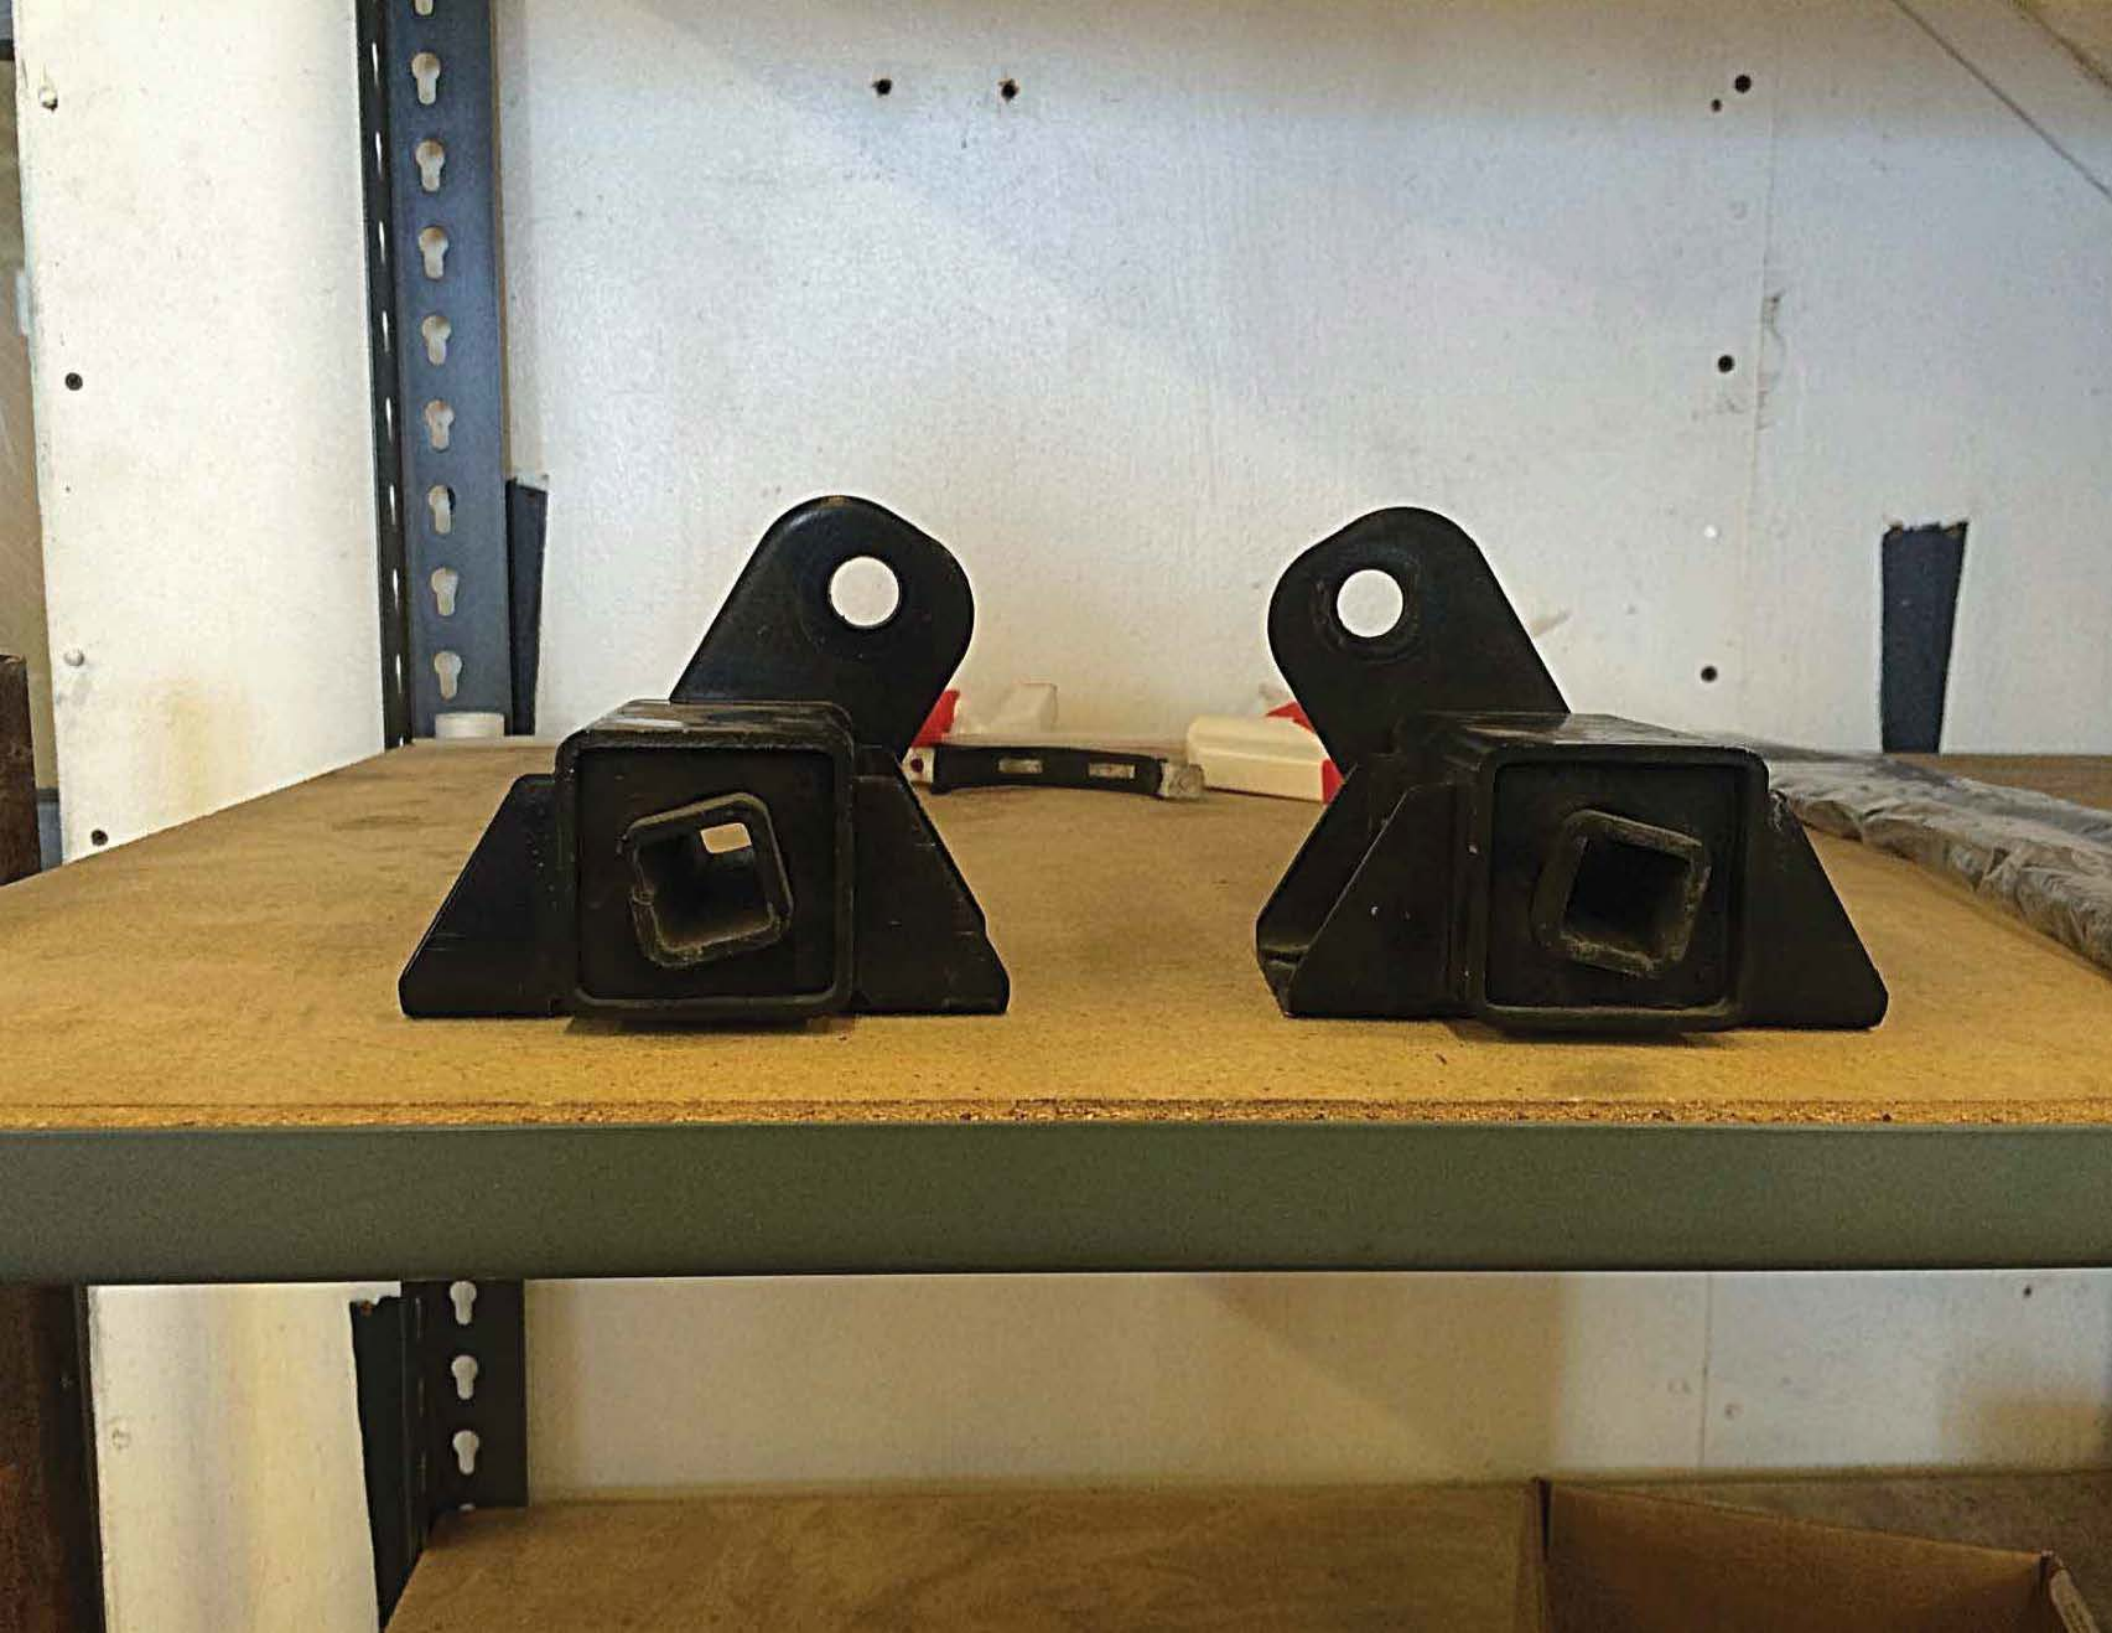
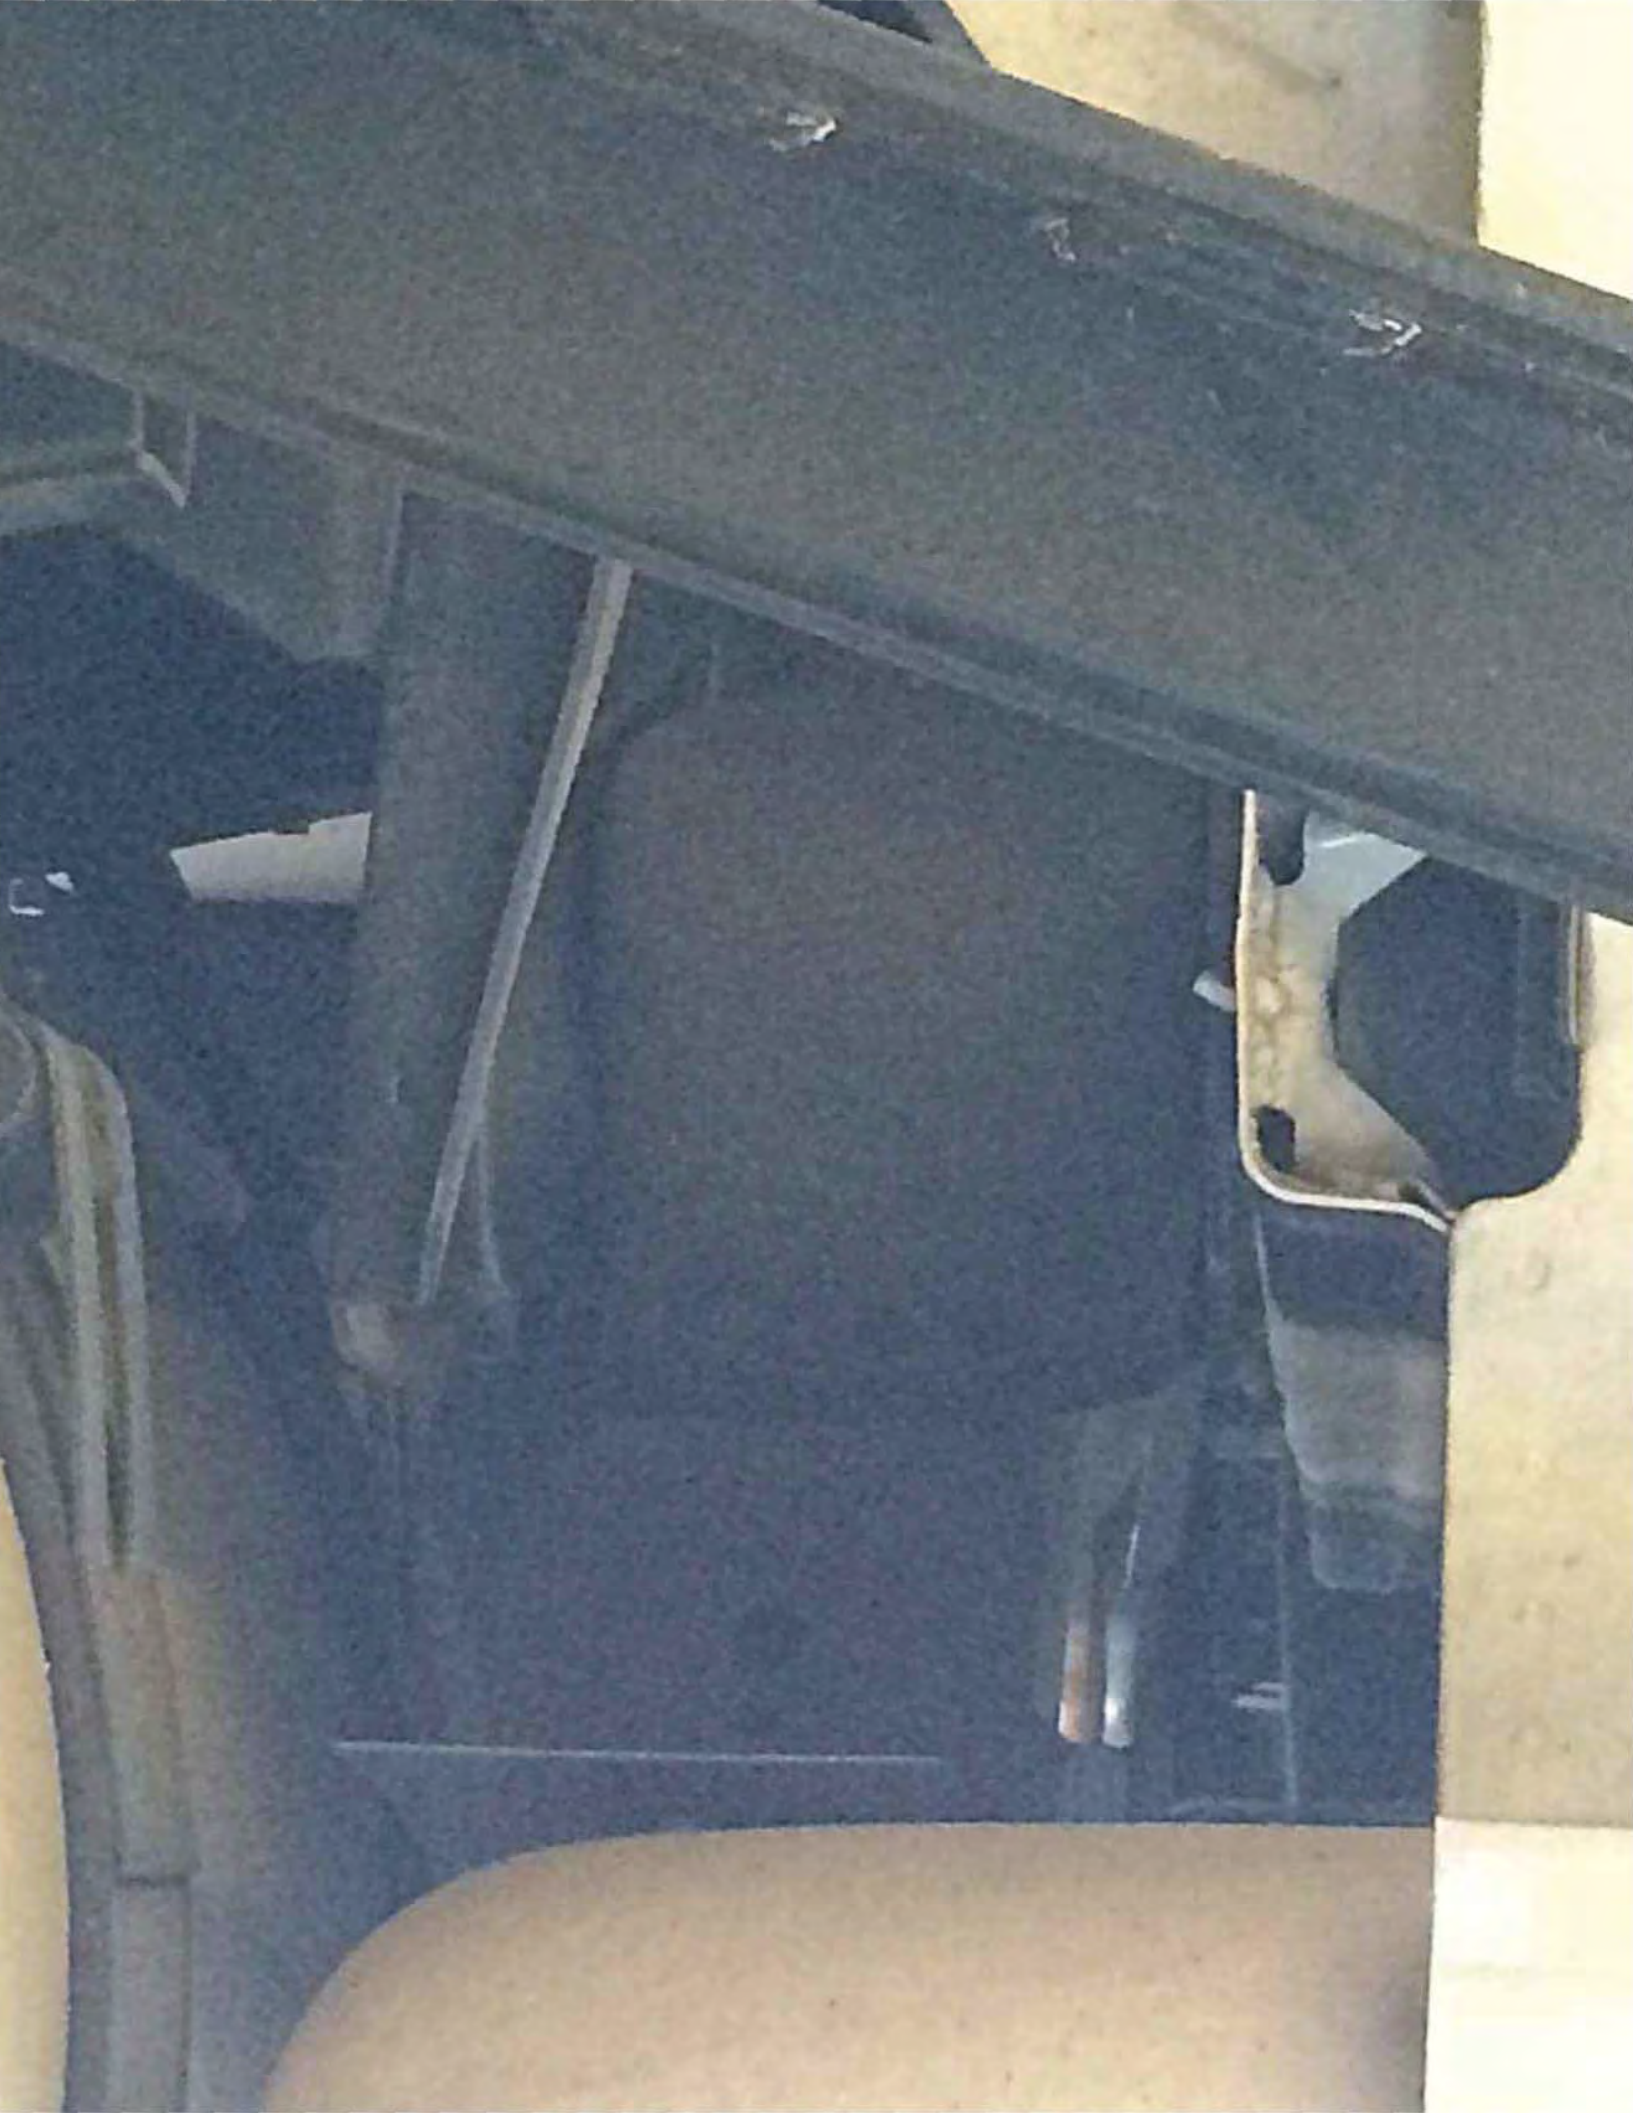
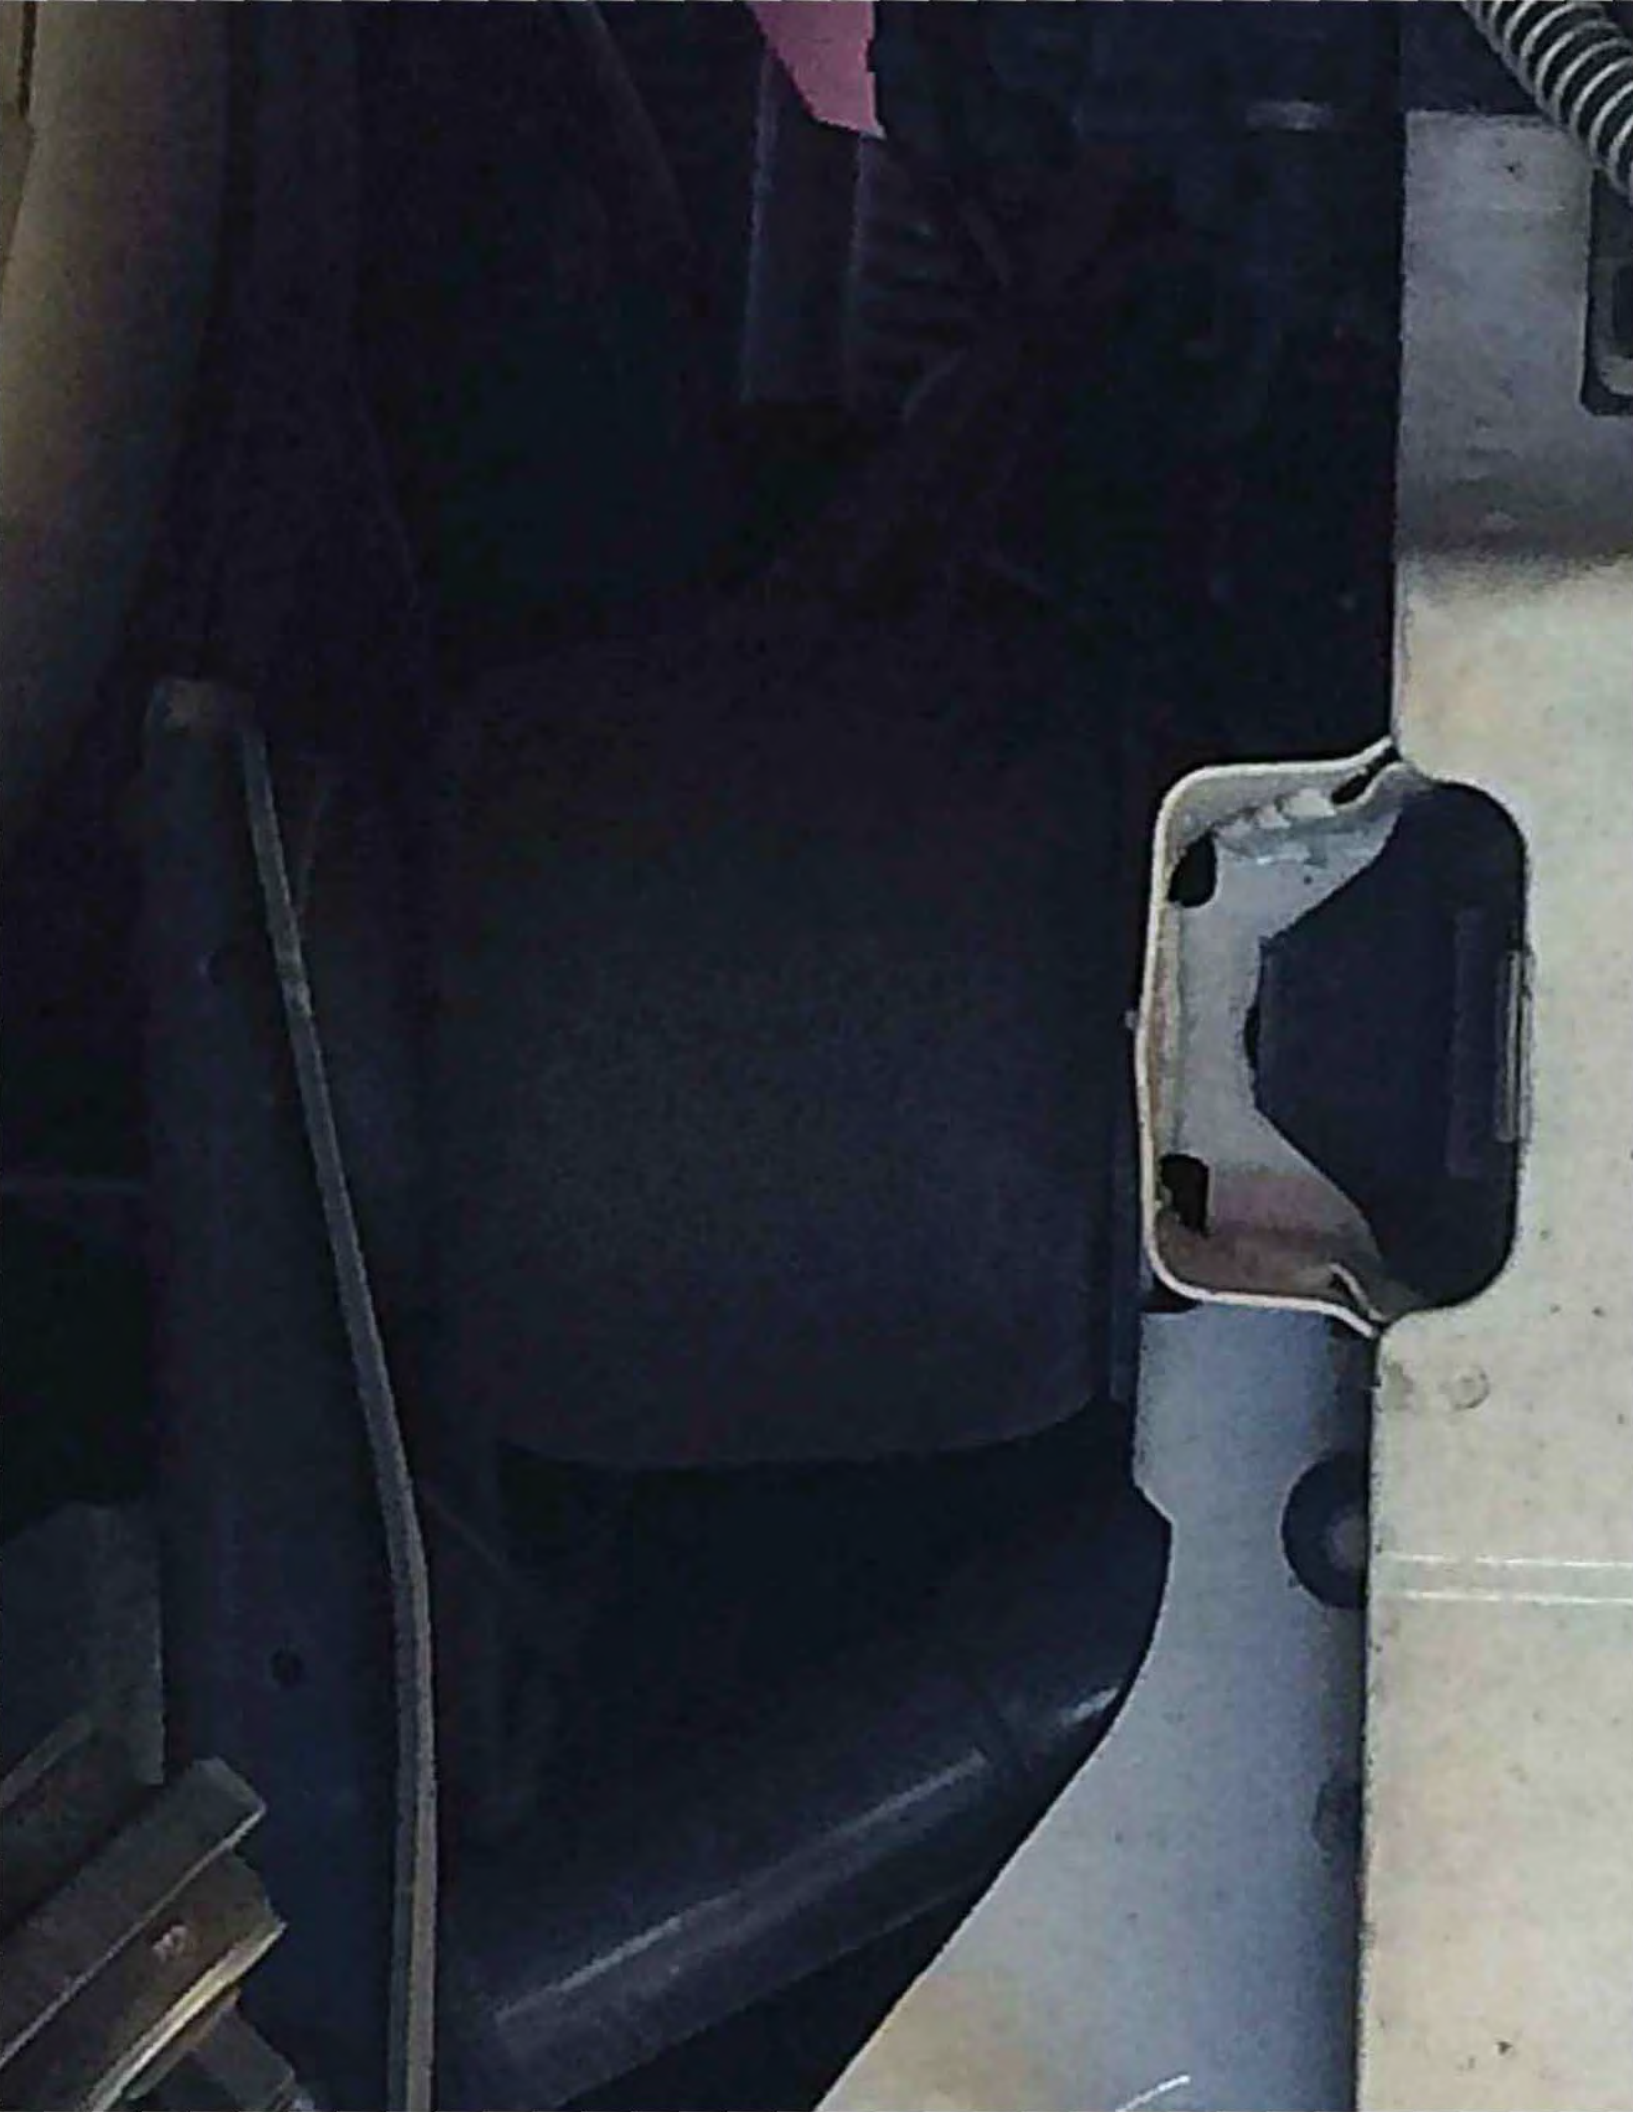
| 08/18/2014<br>17:50:36 | | Public | Work Performed | I REPLACED THE CAB TORSION SPRINGS CHECKED FOR CAB<br>ALIGNMENT BROUGHT THE CAB OVER TO SPEC TWICE BUT<br>THE CAB JUST WANTS TO SHIFT OVER TO THE LEFT SIDE |

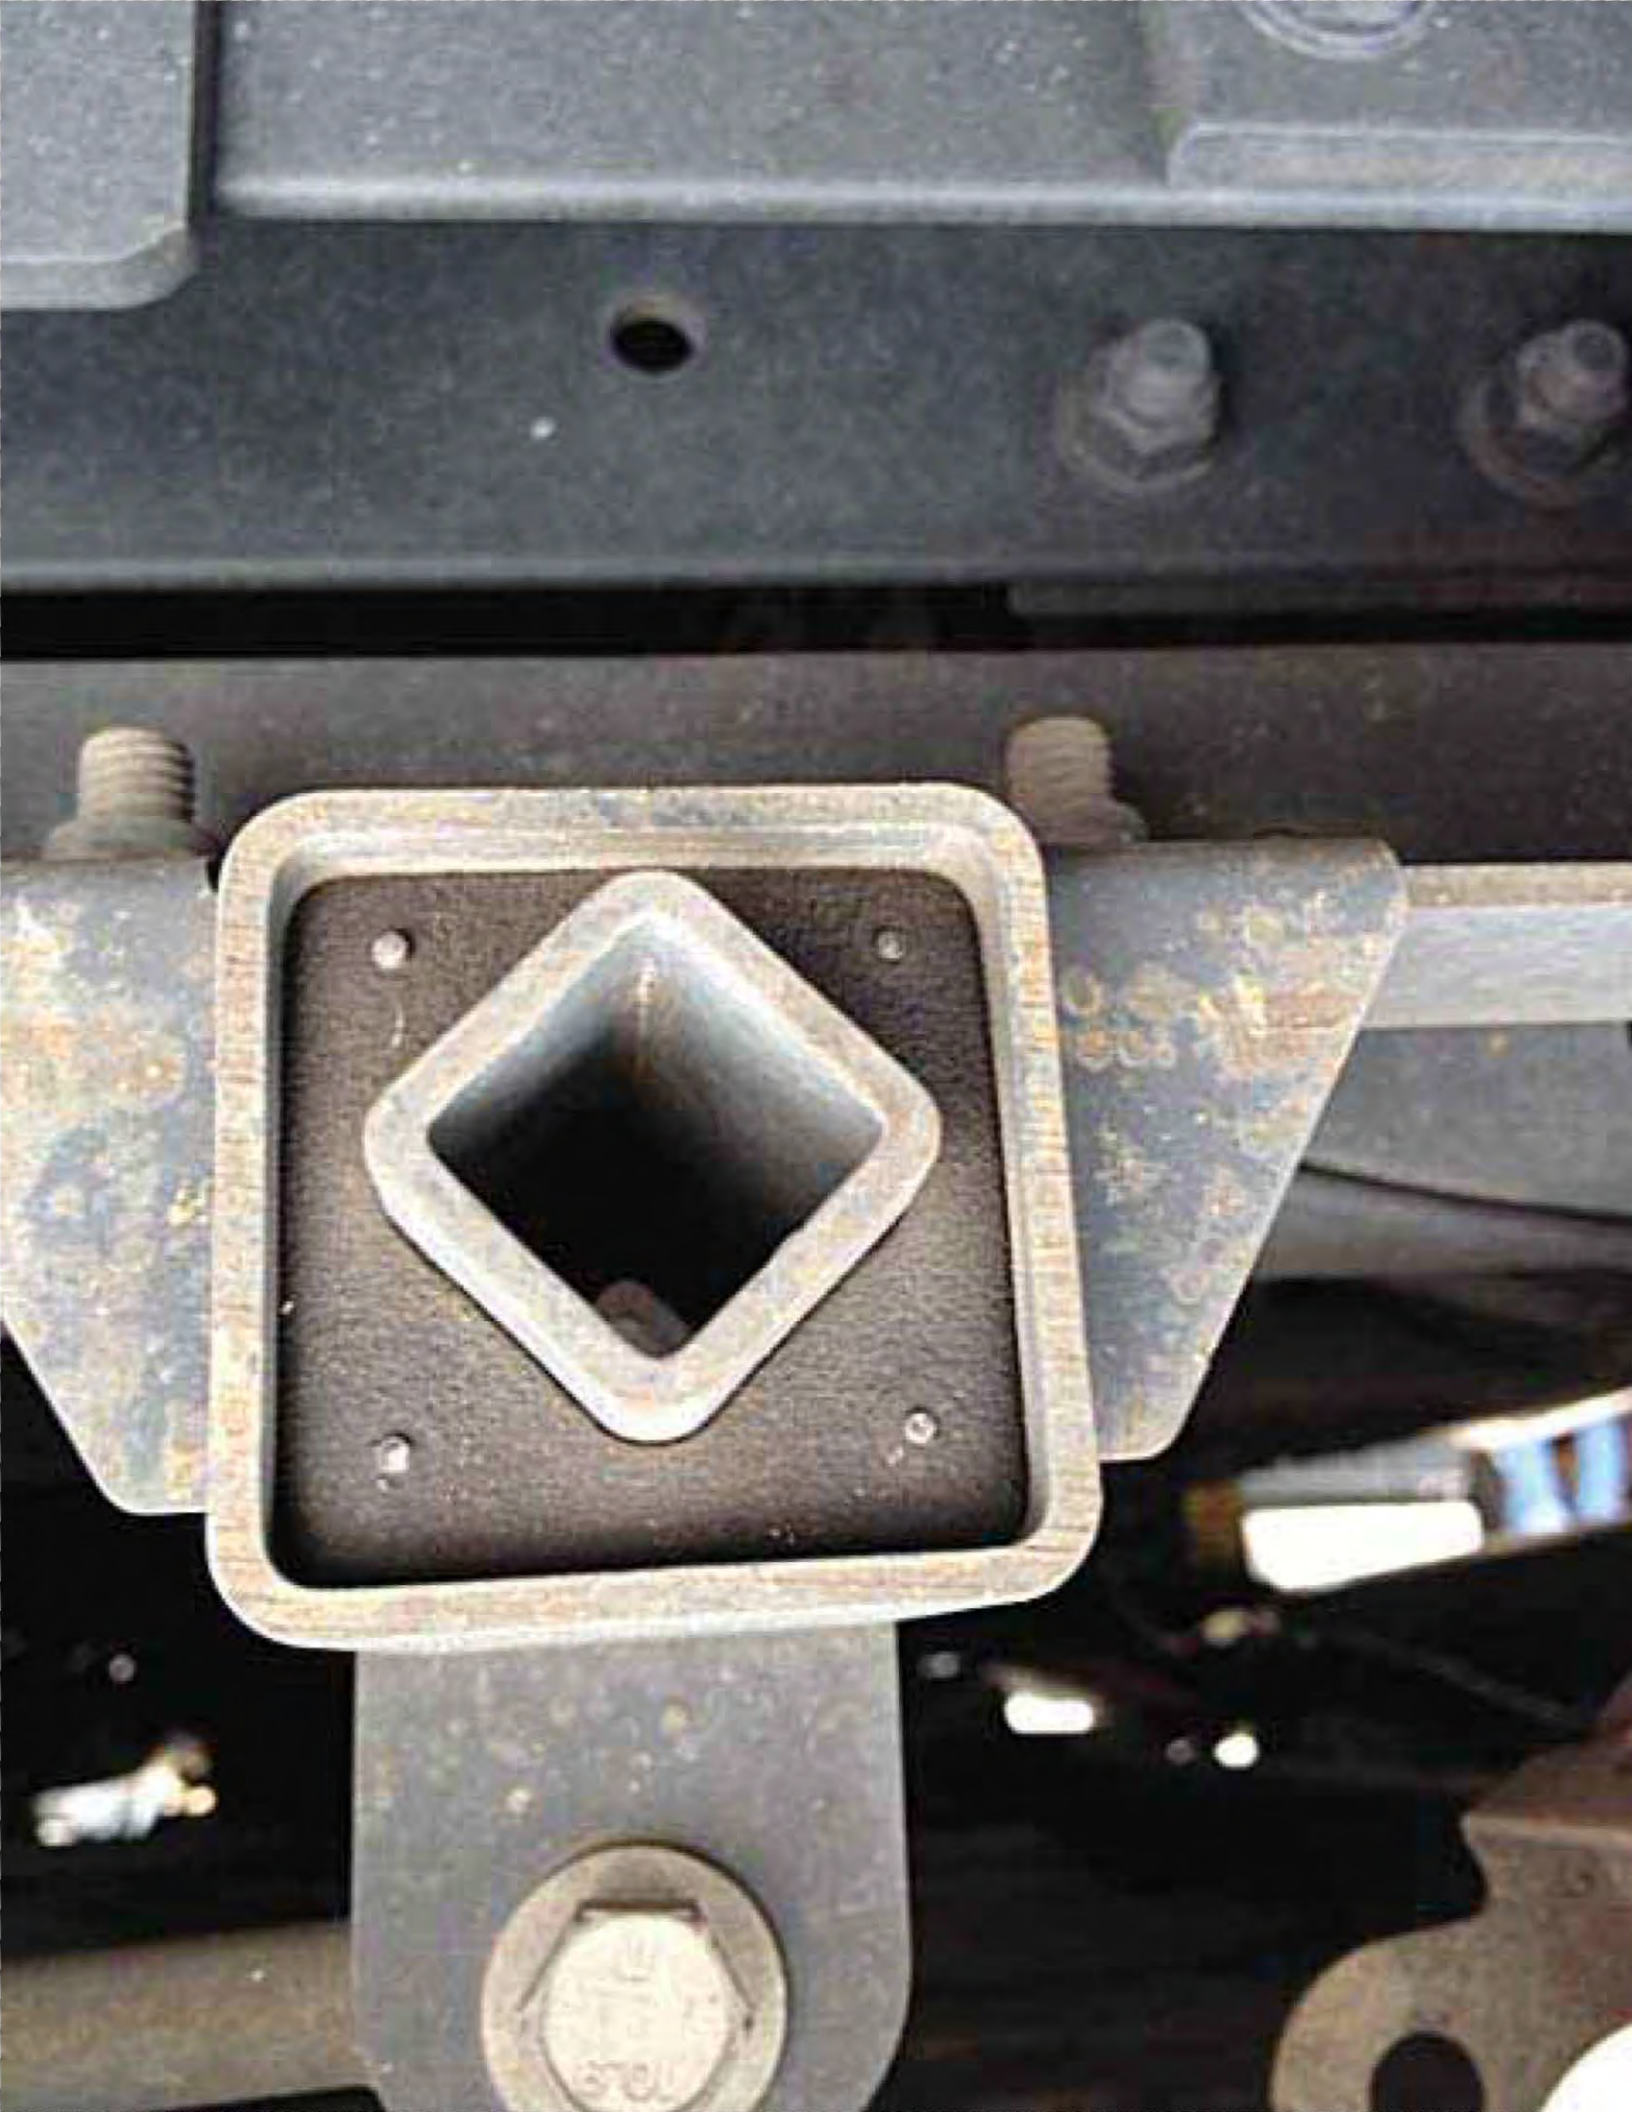
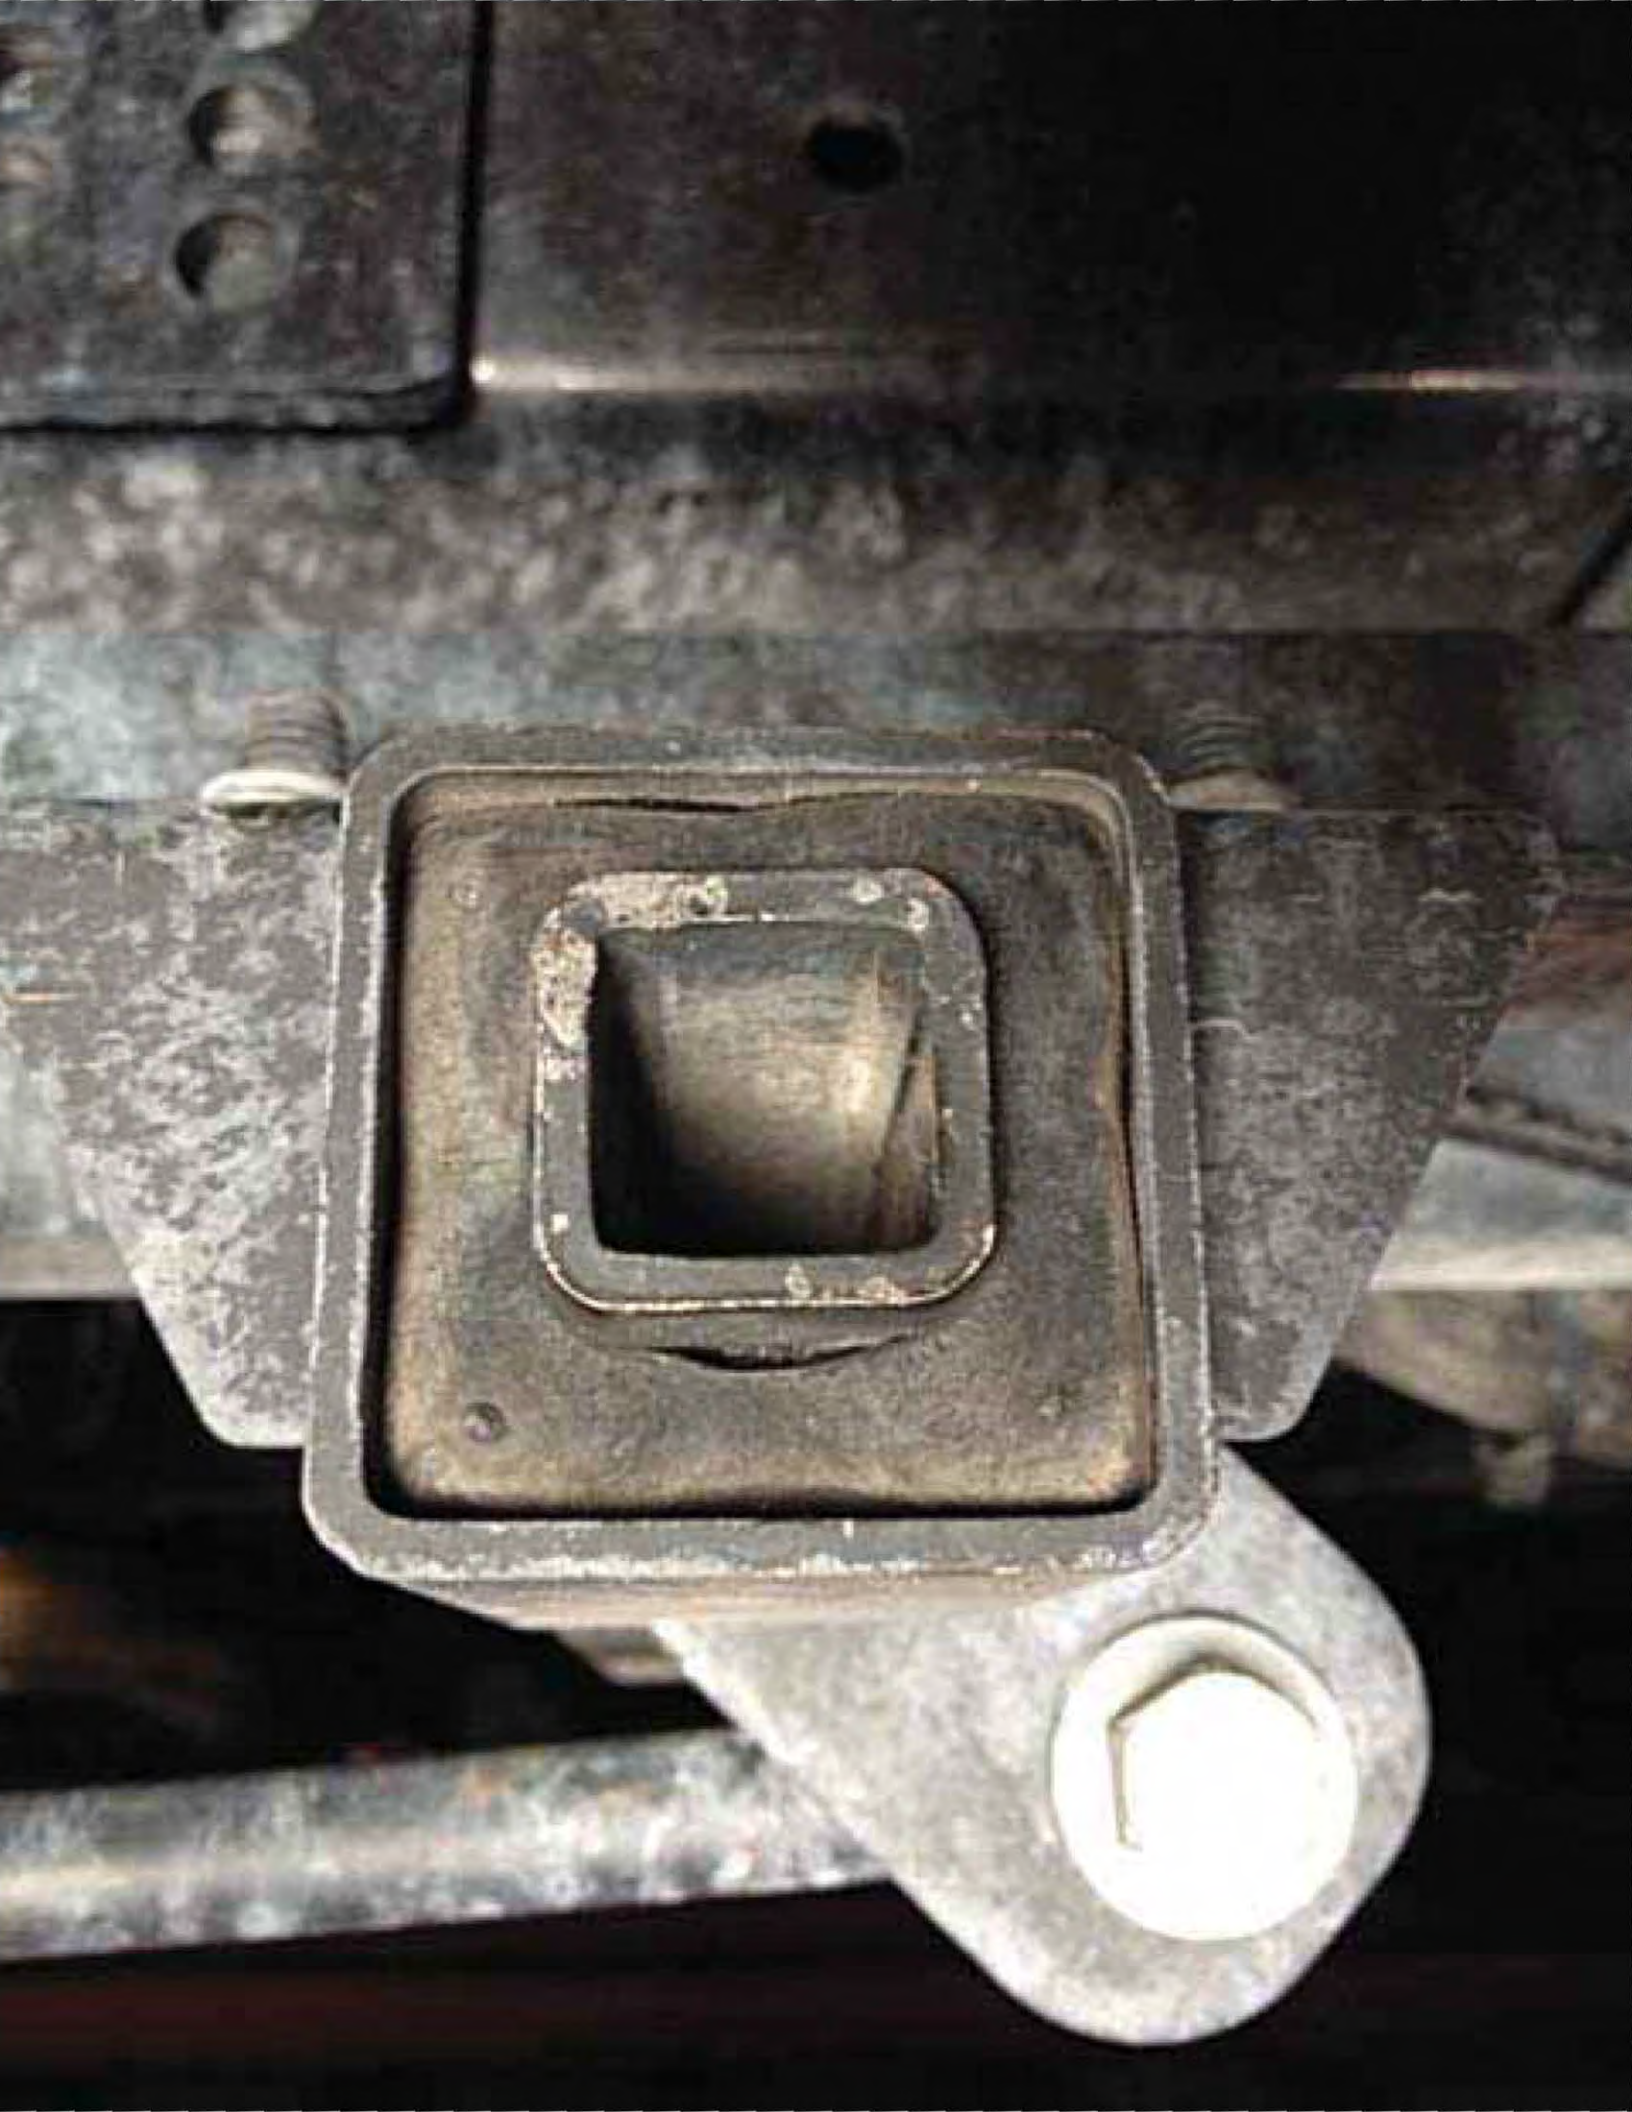
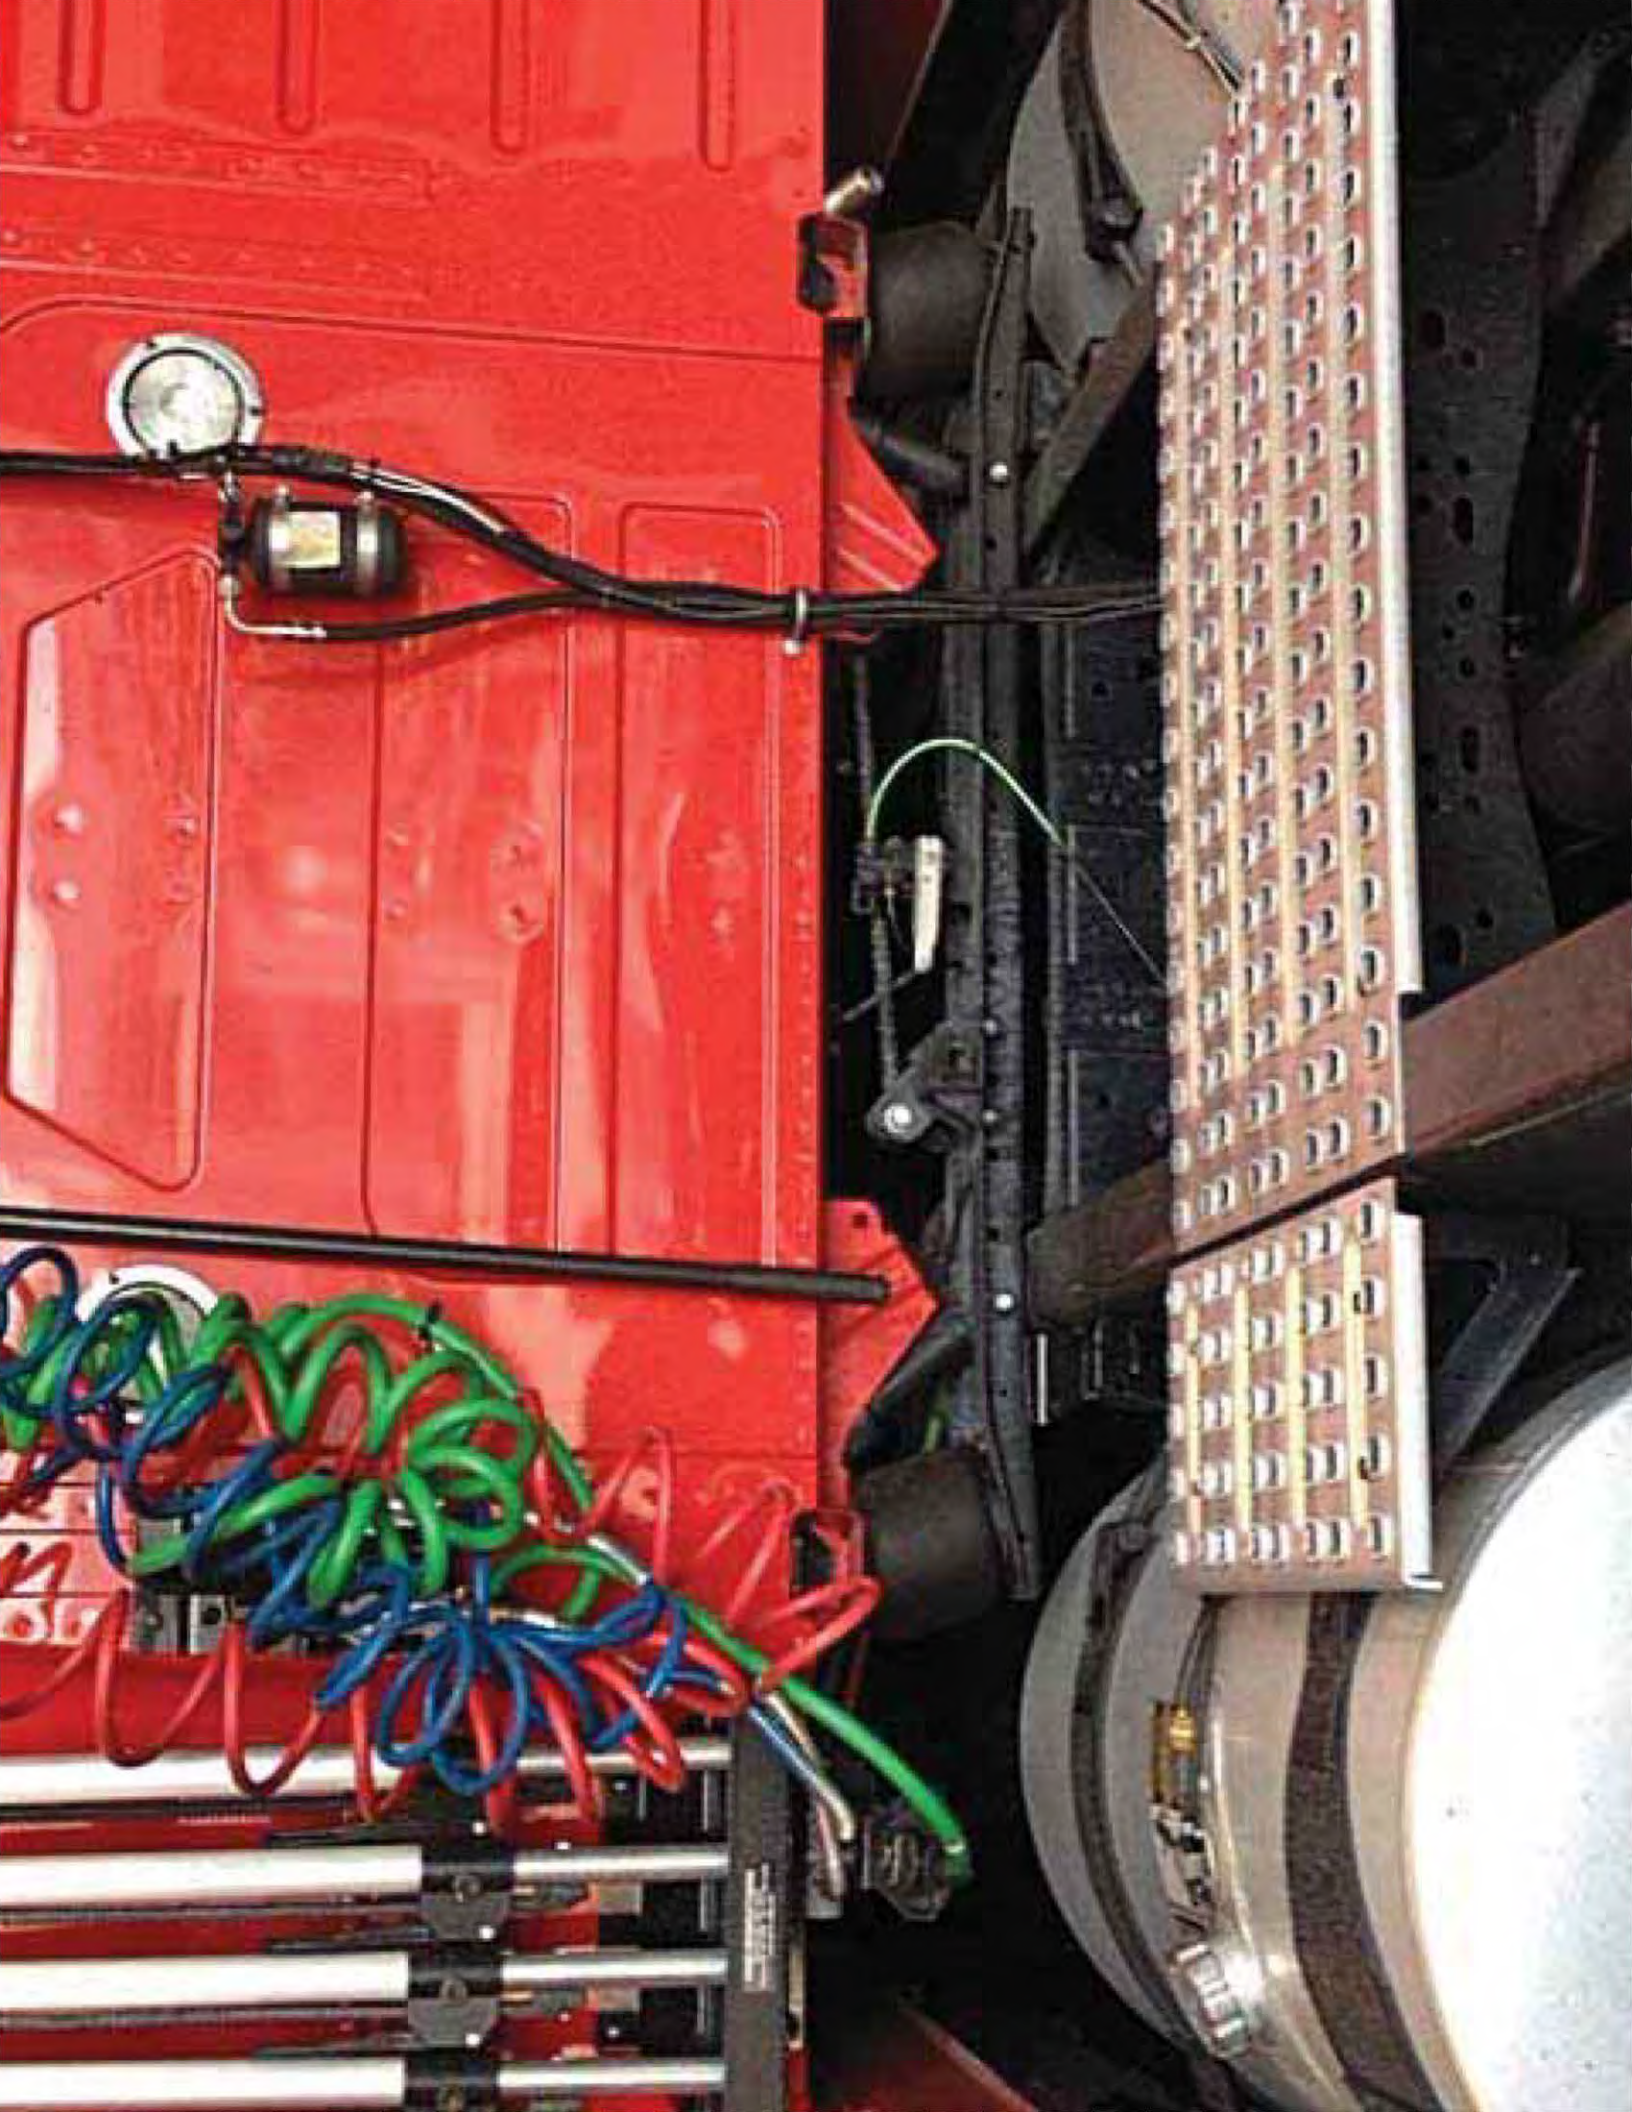
| Created | Created By | Audience | Activity Type | Comments |
|---|---|---|---|---|
| 07/23/2014 14:24:55 | | Public | Work Performed | i checked the front mounts and it seems ok. im attaching pics of the rear being shifted. please advise on possible repair. thanks MC |
