DP15-005

District Service Manager  
Information Letter

SUBJECT: Volvo Cab Leaning  
MODEL(S) VN  
ISSUED BY: Ron Duncan  
APPROVED: Elizabeth Jolin

Cab Mount 20754971.01.1.w

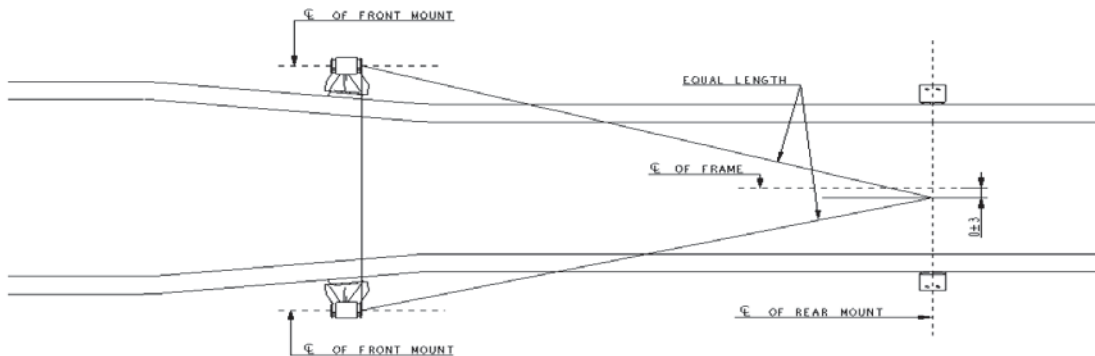
Reliability is receiving reports of leaning cab suspension issues. Please reference the drawing below to ensure the cab is mounted correctly to the frame. The center-line of the frame is critical when placing the front cab mounts. The front two mounts should be placed as closely across from each other as possible. The rear cab mount cross-member comes into play to get a correct triangle measurement in order to properly correct suspect units. Any unit that has yet to exhibit this issue, but when inspected the dimensions required per the drawing below are not in spec, correct the unit and replace the stay rod torsion spring on the rear cab suspension, as it could possibly be compromised. Note: New fixture used in production – mid August 2014 to prevent occurrence

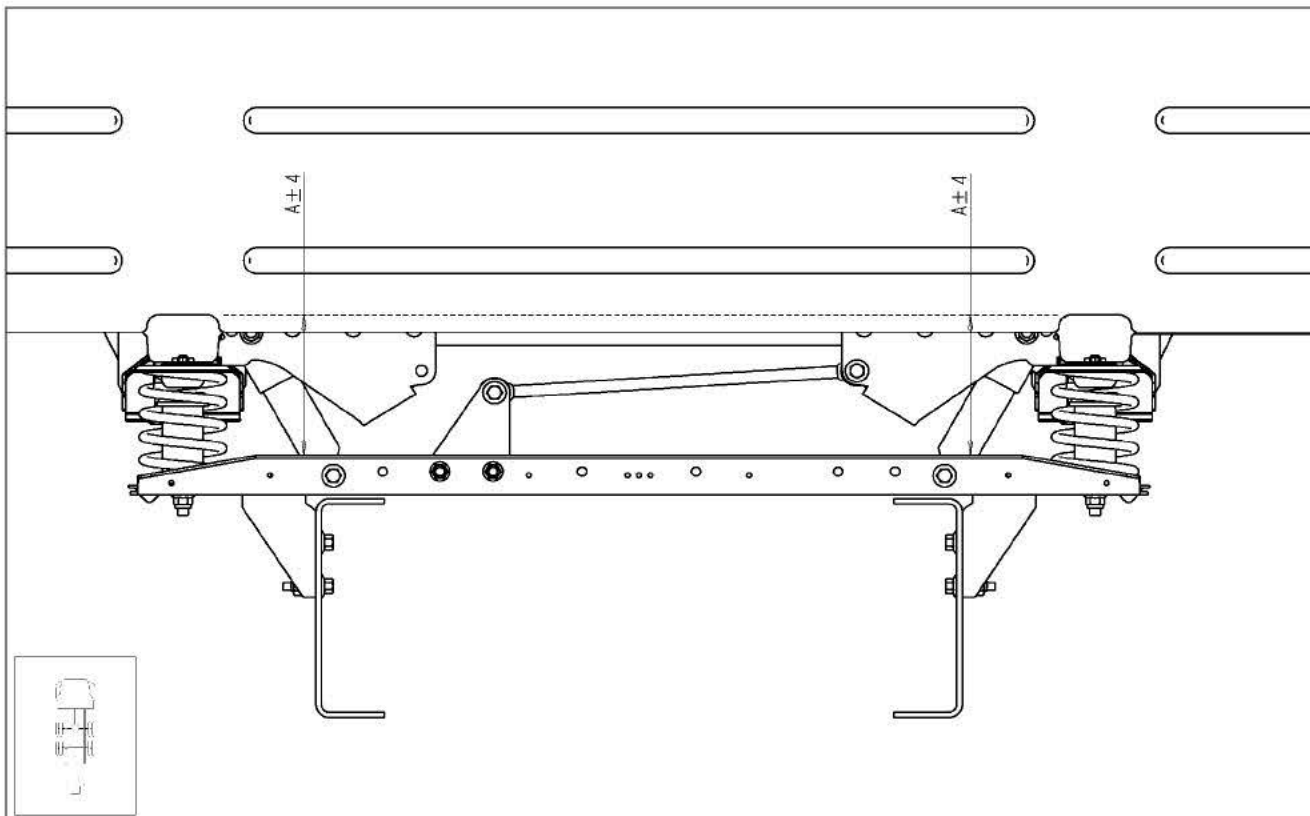
Figure 3 - Coil Spring Suspension

When a roof fairing is specified with a coil spring suspension, a shim is added to the springs to compensate for the extra down force caused by the fairing. The rear cab height should measure  $199 \pm 4$  mm on a coil spring suspension when a roof fairing is specified but not installed. With the fairing installed, the height will be about 2 mm less,  $197 \pm 4$  mm.

DIM A = 192 without roof deflector  
 197 with roof deflector  
 199 with roof deflector specified but not installed

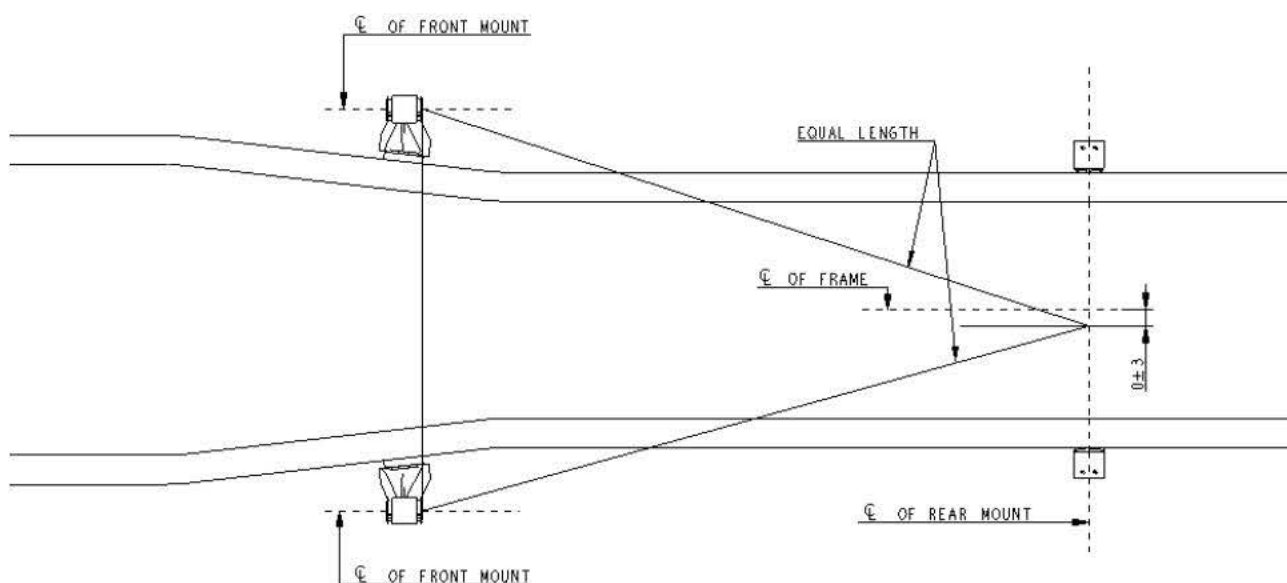
Figure 5 - Squaring Front Cab-Mounts

A fixture must be used to align the front cab mounts relative to each other and relative to the centerline of the frame. This can be established by using an isosceles triangle with the two equal sides of the triangle extending from the two target points on the front mounts to a point on the centerline between the rear cab mounts. The distance that this point may be off of the centerline is  $0 \pm 3$  mm.

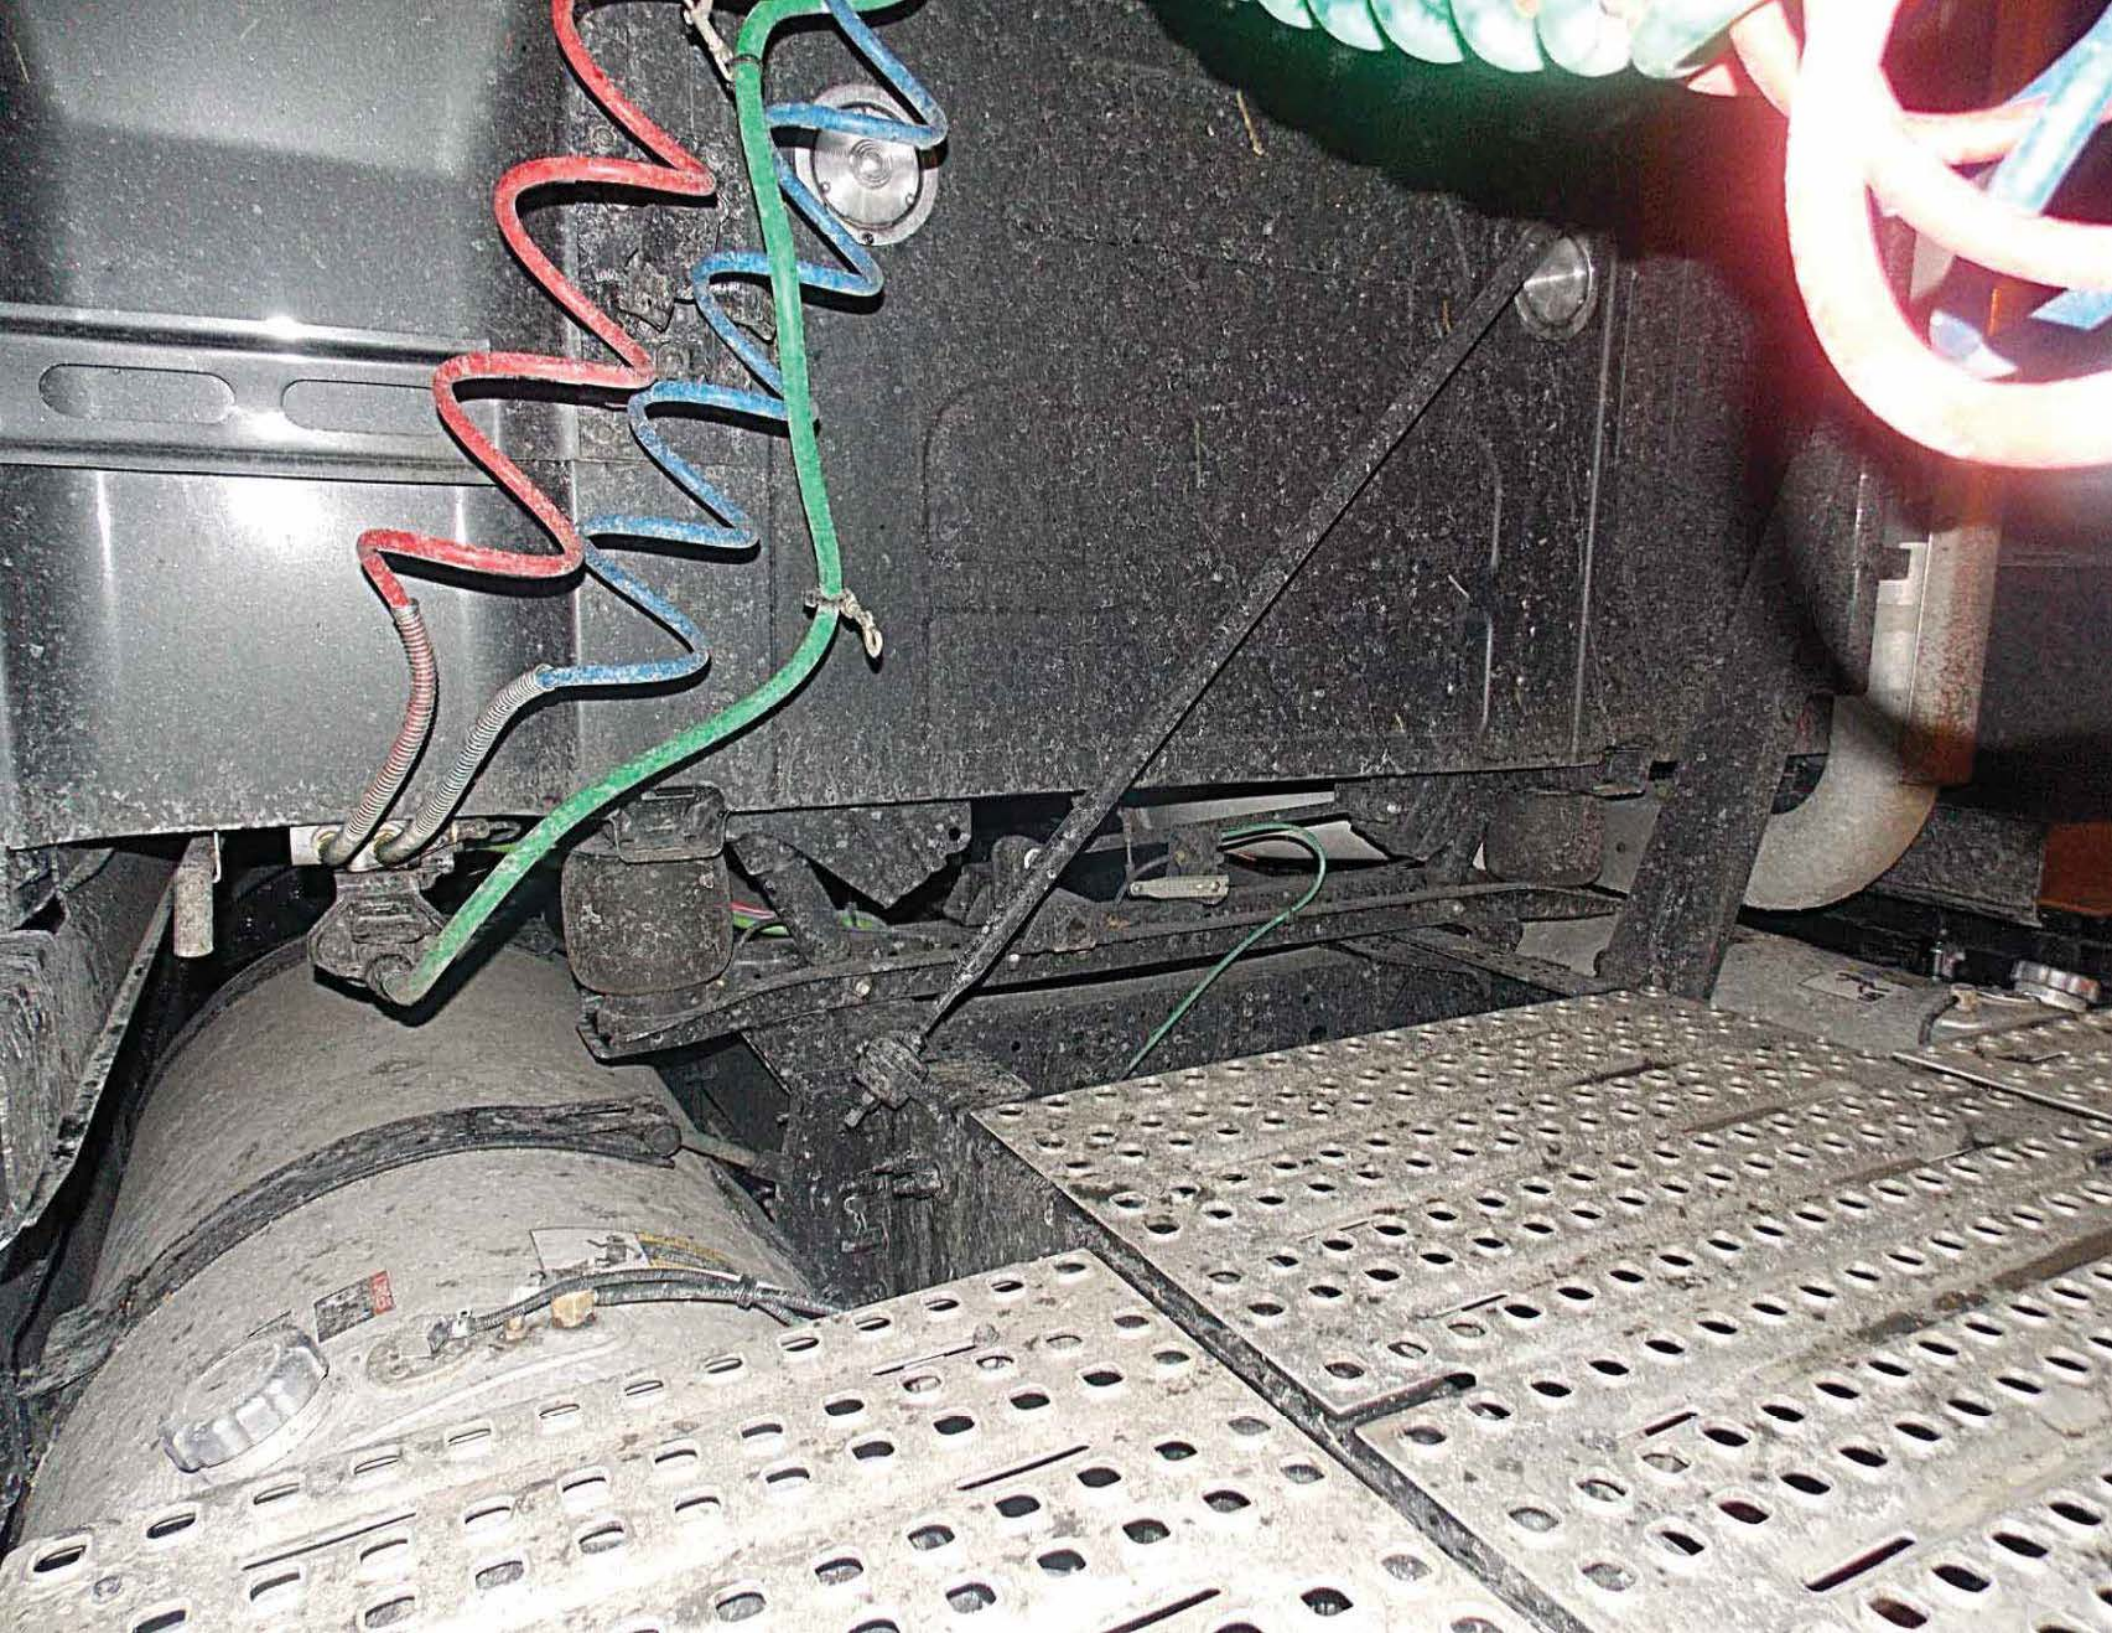
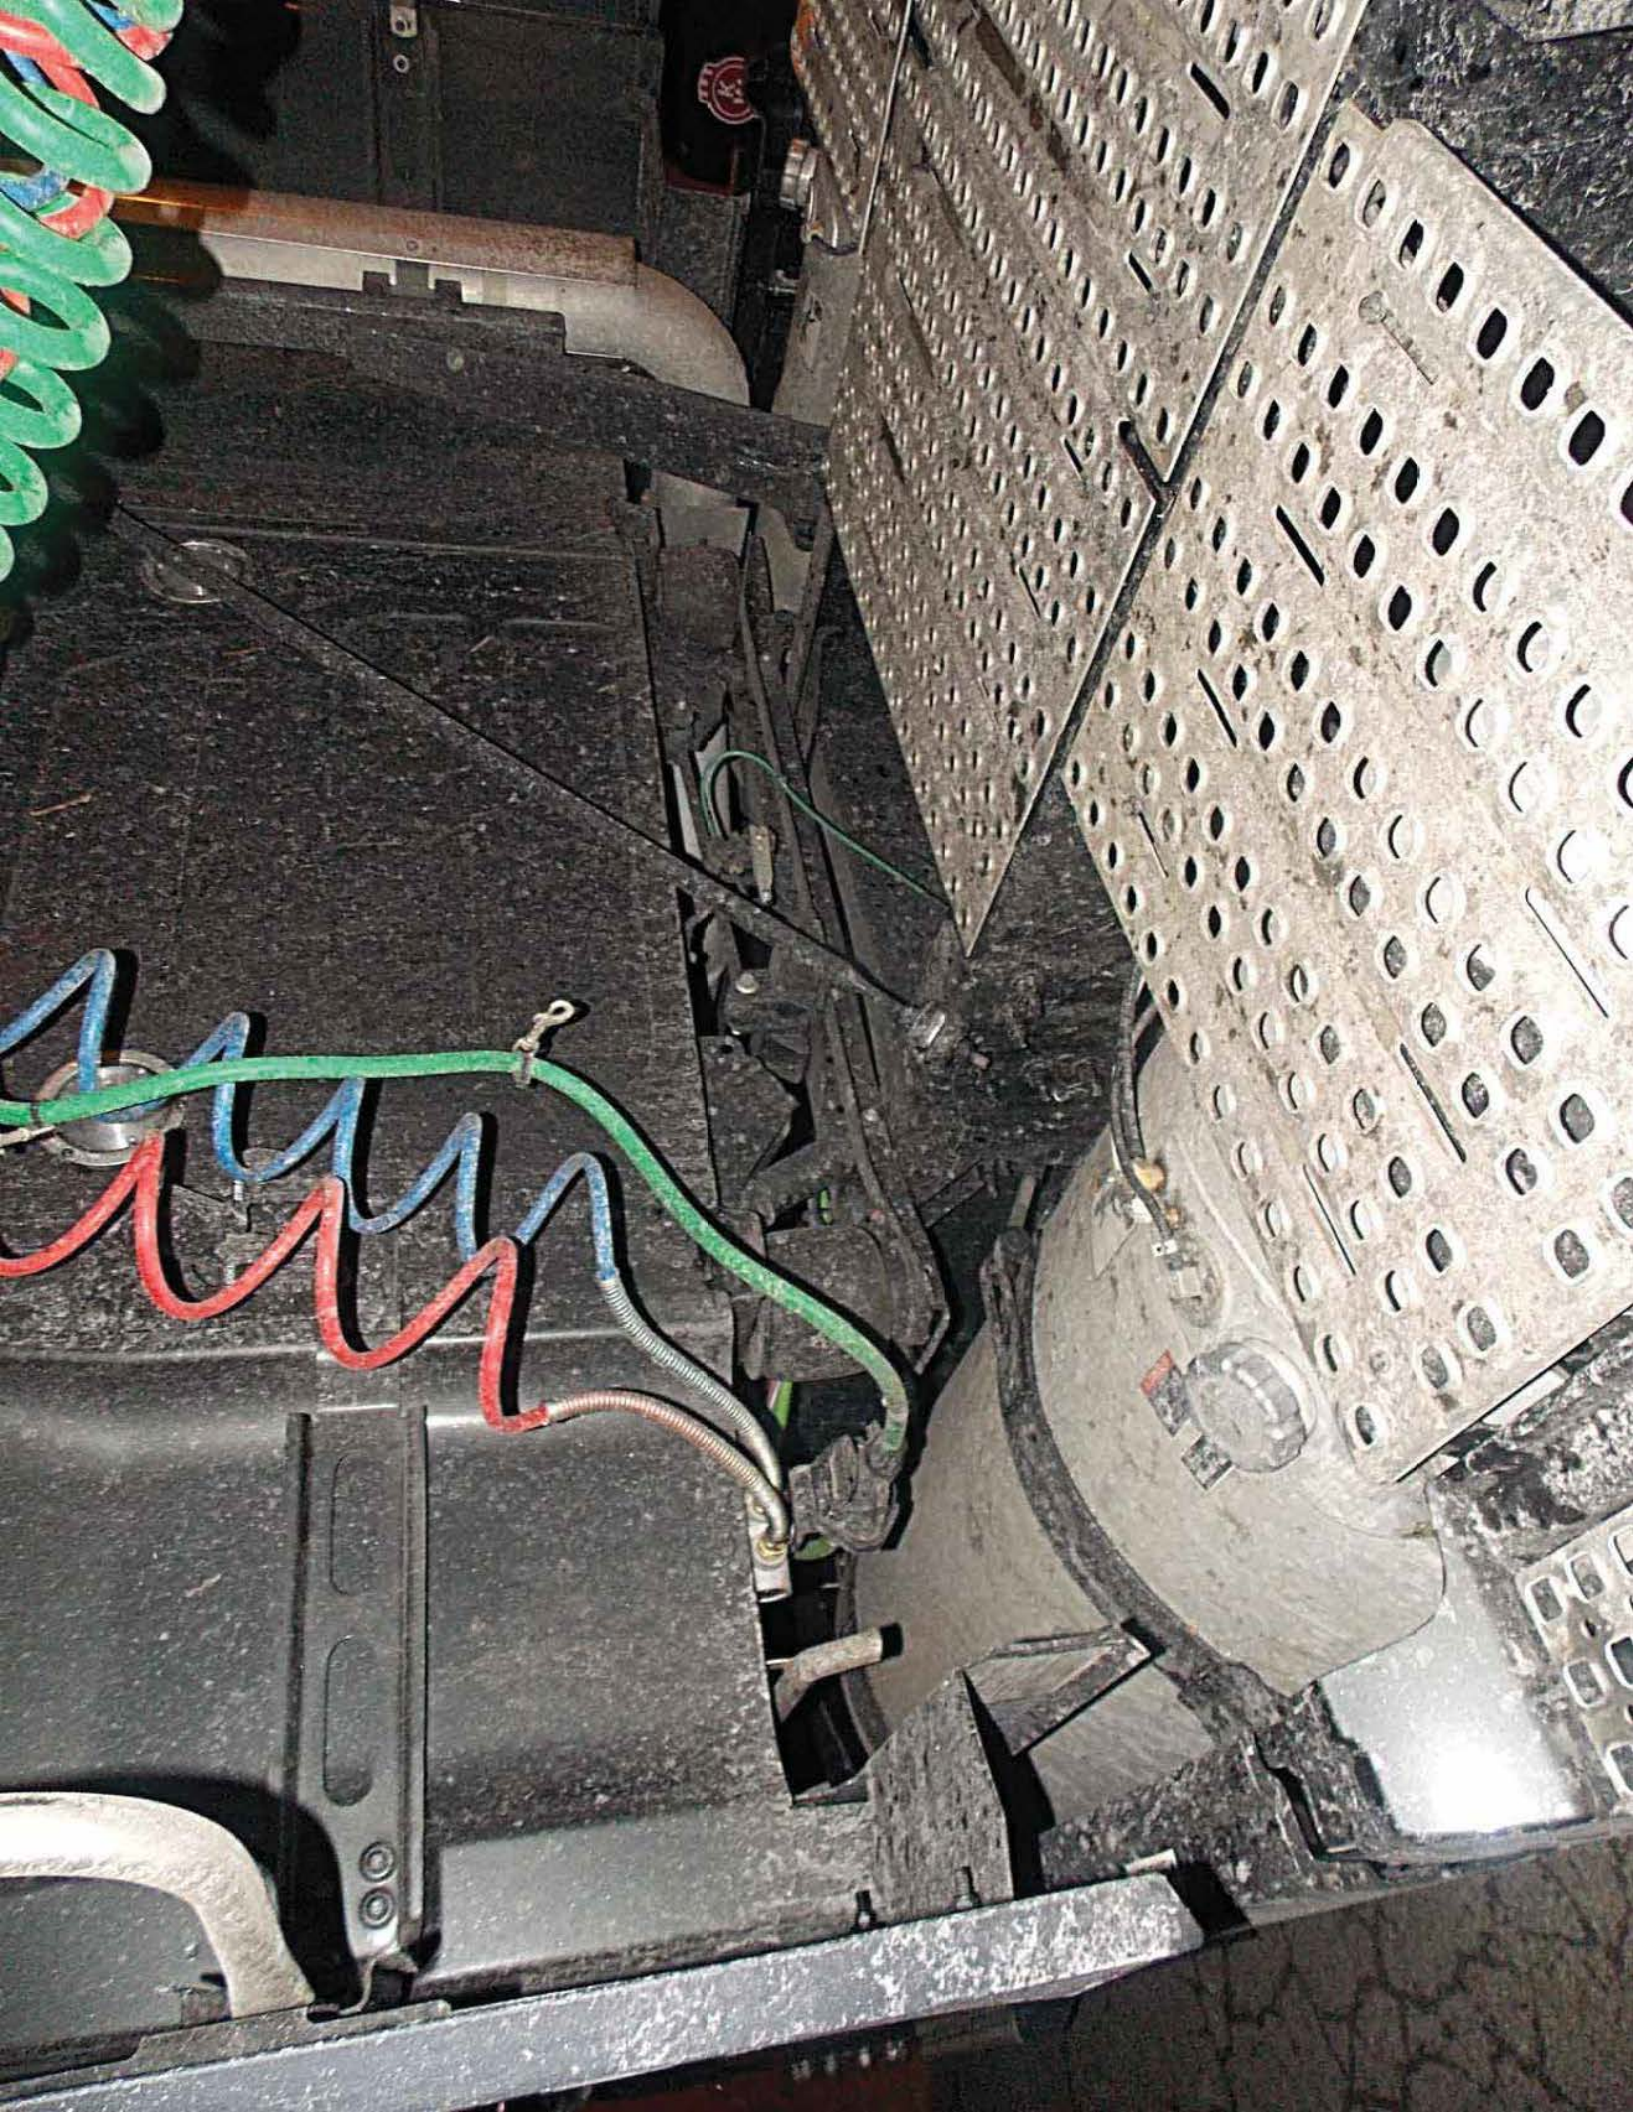
| Created | Created By | Audience | Activity Type | Comments |
|---|---|---|---|---|
| 11/29/2014 11:42:53 | DILLON SCHOUWEILER | Public | Work Performed | we have a new truck and on customers first trip out he noticed the cab air ride uneven. we checked out the truck here and the left side of the sleeper sits half inch higher than the right side. the same air line supplys both air bags so in theory both air bags should have the same air pressure but it is visibly noticable that the left air bag is inflated more than the right air bag. we checked both inside the sleeper and in the side boxes and see no added weight on one side verses the other. weight looks evenly distributed from side to side. we visually inspected the air lines going from the leveling valve to the air bags and see no kinks in the air line. we unhooked the leveling valve, drained the air out of the sleeper air bags and then hooked up leveling valve and inflated air bags with no change in height. will attach pictures to view. Thanks. |
