DP15-005

District Service Manager  
Information Letter

SUBJECT: Volvo Cab Leaning  
MODEL(S) VN  
ISSUED BY: Ron Duncan  
APPROVED: Elizabeth Jolin

Cab Mount 20754971.01.1.w

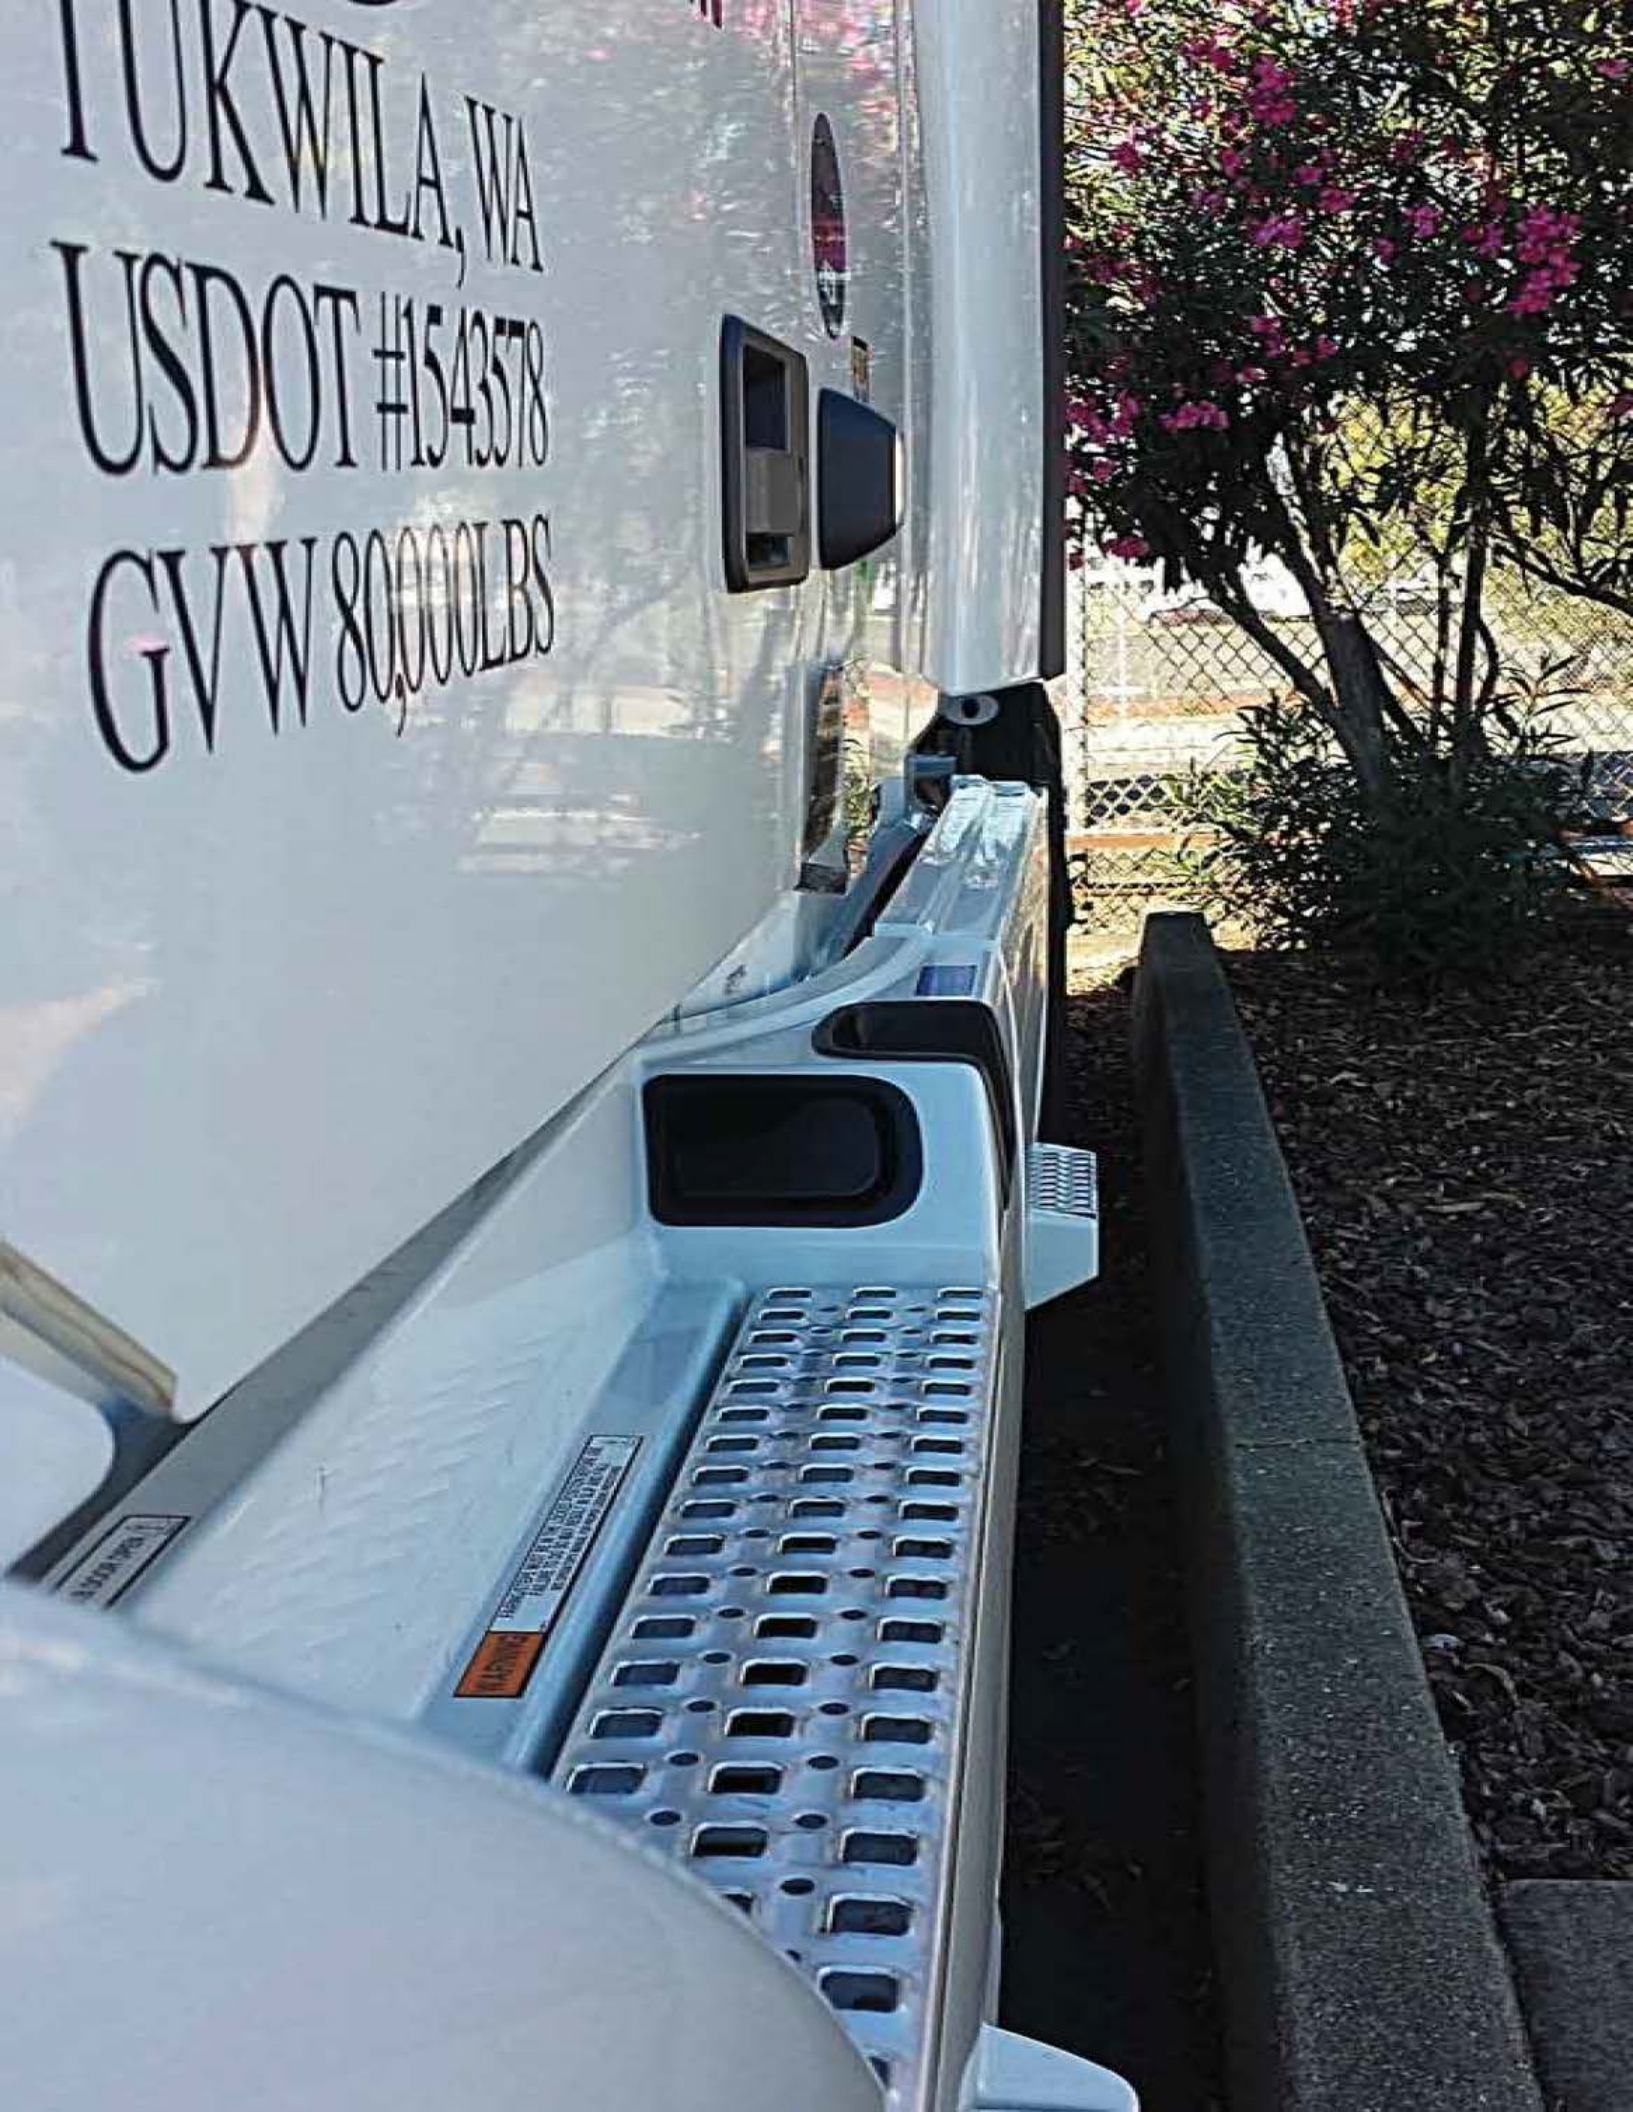
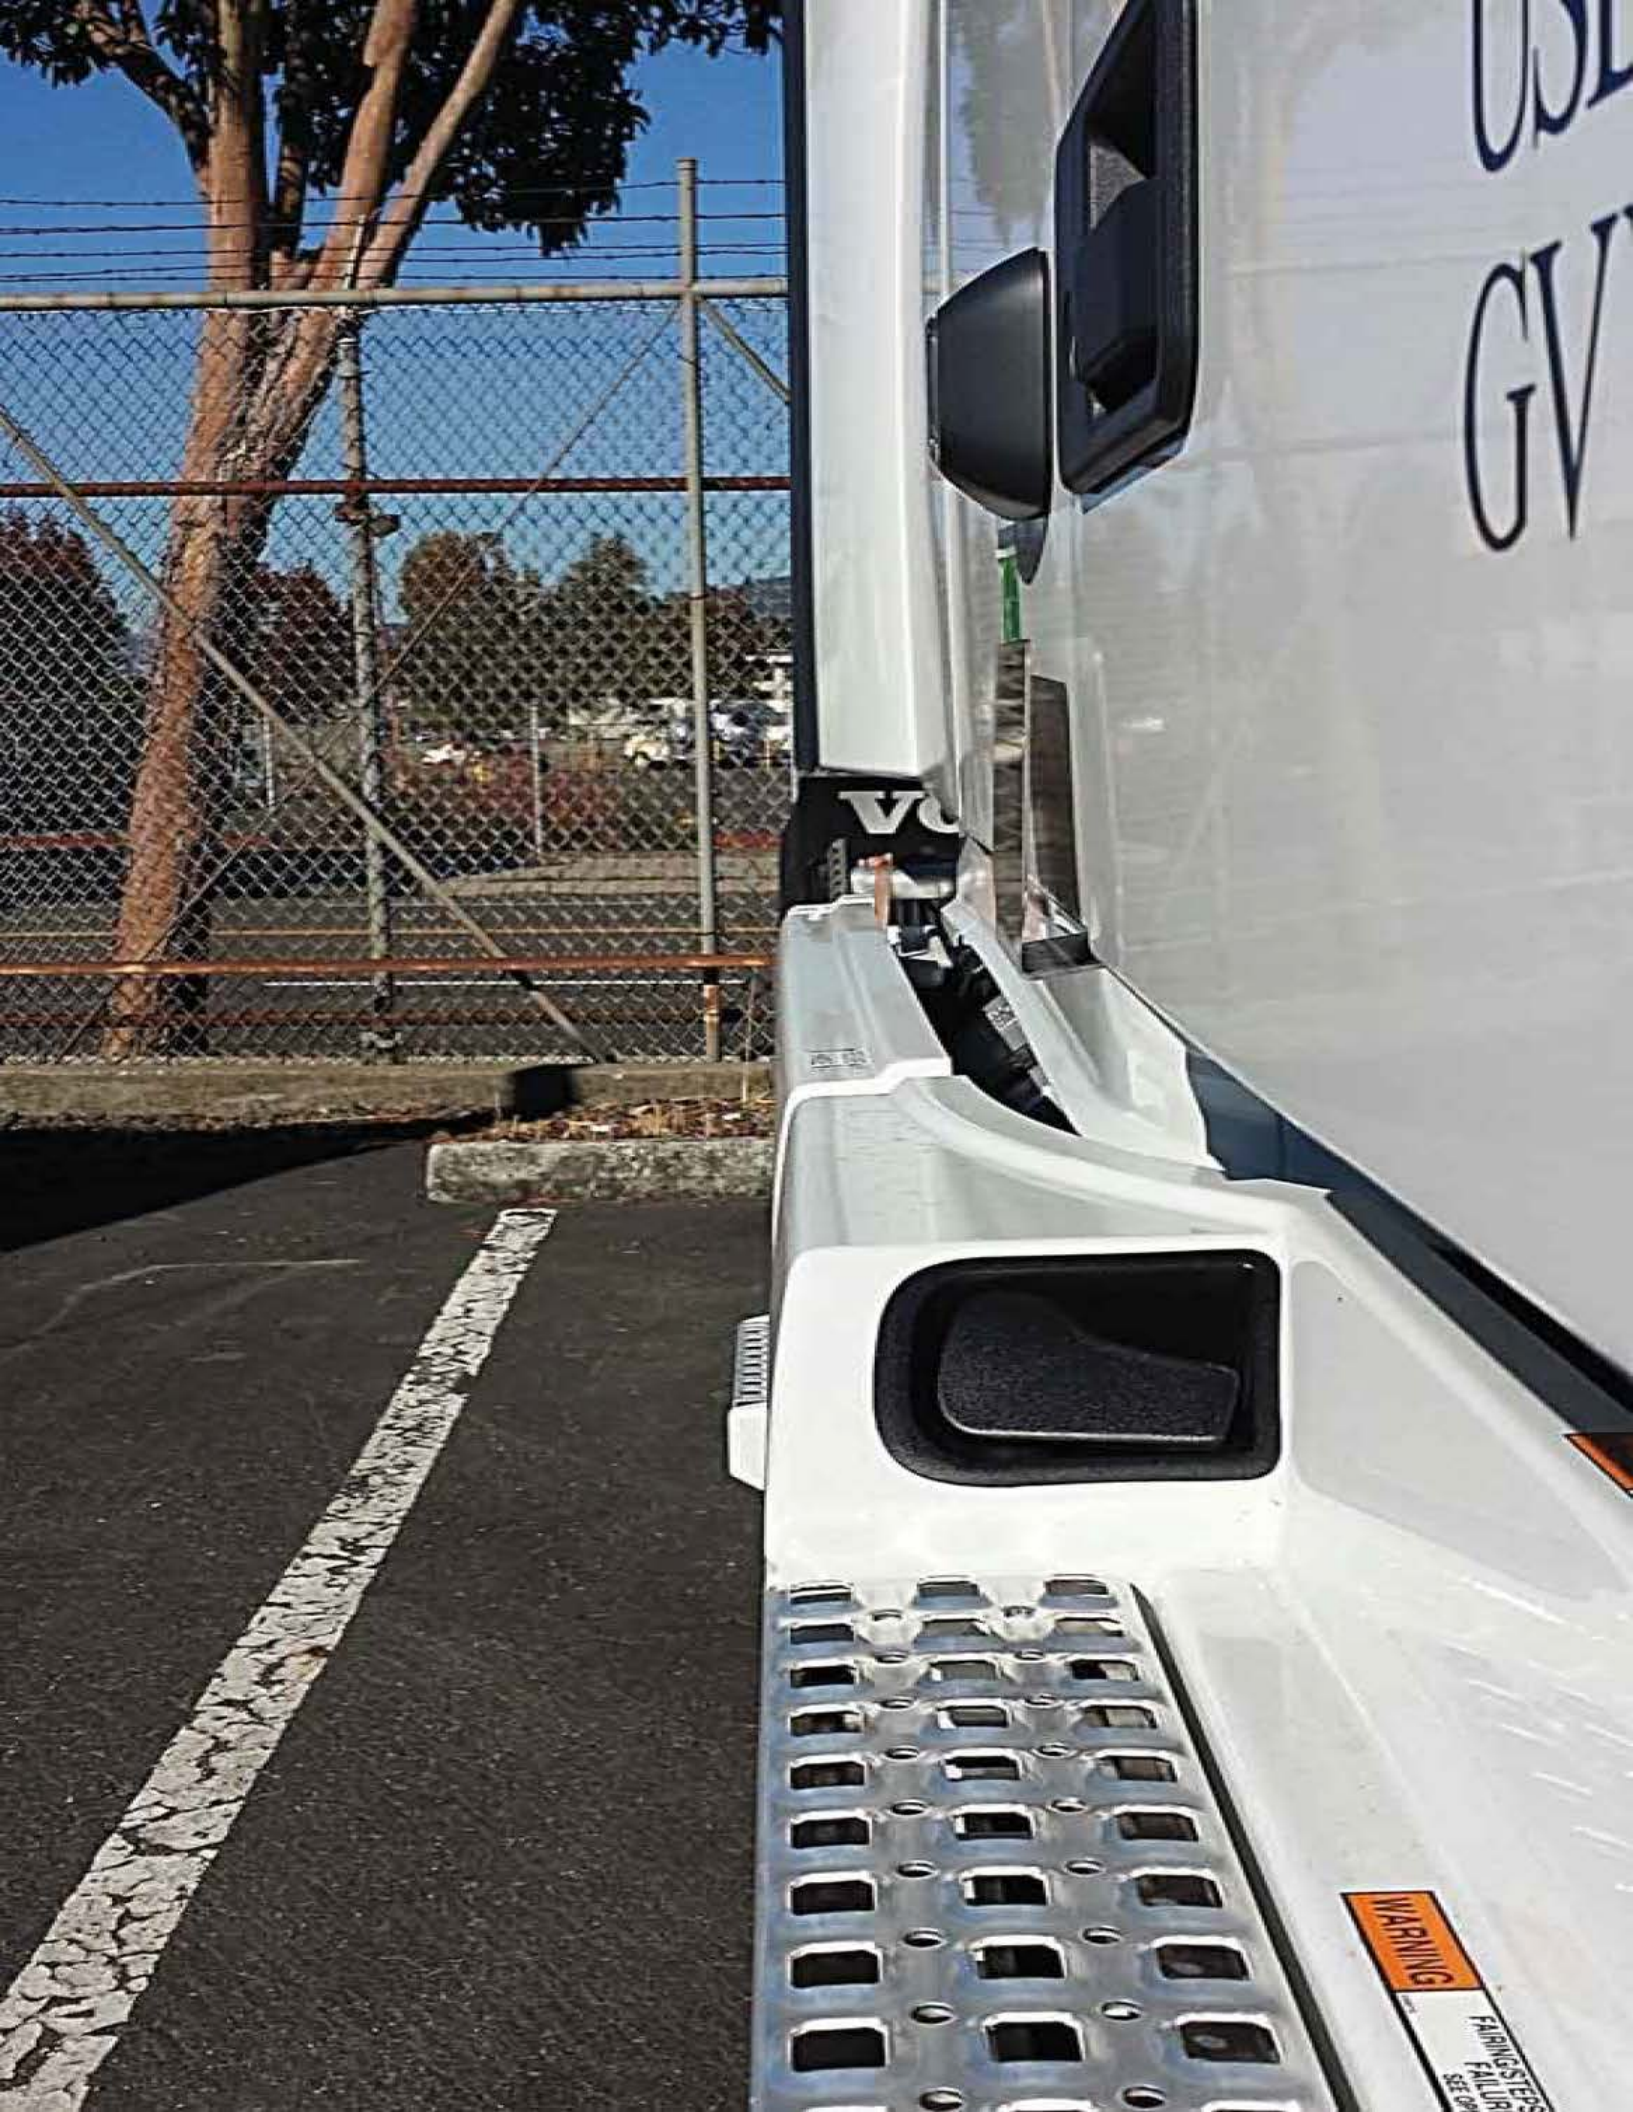
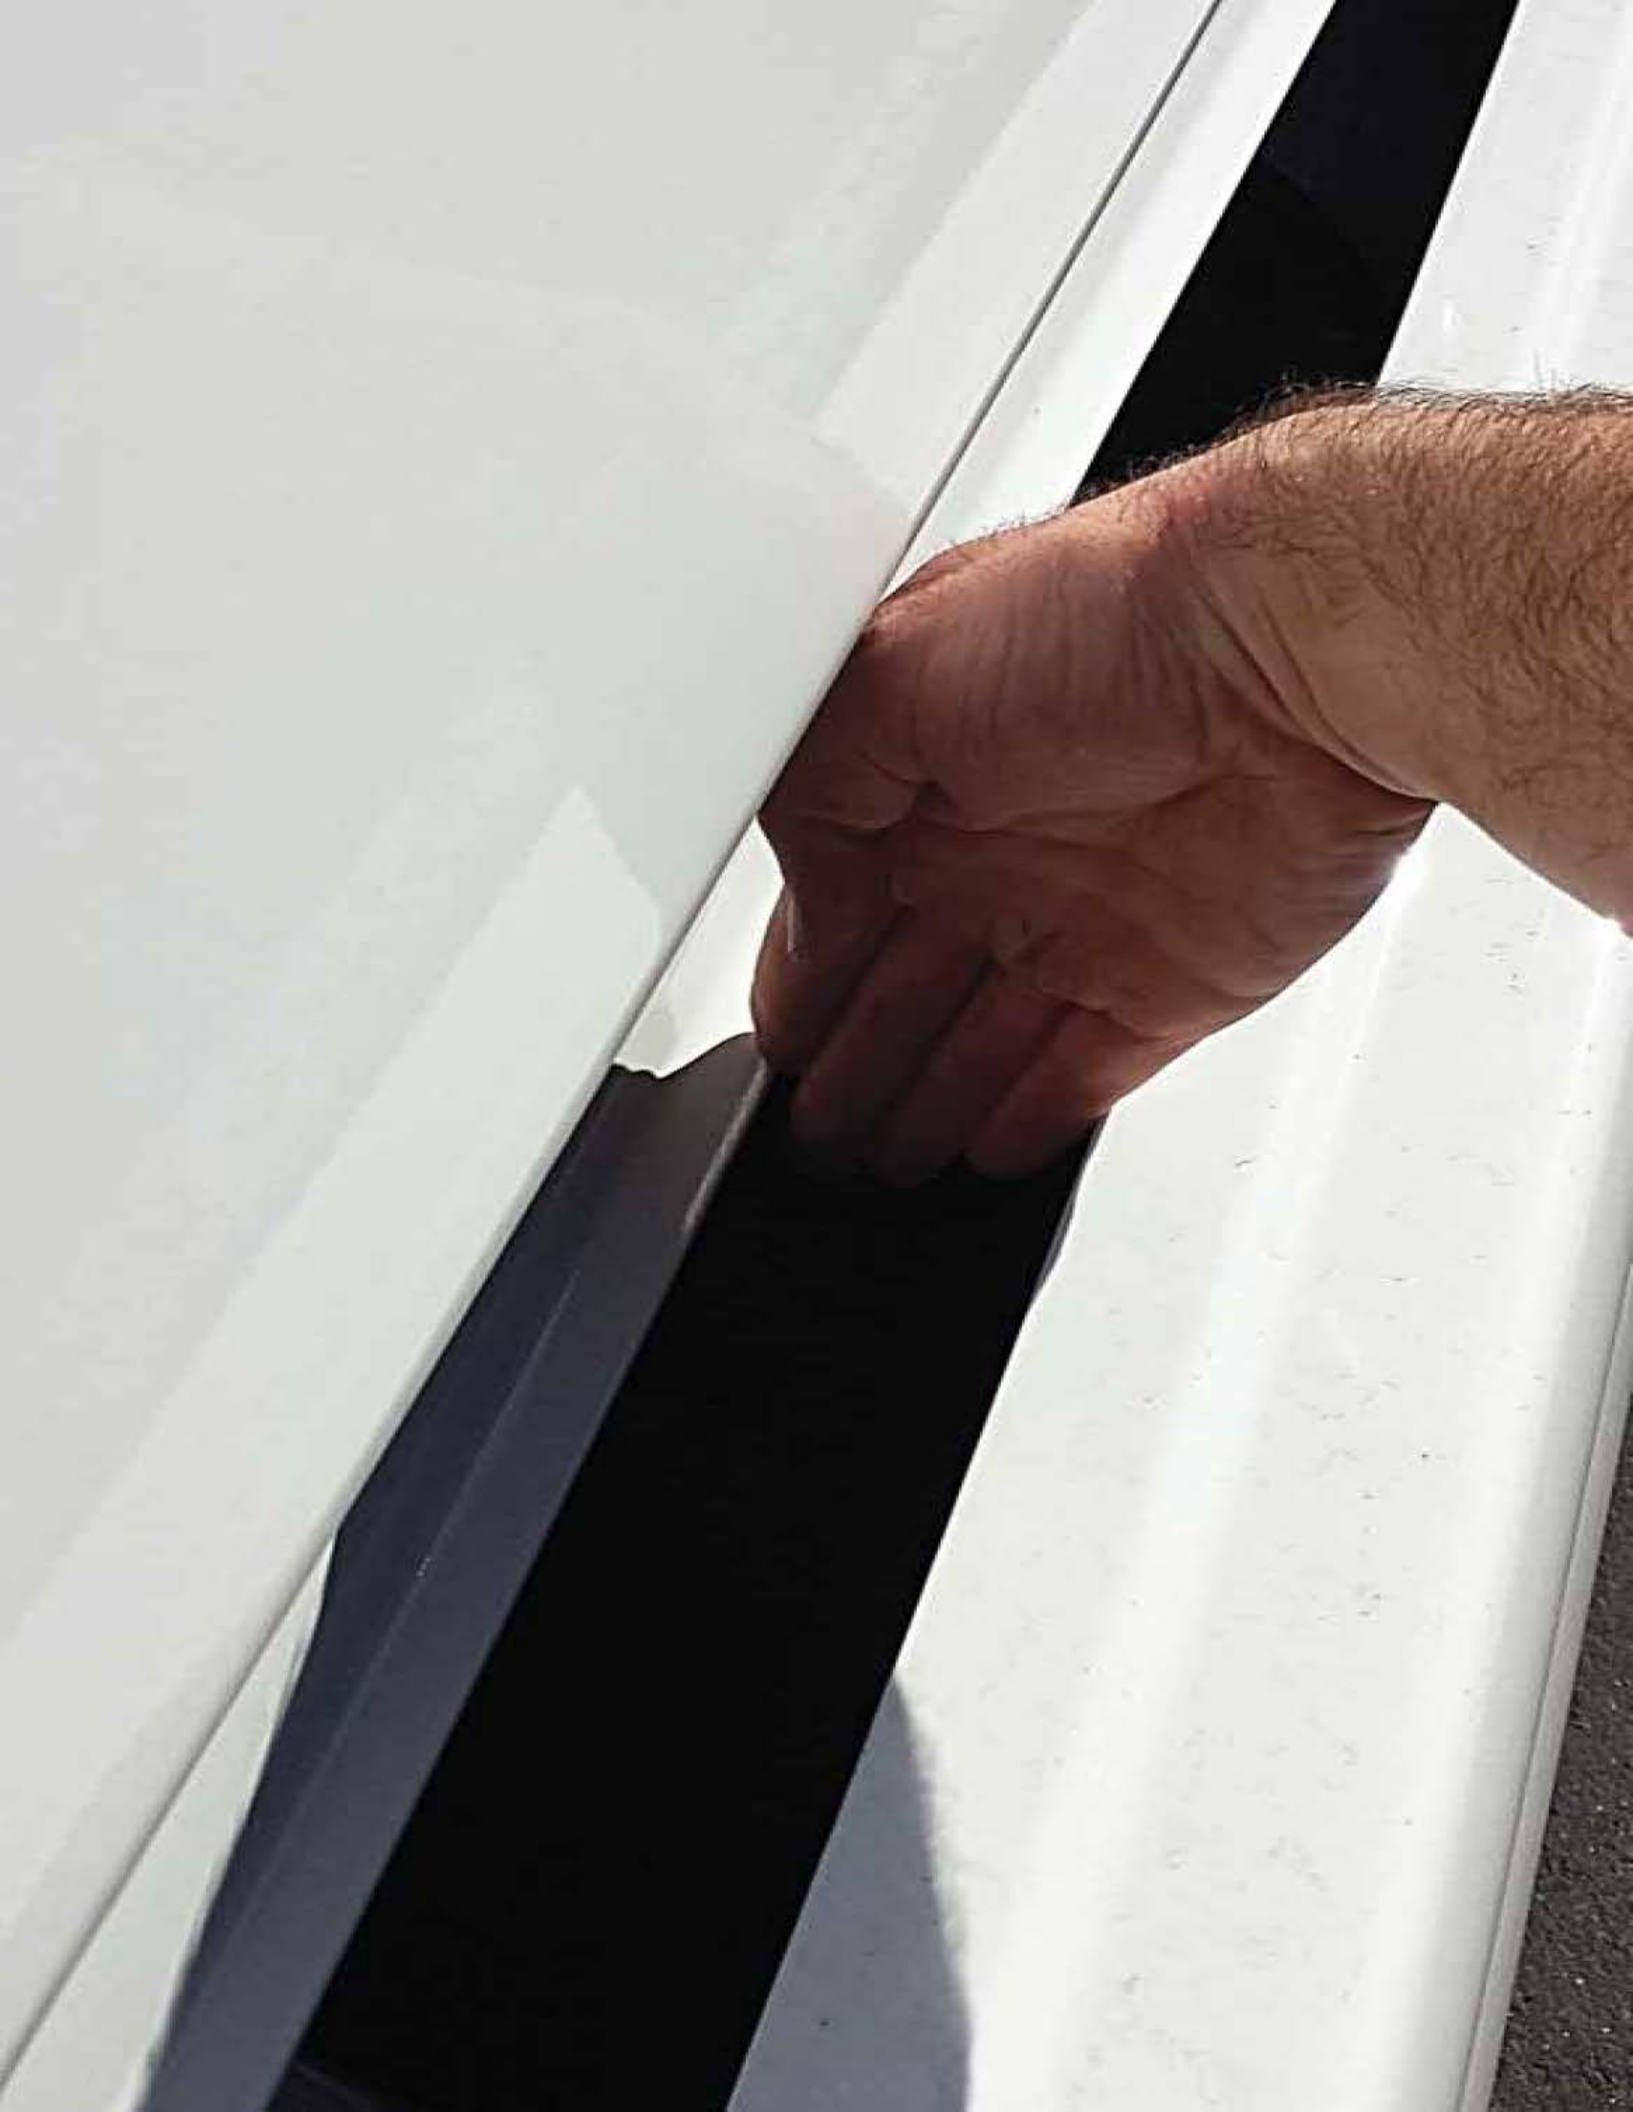
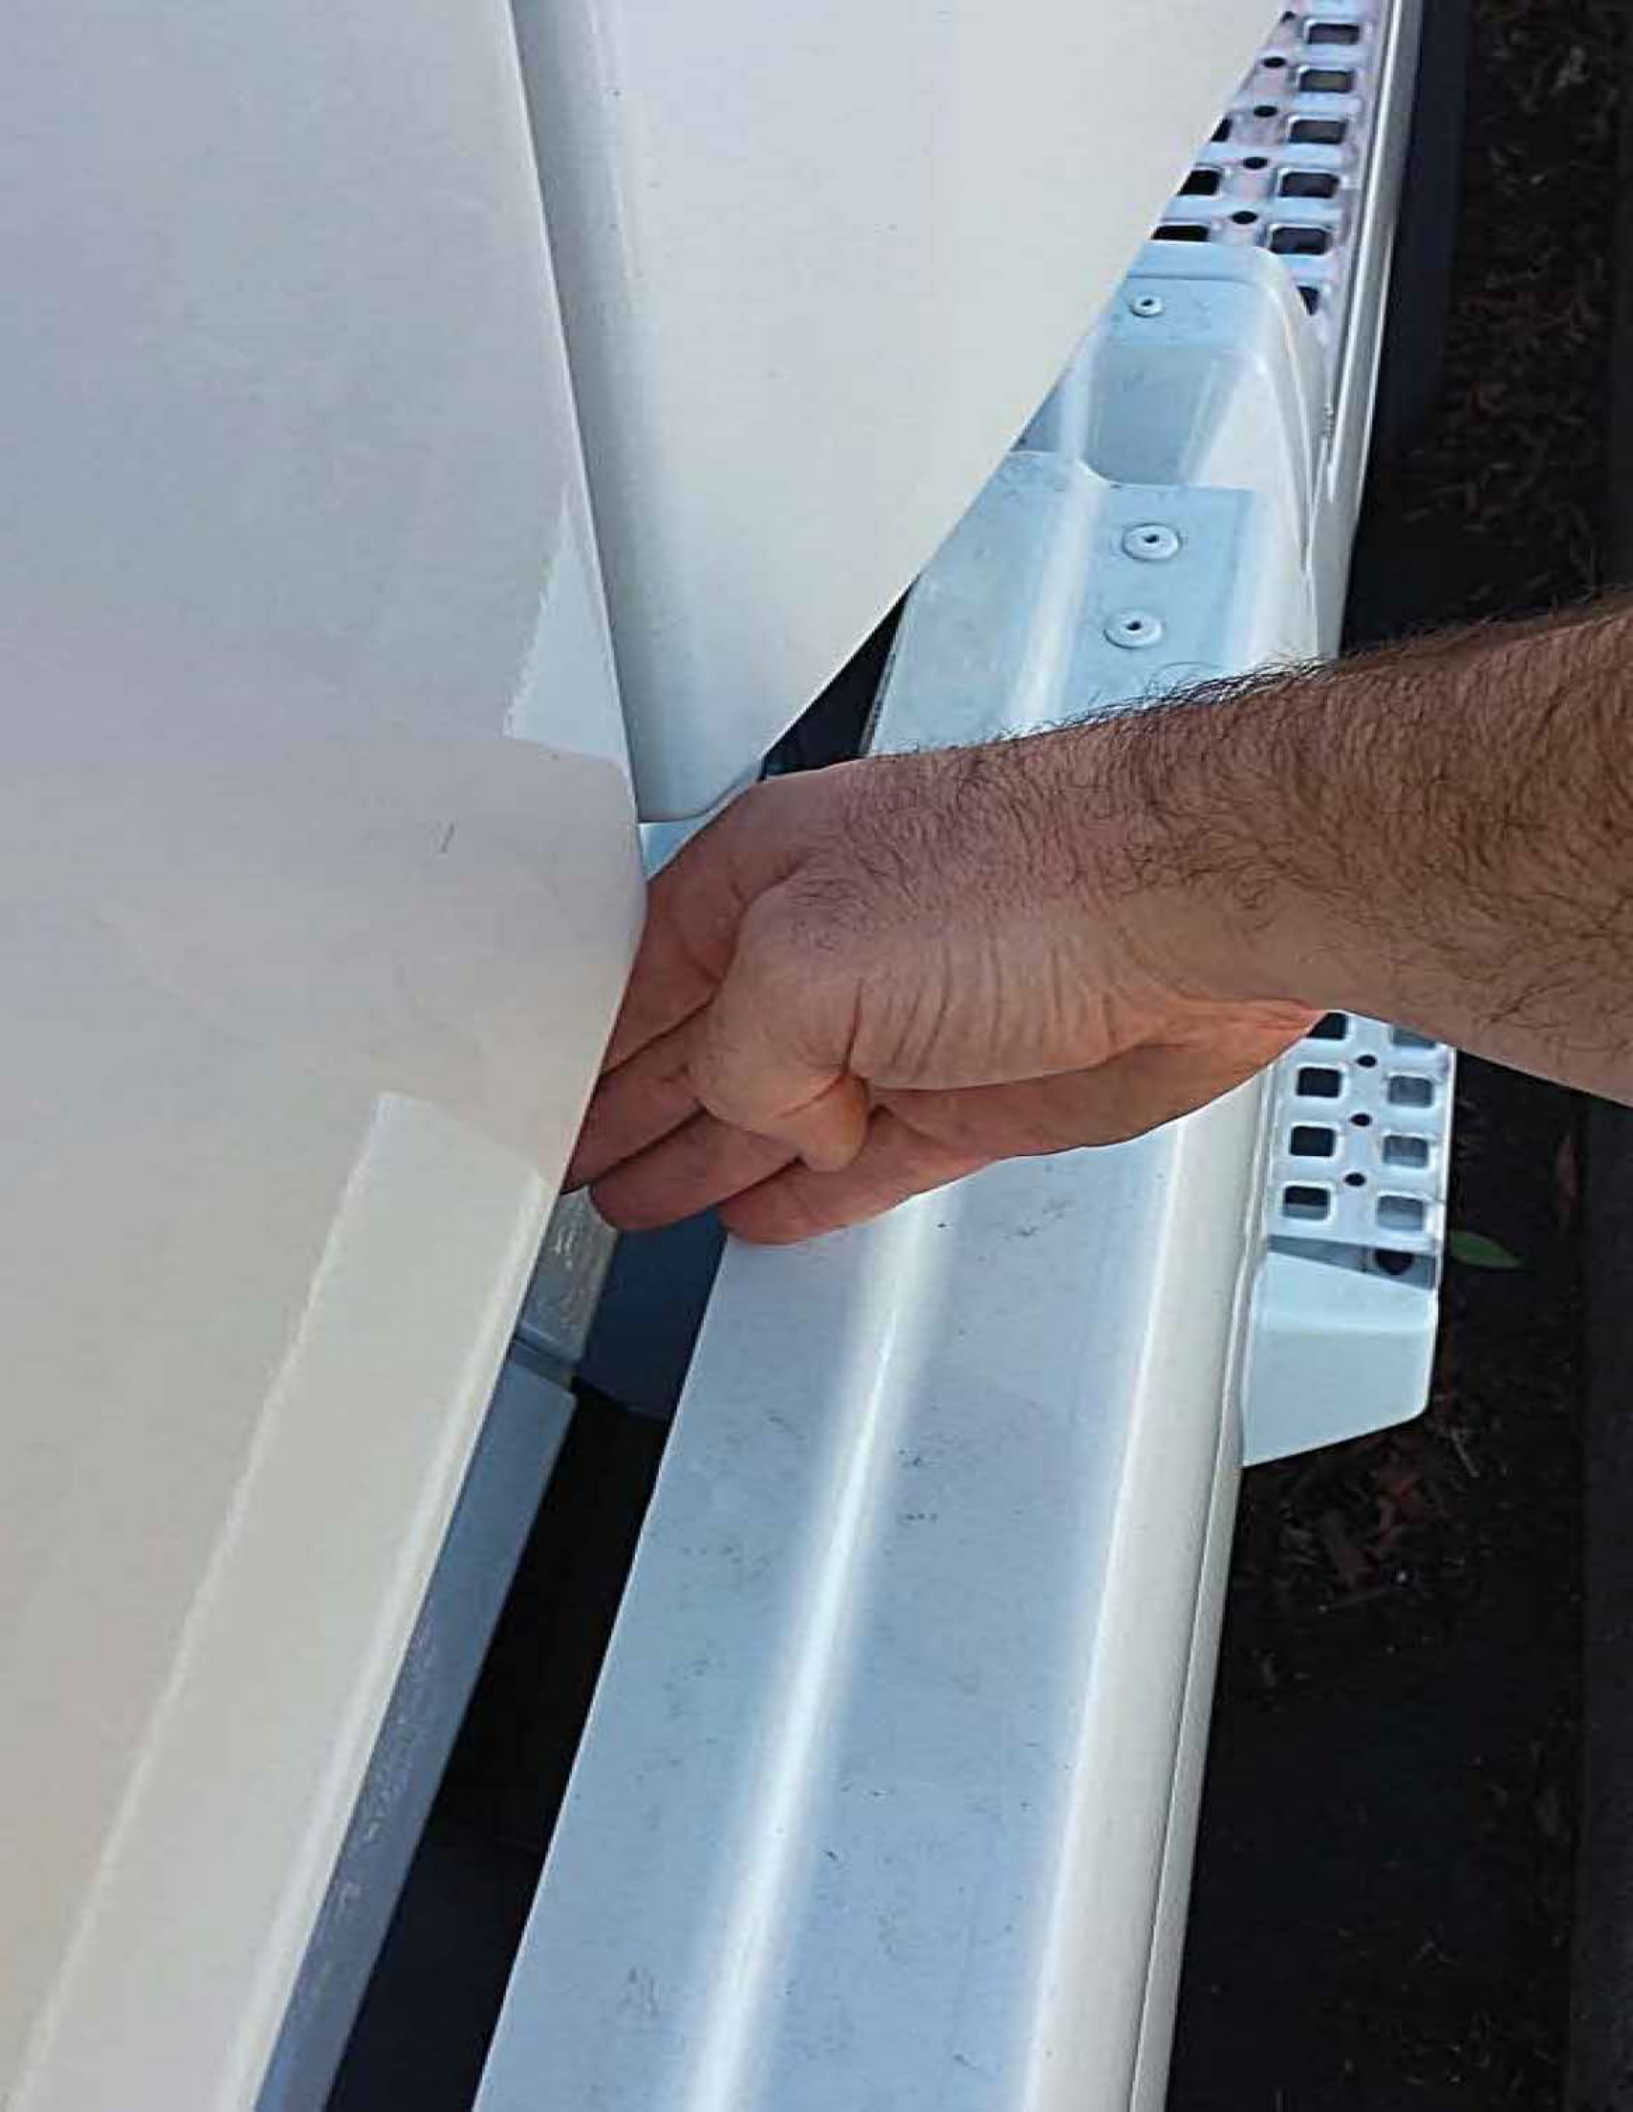
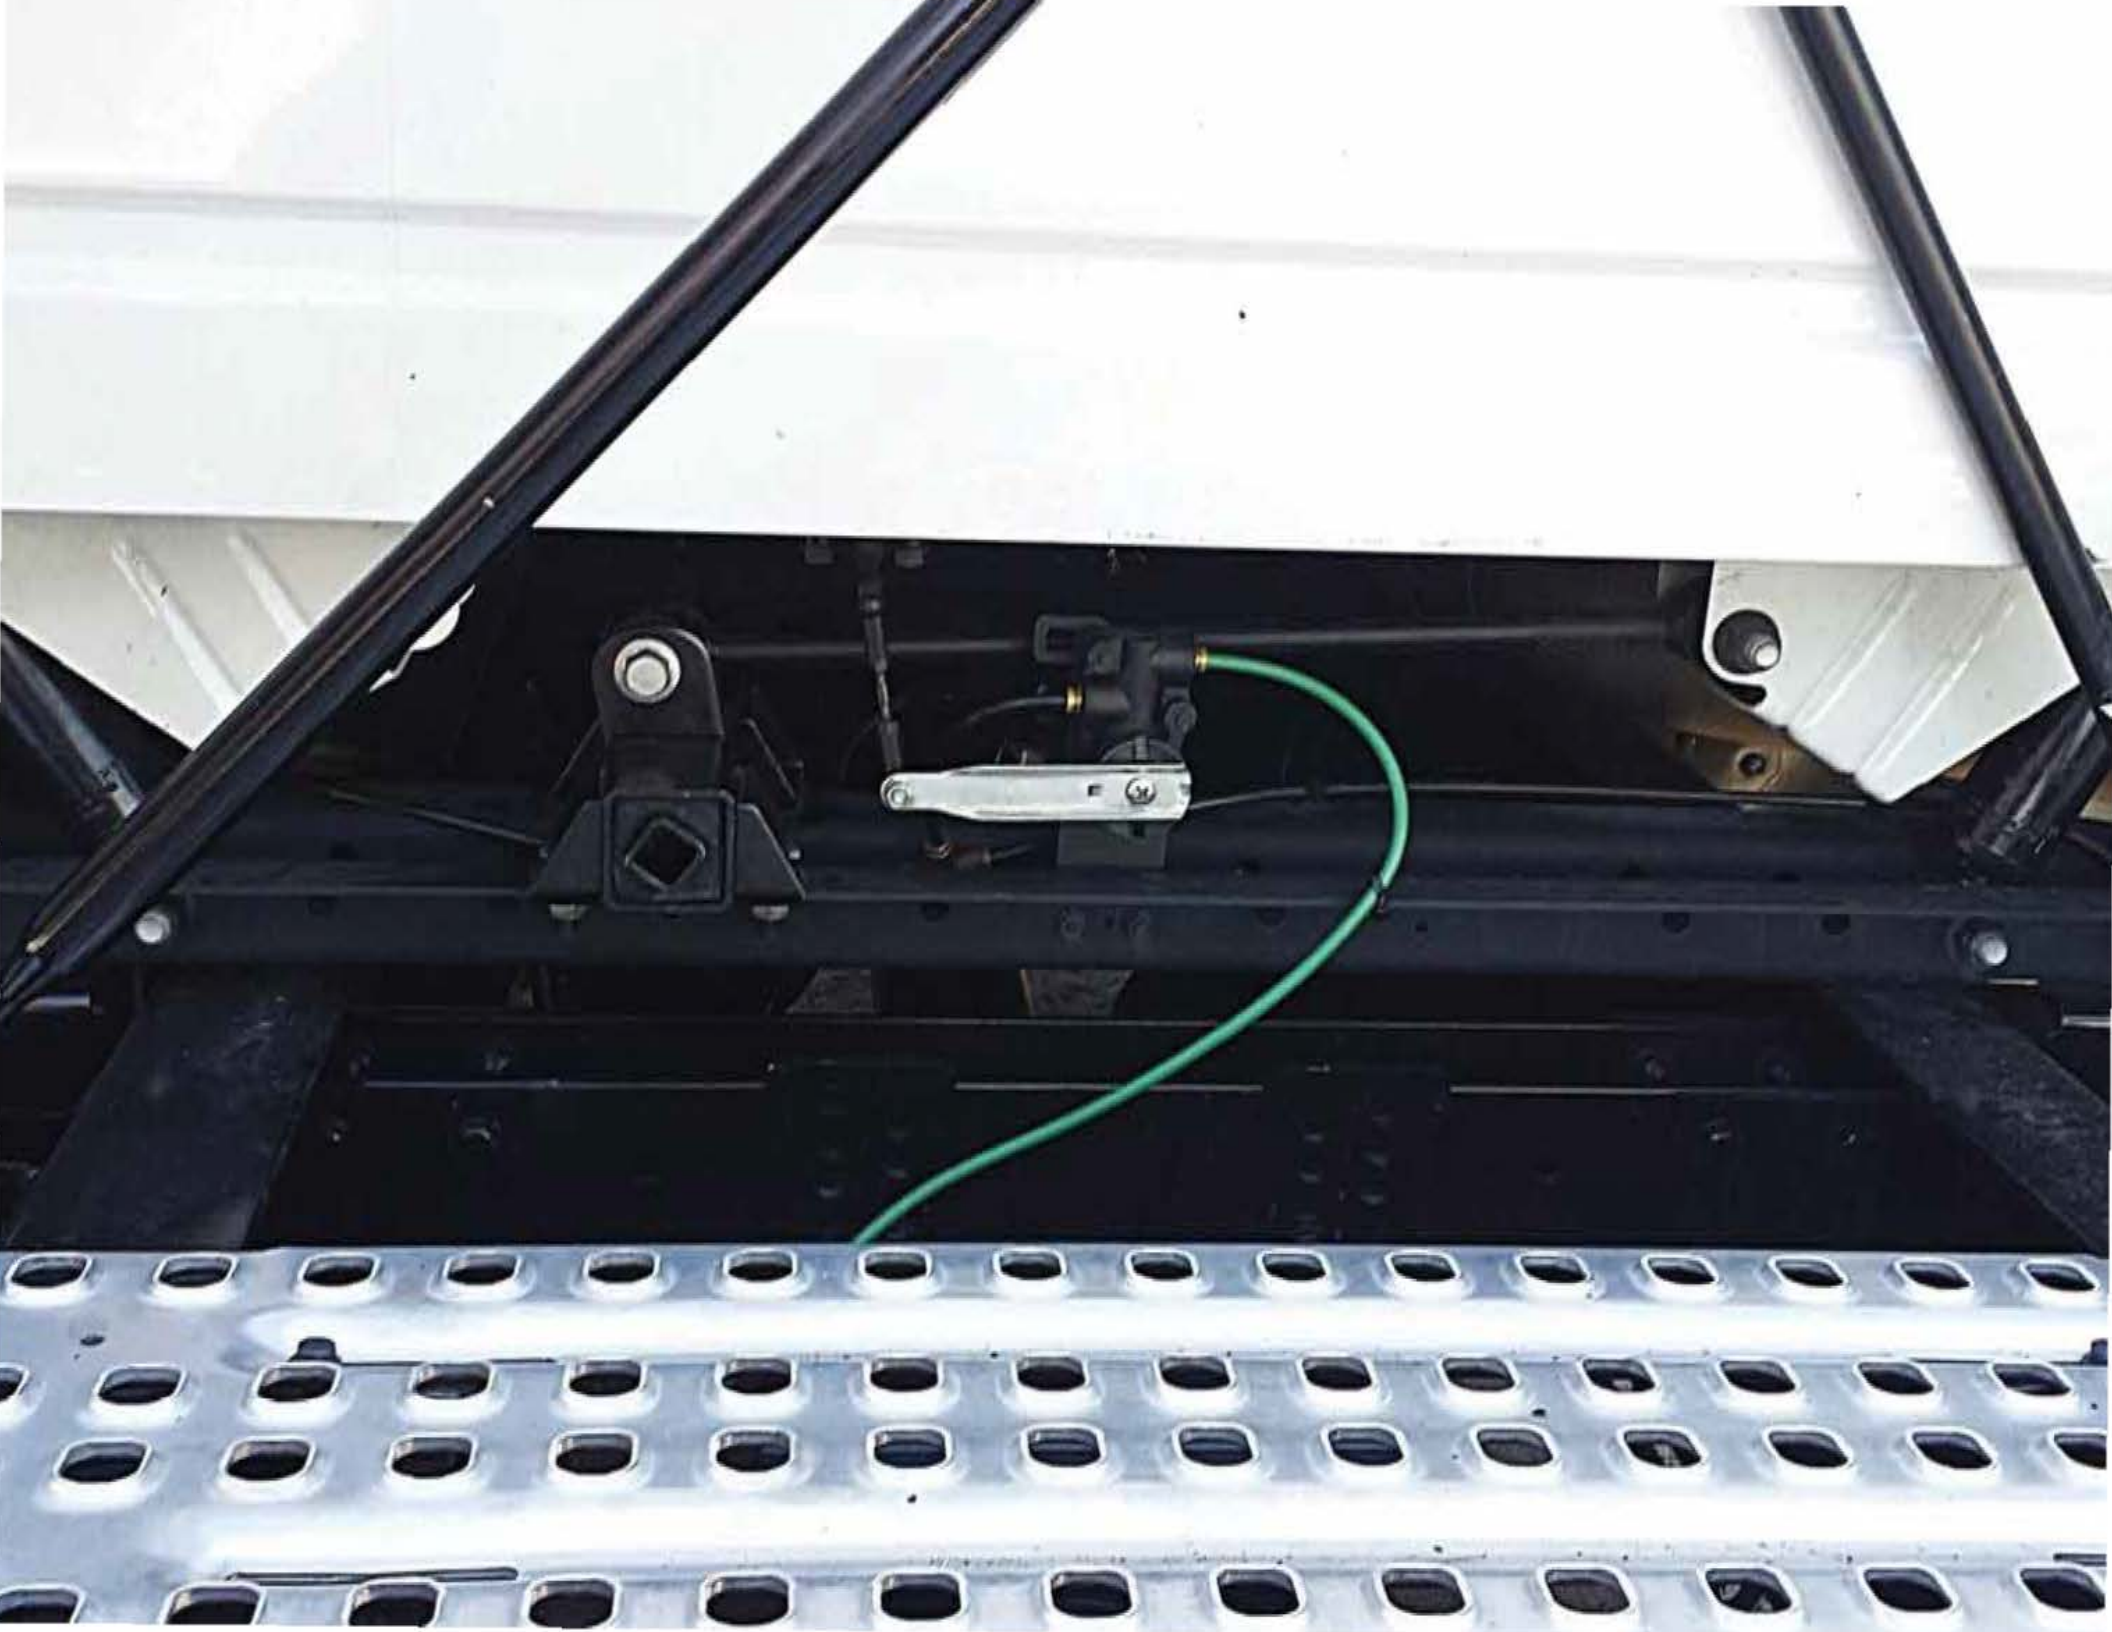
| Created | Created By | Audience | Activity Type | Comments |
|---|---|---|---|---|
| 10/29/2014 10:26:07 | | Public | Work Performed | We have changed the cab suspension torsion springs but the cab still goes to the left. we don't see anything else that would cause this. See attached pictures. How can we repair this? |

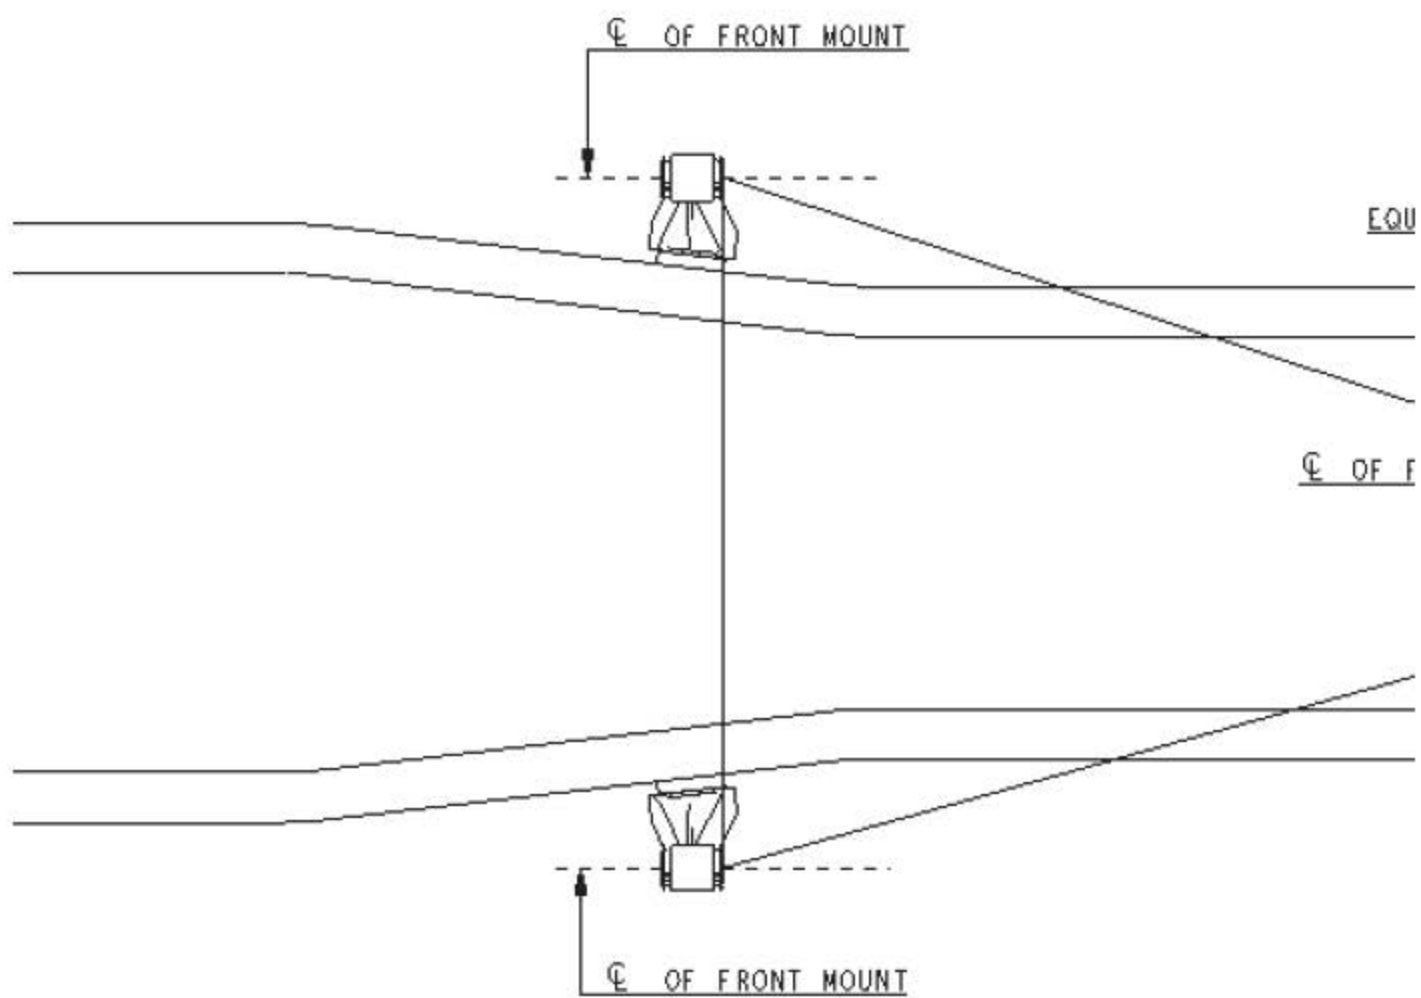
In light of the cab suspension issue that we are seeing in the field I have attached a drawing that will be required to ensure the cab is mounted correctly to the frame. As you can see the center-line of the frame is critical when placing the front mounts. The front two mounts should be mounted as closely across from each other as possible. The rear cab mount cross-member comes into play to get a correct triangle measurement in order to properly correct these units in the field. but when inspected the dimensions required per the attached are not in spec, the stay rod torsion spring should be replaced on the rear cab suspension. ...Thanks very much and let me know how I can further assist...
