DP15-005

District Service Manager  
Information Letter

SUBJECT: Volvo Cab Leaning  
MODEL(S) VN  
ISSUED BY: Ron Duncan  
APPROVED: Elizabeth Jolin

Cab Mount 20754971.01.1.w

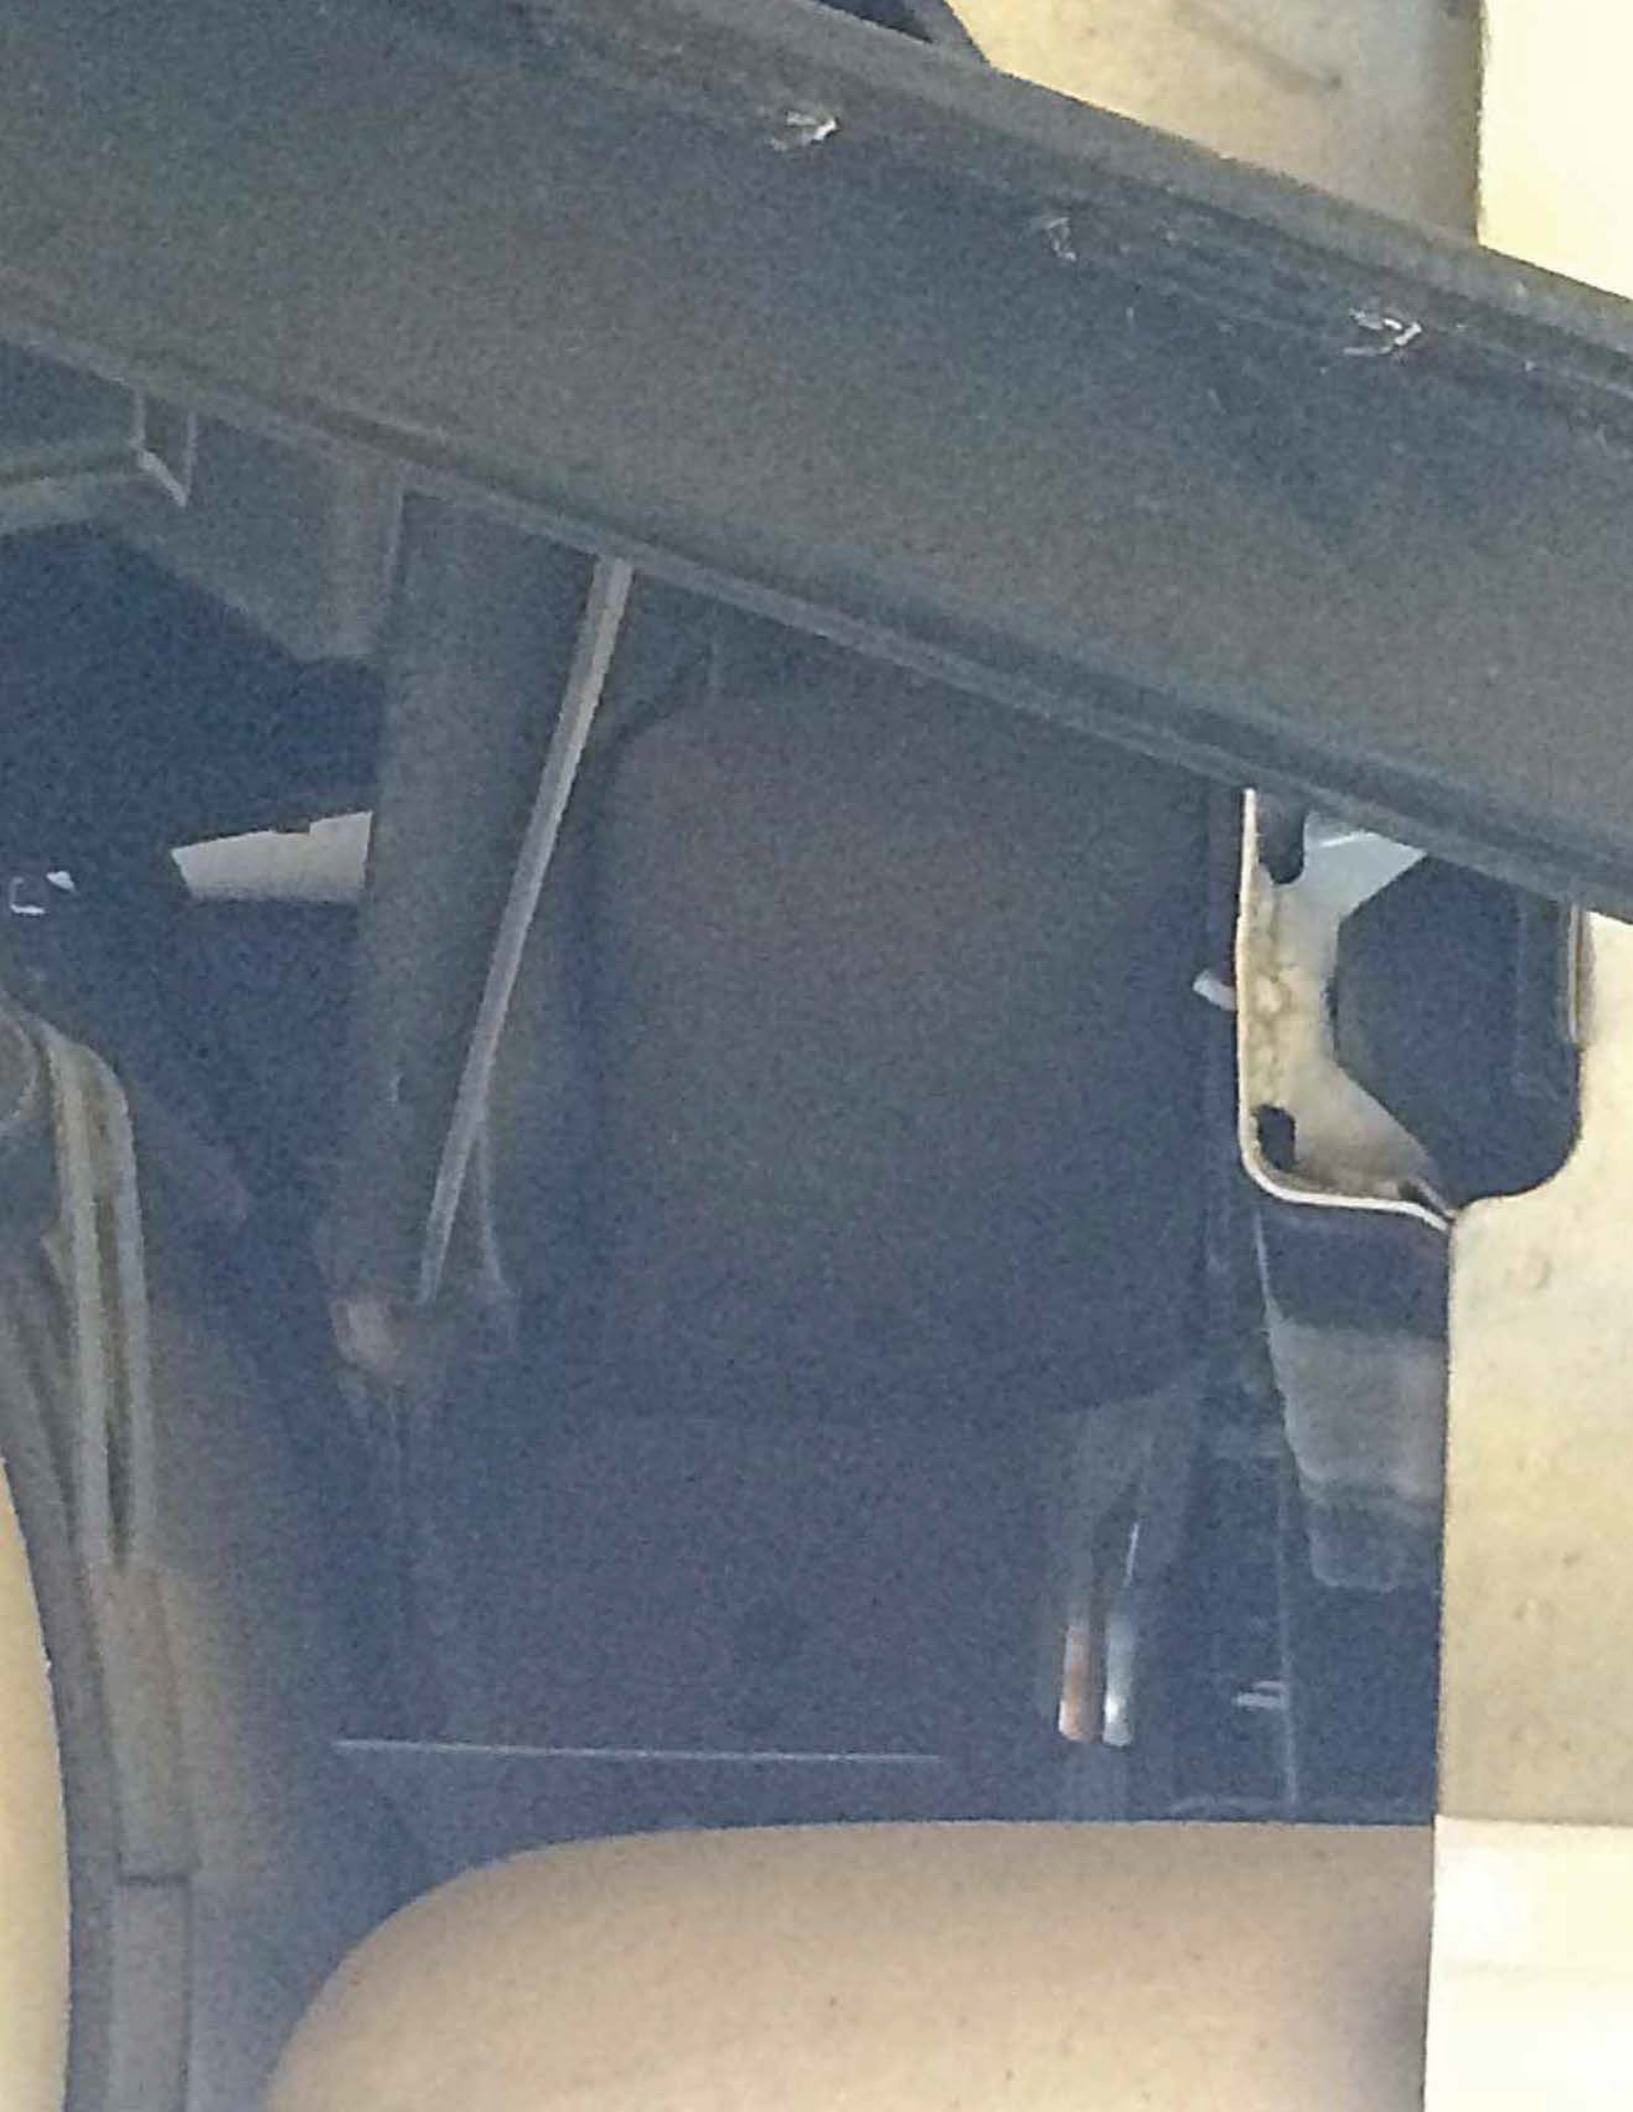
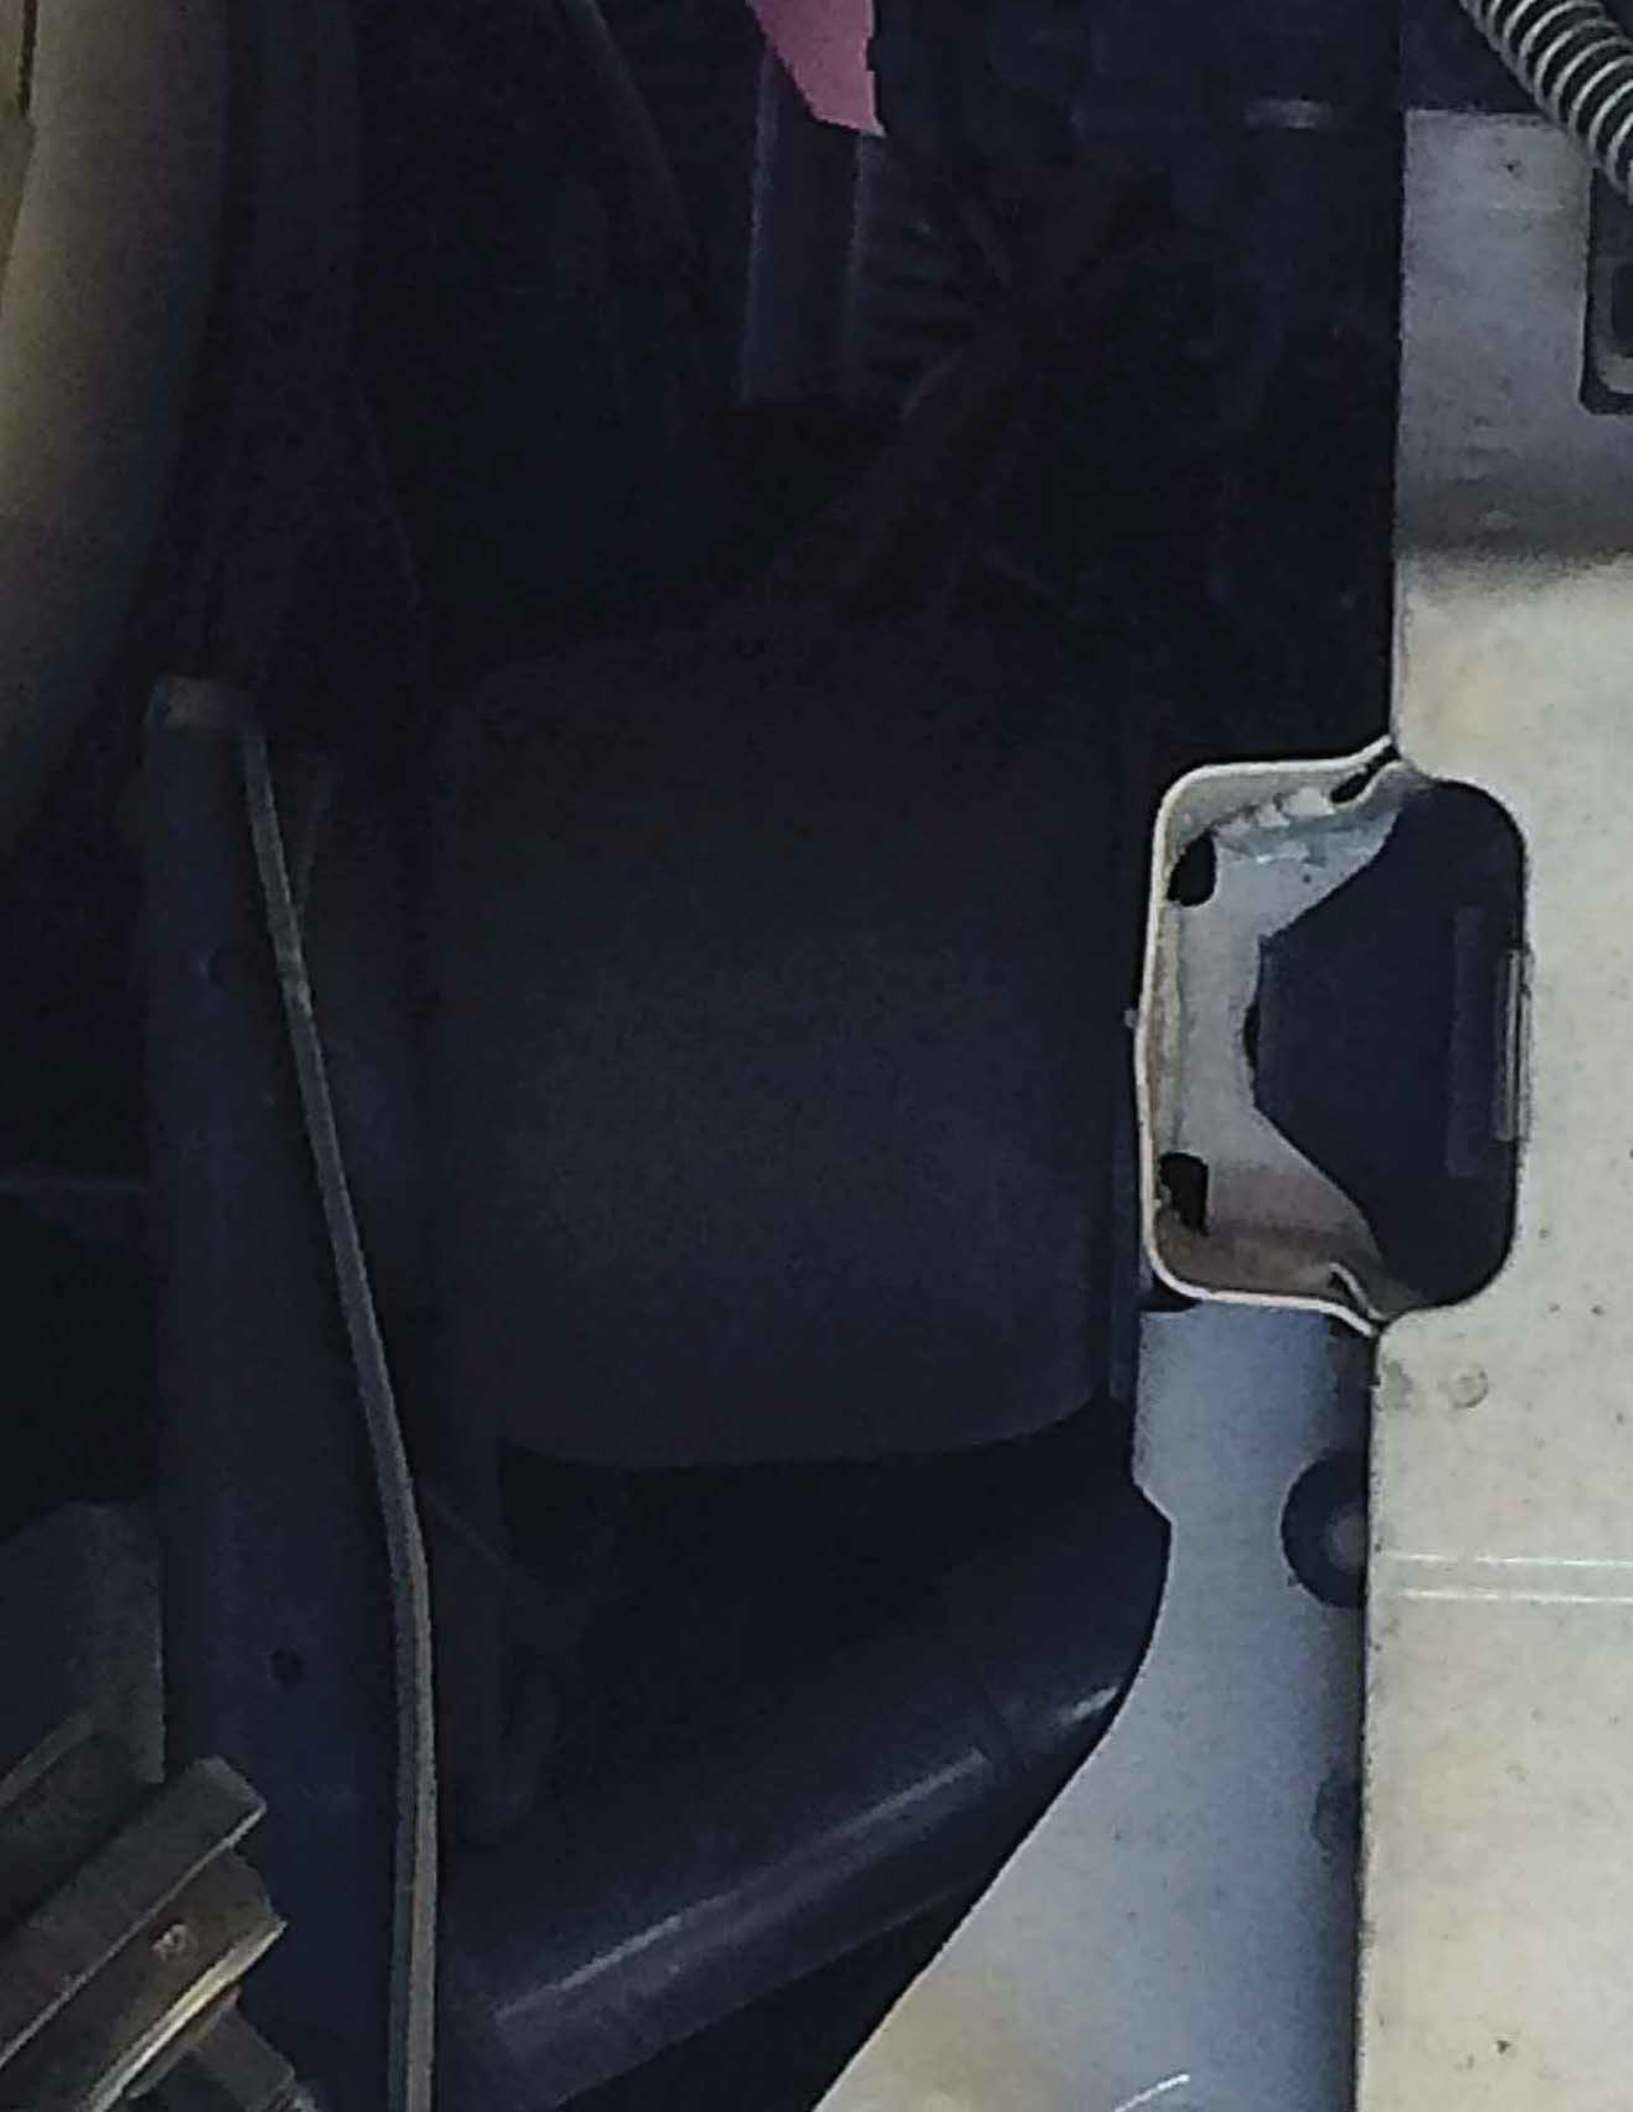
| 08/18/2014<br>17:50:36 | | Public | Work Performed | I REPLACED THE CAB TORSION SPRINGS CHECKED FOR CAB<br>ALIGNMENT BROUGHT THE CAB OVER TO SPEC TWICE BUT<br>THE CAB JUST WANTS TO SHIFT OVER TO THE LEFT SIDE |

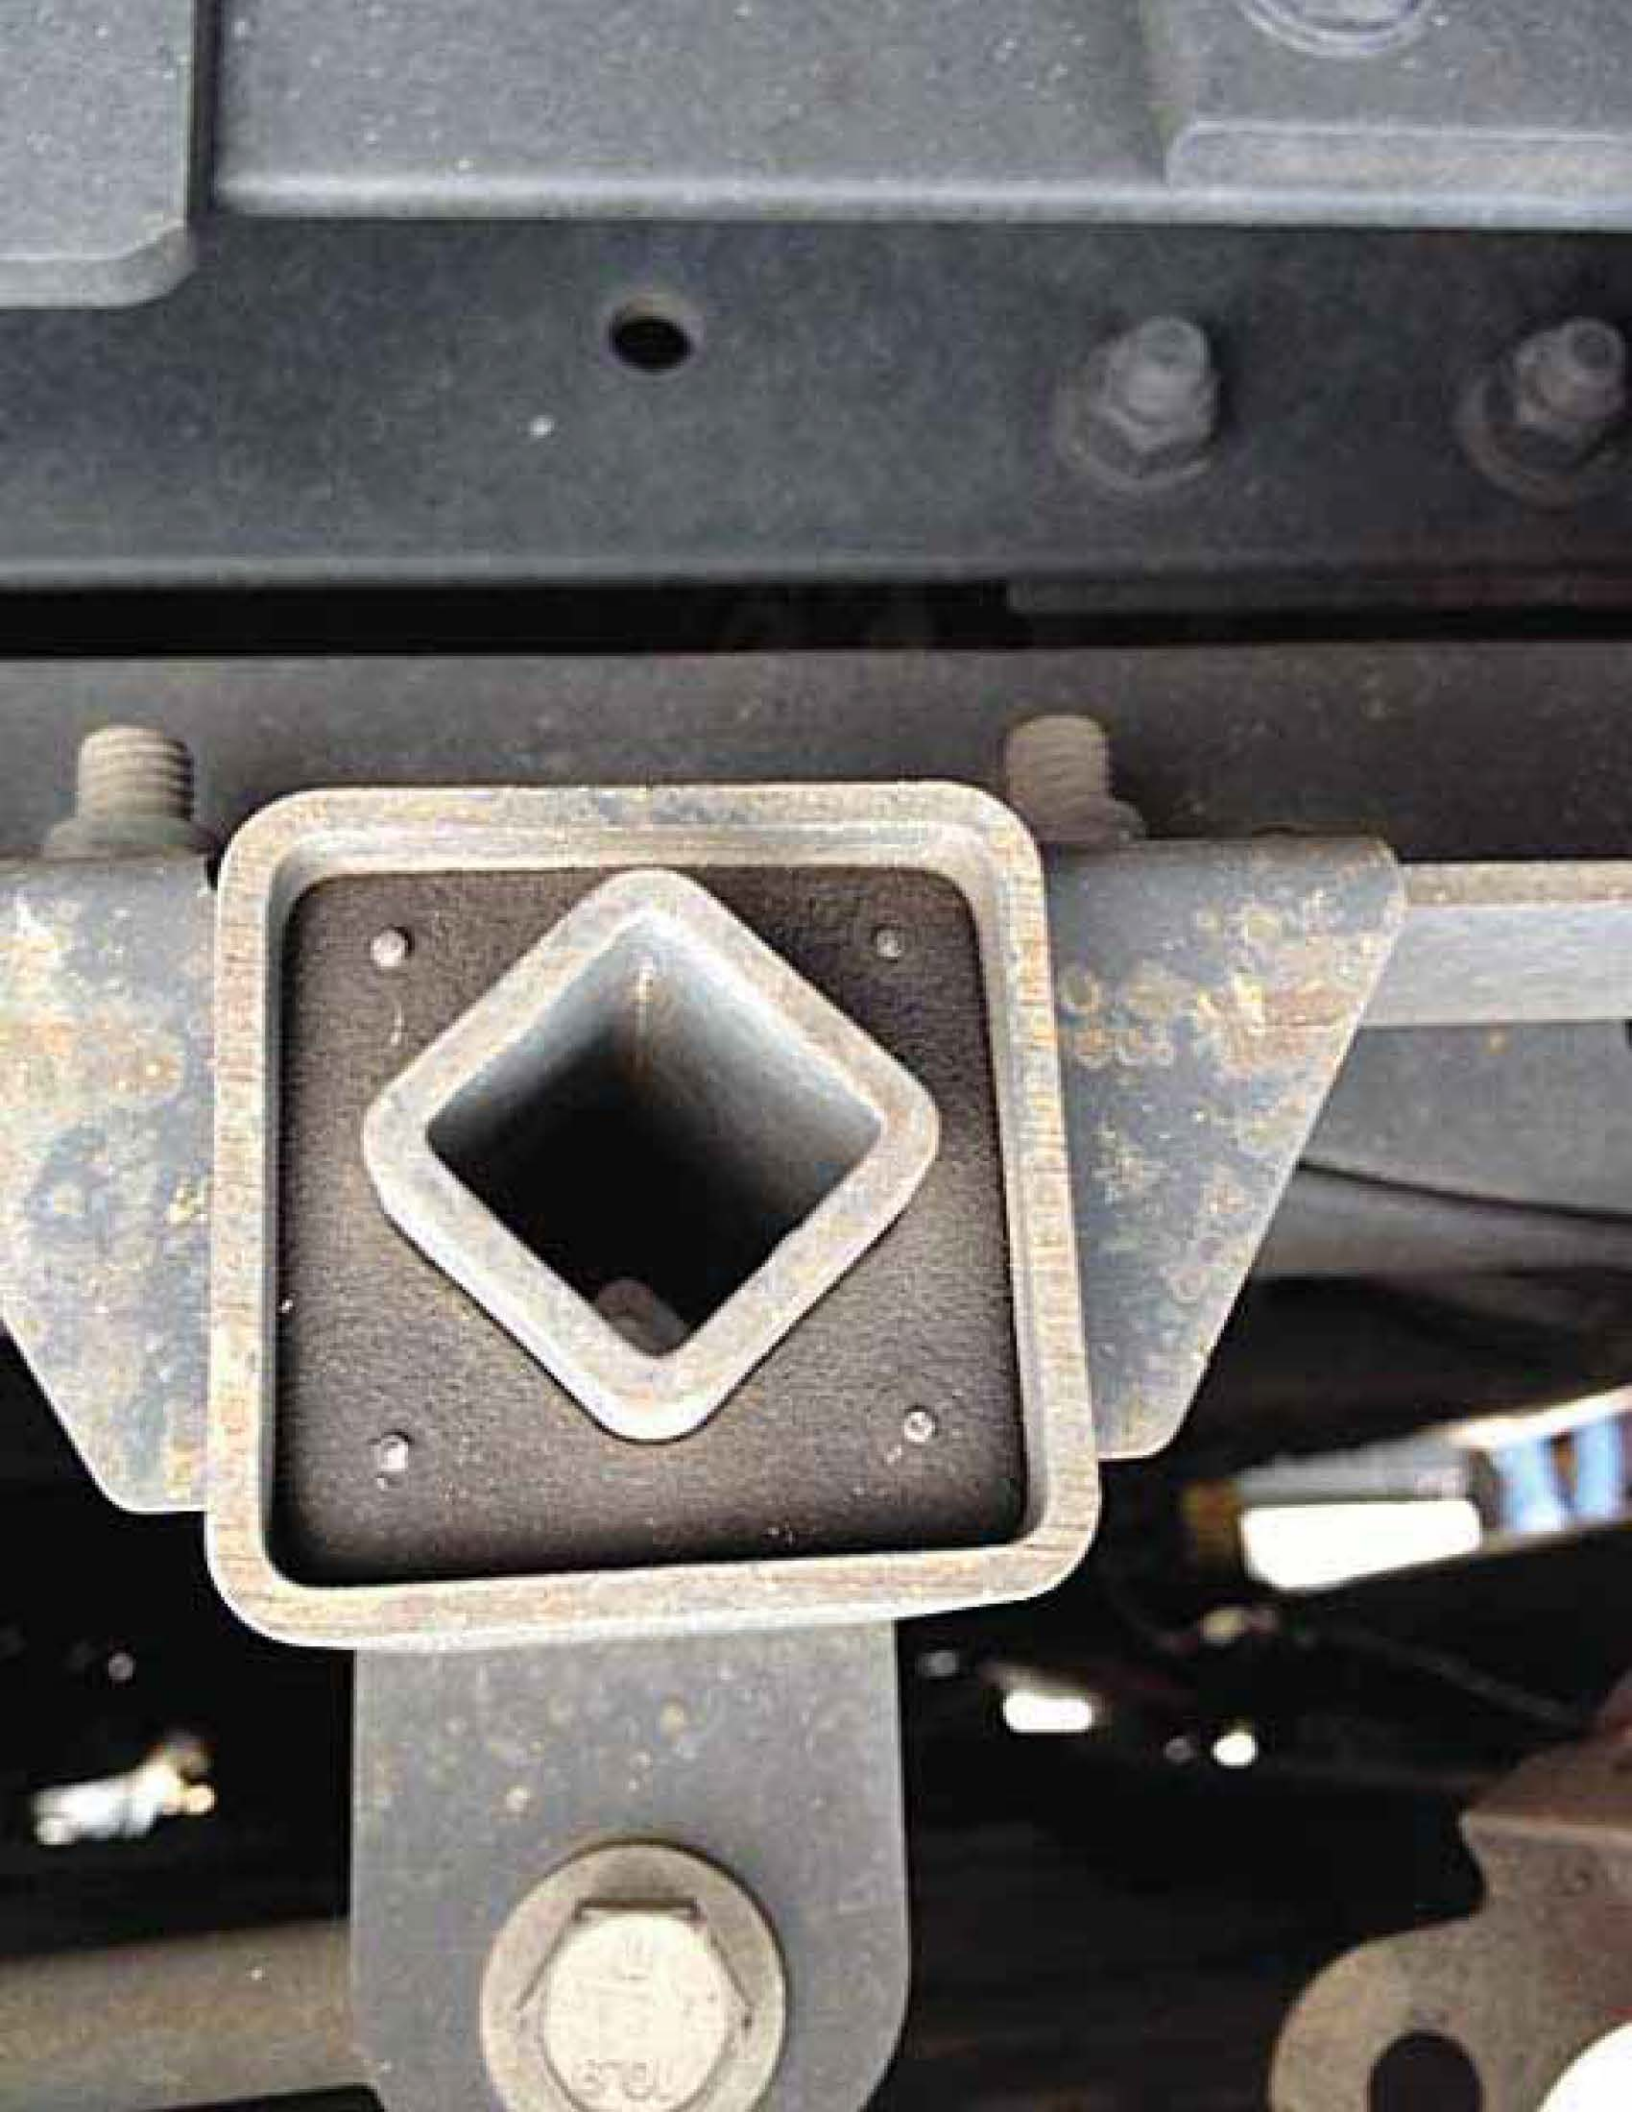
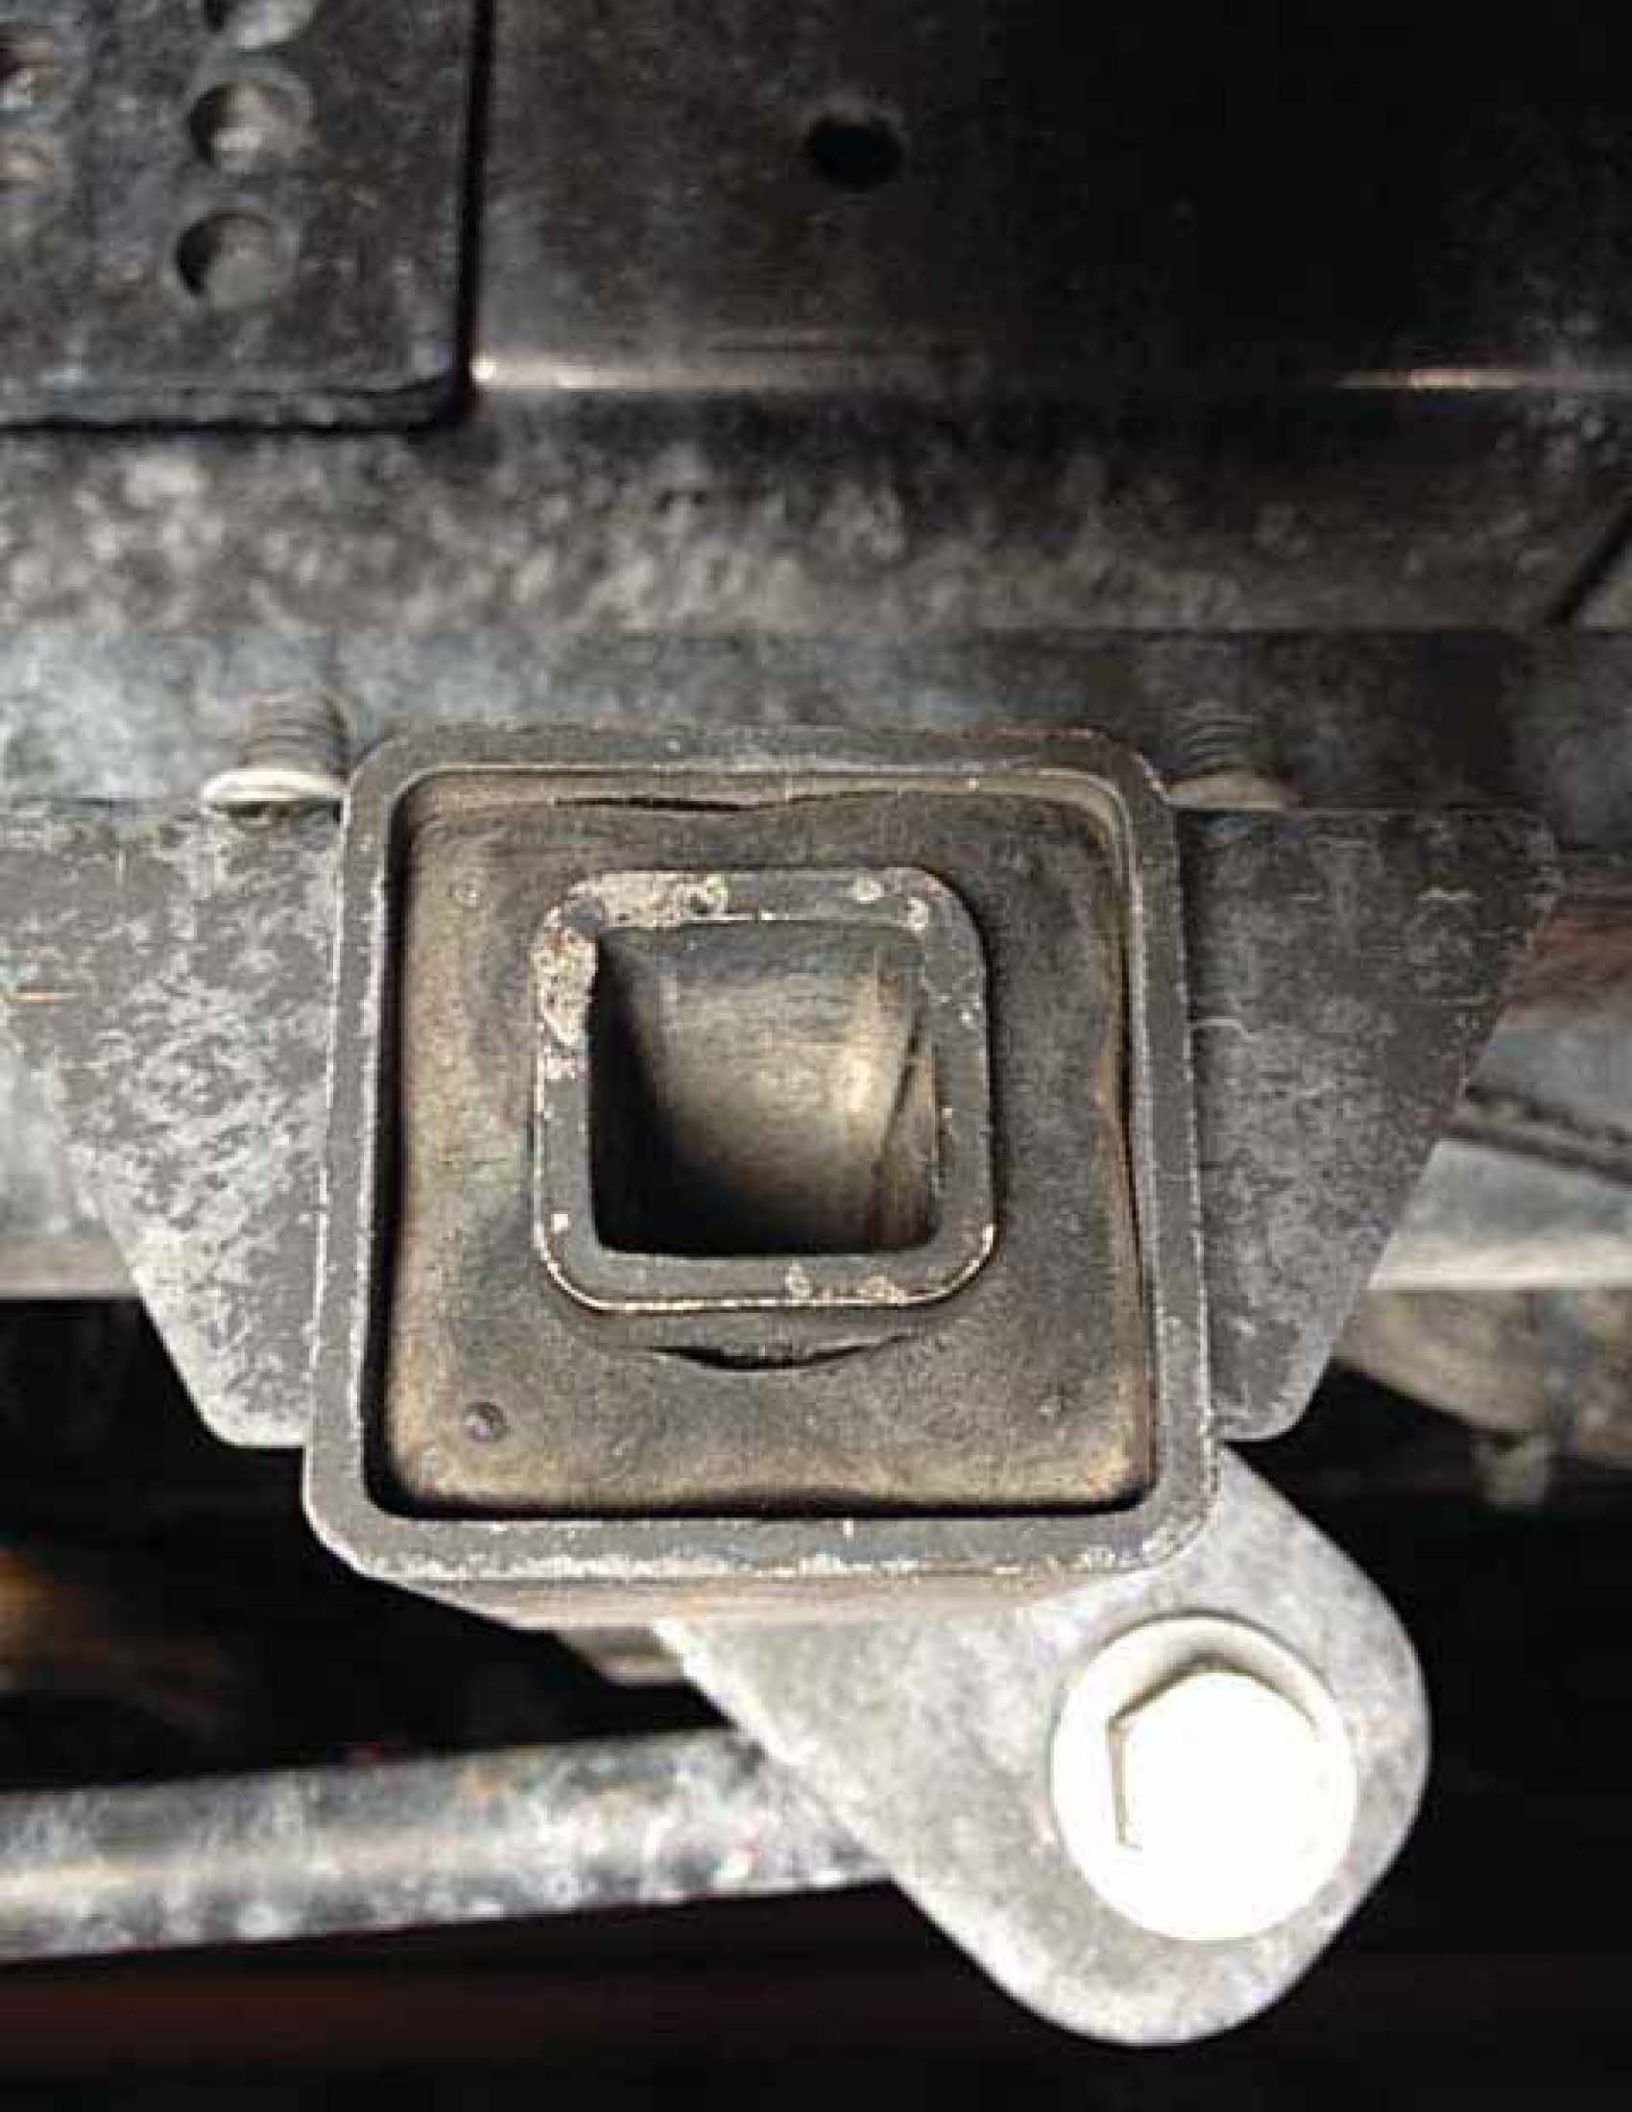
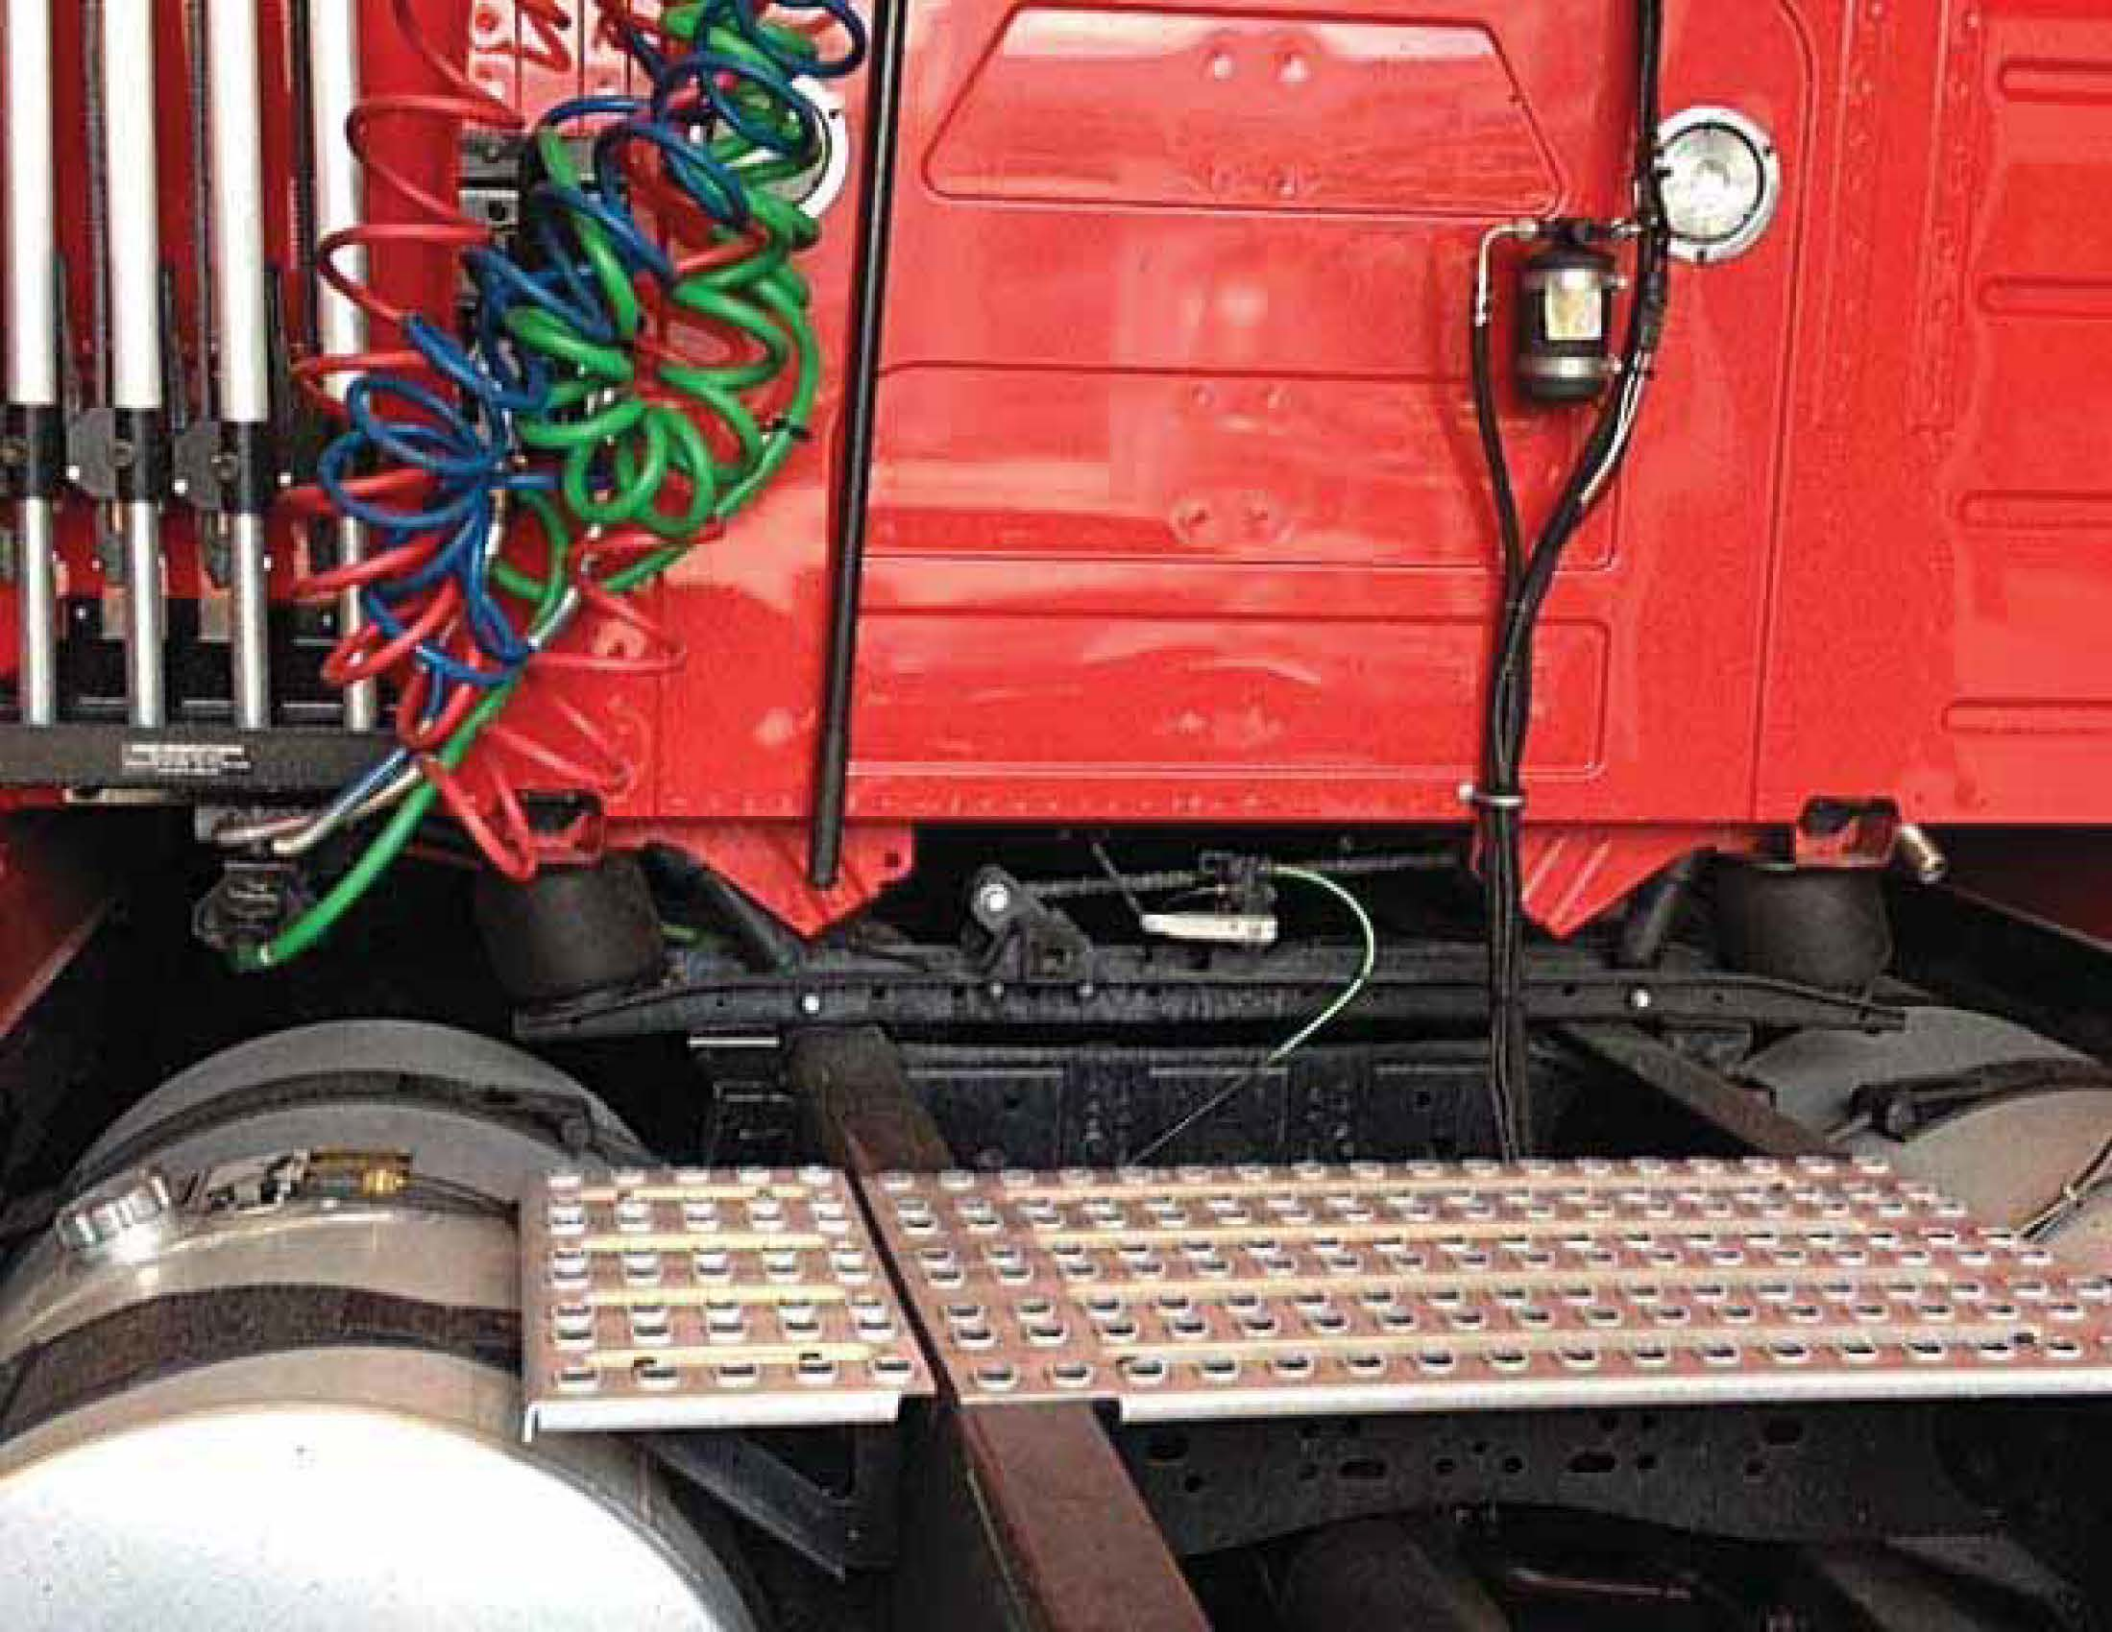
| Created | Created By | Audience | Activity Type | Comments |
|---|---|---|---|---|
| 07/23/2014 14:24:55 | | Public | Work Performed | i checked the front mounts and it seems ok. im attaching pics of the rear being shifted. please advise on possible repair. thanks MC |
