SPECTRA (LD) OCS Damage Inspection Results (Occupant Classification System)

01.09.2009

Quality Testing Team

To report warranty return part inspection results regarding North America LD Spectra Airbag Light ON Issue due to OCS damage

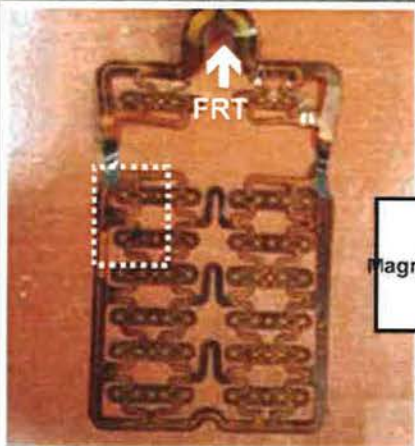
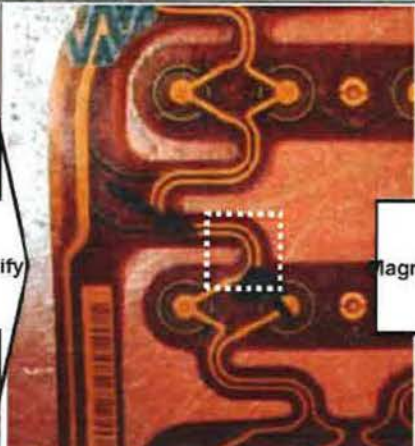
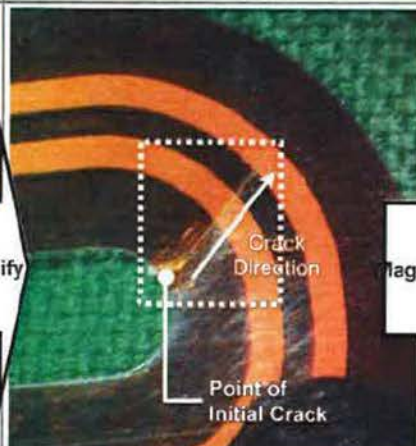
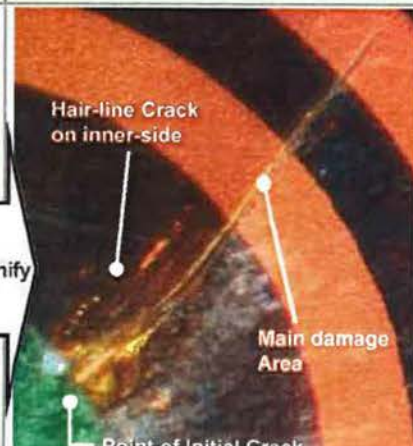
Category	Product Top View	Cracked Area	Cracked Bridge	Pattern of Crack
Pattern of Crack

Remarks	<ul style="list-style-type: none"> Found crack in left-front area of seat cushion 	<ul style="list-style-type: none"> Crack on the 3rd row bridge from the left 	<ul style="list-style-type: none"> Initial crack at the inner-side of bridge due to tensile stress Then, crack was expanded to the upper/outer side 	<ul style="list-style-type: none"> Identified hair-line crack near the initial point of crack - due to repeated weight pressure by angular objects
Conclusion	<ul style="list-style-type: none"> Crack was due to tensile stress on the corner area by weight pressure of angular objects
