# LD Spectra OCS Warranty Return Part Inspection Results

2015.10.07

Kia Quality Division  
Quality Assurance Team 2

## 1. Inspection Summary – To analyze the cause of Airbag Warning Light ON by inspecting OCS Warranty Return Parts

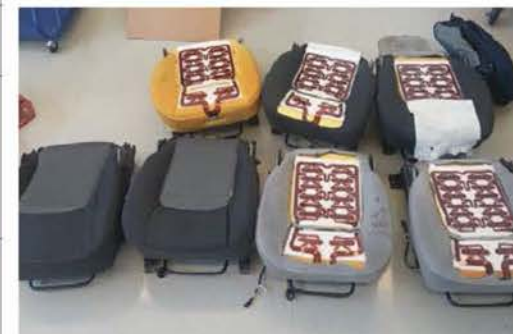
1. Shape/Form of damage: OCS circuit was damaged by repeated weight pressure on small affected areas or by sharp-edged objects
2. Damage Location: Each inspected part had different locations of damage

Damage by repeated weigh pressure on small area	Damage by sharp-edged objects

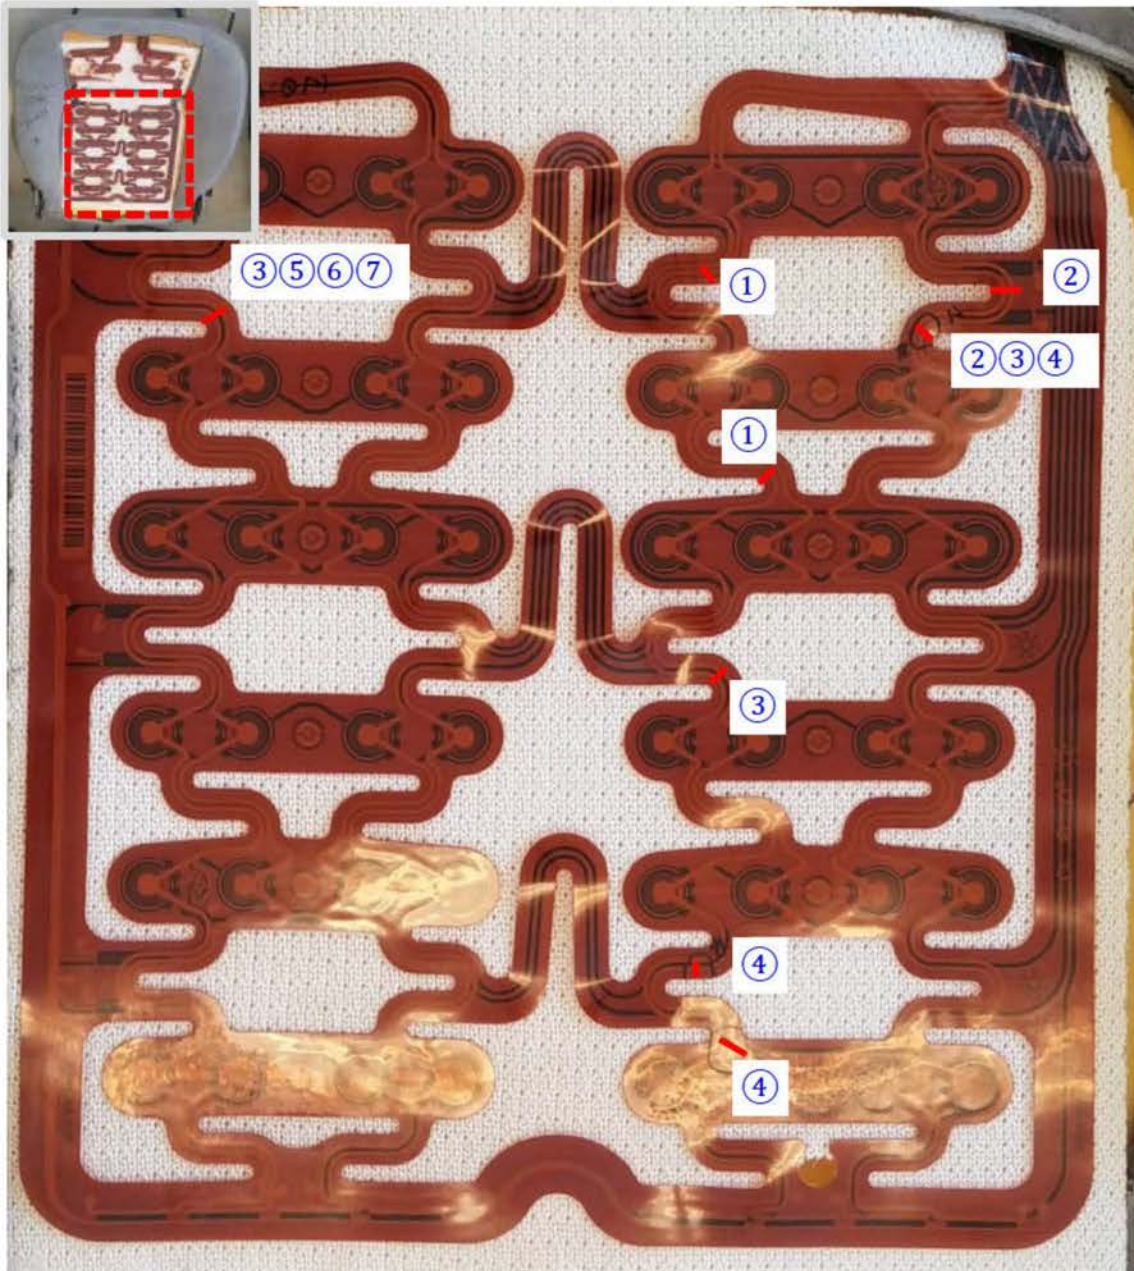
# ■ Circuit Disconnection Location by Inspected Parts

Return Part #	VIN	# of Circuit Breakages
①	KNAFE222X95 [REDACTED] (47,373 mile)	2
②	KNAFE161085 [REDACTED] (74,562 mile)	2
③	KNAFE221295 [REDACTED] (96,452 mile)	3
④	KNAFE222695 [REDACTED] (82,239 mile)	3
⑤	KNAFE241295 [REDACTED] (54,300 mile)	1
⑥	KNAFE161485 [REDACTED] (76,687 mile)	1
⑦	KNAFE241995 [REDACTED] (50,000 mile)	1

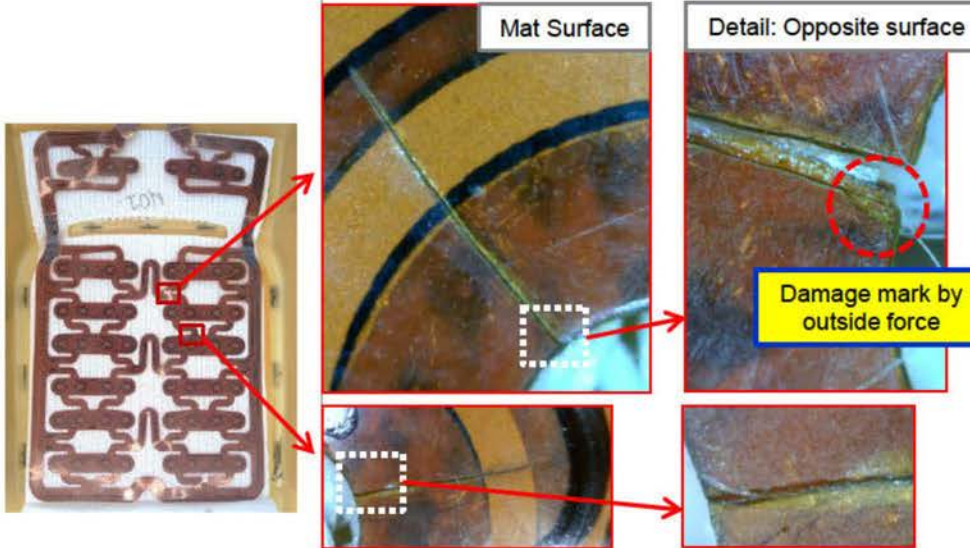
No.	Vehicle Info	Damage Location	Inspection Results
1	KNAFE222X95 (47,373 mile)

<ul style="list-style-type: none"> <li>• Determined as repeated weight pressure focused on a certain area by small-size object(s) damaged the mat sensor circuit                      - Inner-side was damaged first → expanded to outer-side</li> </ul>
2	KNAFE161085 (74,562 mile)

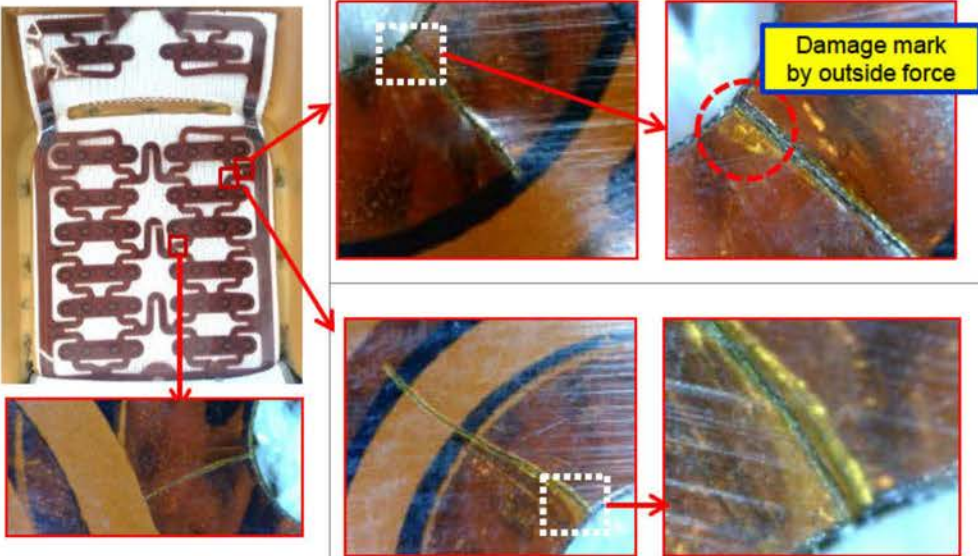
<ul style="list-style-type: none"> <li>• Determined as repeated weight pressure focused on a certain area by small-size object(s) damaged the mat sensor circuit                      - Inner-side was damaged first → expanded to outer-side</li> </ul>

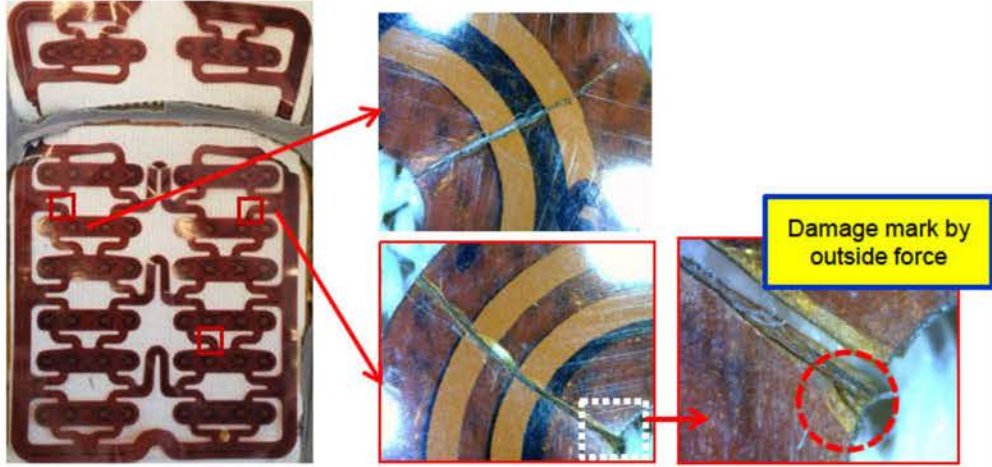
No.	Vehicle Info	Damage Location	Inspection Results
3	KNAFE221295 (96,452 mile)

<ul style="list-style-type: none"> <li>• Determined as repeated weight pressure focused on a certain area by angular object(s) damaged the mat sensor circuit                      - Inner-side was damaged first → expanded to outer-side</li> </ul>
4	KNAFE222695 (82,239 mile)

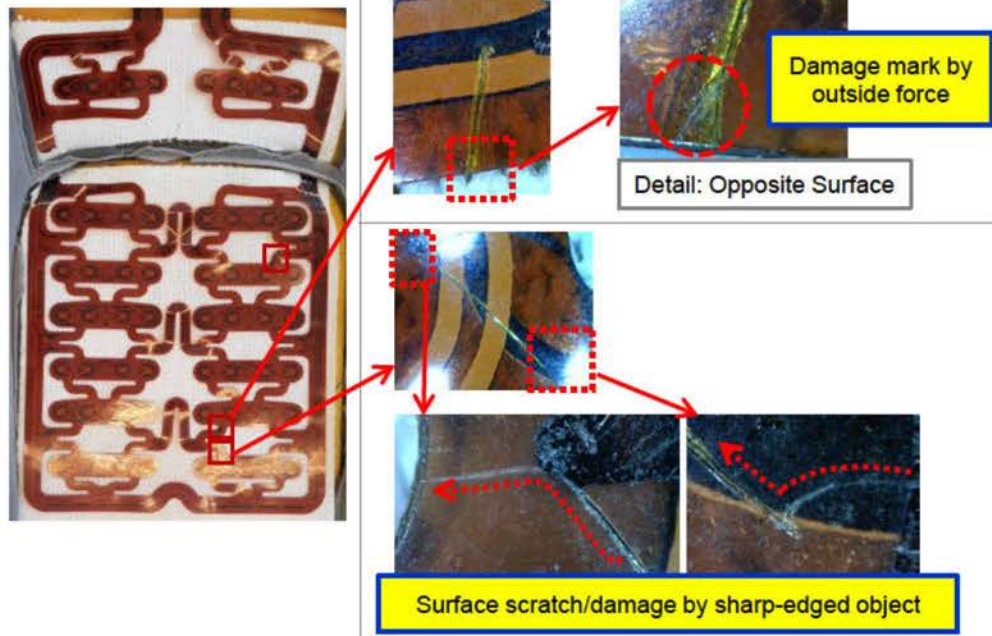
<ul style="list-style-type: none"> <li>• Determined as repeated weight pressure focused on a certain area by small-size object(s) damaged the mat sensor circuit                      - Inner-side was damaged first → expanded to outer-side</li> <li>• Identified scratch mark by sharp &amp; pointy object(s) which possibly damaged the mat sensor circuit</li> </ul>

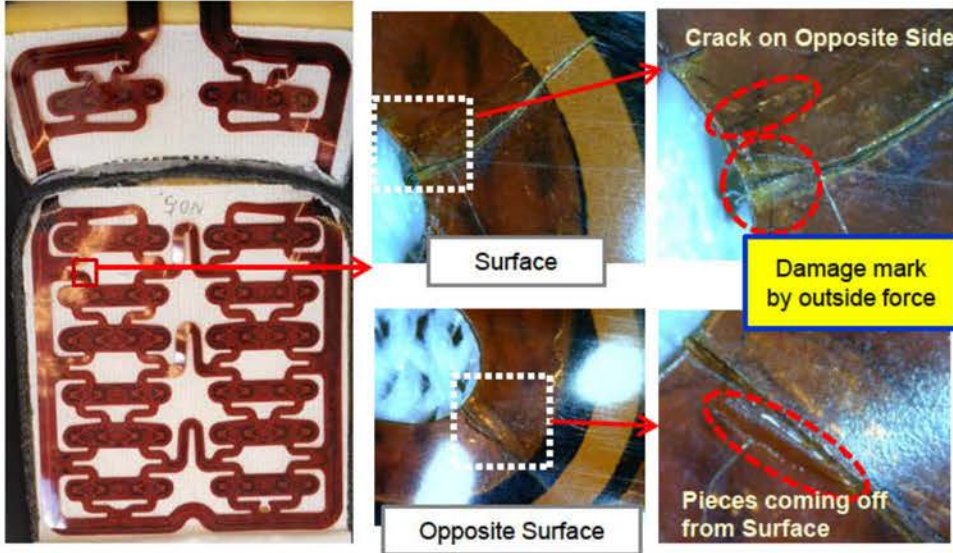
No.	Vehicle Info	Damage Location	Inspection Results
5	KNAFE24129 (54,300 mile)

<ul style="list-style-type: none"> <li>• Determined as direct weight pressure by small-size object(s) cracked the mat sensor circuit</li> <li>• Determined that damages started at crack are due to repeated weight pressure on the damaged area                             <ul style="list-style-type: none"> <li>- Inner-side was damaged first → expanded to outer-side</li> </ul> </li> </ul>
6	KNAFE161485 (76,687 mile)

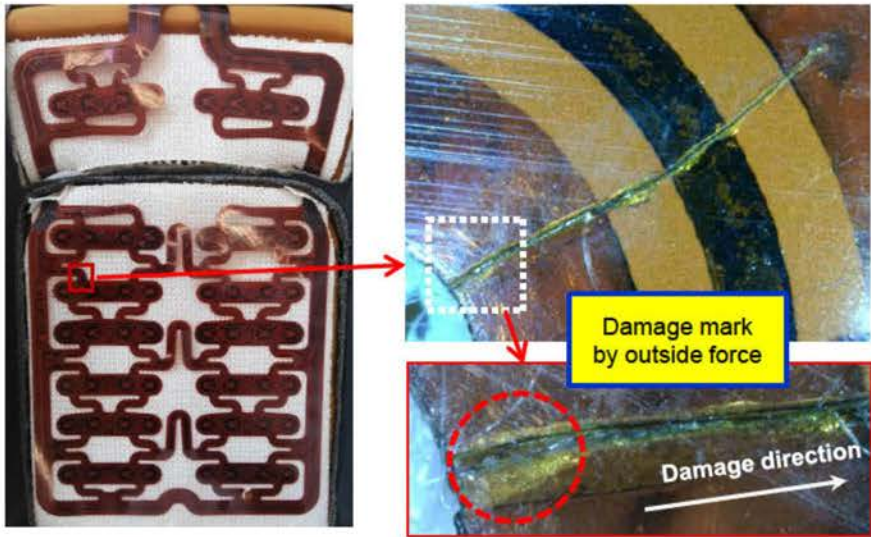
<ul style="list-style-type: none"> <li>• Determined as direct weight pressure focused on a certain area by small-size object(s) distorted and damaged the mat sensor circuit                             <ul style="list-style-type: none"> <li>- V-shaped distortion observed around the damaged area</li> </ul> </li> </ul>

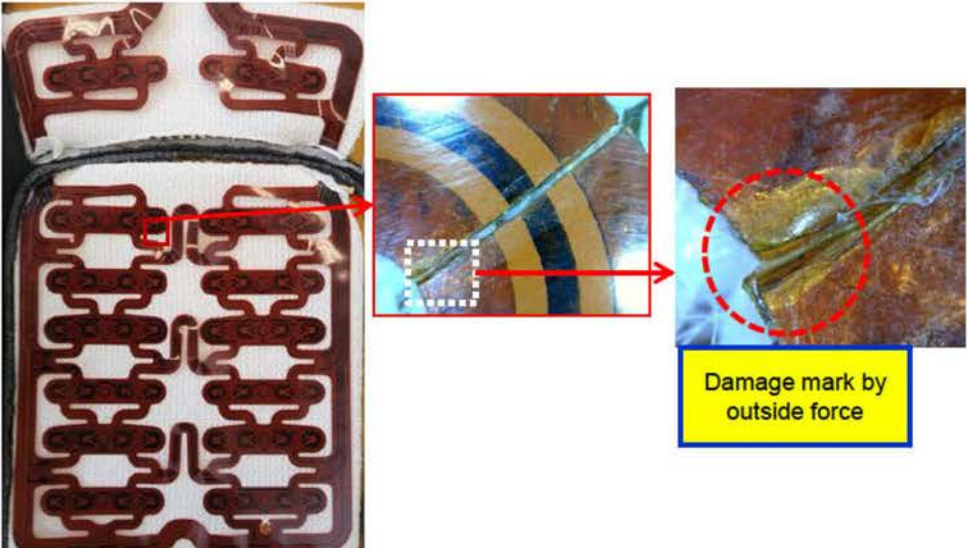
No.	Vehicle Info	Damage Location	Inspection Results
7	KNAFE241995 (50,000 mile)

<ul style="list-style-type: none"> <li>Determined as direct weight pressure focused on a certain area by angular object(s) damaged the mat sensor circuit</li> <li>- Straight-line shaped damage</li> </ul>

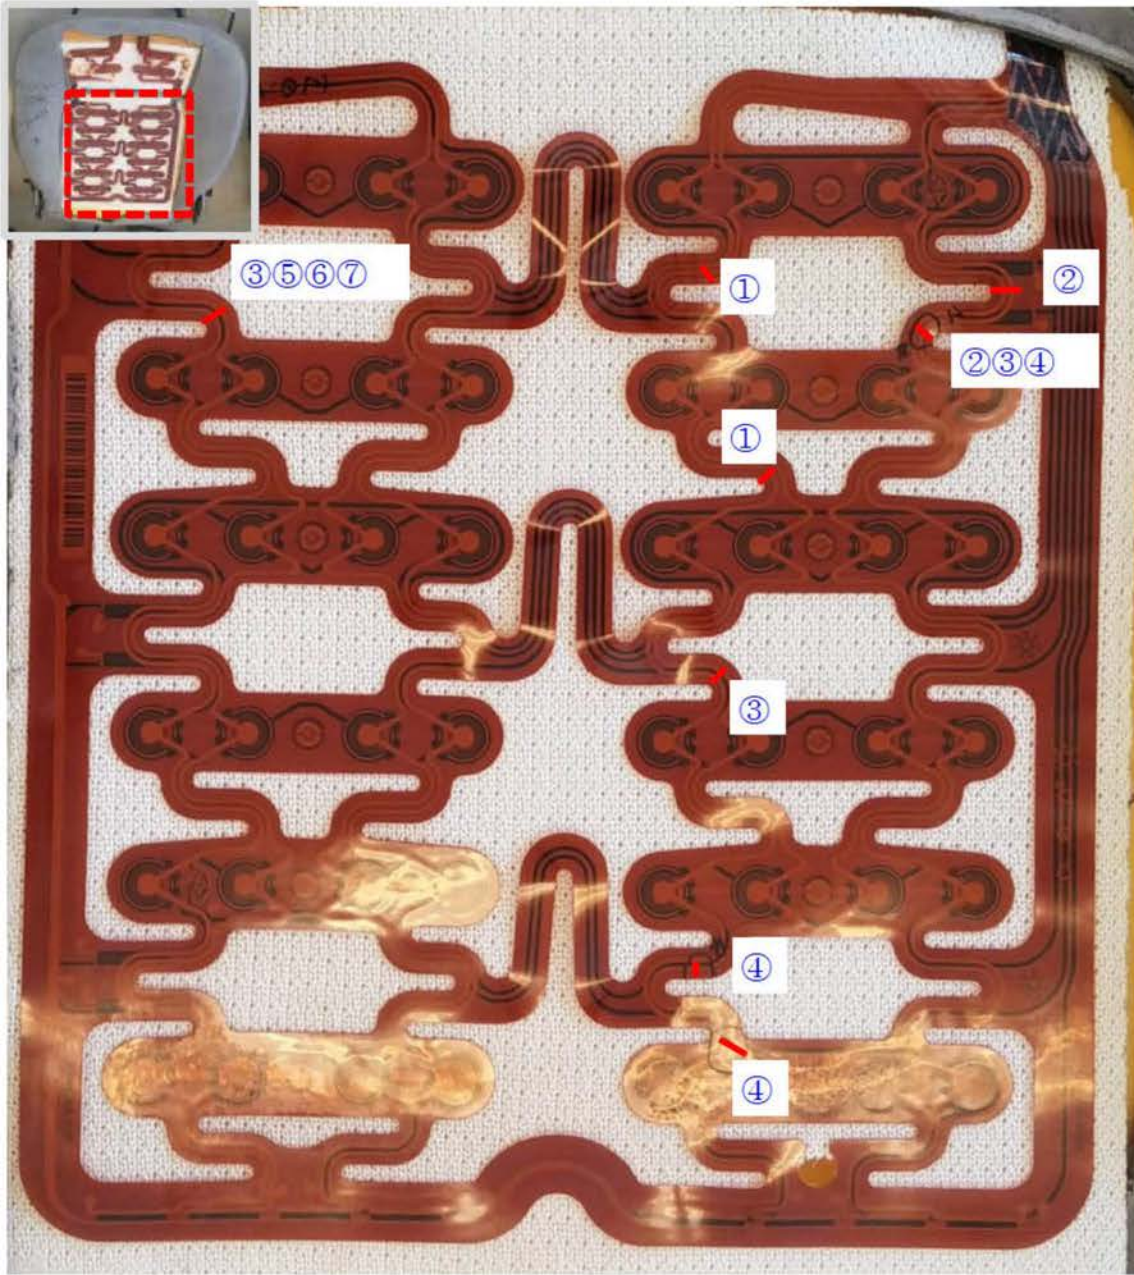
고품별 단선 발생부위

고품 NO	VIN	회로 단선 (발생 개수)
①	KNAFE222X95 [REDACTED] (47,373 mile)	2
②	KNAFE161085 [REDACTED] (74,562 mile)	2
③	KNAFE221295 [REDACTED] (96,452 mile)	3
④	KNAFE222695 [REDACTED] (82,239 mile)	3
⑤	KNAFE241295 [REDACTED] (54,300 mile)	1
⑥	KNAFE161485 [REDACTED] (76,687 mile)	1
⑦	KNAFE241995 [REDACTED] (50,000 mile)	1

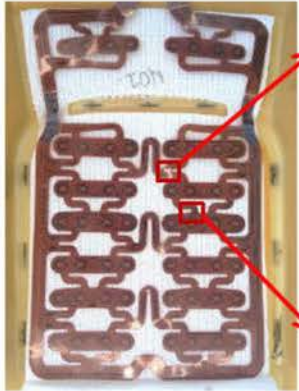
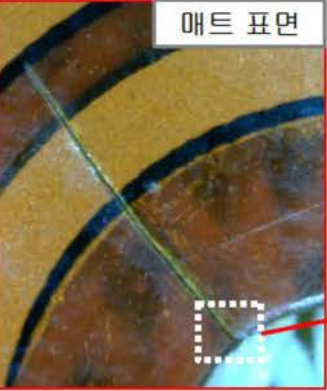
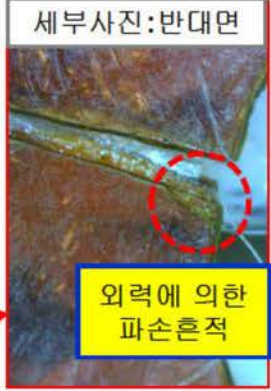
No.	차량정보	고품 - 발생부위		분석내용
1	KNAFE222X95 (47,373 mile)

</div> </div> <div style="text-align: center; margin-top: 10px;"> <p>외력에 의한 파손흔적</p>

</div>	<ul style="list-style-type: none"> <li>면적이 좁은 물체가 특정 부위에 하중을 집중 시켜 매트 인장에 의한 파손 판단됨</li> <li>- 내측 최초 파손 → 외측으로 전이</li> </ul>
2	KNAFE161085 (74,562 mile)

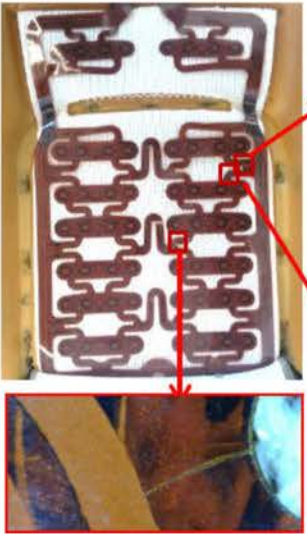
<div style="text-align: center; margin-bottom: 10px;"> <p>외력에 의한 파손흔적</p>

</div> </div>	<ul style="list-style-type: none"> <li>면적이 좁은 물체가 특정 부위에 하중을 집중 시켜 매트 인장에 의한 파손 판단됨</li> <li>- 내측 최초 파손 → 외측으로 전이</li> </ul>
