Navistar, Inc.  
2701 Navistar Drive  
Lisle, IL 60532 USA

Ref.: NVS-213  
PE15-013phk

This letter is in response to your letter of July 29, 2015 requesting information for a Preliminary Evaluation to investigate allegations of accelerator pedals that do not return completely to an idle position in certain Navistar trucks and busses built since 2011 that use the Williams throttle control unit.

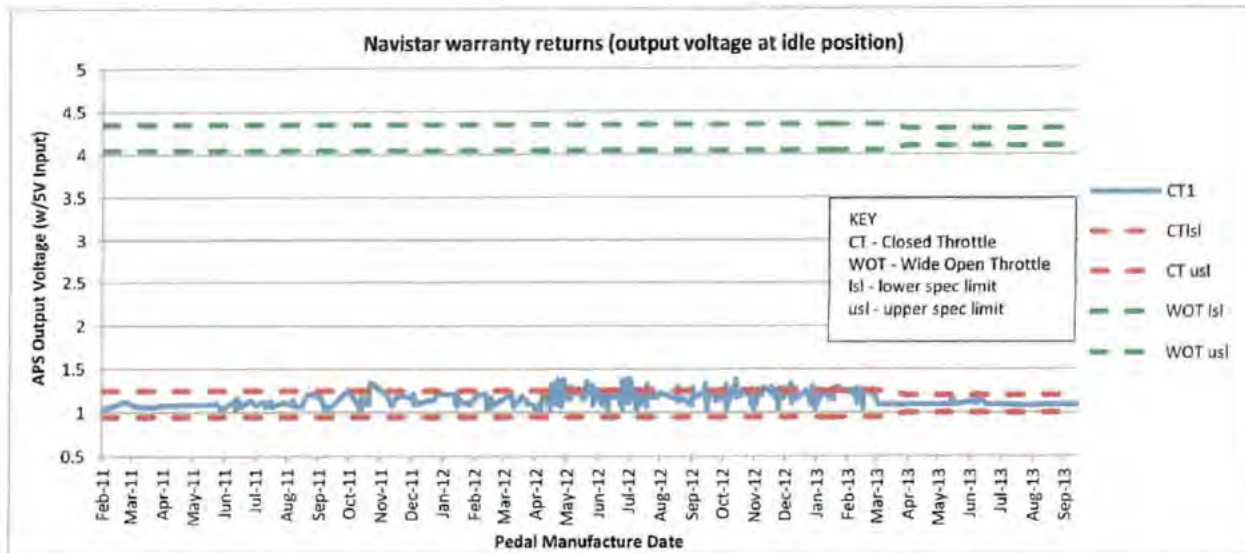
In summary, the accelerator pedal in question was cause for a number of the complaints due to slightly elevated accelerator pedal sensor voltage output levels at the closed throttle (CT) position causing an increase in the idle speed. This phenomenon with the pedal does not, and cannot occur at any position other than at the idle position. The chart below shows the output voltage of the CT position of 496 returned accelerator pedals by pedal manufacture date. The chart shows the increased voltage output within a small band slightly above the intended idle position. Also evident in the chart is the number of alleged accelerator pedals with slightly elevated CT output increased in the May 2012 timeframe and the number decreased in the March 2013 timeframe.

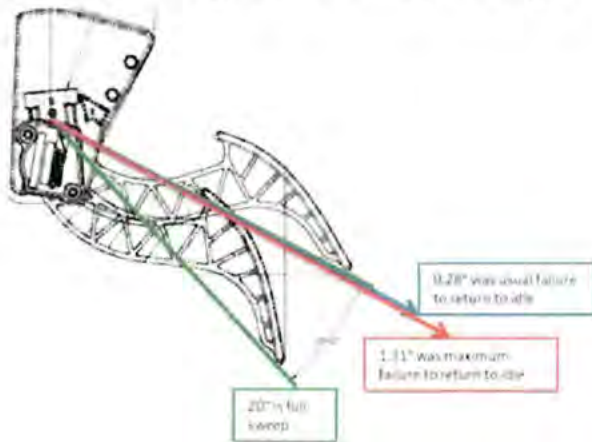
This issue physically equates to a maximum of 1.31 degrees of increased pedal angle at the CT position relative to a 20 degree accelerator pedal angle associated with the full throttle position.

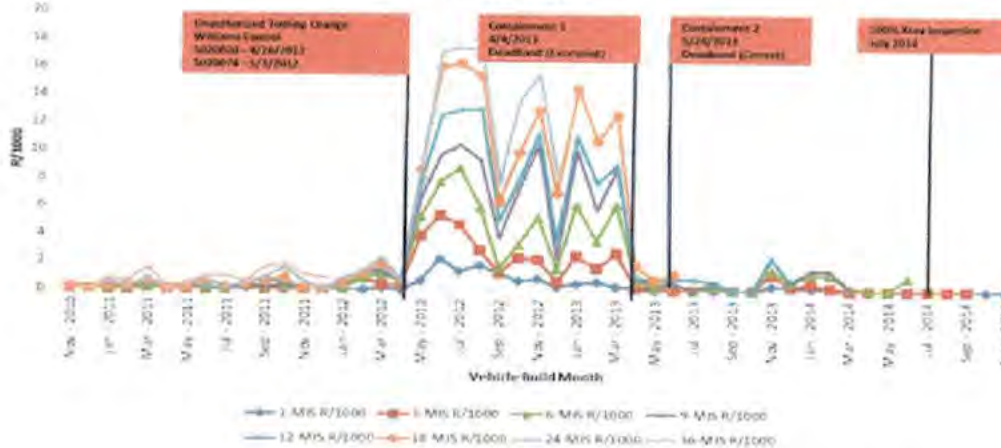
### Sticky APS R/1000 Trend chart, US/CAN

The Chart below shows the repairs per 1000 vehicles by vehicle build date. This clearly shows the increased APS warranty repairs for various "months in service" (MIS) for vehicles built in the April 2012 to March 2013 timeframe which corresponds to the April 26, 2012 tooling change by Williams Controls and the updates implemented on April 4, 2013.

The increased warranty during this timeframe was what drove the change request (Pyxis Concern) which was included in Navistar's third quarter 2013 TREAD report. The resulting investigation and correction of the accelerator pedal issue has resulted in having only 17 related warranty claims on vehicles built since January 1, 2014.
