**National Highway
Traffic Safety
Administration**

ODI RESUME

Investigation: PE 16-006
Date Opened: 06/14/2016
Investigator: Kareem Habib
Approver: Michael Brown
Subject: Yaw rate sensor malfunction

Manufacturer: Toyota Motor Corporation
Products: MY2001-2002 Toyota Sequoia
Population: 133,279

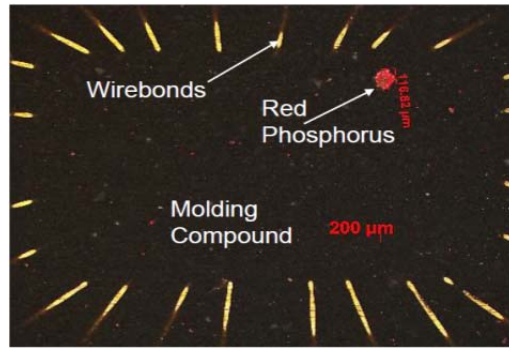
Figure 1

Recovered yaw sensors showing evidence of field failures were purchased from complaint vehicles by ODI in order to be analyzed, tested and cross sectioned to identify all sensor failure mechanisms. Recovered part analysis performed on all 5 sensors collected from the field indicated a shorting condition due to silver migration resulting in an erroneous sensor output signal. Cross sectioning showed evidence of flame retardant red phosphorus particles of varying size and voids (see figure 1) in the sensor digital potentiometer Integrated Circuit (IC) plastic molding compound. Optical images and electron microscopy identified a failure mechanism related to electrochemical migration resulting in an intermittent shorting condition between the IC adjacent pins.

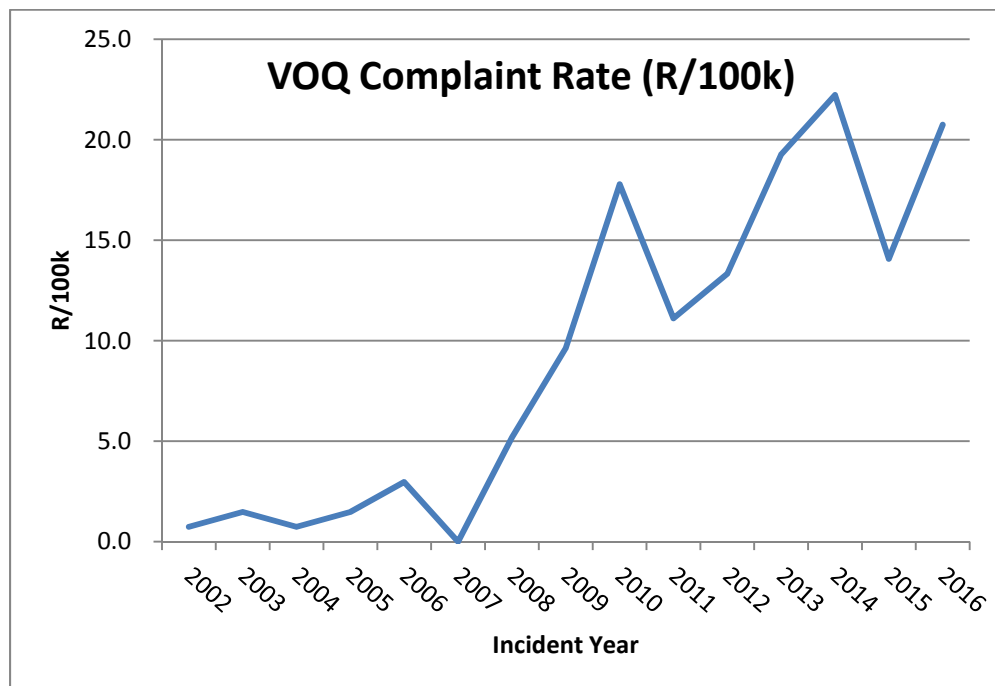
Figure 2

Teardown analysis indicated that when the sensor is exposed to heat and humidity especially over the vehicle lifecycle, red phosphorus may form an electrolytic combination of phosphine gas and phosphoric acid resulting in extremely low leakages currents due conductive filaments and corrosion. Heat and humidity effects on sensor field life are confirmed in complaint data with 72 percent of complaints are related to hot and humid states. Complaint incident dates indicated that sensor malfunctions related to Phosphorus Flame Retardants may take approximately 7 years of field exposure to manifest any intermittent shorting conditions due to migration, see figure 2. Toyota and its suppliers, Continental and Analog Devices, changed the molding compound from Phosphorus Flame Retardant (PFR) to non-PFR effective October 2002.

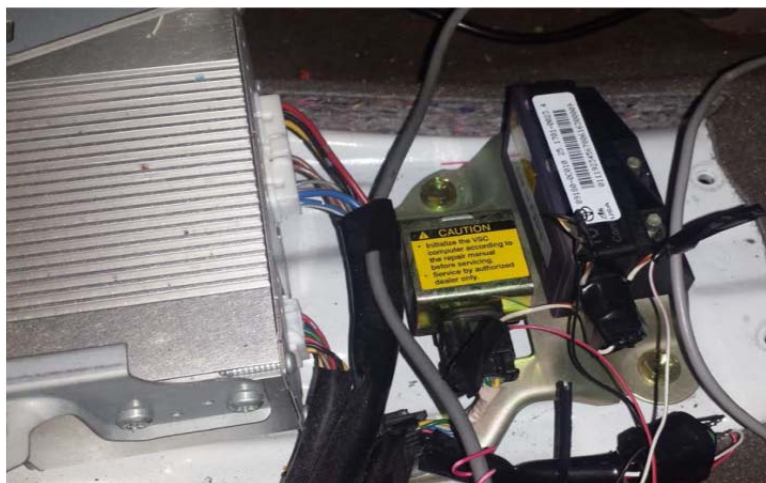
Figure 3

Vehicle testing performed at NHTSA Vehicle Research and Transportation Center (VRTC) and conducted by simulating various yaw rate sensor offset conditions during driving maneuvers and vehicle speeds could not yield any significant path deviation or vehicle deceleration as a result of inappropriate VSC interventions. Failure cases of the yaw rate sensor attempted to reproduce vehicle owner complaints and extensive evaluation of the VSC fault detection logic was conducted using modified yaw rate data with a failure signal routed into the VSC controller, see figure 3. Testing results showed that no VSC intervention related to sensor malfunctions in straight line driving, understeer or oversteer conditions caused any vehicle directional changes that were likely to result in lane departure or difficulty controlling the vehicle. The longest VSC intervention occurred with yaw sensor output below 10deg/sec and resulted in pulsed brake application to the front right wheel for approximately 15 second under straight steady driving conditions above 30mph. Under these conditions, the offset steering torque required to maintain vehicle direction is consistent with a vehicle pull condition that a customer may experience due road crowns, crosswind or wheel misalignment. In the event the operator does not maintain control of the vehicle by keeping his hands on the wheel, small changes in the vehicle direction of travel may occur which may be counteracted by small steering angles. VSC interventions due to yaw sensor offset conditions above 10deg/sec are extremely brief lasting no more than a fraction of a second resulting in abrupt noise and vibration from the steering wheel (frequently reported as steering wheel jerk by the driver) without any effects on vehicle steering or controllability.
