**National Highway  
Traffic Safety  
Administration**

## ODI RESUME

**Investigation:** PE 16-015

**Subject:** Powered vehicle rollaway

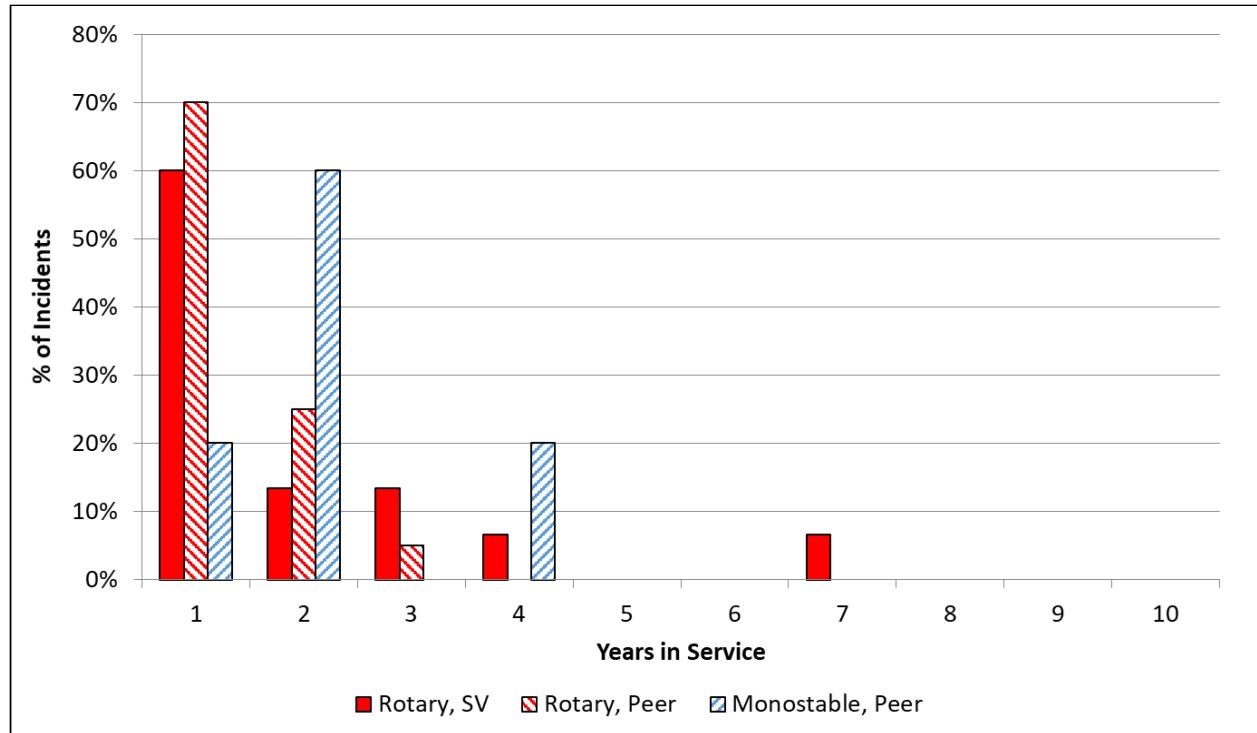
Figure 3. Distribution of incidents by gear selector and vehicle age.

Table 1 provides a breakdown of total field incidents of rollaway in the subject vehicles, peer rotary shift vehicles and peer monostable shift vehicles by platform. As noted, the data show disproportionate experience for the subject Range Rover Evoque vehicles. The experience is biased to early-life incidents, with 60 percent of the subject vehicle incidents occurring in the first 12 months of service (Figure 3). Subject and peer vehicles all show relatively low field experience over the most recent 36 months (Table 2). ODI has not received any new complaints of the alleged defect in the subject vehicles since PE16-015 was opened. JLR has received just one complaint of the alleged defect in the subject vehicles in the past 54 months.

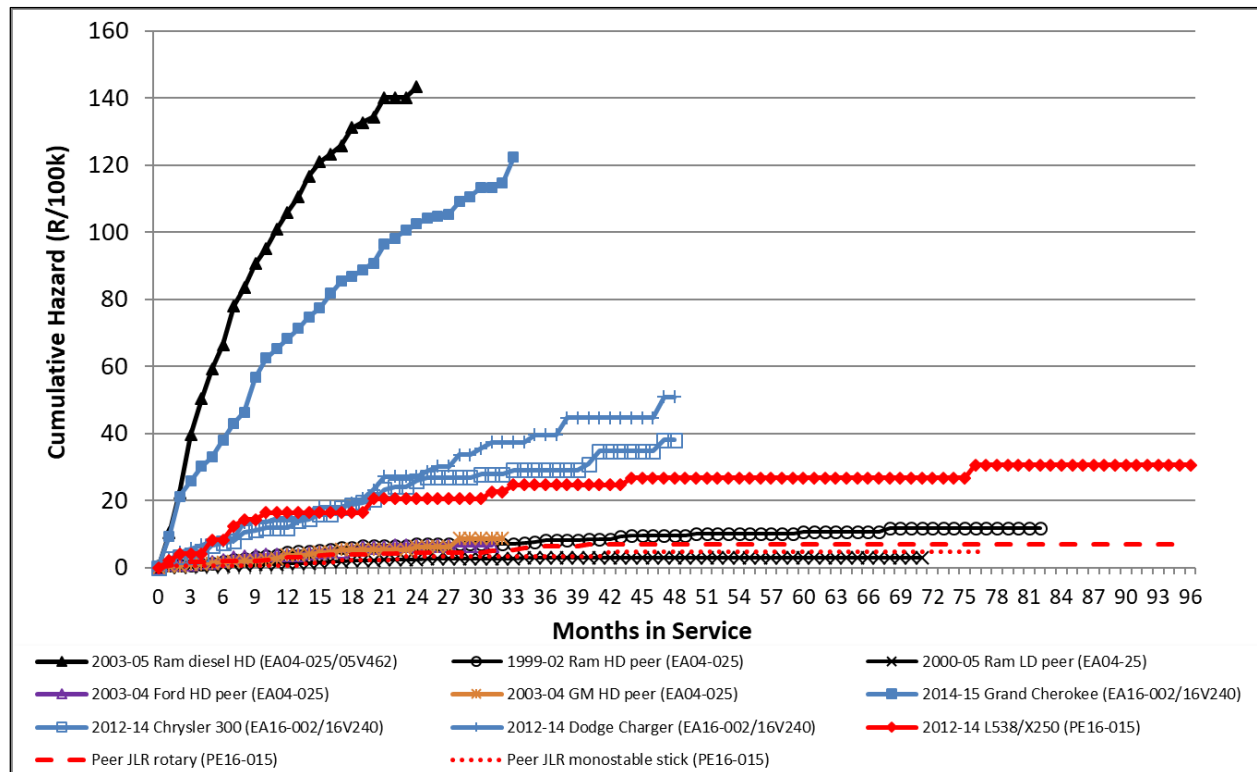
Figure 4. Cumulative hazard analysis in comparison with prior powered rollaway investigations.

Figure 4 compares the failure rates for the vehicles recalled in 05V-462 and 16V-240 with the subject vehicles, peer rotary vehicles, and peer monostable vehicles. None of the JLR vehicles analyzed by ODI showed failure trends as high as the vehicles that were the primary focus of EA04-025 and EA16-002. As previously noted, the subject vehicles showed an early-life trend through the first year of service. No design or HMI factor has been identified to explain the difference between the subject and peer rotary vehicles. Similar to other analyses discussed in 7.0 Field Data, the subject and peer vehicles show no evidence of a defect trend over the past three to four years.
