## PE16-014 Closing Resume Summary Details Dodge Durango / Ram 1500 Vehicle Rollaway

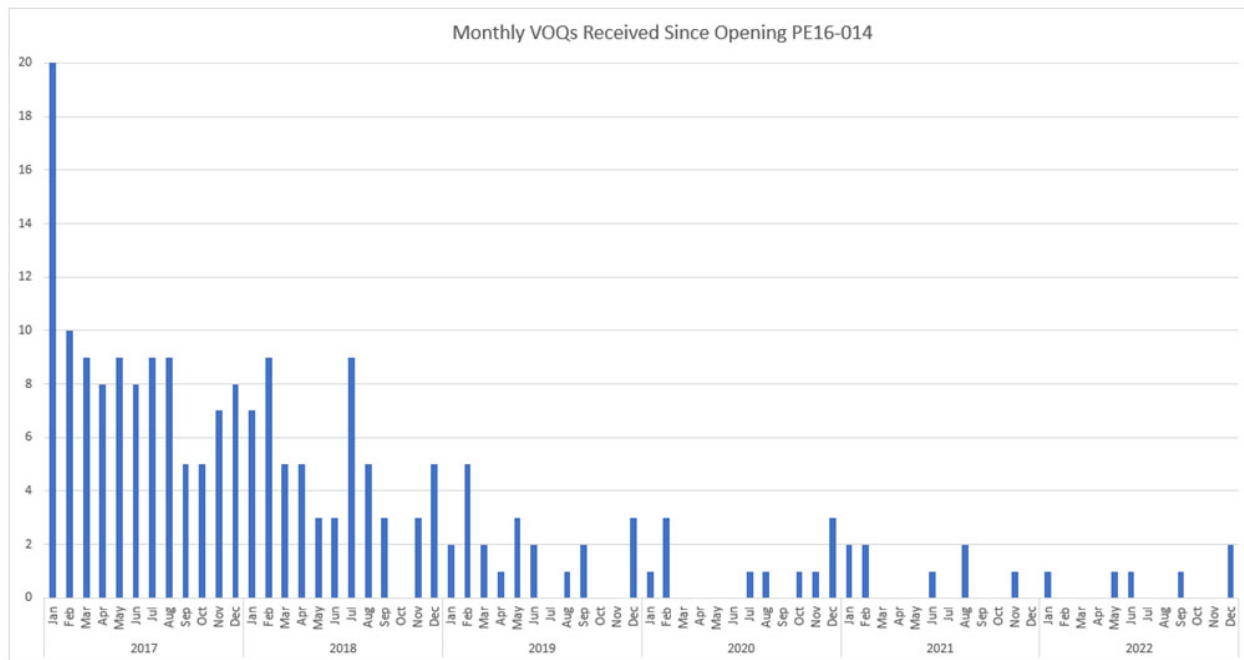
**Graph 1.**

**Complaint History** – During the course of this investigation, NHTSA has seen a decrease in the rate of consumer complaints. NHTSA believes that the decrease is due to the FCA CSN actions as well as consumers becoming more familiar with the rotary shifter functionality. The below graph illustrates the decrease in consumer complaints received by the Agency.
