PE16-008

Technical Service
Bulletins

TSB 12-12-04

2011-2013 Explorer

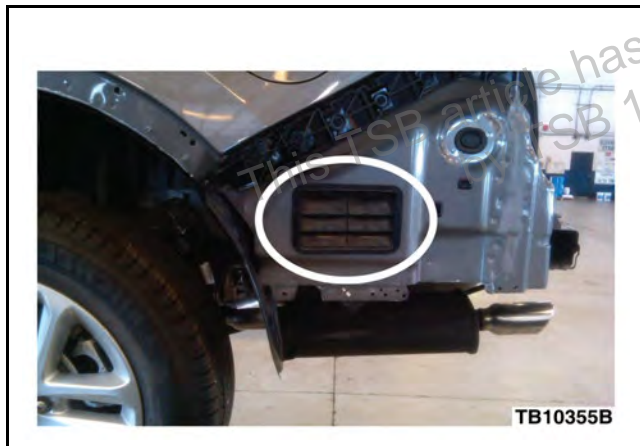
Figure 1 - Article 12-12-4

Some 2011-2013 Explorer vehicles may exhibit an exhaust odor in the vehicle with the auxiliary climate control system on. Customers may indicate the odor smells like sulfur.

1. Remove the rear bumper cover. Refer to Workshop Manual (WSM), Section 501-19.
2. Replace the left side rear air extractor. (Figure 1)

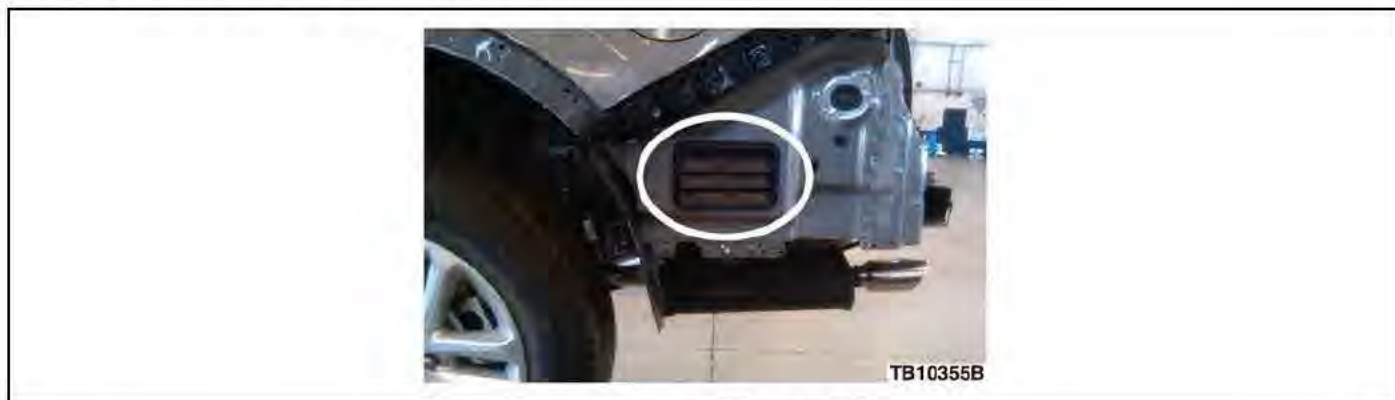
Figure 1 - Article 14-0130

Some 2011-2015 Explorer vehicles may exhibit an exhaust odor in the vehicle with the auxiliary climate control system on. Customers may indicate the odor smells like sulfur.

1. Reprogram the Heating Ventilation Air Conditioning (HVAC) module to the latest calibration using IDS release 91.02 or higher. Calibration files may also be obtained at www.motorcraftservice.com.
 - a. When reprogramming the HVAC, IDS will have additional questions that require a yes response to reprogram the module.
2. Remove the rear bumper cover. Refer to Workshop Manual (WSM), Section 501-19.
3. Replace the left side rear air extractor. (Figure 1)
